Highway–Railroad Grade Crossing Collision  
Rosedale, Maryland  
May 28, 2013

NTSB/HAR-14/02  
PB2014-109131

# Highway Accident Report

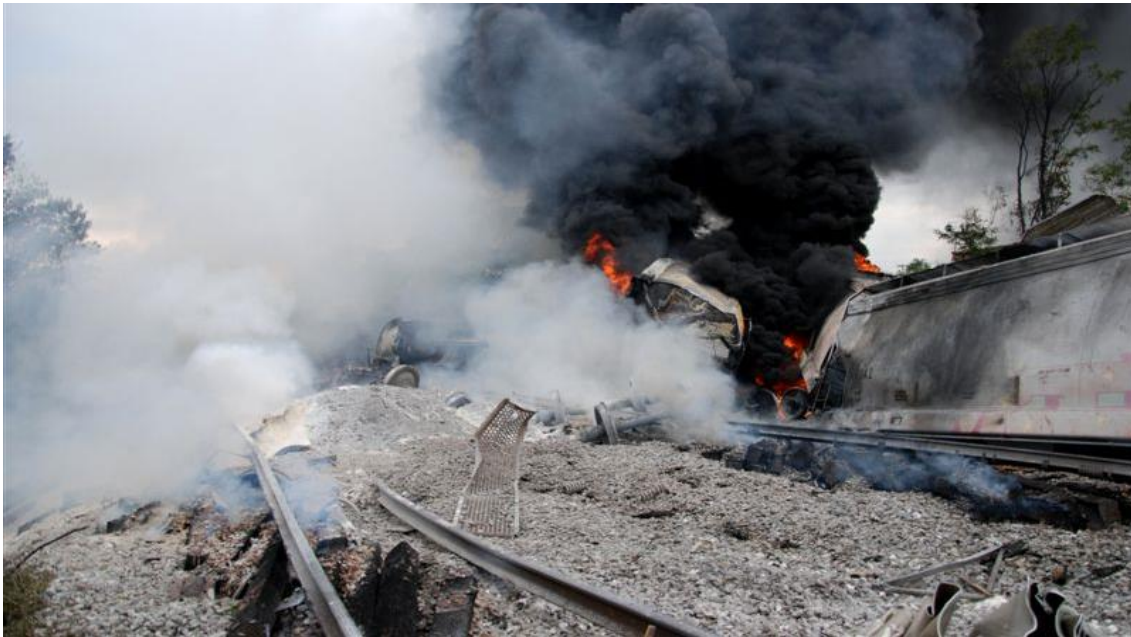
At 3:10 p.m., 1 hour and 10 minutes following the crash, the BCFD, CSXT, and the MDE–Emergency Response Division first responders jointly entered the hazmat exclusion zone to inspect the scene and conduct a photographic survey. They discovered that two rail cars containing terephthalic acid (cars 9 and 10) were burning and severely damaged (see figure 3). Because the air monitoring did not detect any substances that were a threat to public health, the IC decided to “allow the product to burn off” until responders could identify and confirm all of the materials.<sup>10</sup> As a precaution, the IC issued a voluntary evacuation of the adjacent community.

**Figure 3.** Burning rail cars containing terephthalic acid, May 28, 2013, 3:14 p.m.  
(Source: Maryland Department of the Environment)

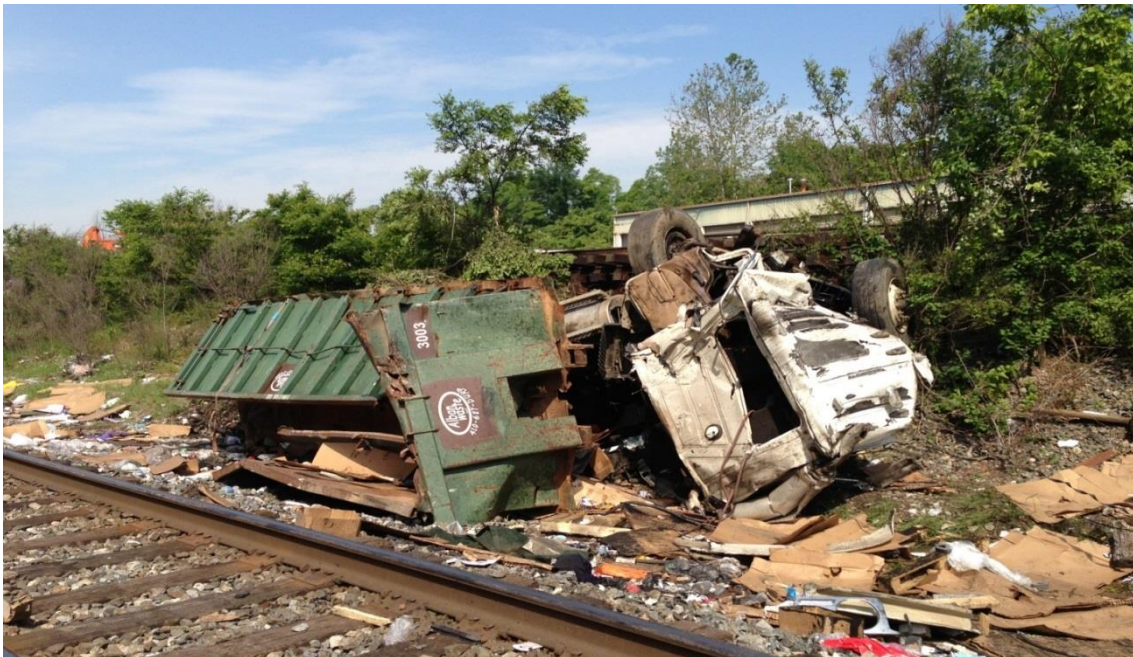
The lead locomotive struck the truck on the right side near the rear drive axles. The truck rotated, overturned, and came to rest in the earthen embankment northwest of the tracks. As shown in figure 4, the truck sustained severe damage, affecting all major mechanical systems. The driver's seat was in place in the truck; however, because of the crush damage to the cab, the seat was touching both the rear of the cab and the steering wheel. The driver's seat belt was found unbuckled, retracted, and hanging from the upper attachment point to the left of the driver's seat location.<sup>12</sup>

**Figure 4.** Wreckage of Mack truck adjacent to railroad tracks.

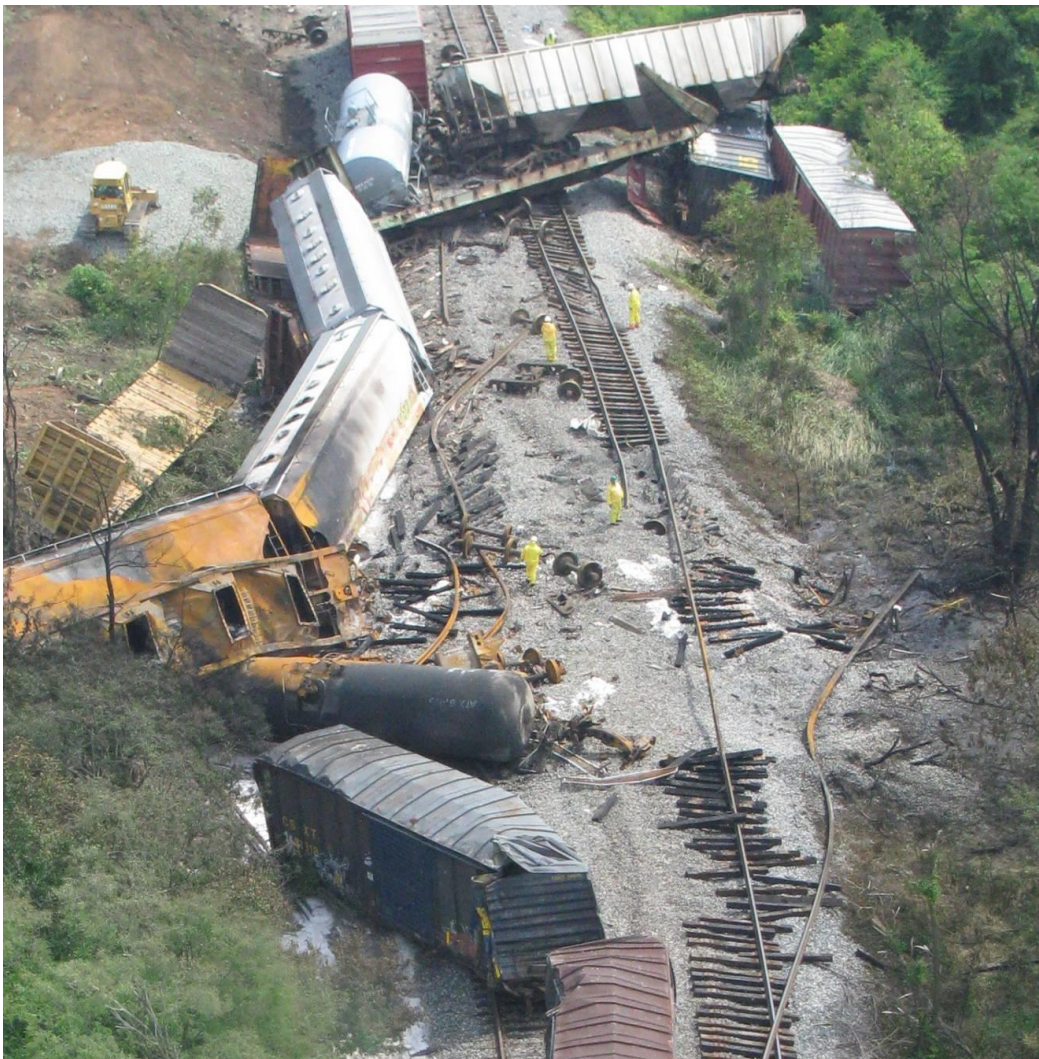
Damages to the railroad equipment, cars, and locomotives—and to the track structure—were estimated to be \$502,920 and \$100,000, respectively. The first 15 rail cars following the locomotives derailed approximately 500 feet beyond the highway–railroad grade crossing. Car 7, the aluminum hopper car containing sodium chlorate (UNPX 128076), failed catastrophically in the postcrash fire and explosion, and several other cars had thermal damage. The track ballast was displaced in the area of the explosion, leaving the surface with a cratered appearance. As shown in figure 5, approximately 80 feet of wooden crossties was missing from both sets of tracks in this area. Vegetation south of the tracks was burned, and trees were defoliated or blown over; the damaged area extended approximately 120 feet south of the approximate center of the explosion.

**Figure 5.** Aerial photograph, May 29, 2013, showing explosion site, derailed cars, and damaged tracks.

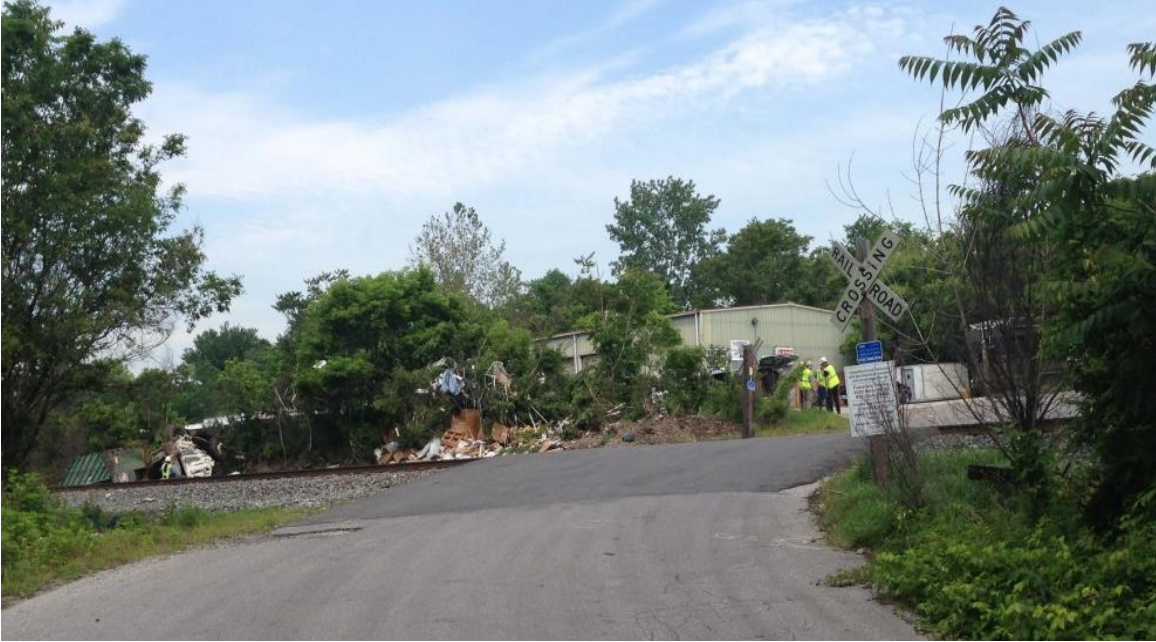
**Figure 7.** Truck driver's approach view of grade crossing when heading northwestward on private road from carrier terminal (STOP sign not visible).

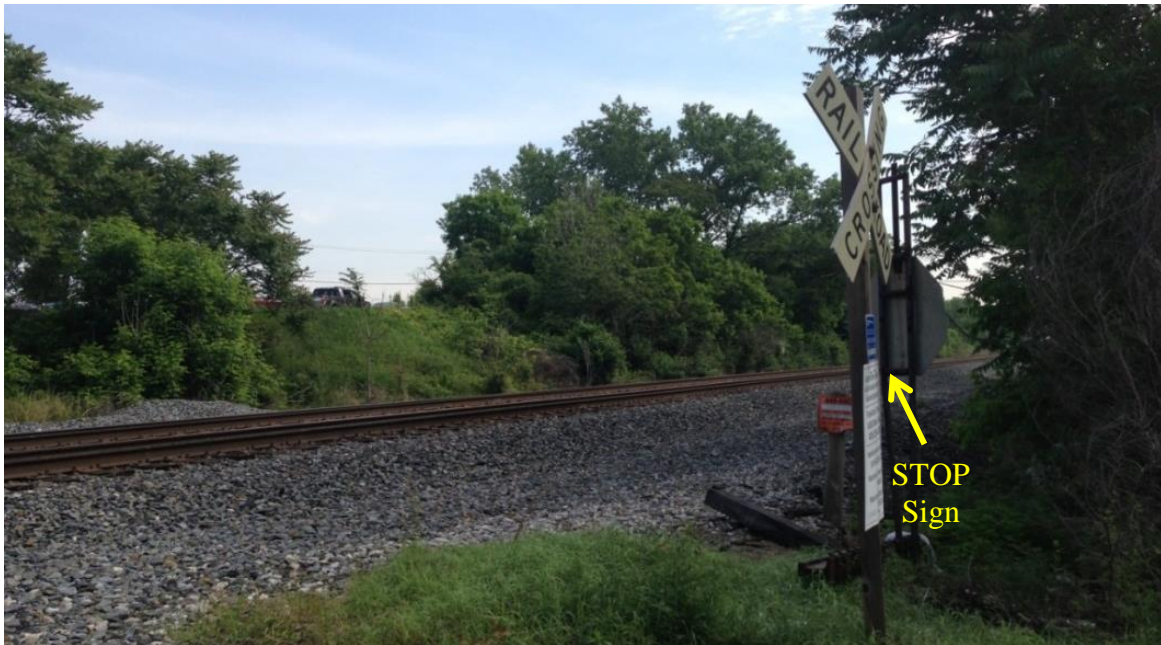
A crossbuck sign was located on each side of the crossing.<sup>41</sup> On the southeast side, the crossbuck sign was 25 feet from the nearest rail; and on the northwest side, the sign was 17 feet from the nearest rail. STOP signs were located to the right of each crossbuck sign; however, the signs were not compliant with the *Manual on Uniform Traffic Control Devices for Streets and Highways* (MUTCD; Federal Highway Administration [FHWA 2009]). The yellow paint on both STOP signs had faded significantly, and both signs had been displaced from their original mountings prior to the crash. Both signs featured stamped metal embossed with the words “stop, look, listen.” The STOP sign that should have been regulating traffic moving northwestward, shown in figure 8, was facing away from the roadway, rusted bolt holes had allowed it to rotate upside down, and it was completely obscured from view by vegetation. Figure 9 shows a detail view of the STOP sign.

**Figure 8.** View of STOP sign facing away from roadway, relative to road, railroad, and crossbuck sign.

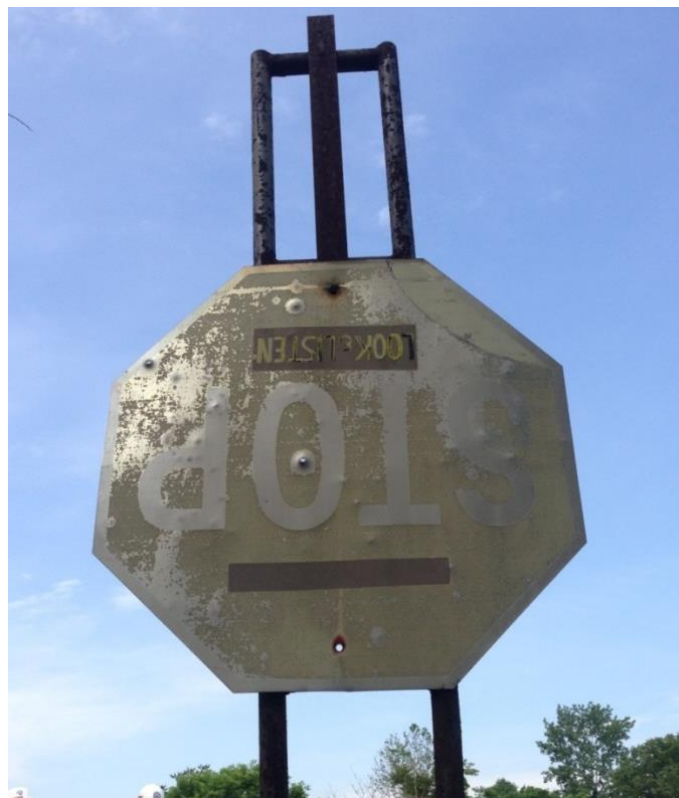
**Figure 9.** Detail view of STOP sign at grade crossing.

On June 12, 2013, NTSB investigators requested that CSXT cut back vegetation at the crossing to improve sight lines and work with the Maryland State Highway Administration (MDSHA) to perform an engineering analysis to determine the need for upgraded warning devices. CSXT responded by removing the vegetation approximately 27.5 feet from the nearest rail and installing a YIELD sign at the southeast approach to the crossing; however, it said that it expected MDSHA to take the lead in determining if additional improvements were needed. The NTSB also asked MDSHA to work with CSXT in conducting an engineering study at the accident crossing; however, the agency refused, citing liability concerns and a prohibition in *23 United States Code (USC) Section 130* about using public funds for improvements at private crossings.

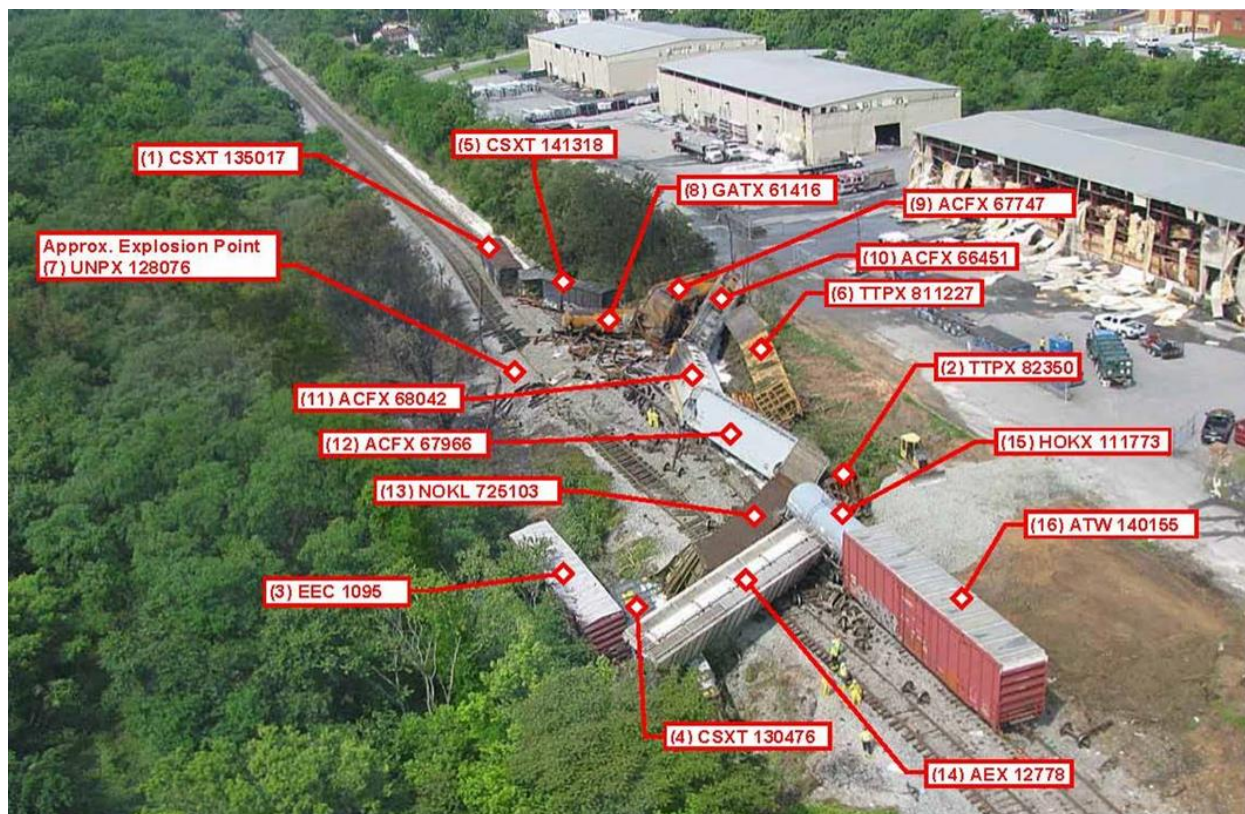
Three of the 15 derailed cars contained hazardous materials (cars 7, 8, and 15). The other derailed cars contained non-DOT-regulated commodities or were empty. Figure 11 shows the postcrash locations of the derailed cars; and table 8 describes the car type, load, commodity, and fire damage for each derailed car. Additional details are provided about the cars containing hazardous materials and the non-DOT-regulated material (terephthalic acid) that was involved in the postcrash fire.

**Figure 11.** Aerial photograph taken May 29, 2013, showing 15 derailed cars labeled by position in train (in parentheses), followed by car reporting marks. (Car 16 is included and labeled, but it did not derail.)

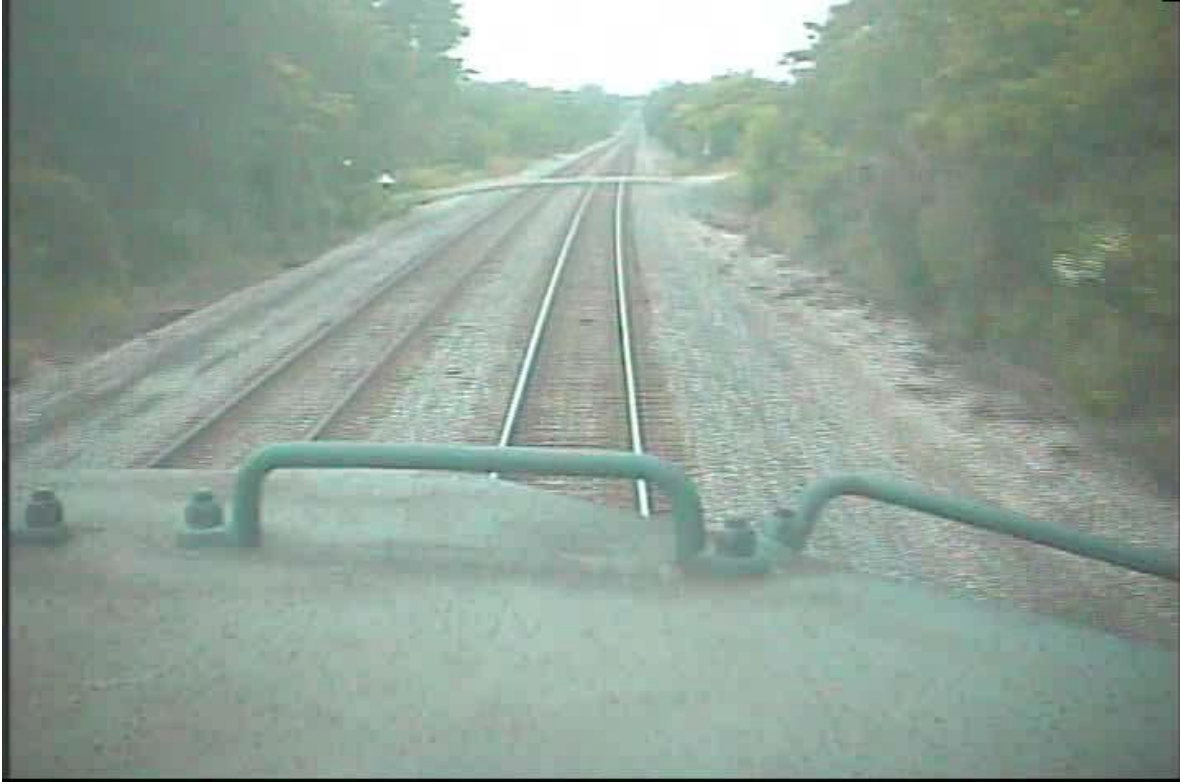
Security video from a building in the area and data from the truck’s VECU and the train’s locomotive event recorder and forward-facing locomotive video were analyzed to evaluate the relative positions of the truck and the train. When the front of the truck reached the crossbuck sign, the train was about 312 feet from the crossing and traveling 49 mph. At this point, the truck was 25 feet from the nearest rail, traveling 13 mph, and vegetation completely obscured the train from the truck driver’s view. Figures 14 and 15 depict the relative positions of the truck and the train at this location and time. After passing the vegetation, the truck driver did not reduce his speed or stop to ensure that the railroad tracks were clear. About 1.6 seconds later, the front of the truck began to cross the nearest rail. The train struck the truck on the right side near the rear drive axles about 2.8 seconds later. The NTSB concludes that had the truck driver slowed and stopped his truck before traversing the crossing, he could have seen the train and the crash could have been prevented.

**Figure 15.** View from forward-facing locomotive video showing accident truck (at left of center) emerging from behind foliage.
