*METALLURGICAL INVESTIGATION OF A
FRACTURED SECTION OF THE 20" O.D.
PIPELINE AT MILEPOST 314.77 IN THE
CONWAY TO CORSICANA SEGMENT OF
THE PEGASUS CRUDE OIL PIPELINE*

REPORT NO. 64961, REV. 1

Prepared for
ExxonMobil Pipeline Company and the
Pipeline and Hazardous Materials Safety Administration
pursuant to Corrective Action Order CPF 4-2013-5006H

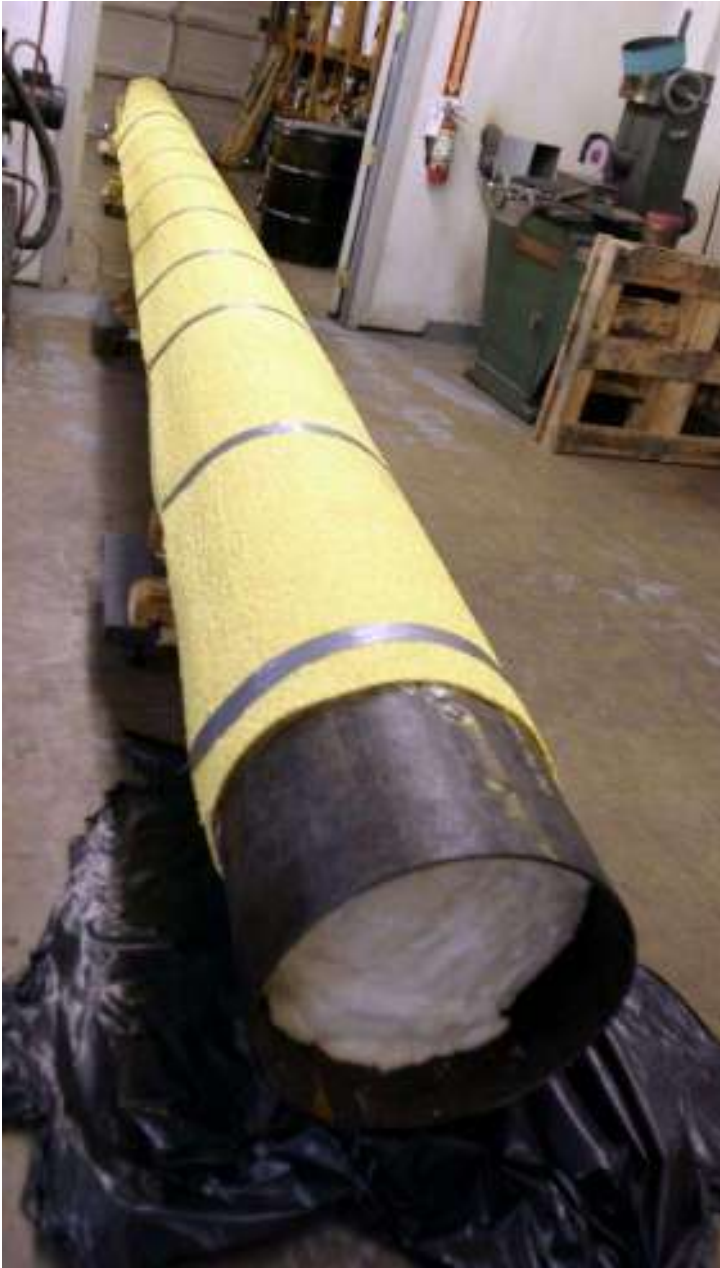
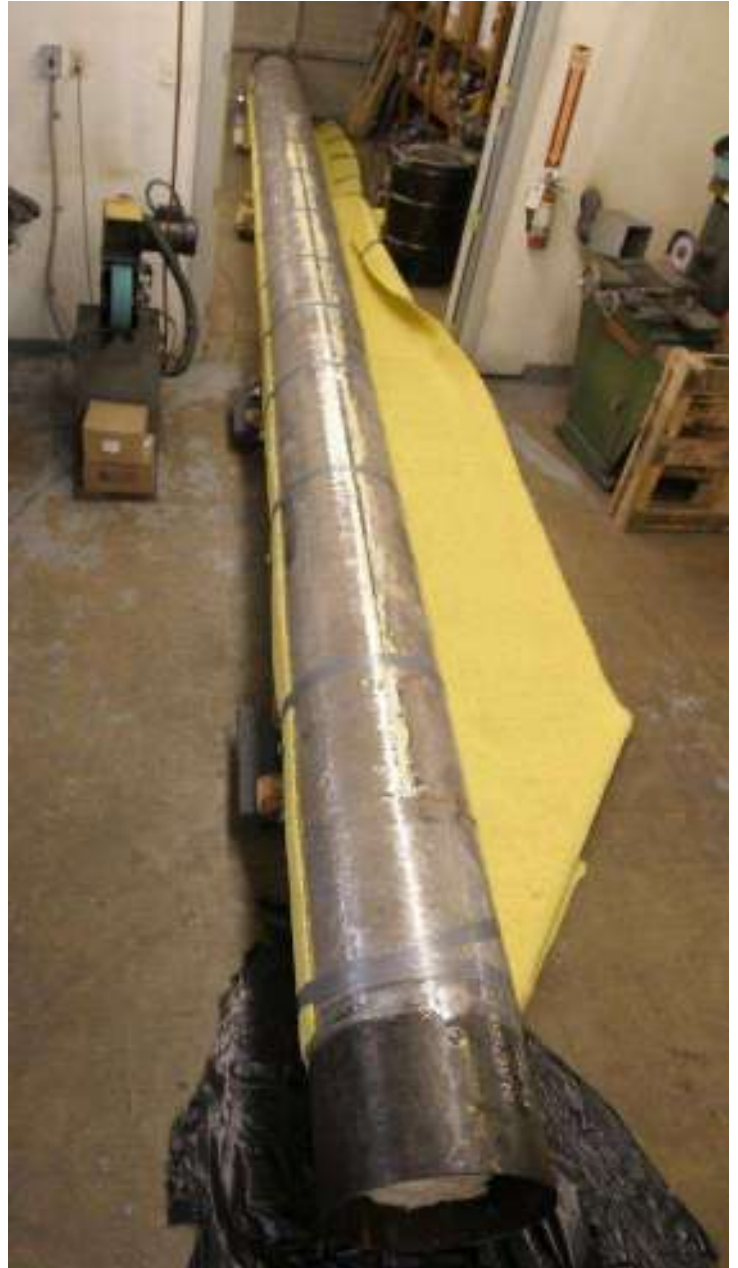
Photograph No. 4

The photographs display the fractured section of the pipe in the as-received condition and following removal of the outer protective wrapping material.

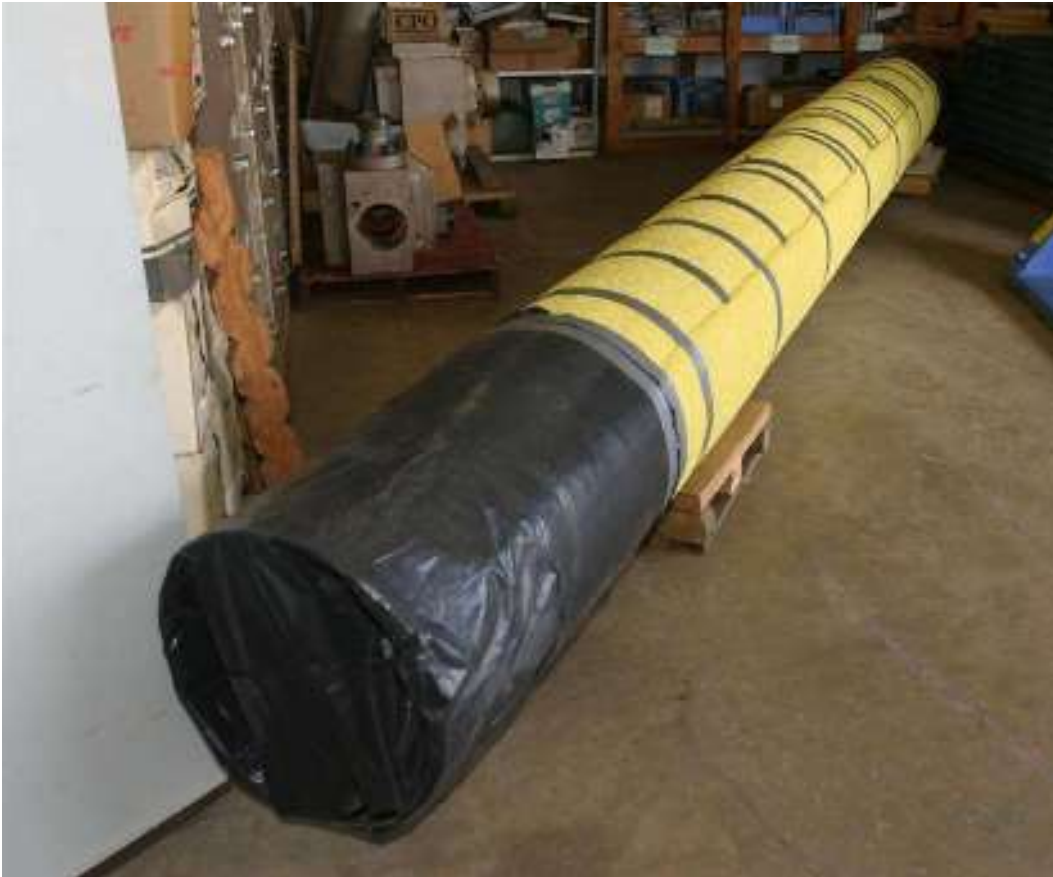
Photograph No. 6

The photograph displays the intact section of the pipe in the as-received condition with the outer protective wrapping material.

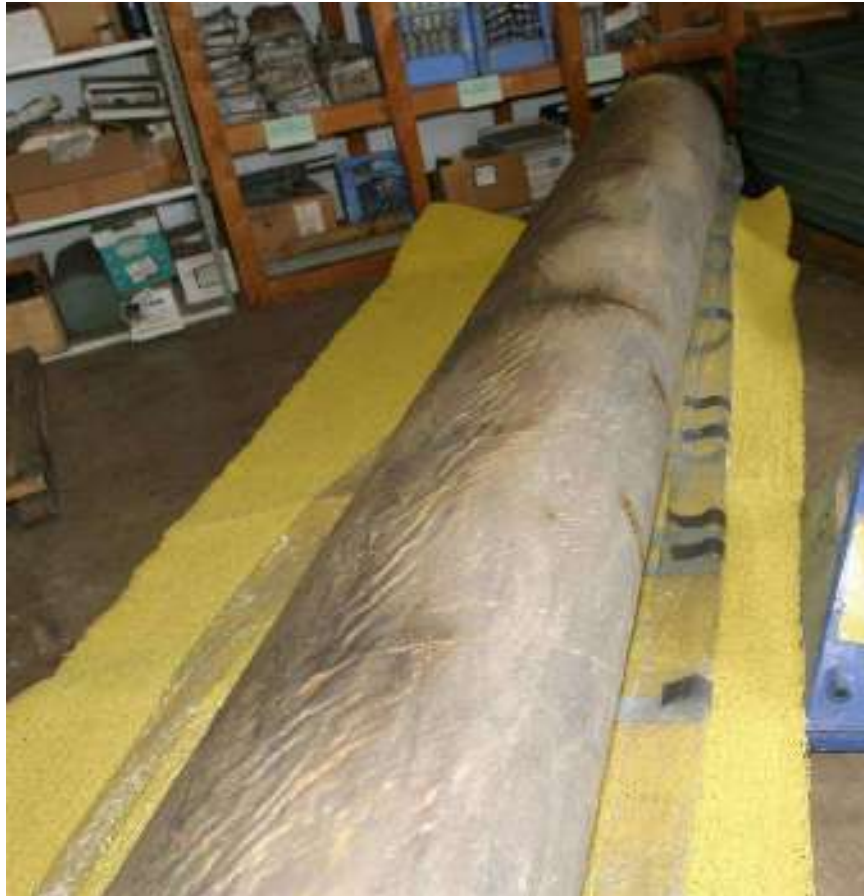
Photograph No. 7

The photograph displays the intact section of the pipe following removal of the 2nd protective wrapping material.

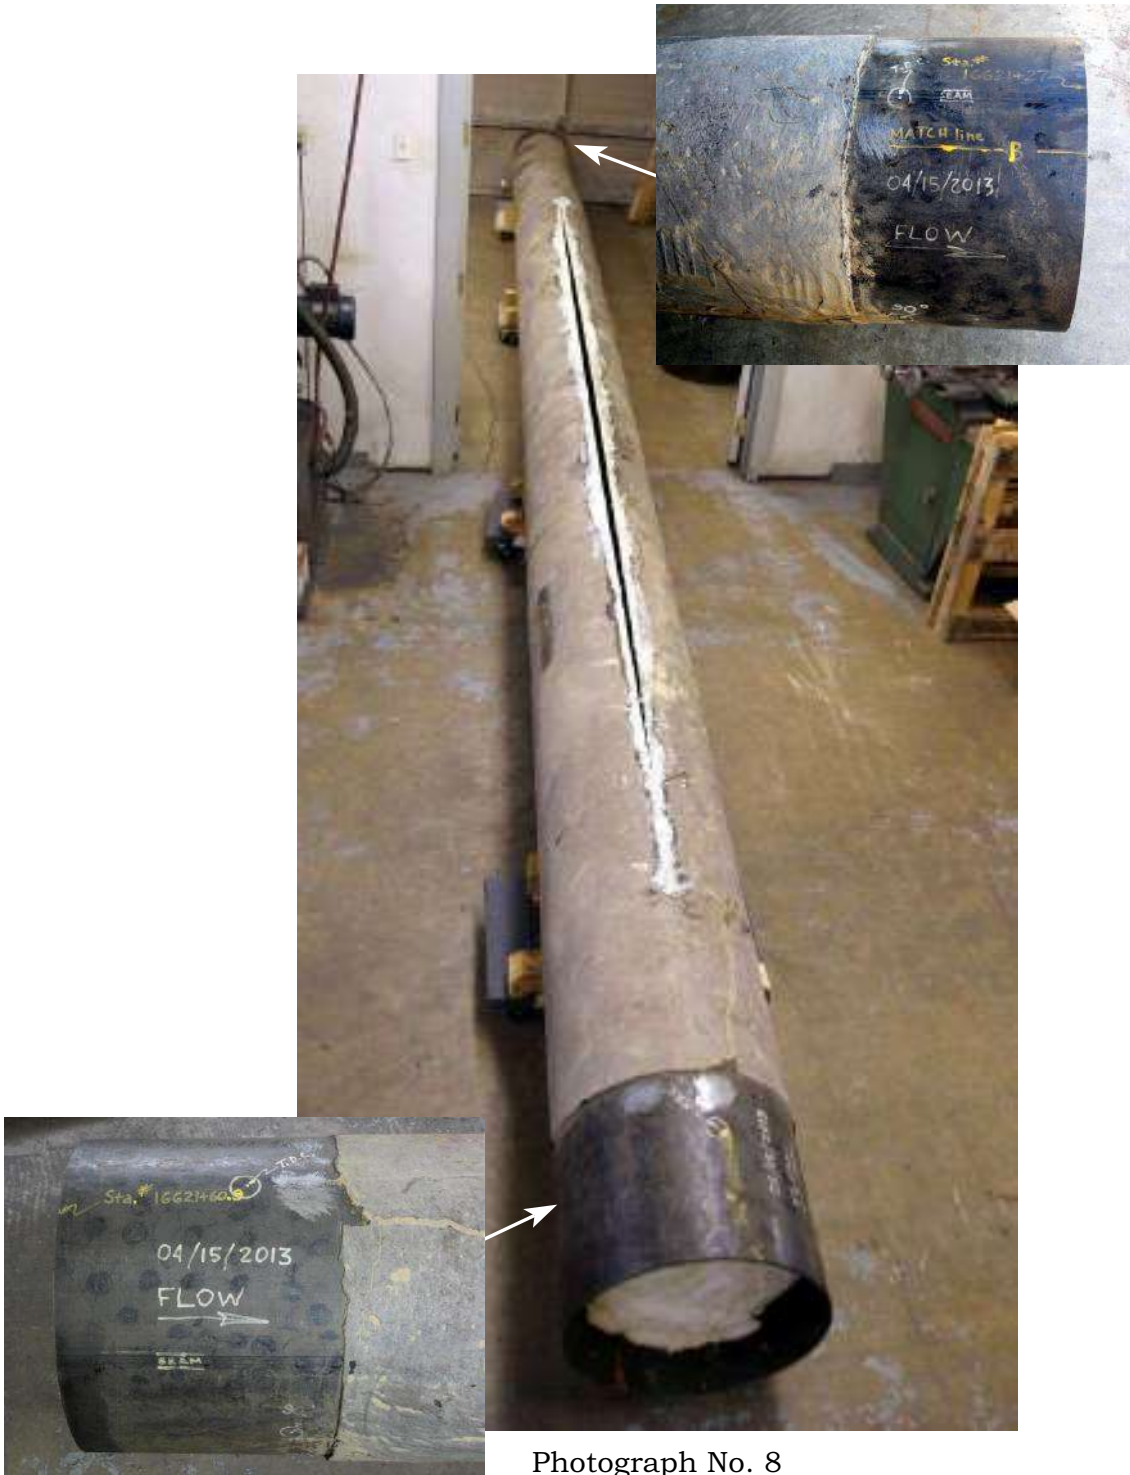
Photograph No. 8

The photograph displays the fractured pipe section following removal of the 2nd wrapping material, revealing the fracture faces coated with grease to protect from post-incident corrosion.

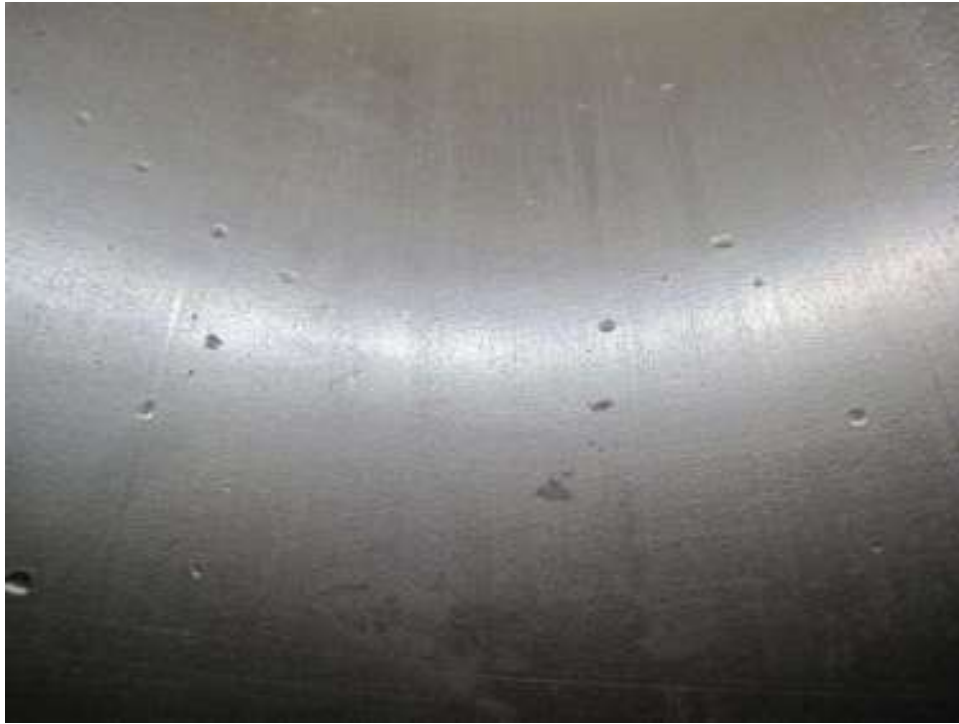
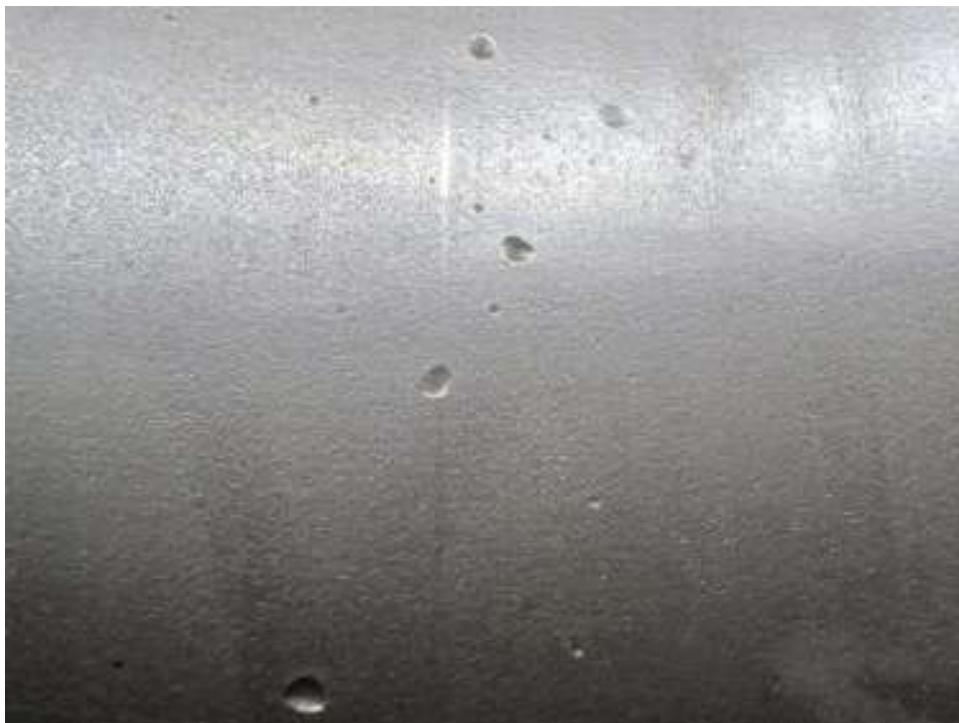
Following sectioning of the 33' 11-1/2" long and the 19' 10" long pipe lengths, the I.D. surfaces at several areas were more closely examined. Multiple shallow depressions, including those noted above, were visible around the entire circumference of the I.D. surface. The depressions were very smooth in appearance and contained no visible corrosion products, suggestive of mechanical deformation as opposed to corrosion pitting. No evidence of any significant corrosion pits was visible on the I.D. surface. Photographs No. 83 and No. 84 show representative areas of the I.D. surface.

The photographs display representative areas of the I.D. surface at an intact area of the pipe, showing the smooth, shallow impressions that resulted from mechanical damage, most likely during the hot-rolling of the steel or manufacturing of the pipe. No evidence of corrosion pitting was observed on the I.D. surface.

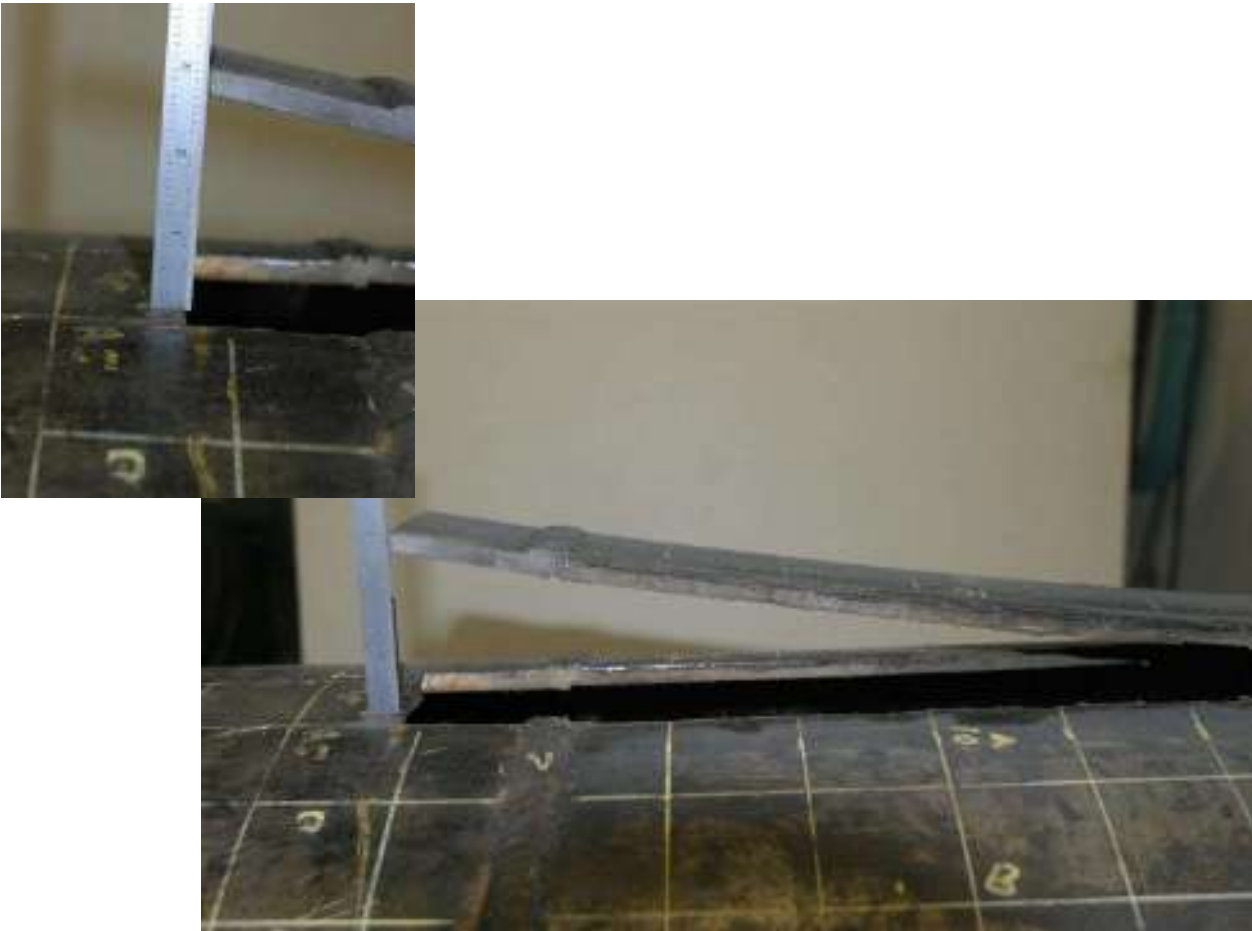
Photograph No. 85

The photograph shows the displacement of the pipe by approximately 2-31/32" following sectioning through the intact portion of the adjoining pipe, indicative of the presence of significant residual stress.

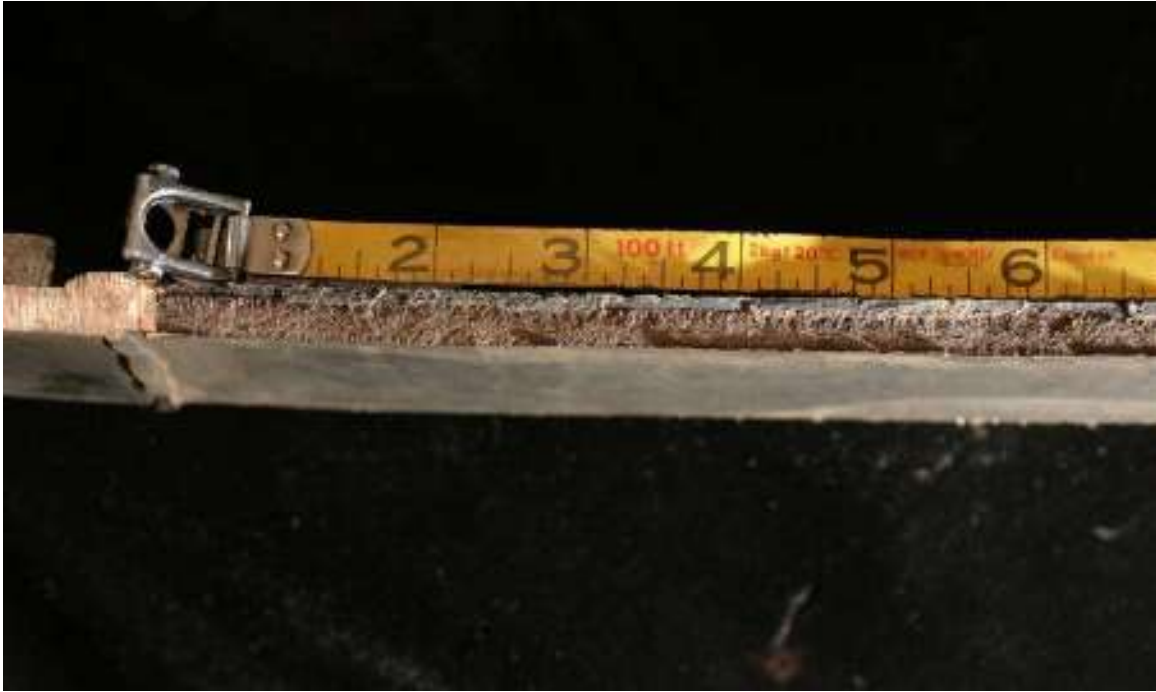
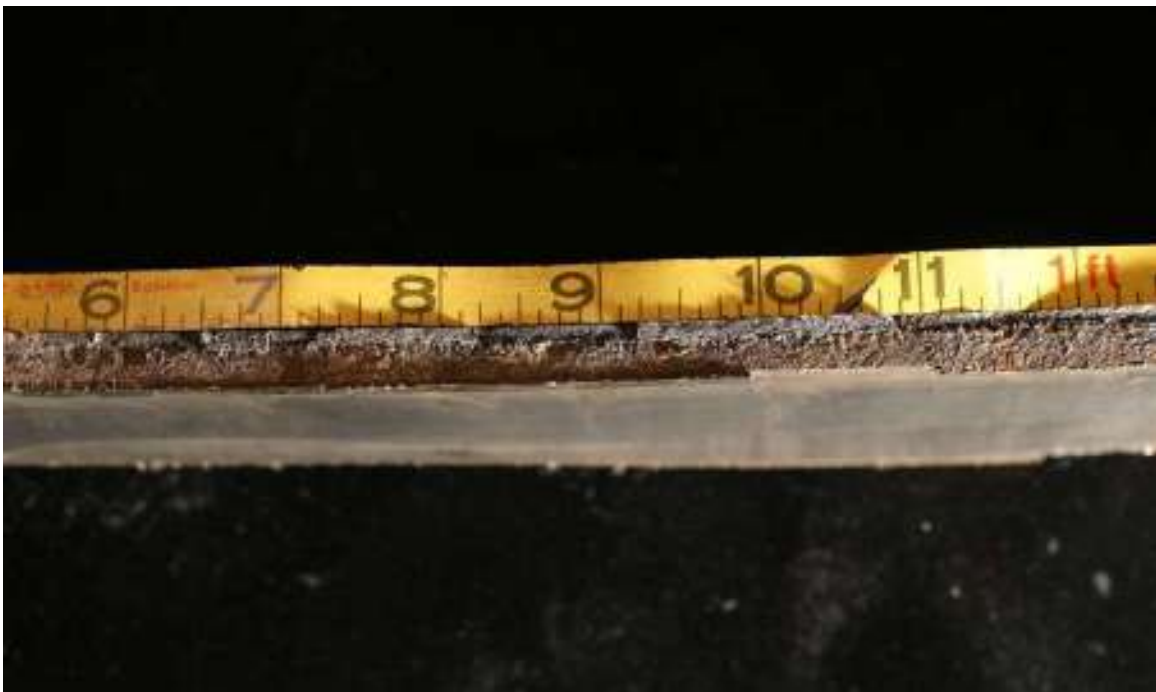
The photographs display evidence of manufacturing imperfection, i.e. the upturned bands near the O.D. in the fracture path of the final fracture.

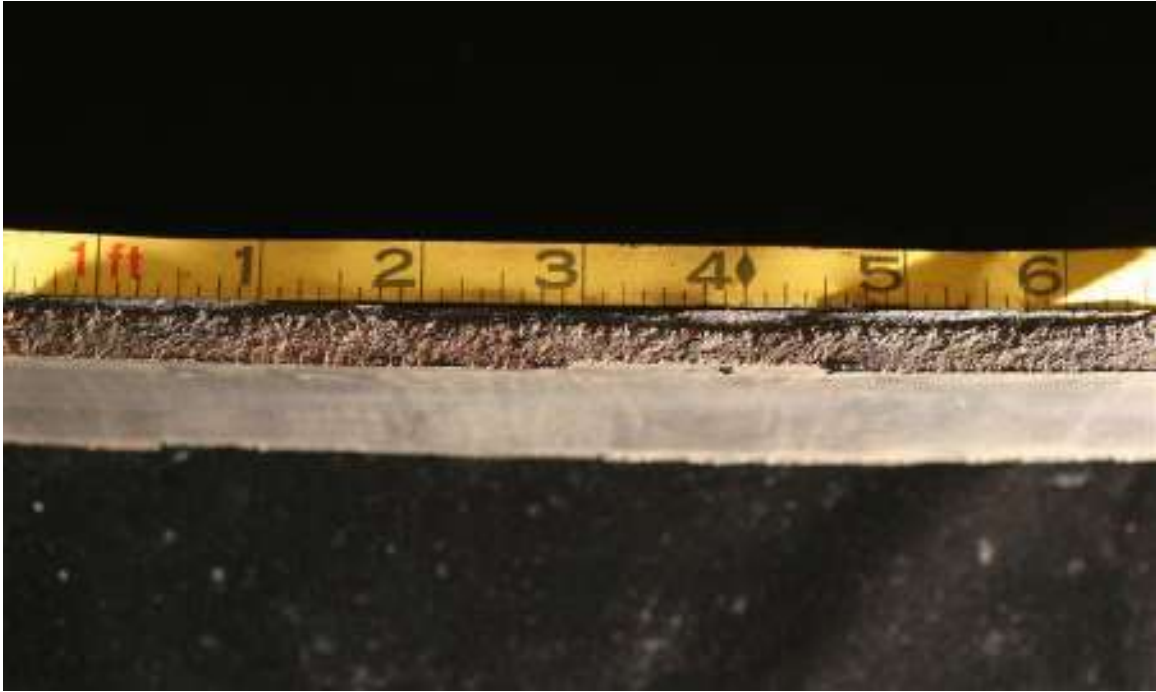
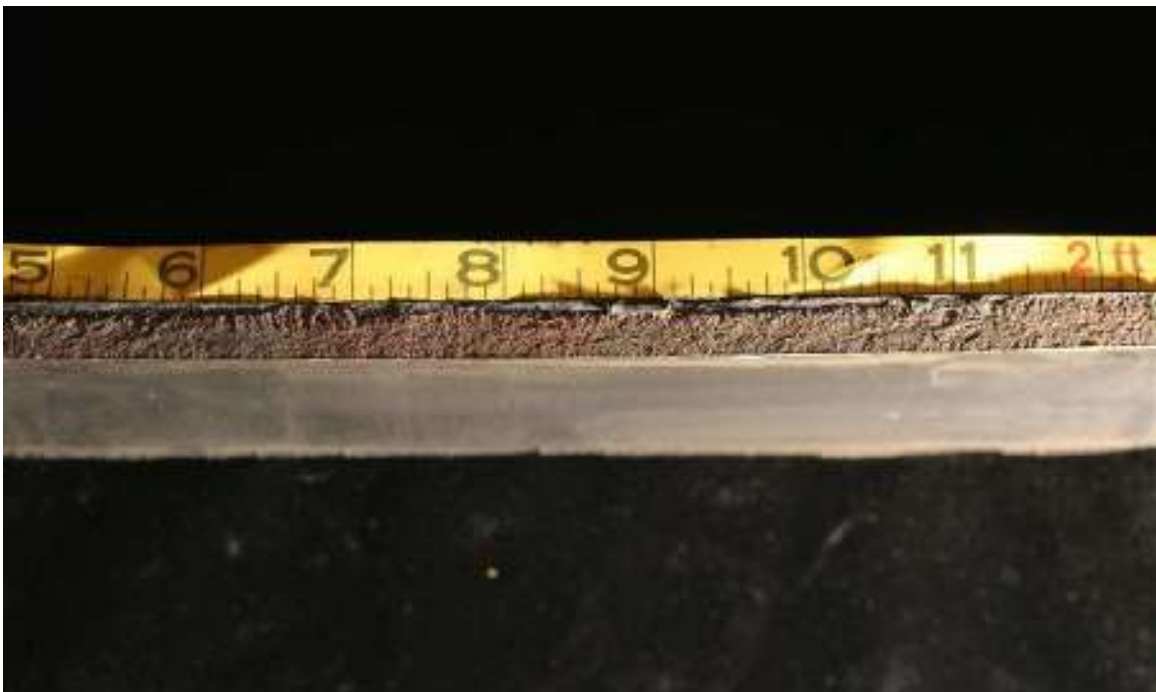
The photographs display the continuation of the manufacturing imperfections in the path of the final fracture.

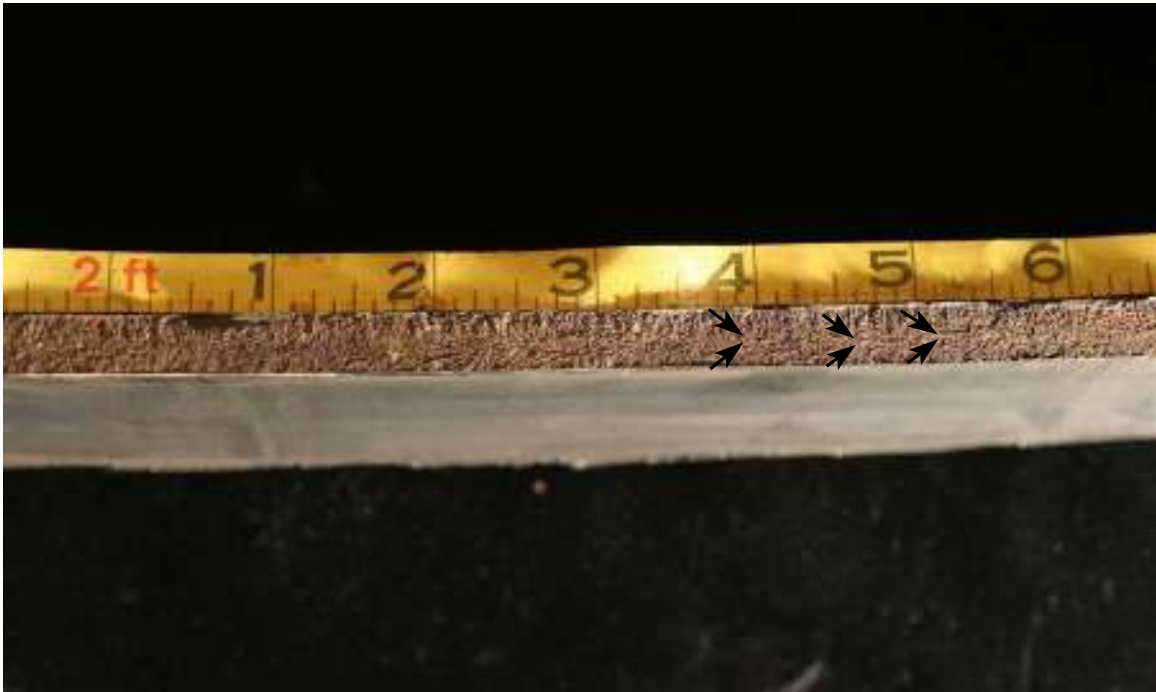
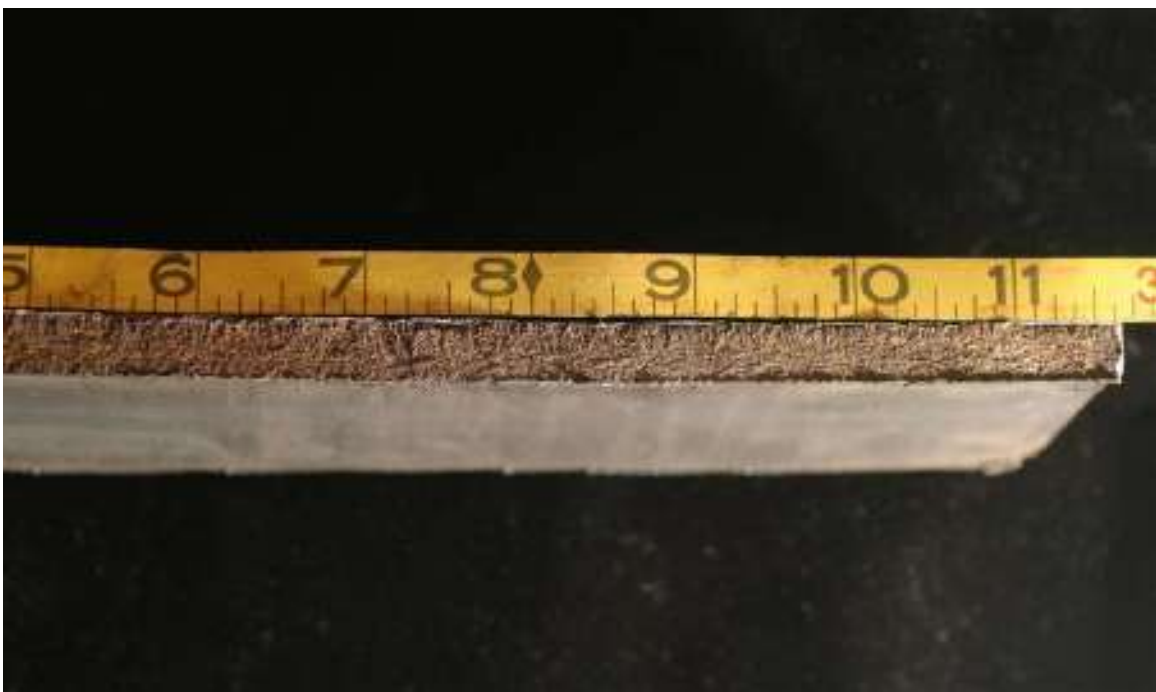
The photographs display evidence of chevron marks pointing downstream toward the fracture origins. The arrows point to some of the fine chevrons.

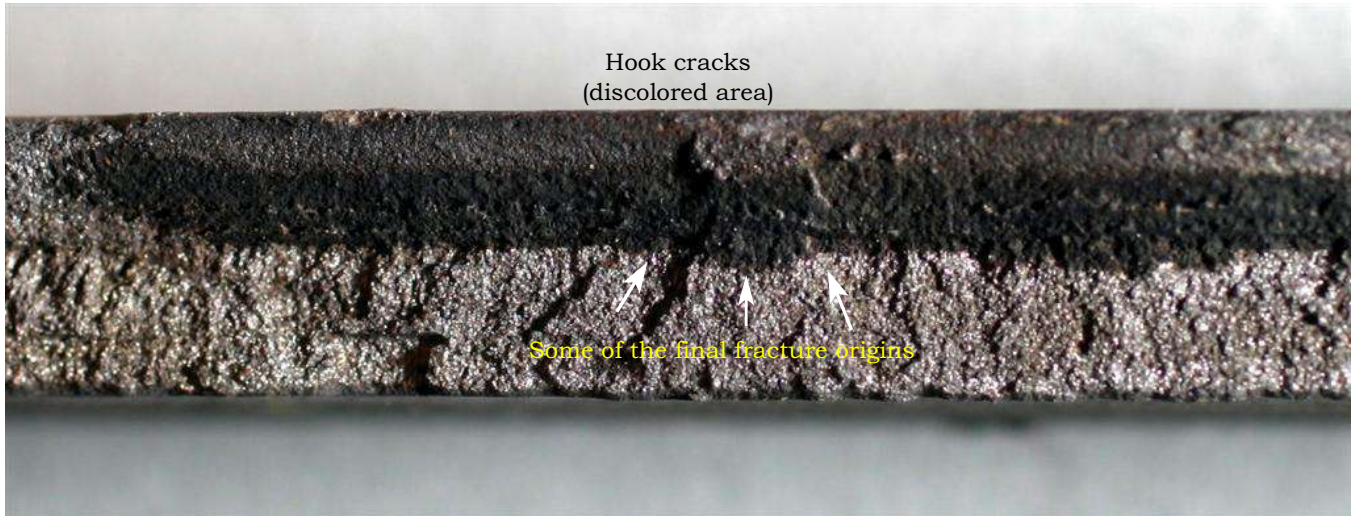
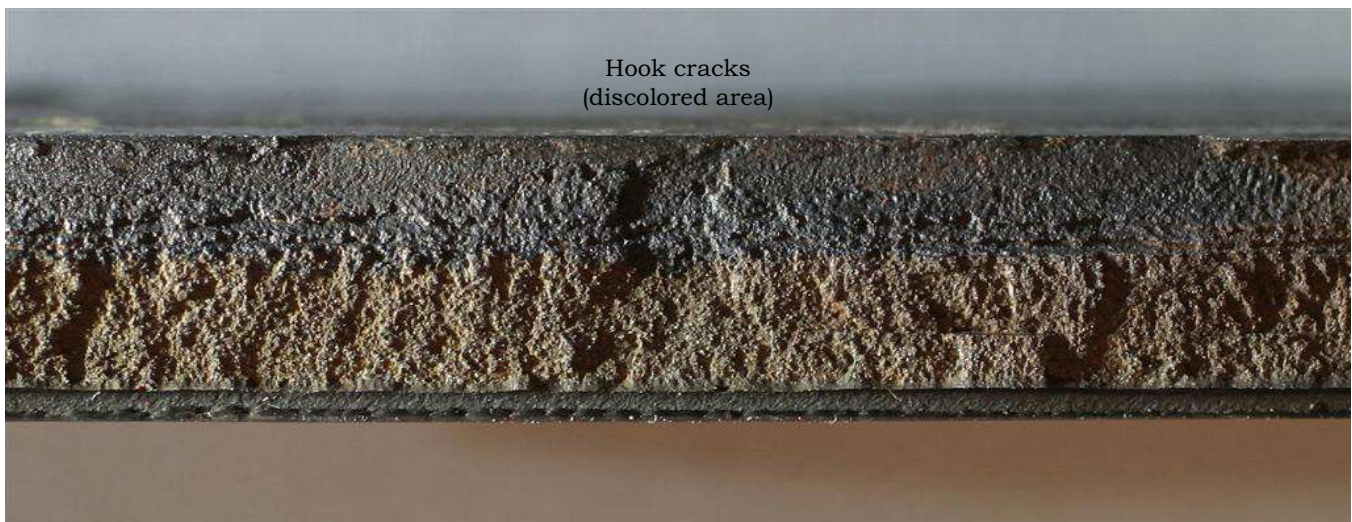
The photographs display the mating fracture faces revealing some of the fracture origin site(s) at a distance of approximately 20' 5-5/16" from the north girth weld, which were later examined at higher magnifications using a Scanning Electron Microscope (SEM) to characterize the fracture morphologies.

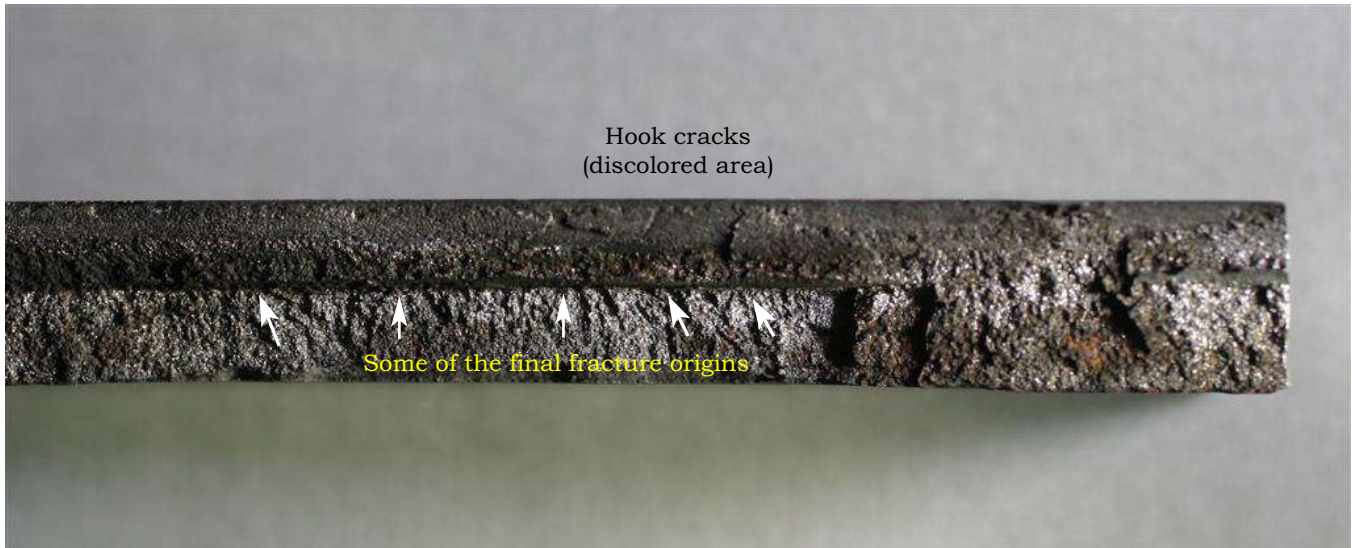
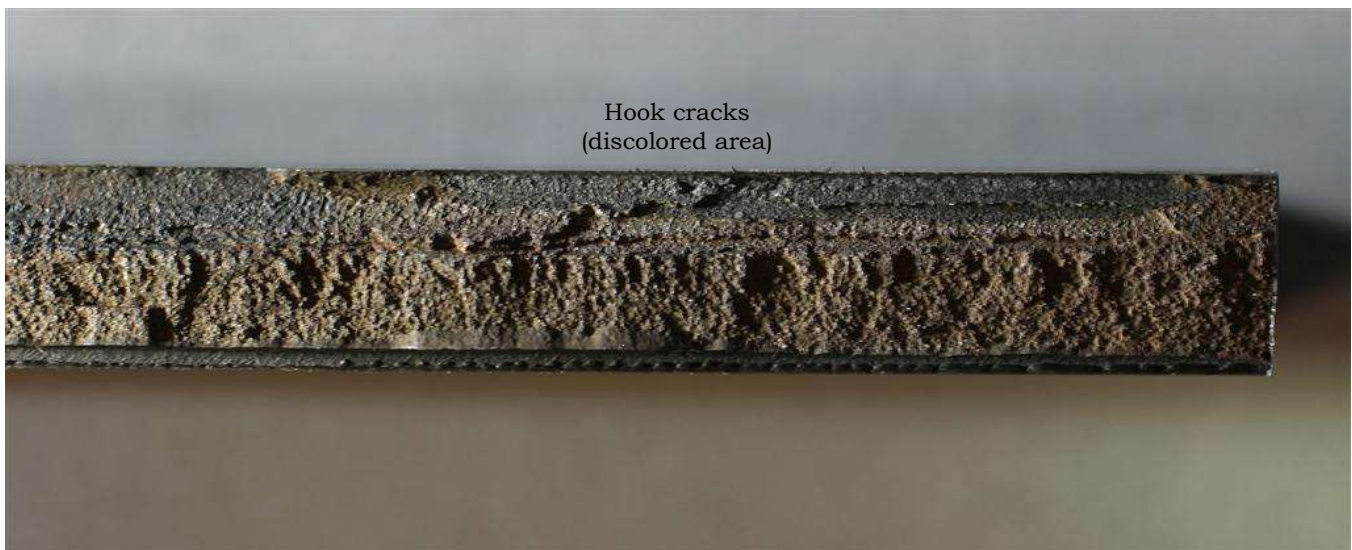
The photographs display the mating fracture faces revealing some of the fracture origin sites at a distance between 20' 5-3/4" and 20' 7-1/2" from the north girth weld, which were later examined at higher magnifications using an SEM to characterize the fracture morphologies.

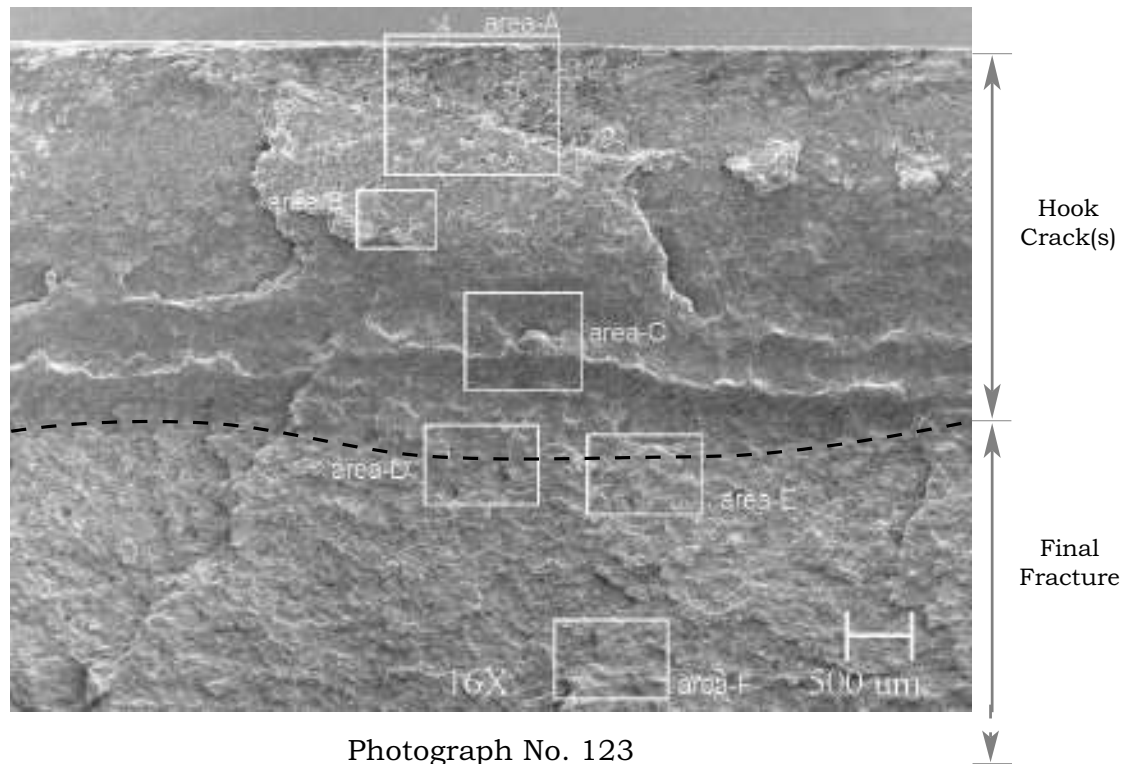
Photograph No. 123

The SEM fractograph taken of one of the final fracture origin sites at a distance of 20' 5-5/16" from the north girth weld shows an hook crack and the final fracture zone. The fracture locations within the rectangles were examined at high magnifications to further characterize the fracture morphologies. The dotted line denotes the transition zone between the hook cracks and the final fracture.

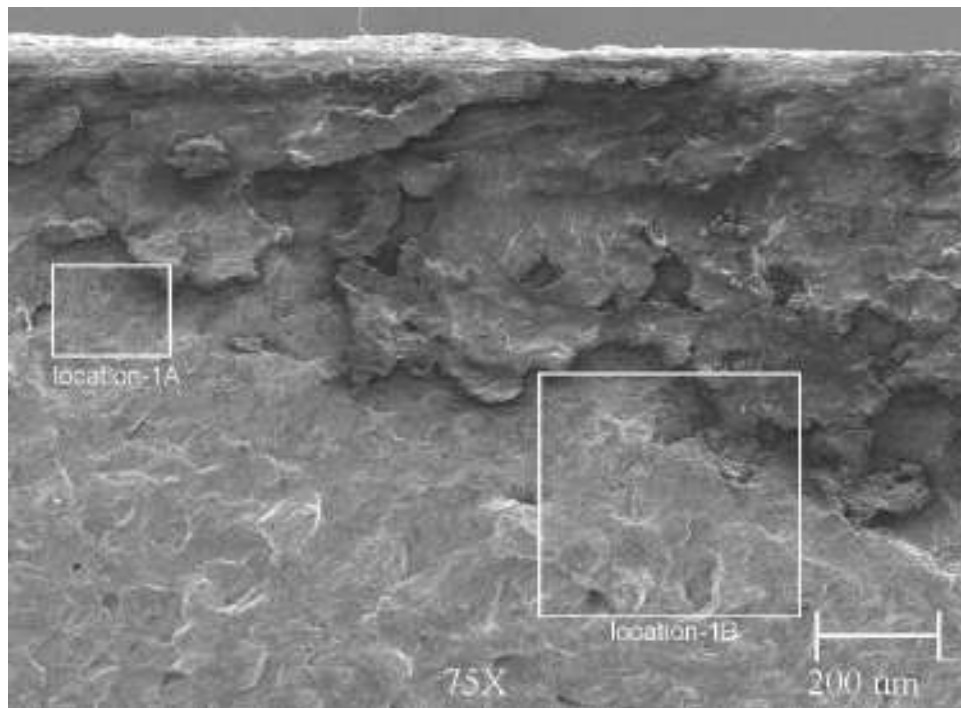
Area-A
Photograph No. 124

The SEM fractograph taken of the Area-A of the hook crack near the O.D. surface, as displayed in Photograph No. 123, displays essentially a nondescript featureless fracture surface. Note the absence of any fracture features, likely due to the metal-to-metal contact from the mating fracture faces of the crack and post-crack oxidation. The fracture locations labeled as Location-1A and Location-1B were examined at higher magnifications to further characterize the fracture morphology.

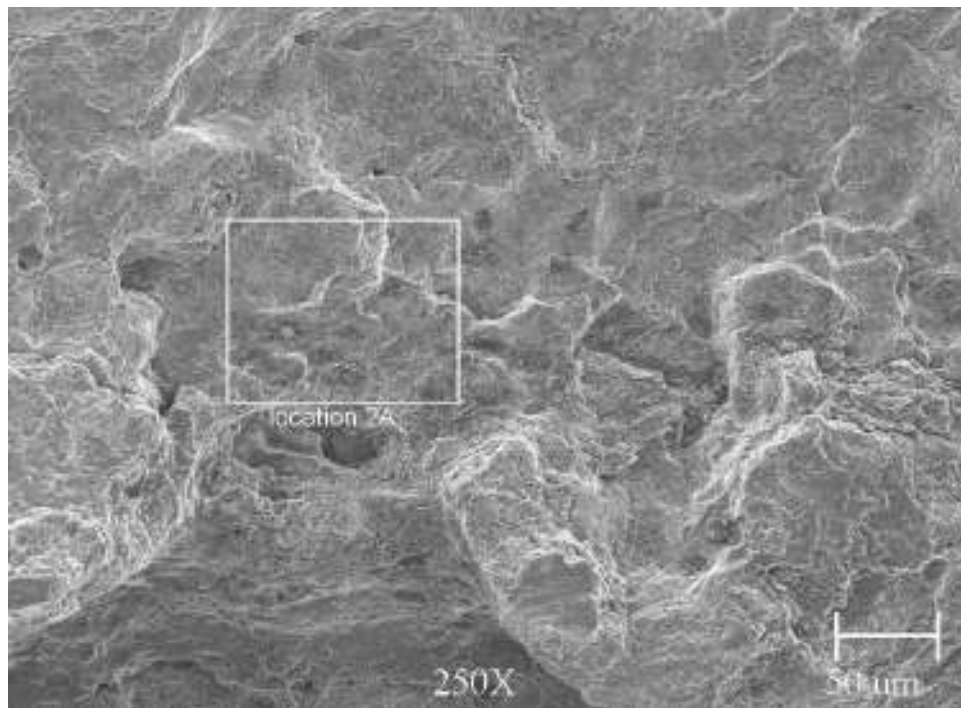
Area-B
Photograph No. 127

The SEM fractograph taken of the Area-B at Location-2A of the hook crack zone, as displayed in Photograph No. 127, reveals tightly adhered oxidation product on the fracture surface.

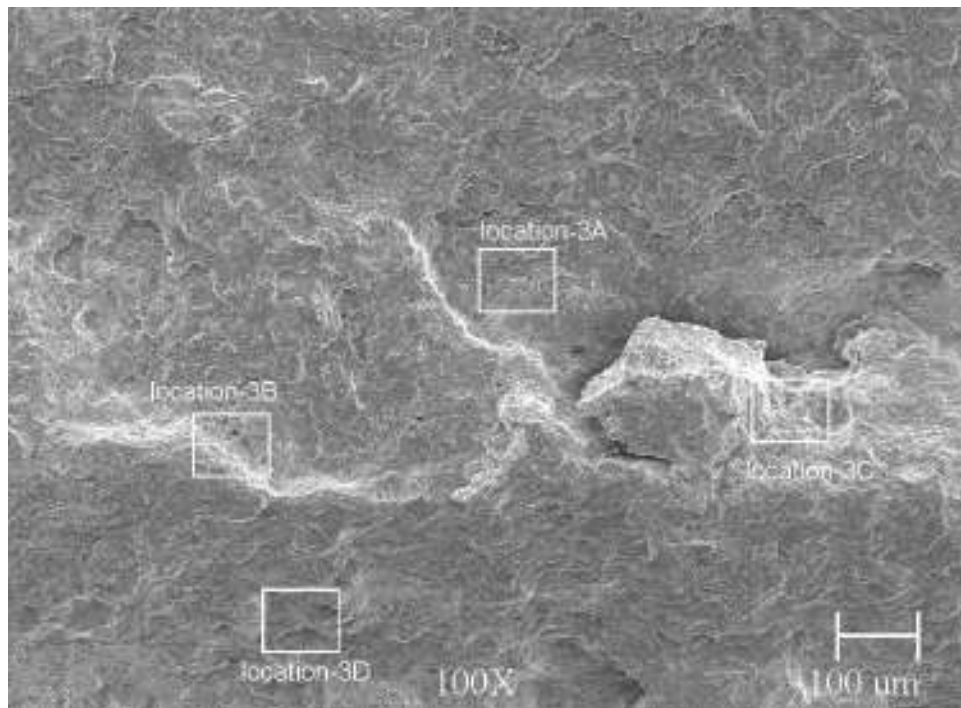
Area-C
Photograph No. 129

The SEM fractograph taken of the Area-C of the hook crack zone, as displayed in Photograph No. 123, reveals a nondescript, featureless fracture surface. The fracture locations, labeled as Location-3A, Location-3B, Location-3C, and Location-3D, were examined at higher magnifications to further characterize the fracture morphologies.

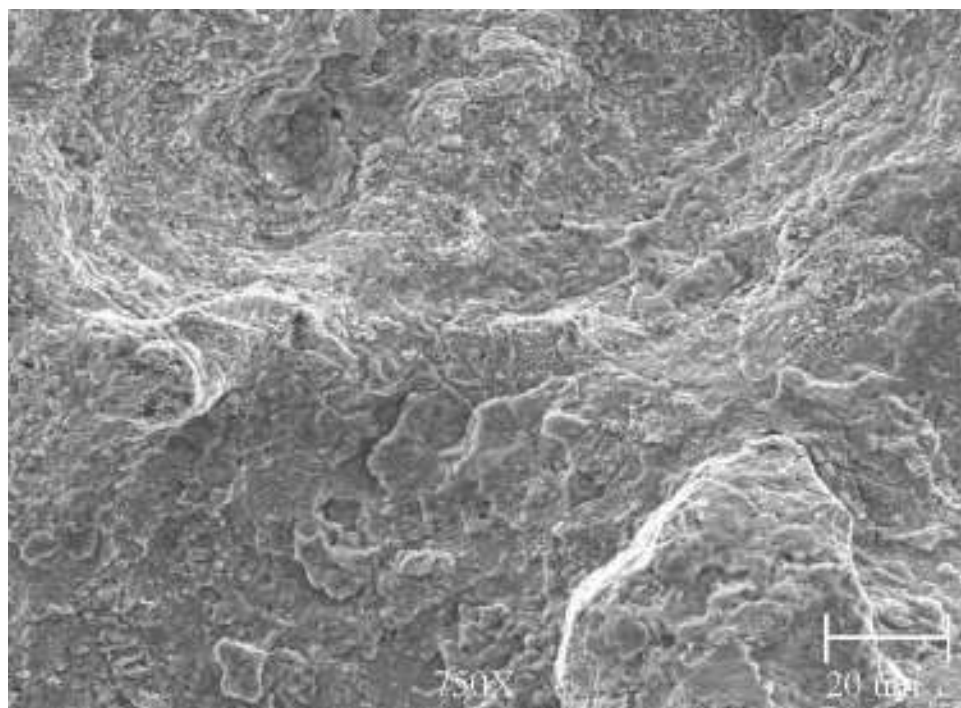
Area-D within the rectangle
Photograph No. 135

The SEM fractograph taken of the Area-D within the rectangle of the hook crack zone, as displayed in Photograph No. 134, reveals tightly adhered oxidation product.

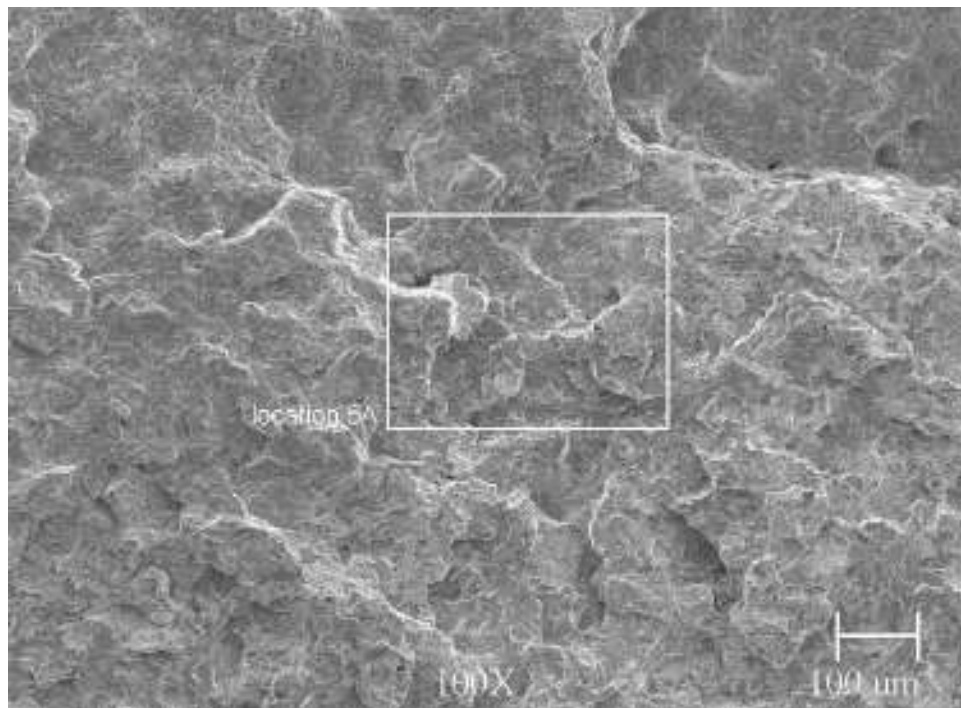
Area-E
Photograph No. 136

The SEM fractograph taken of the Area-E in the transition zone between the hook crack and the final fracture zones, as displayed in Photograph No. 123, reveals a nondescript, featureless fracture surface. The fracture location labeled as Location-5A was examined at higher magnification to characterize the fracture morphology.

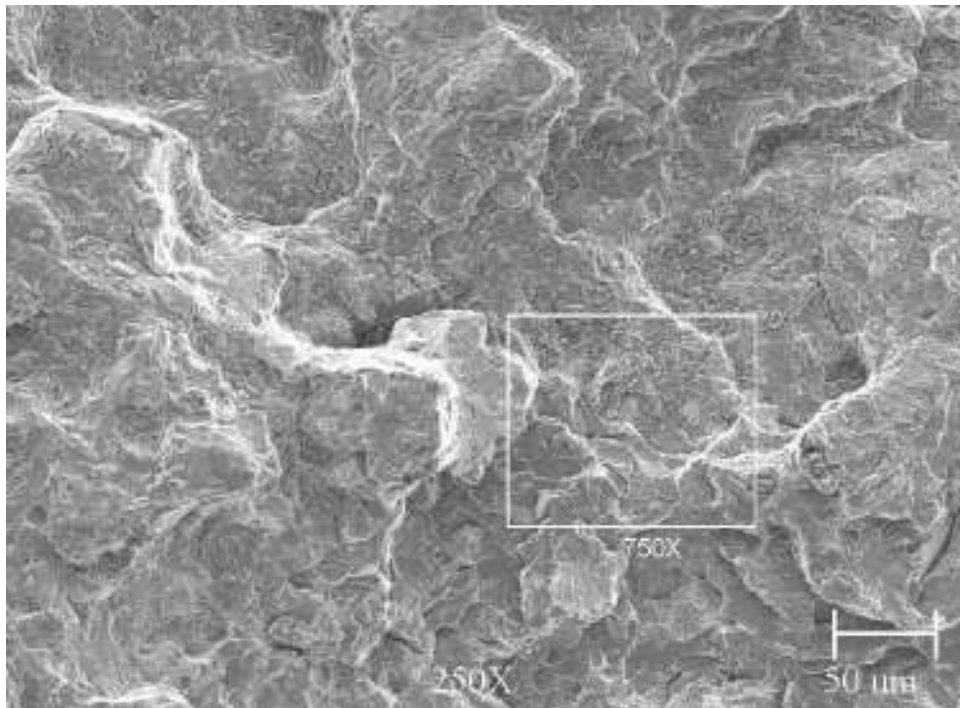
Area-E, Location-5A
Photograph No. 137

The SEM fractograph taken of the Area-E at Location-5A displays some evidence of oxidation product in the hook crack and evidence of quasi-cleavage separation in the final fracture zone, indicative of pre-existing crack and final brittle fracture, respectively.

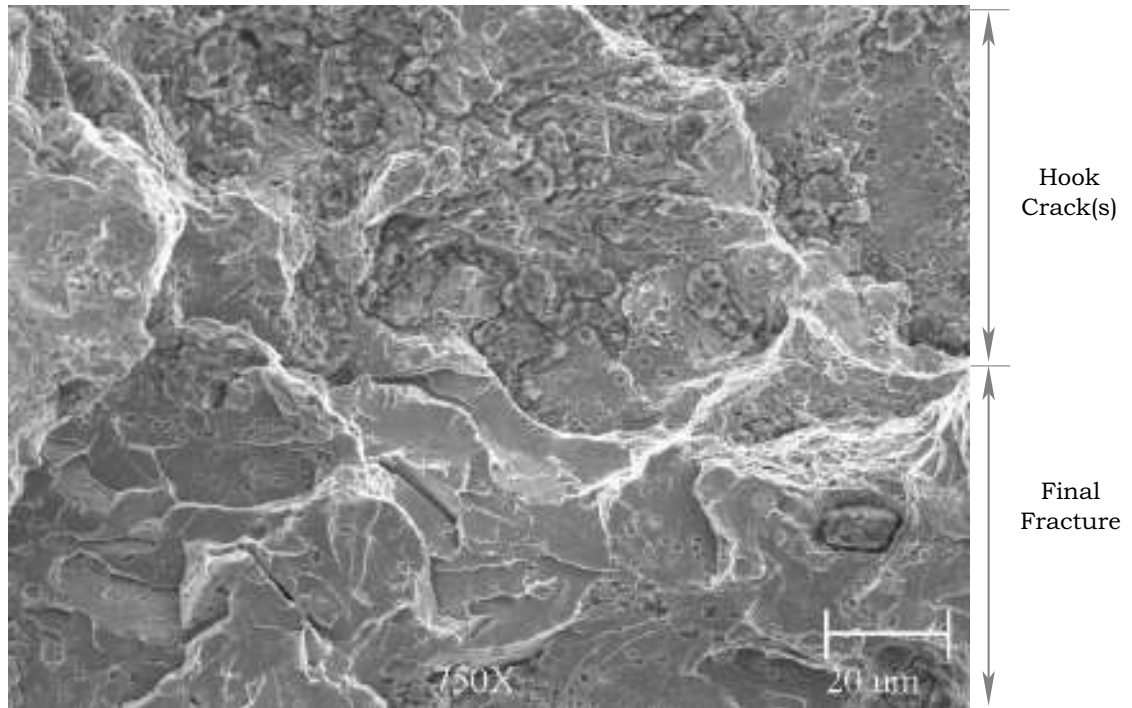
Area-E, Location-5A, Location within rectangle
Photograph No. 138

The SEM fractograph taken of the Area-E at Location-5A, as displayed in Photograph No. 137, confirms the oxidation on the hook cracks and the final fracture in the brittle manner.
