*METALLURGICAL INVESTIGATION OF A
FRACTURED SECTION OF THE 20" O.D.
PIPELINE AT MILEPOST 314.77 IN THE
CONWAY TO CORSICANA SEGMENT OF
THE PEGASUS CRUDE OIL PIPELINE*

REPORT NO. 64961, REV. 1

Prepared for
ExxonMobil Pipeline Company and the
Pipeline and Hazardous Materials Safety Administration
pursuant to Corrective Action Order CPF 4-2013-5006H

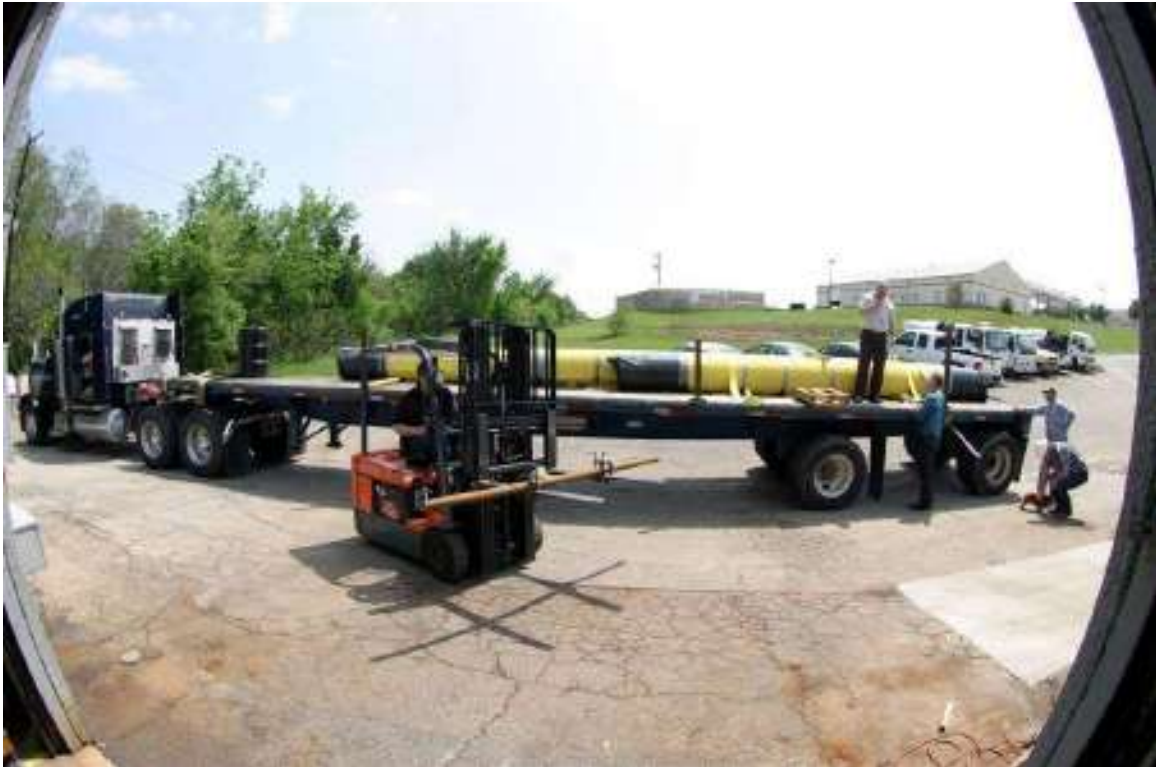
The photograph displays the pipe sections in the as-received condition with the protective wrapping on the outside surface of the pipe sections that was applied to prevent any damage during transportation.

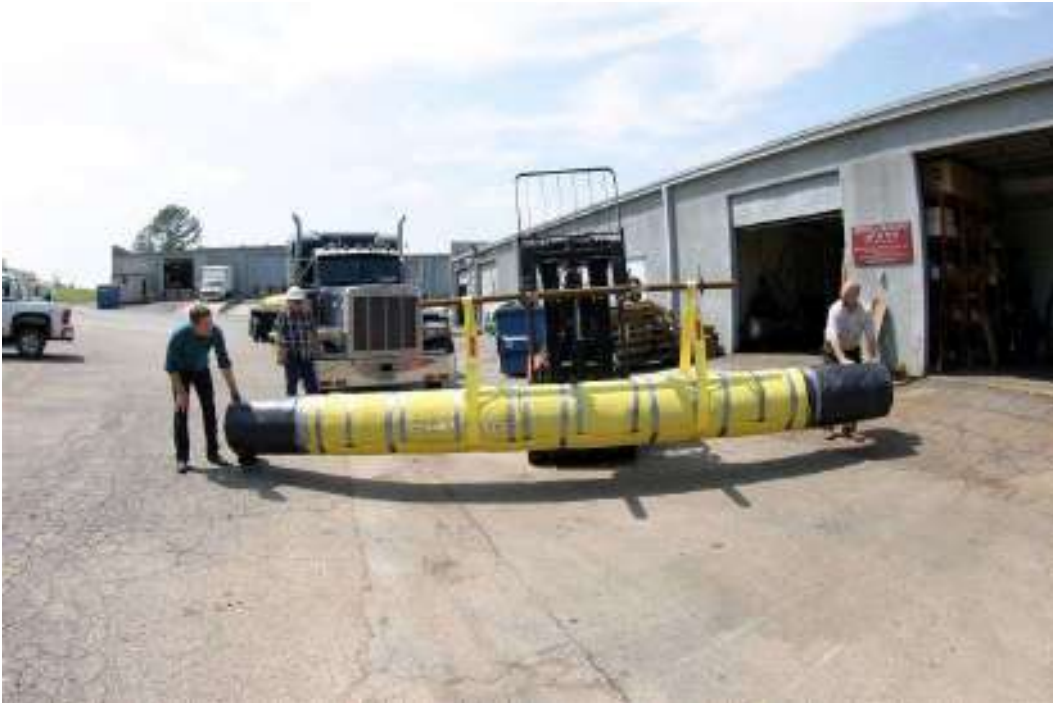
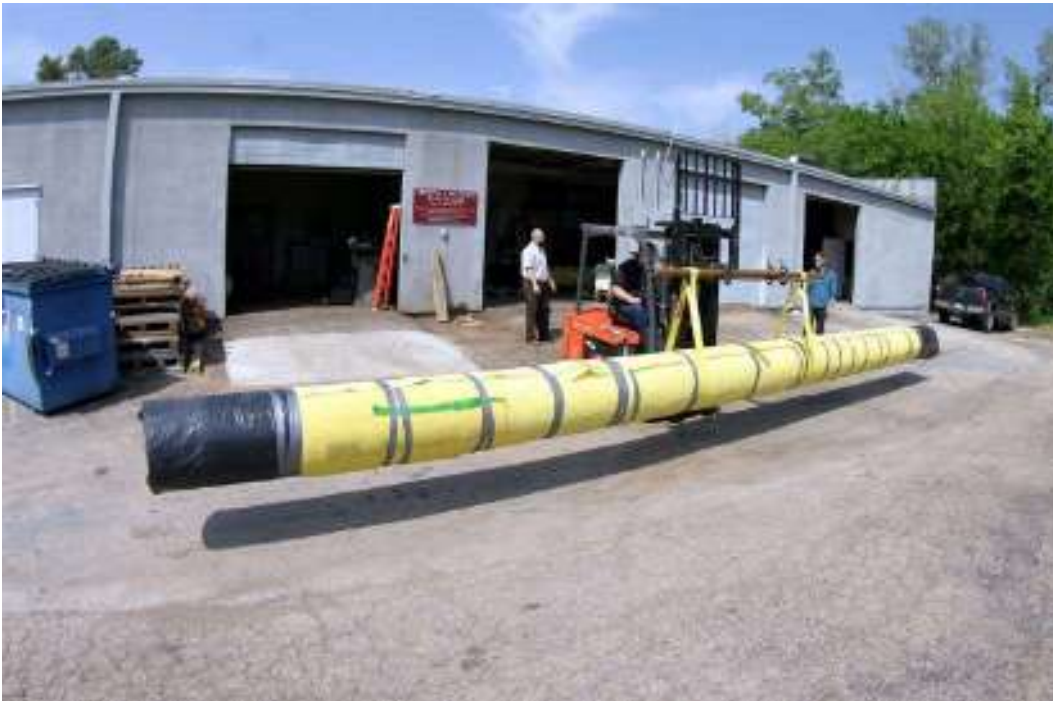
The photographs display two (2) pipe sections during the unloading process. There was no evidence of any transportation related damage to the pipe sections.
