Safety Study - Transport of Hazardous Materials by Rail

(U.S.) National Transportation Safety Board, Washington, DC

16 May 91

PB91-917002
NTSB/SS-91/01

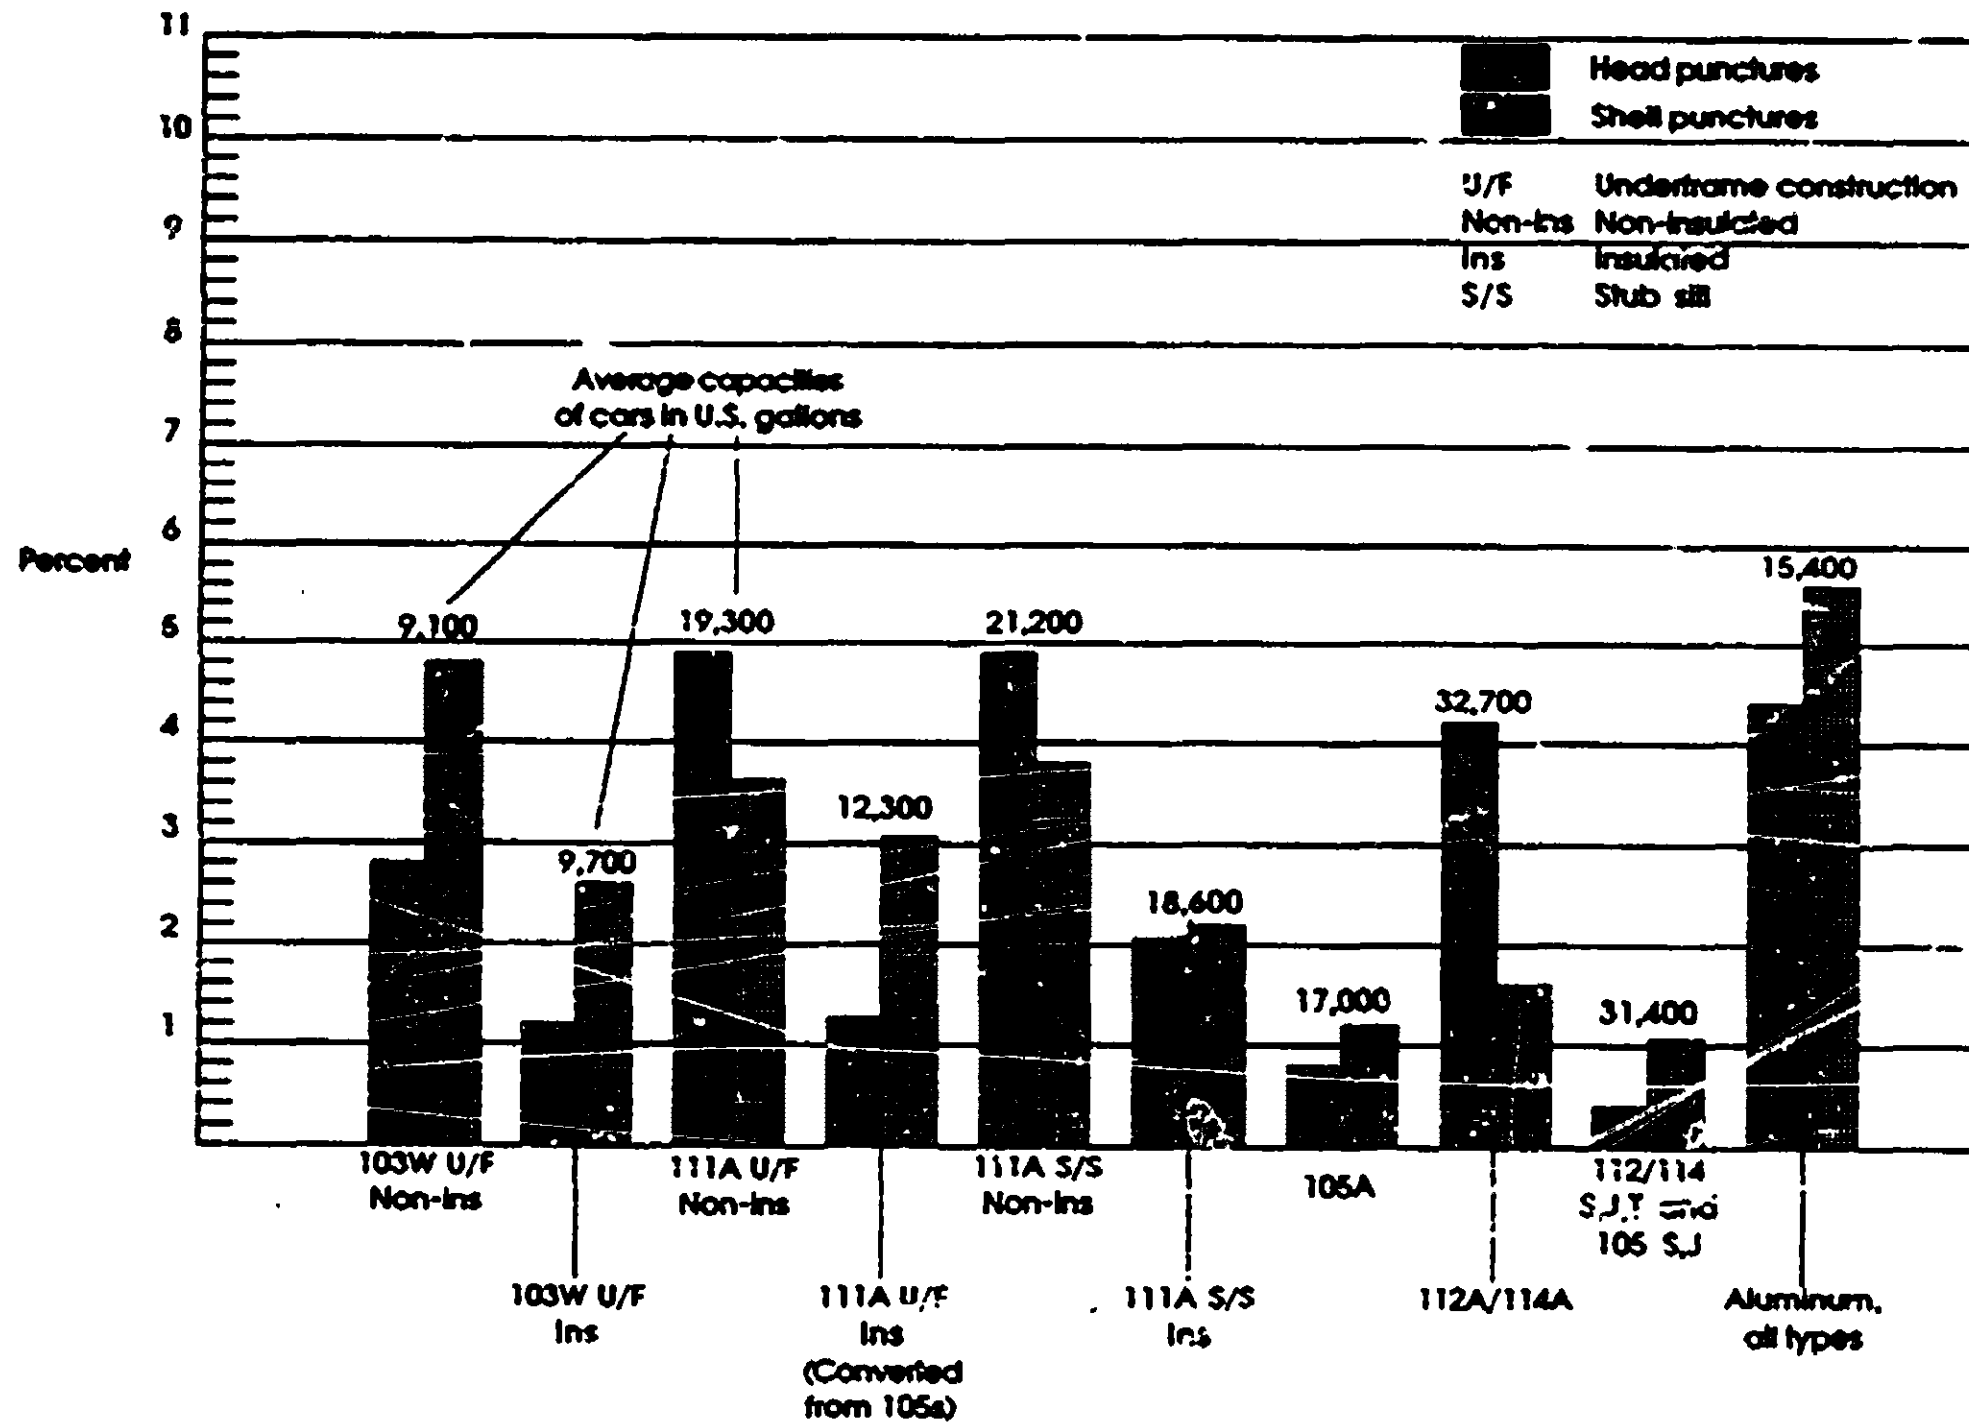
The RPI and AAR, in their 1990 study that analyzed the performance of the DOT-111A tank cars and other tank cars (RPI and AAR 1990a), reported a greater incidence of head and shell punctures in DOT-111A (insulated and non-insulated), DOT-112A/114A, and aluminum tank cars (fig. 1)--none of which have the improved tank head resistance protection and/or thermal protection as required for the DOT-112S, J, and T tank cars, the DOT-114S, J, and T tank cars, and for the DOT-105S, J, and T tank cars (see footnote 5). The incidence of head and shell punctures in tank cars damaged in accidents to the total number of tank cars damaged in accidents during a 22-year period (1965-86) is also shown in figure 1.

Figure 1.--Incidence of head and shell punctures to total number of tank cars damaged in accidents, 1965-86. (Source: Railway Progress Institute and Association of American Railroads 1990a.)
