**CCW IMPOUNDMENTS
INSPECTION REPORT**

**DAN RIVER STEAM STATION
ROCKINGHAM COUNTY,
NORTH CAROLINA**

**PROJECT No. 09-4157
SEPTEMBER 2009**

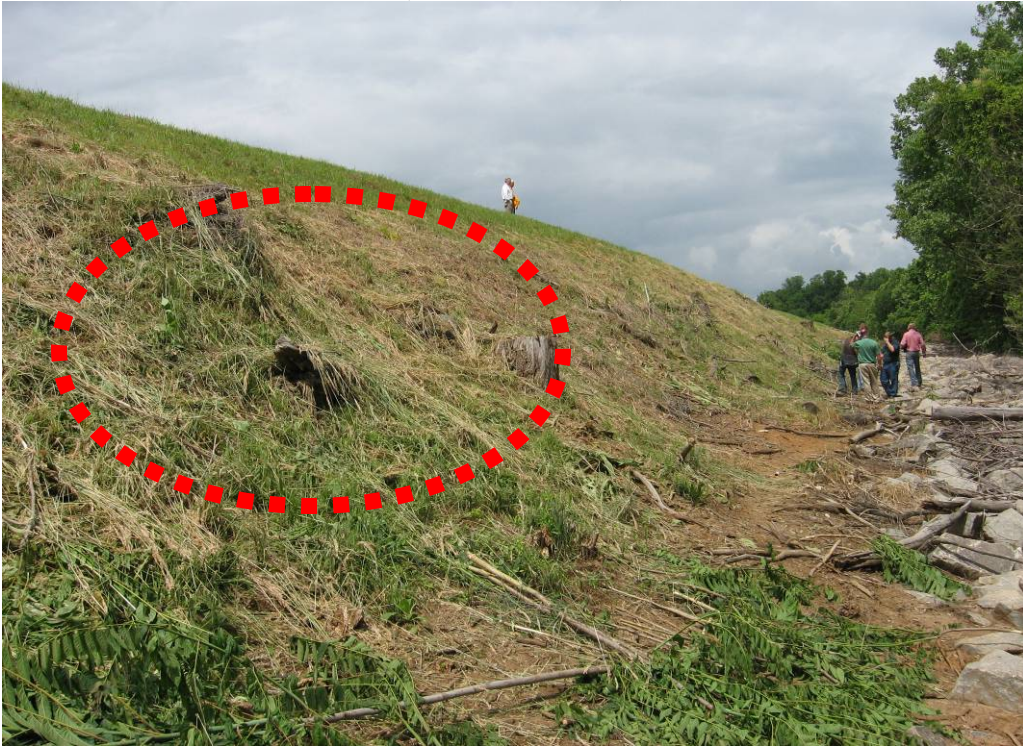
**PHOTO 5: STUMPS IN PRIMARY POND SOUTHERN EMBANKMENT SLOPE
(LOOKING NE)**

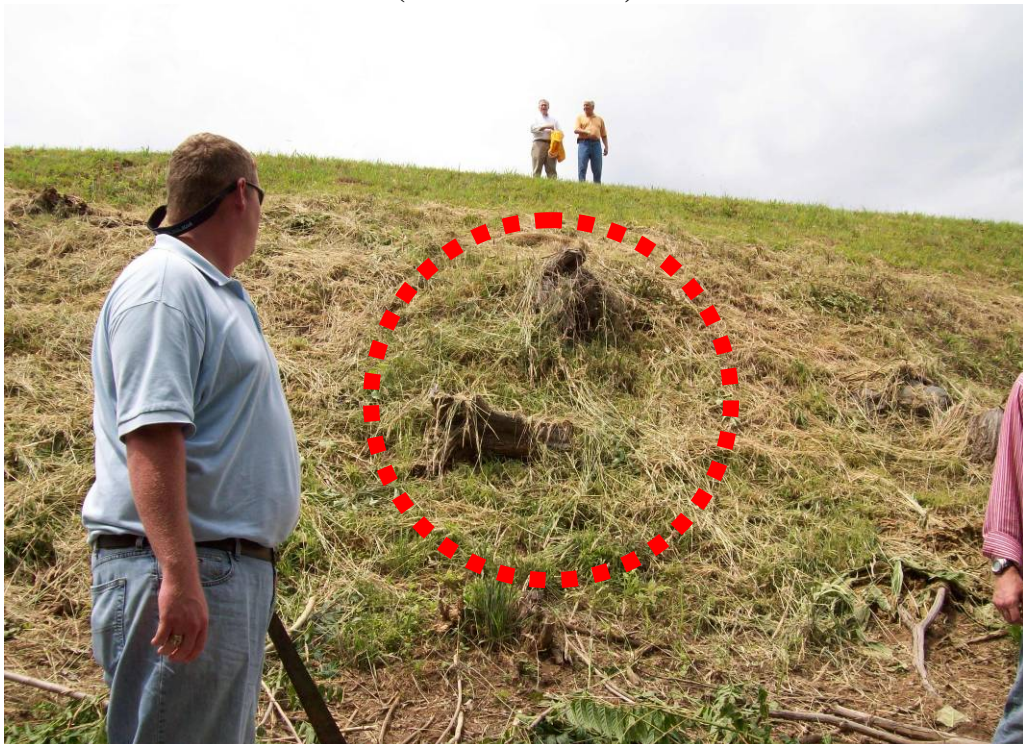
**PHOTO 6: STUMPS IN PRIMARY POND SOUTHERN EMBANKMENT SLOPE
(LOOKING NW)**

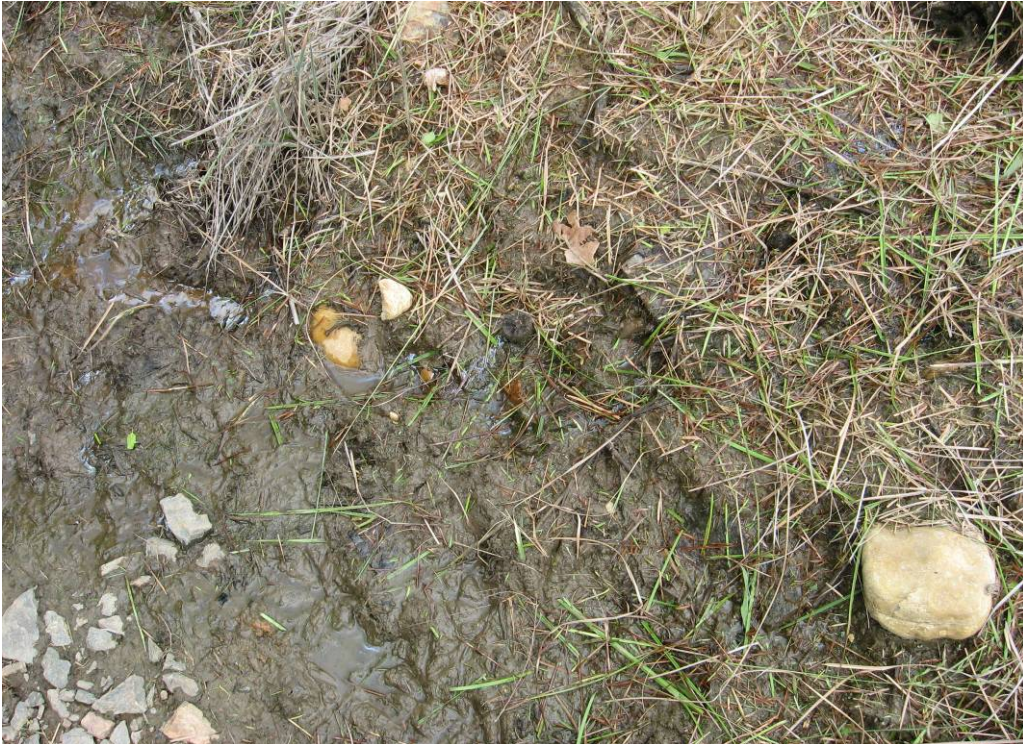
**PHOTO 9: SEEPAGE AND SATURATED AREA AT TOE OF PRIMARY POND
SOUTHERN EMBANKMENT**

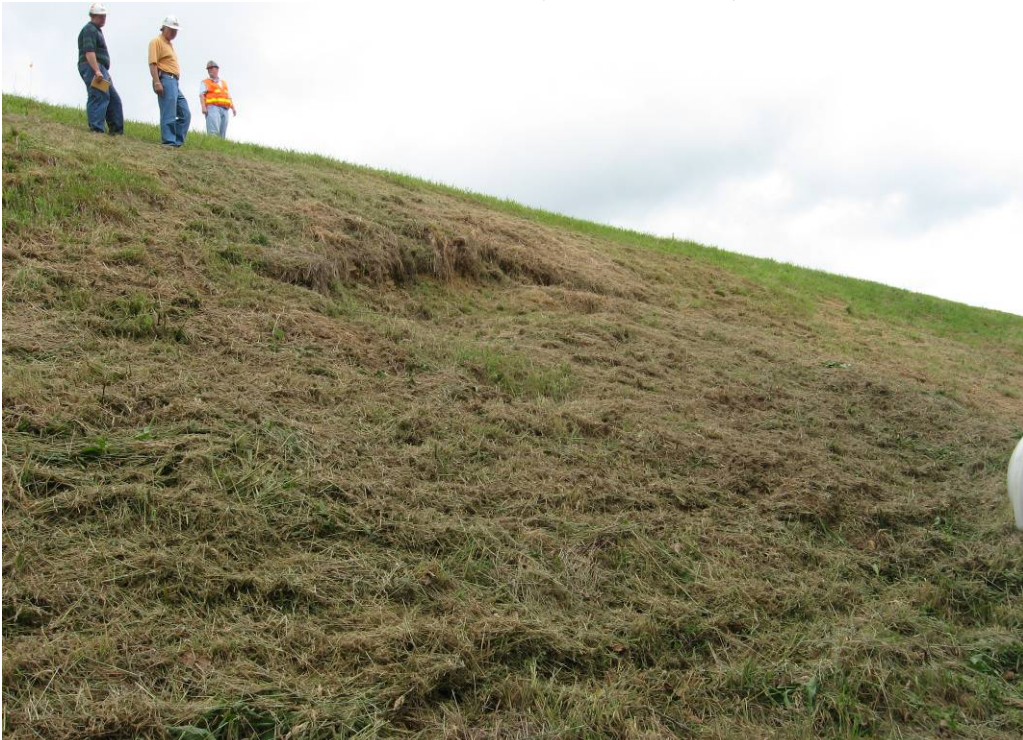
**PHOTO 10: SURFICIAL SLOUGH OF PRIMARY POND SOUTHERN
EMBANKMENT (LOOKING N)**

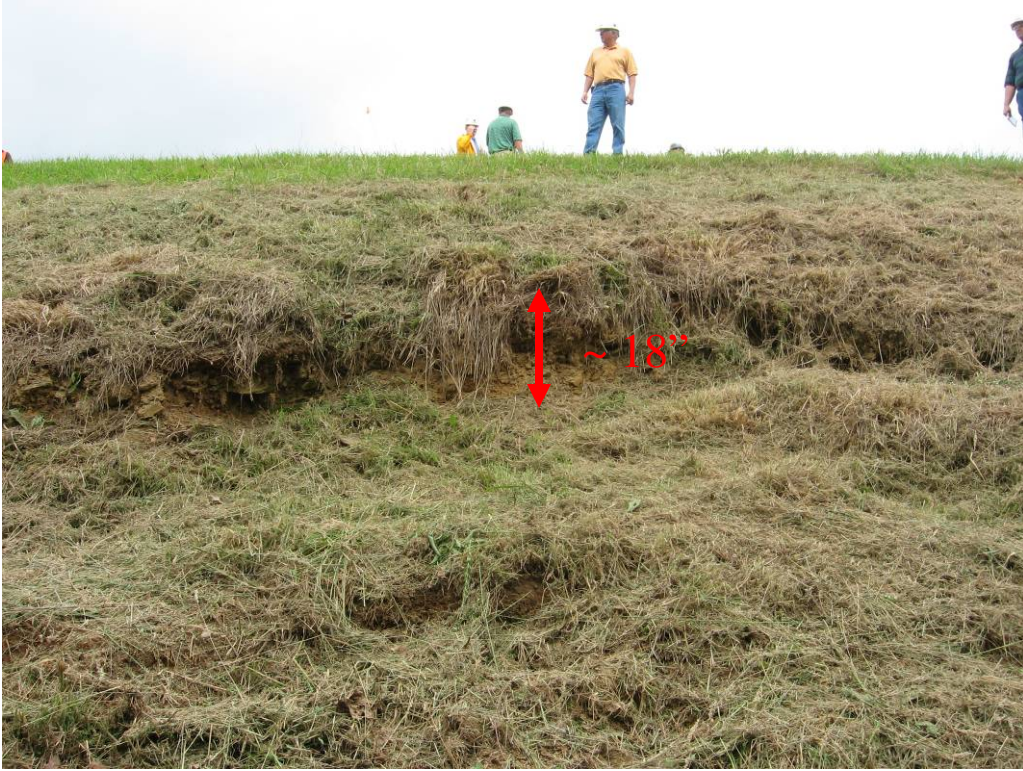
**PHOTO 11: SCARP OF SURFICIAL SLOUGH OF PRIMARY POND
SOUTHERN EMBANKMENT (LOOKING NW)**

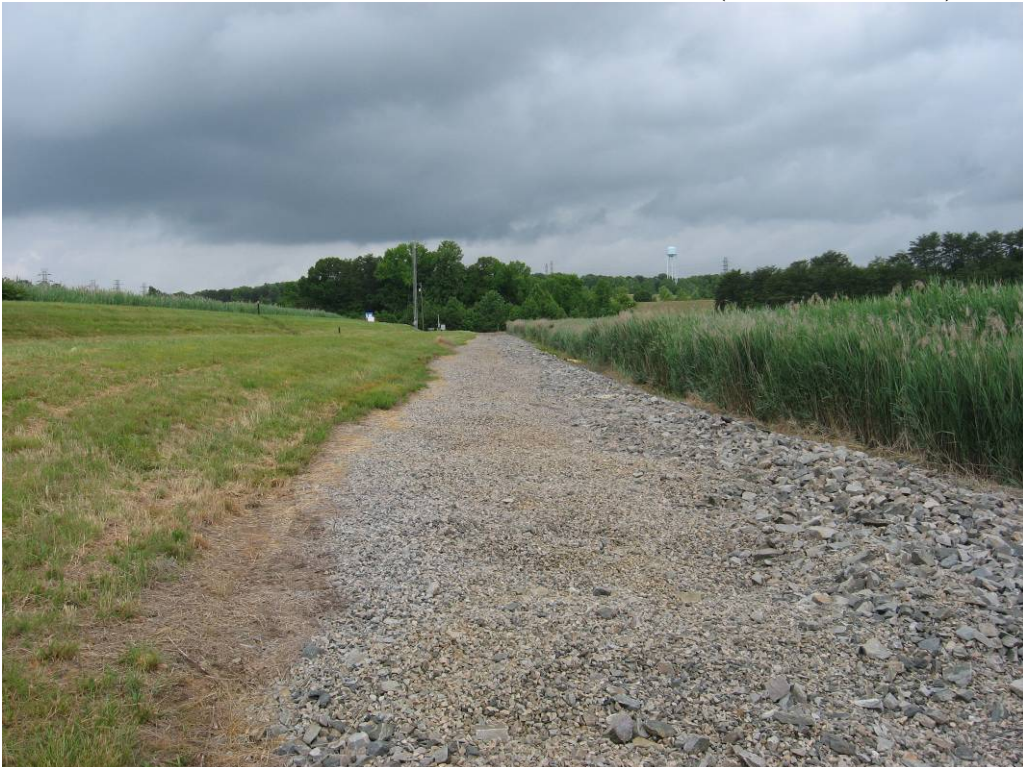
The intermediate dike dividing the Primary and Secondary Ponds appeared to be well maintained and in good condition, with a crushed gravel road across its crest and recently mowed slopes on the Primary Pond side (see *Photo 12*).

PHOTO 12: INTERMEDIATE DIKE CREST (LOOKING NW)

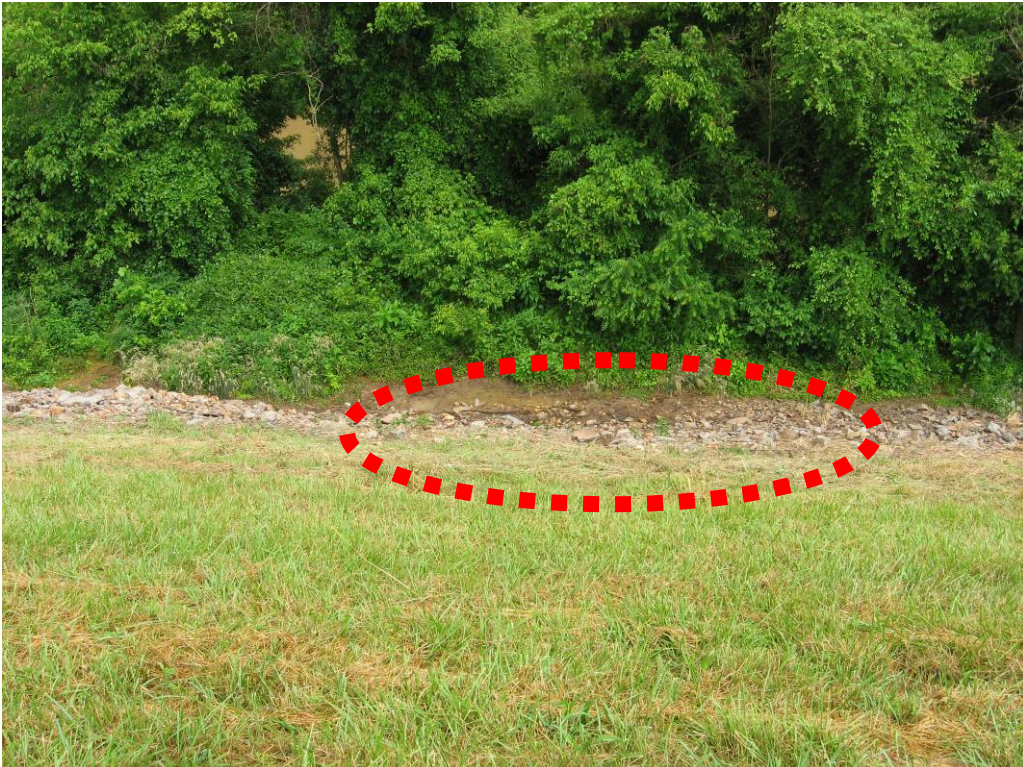
PHOTO 16: WET AREA AT TOE OF SOUTHERN EMBANKMENT OF SECONDARY POND (LOOKING SE)

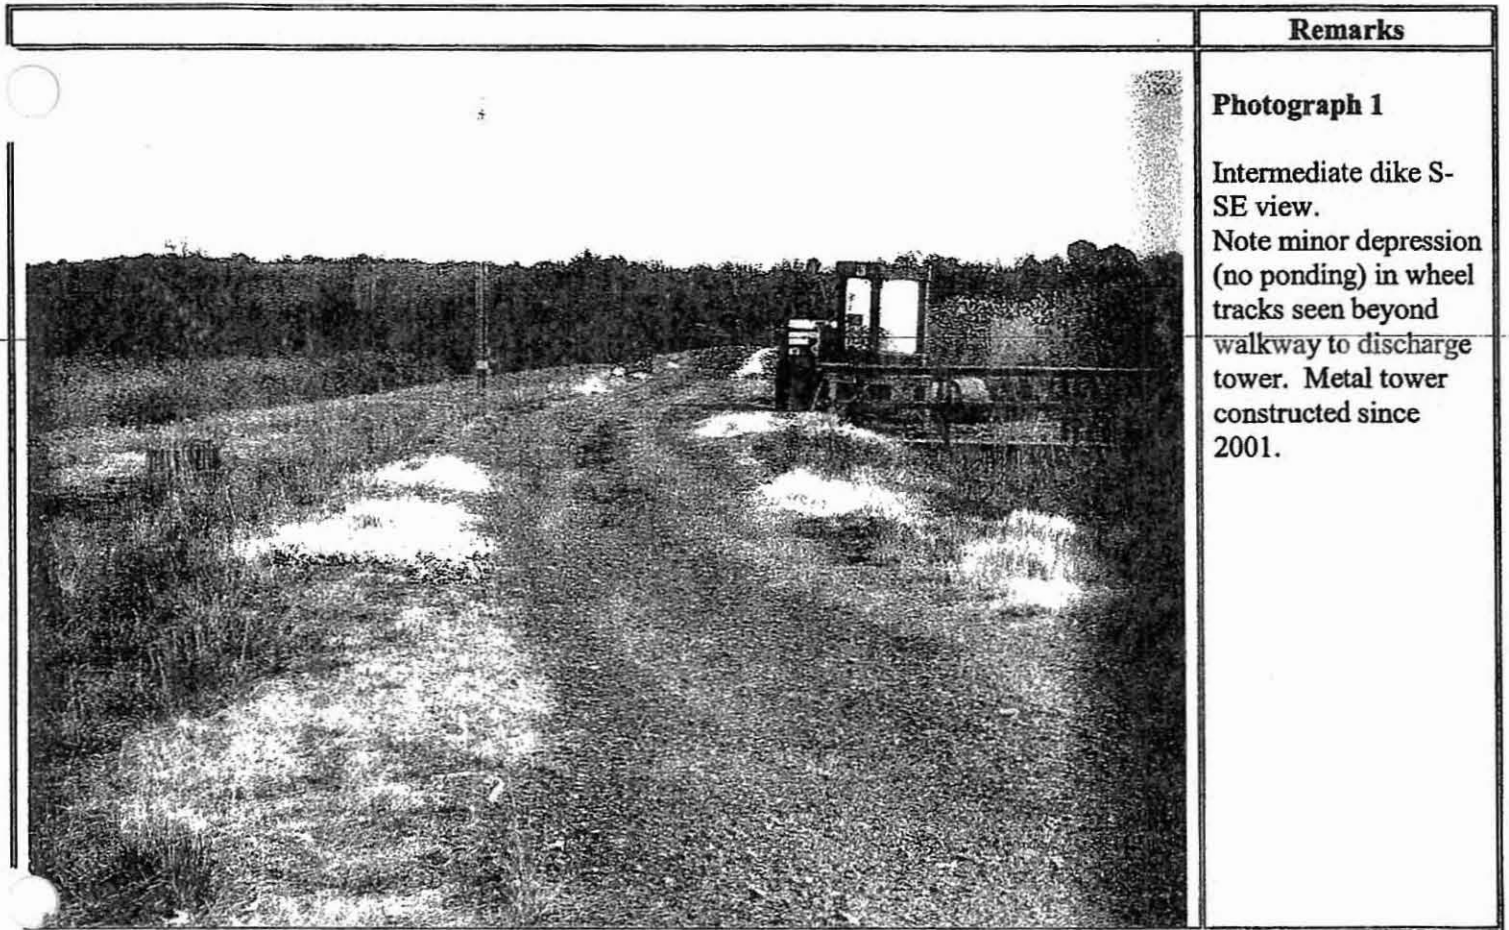
Photograph 1

Intermediate dike S-SE view. Note minor depression (no ponding) in wheel tracks seen beyond walkway to discharge tower. Metal tower constructed since 2001.

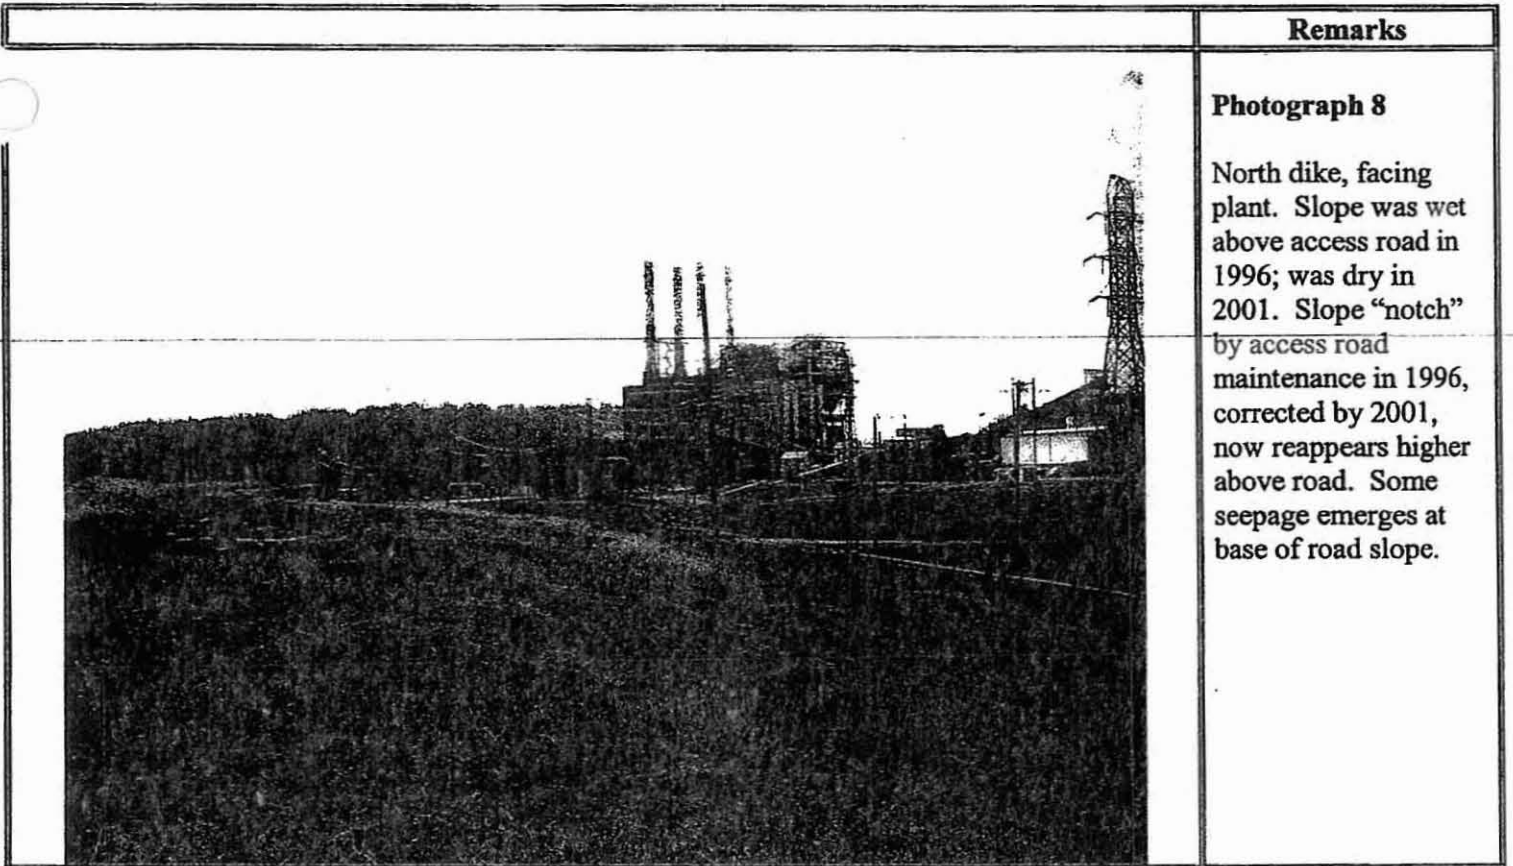
Photograph 8

North dike, facing plant. Slope was wet above access road in 1996; was dry in 2001. Slope "notch" by access road maintenance in 1996, corrected by 2001, now reappears higher above road. Some seepage emerges at base of road slope.

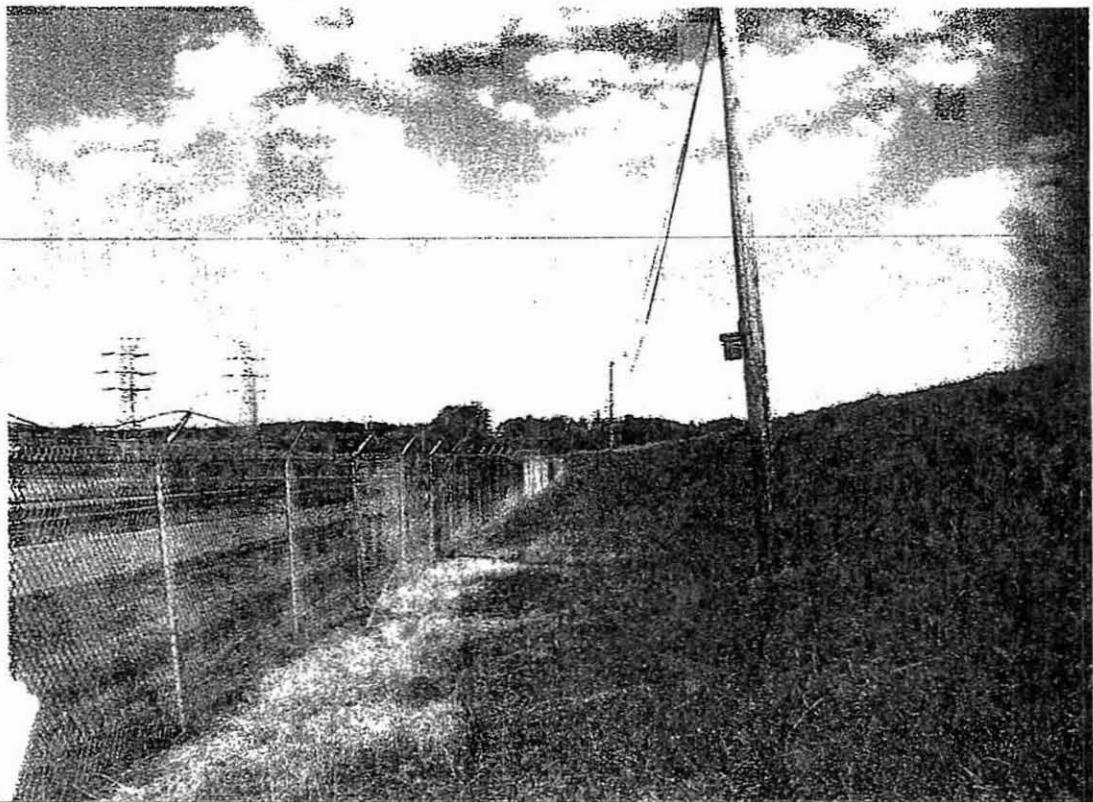
<p>Photograph 9</p> <p>Downstream slope of northern embankment with Piezometers 6 and 7 in background. Pole 77 closest to Photographer. Poles lean in same direction as in 2001. Poles loose in embankment. Road ditch (outside chain link fence in left side of Photograph) is wet with ponded seepage, consistent with high phreatic line in P-6 and P-7. A minor wet pothole on the crest road was observed near P-6.</p>

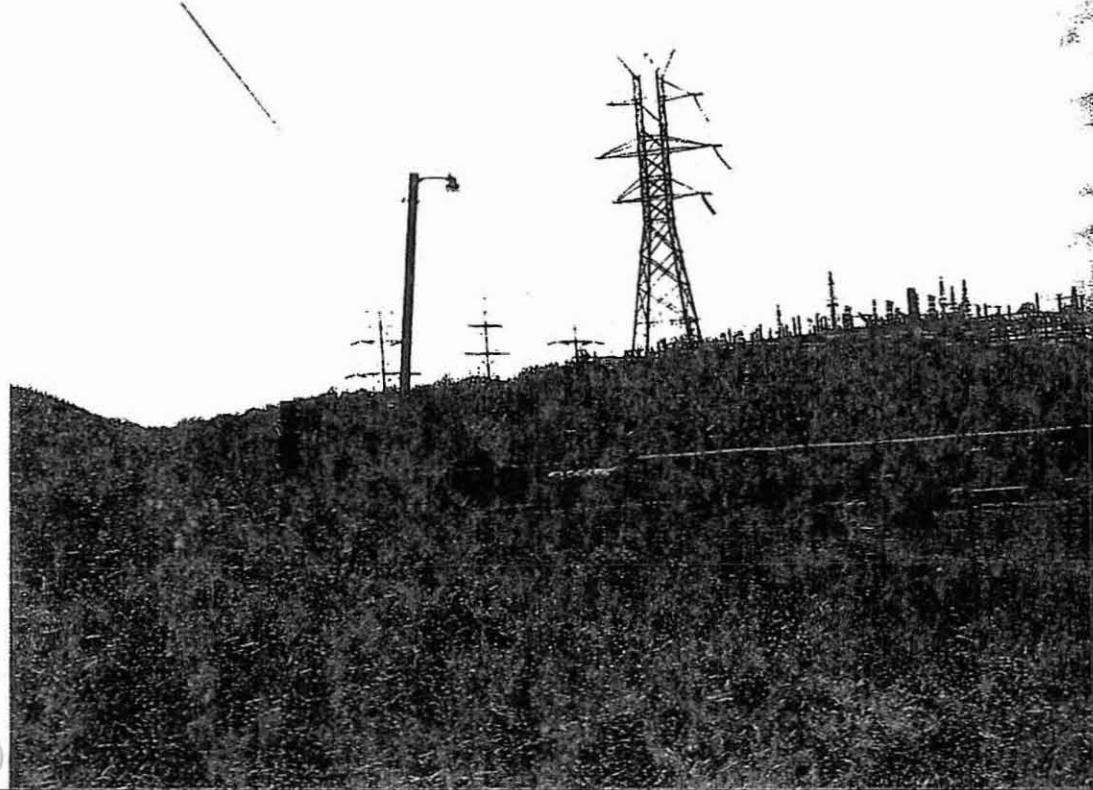
<p>Photograph 10</p> <p>Downstream slope of north embankment with piezometer 11. Pole leans about the same as in 2001. Road ditch outside fence to right in Photograph is wet from seepage.</p>

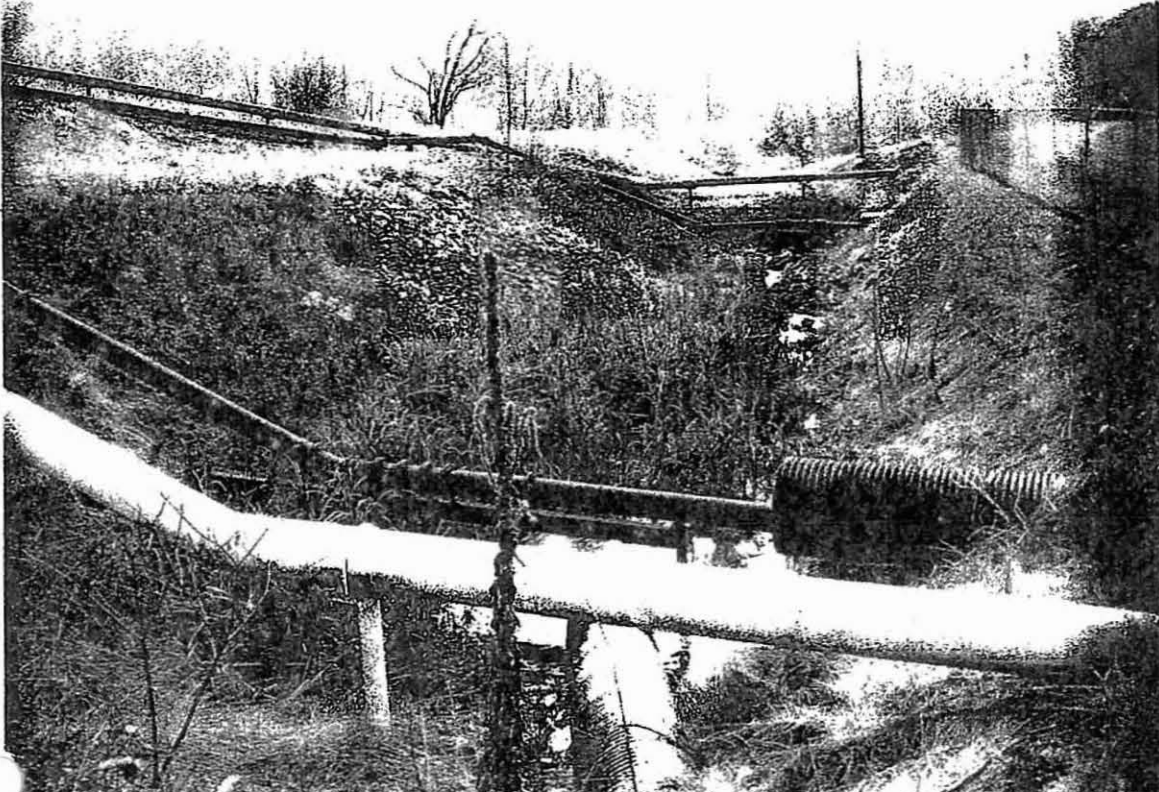
<p>Photograph 13</p> <p>Next to Photograph No 12 slightly to the left going up the embankment. Wet slump visible in Embankment in 1996 was repaired in 2001 (see rock fill area). Slope still appears stable.</p>

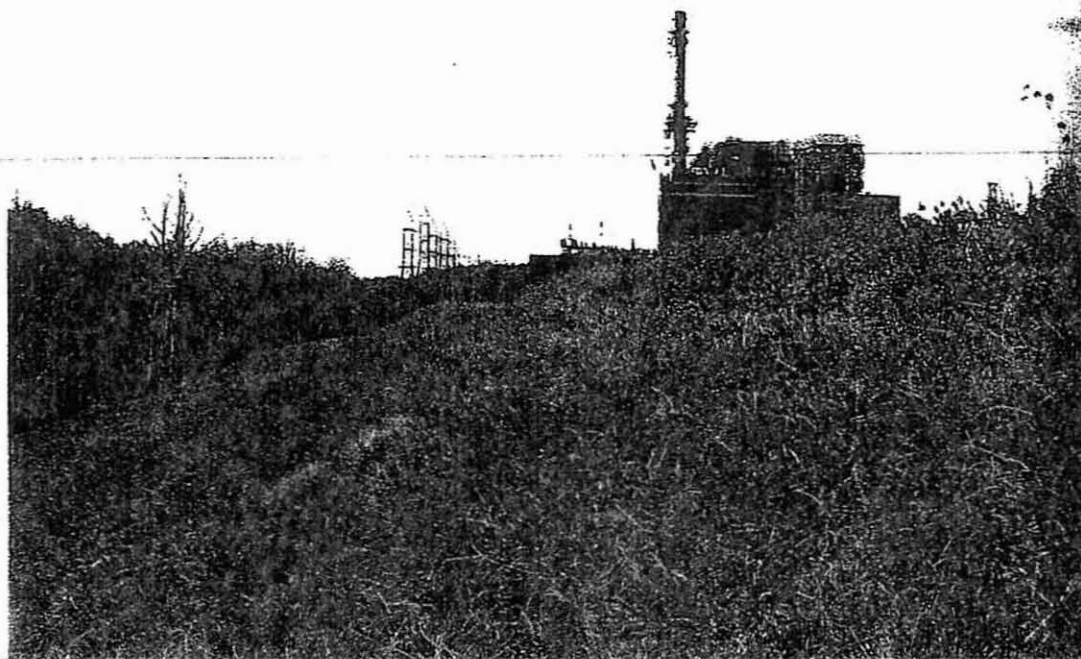
Photograph 19A

Slump in slope below elevation 525 berm looking S-SW. Slump has moved since 2001.

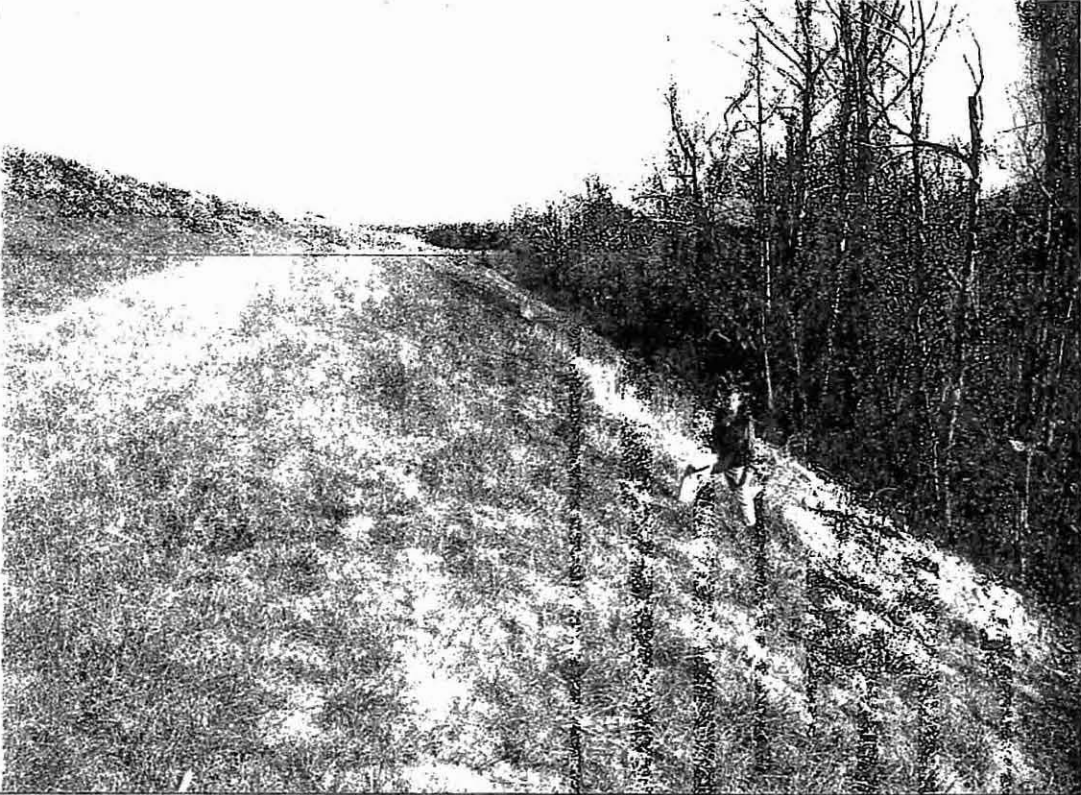
<p>Photograph 19B</p> <p>Slump in slope below elevation 525 berm looking N-NE. Slump has moved since 2001.</p>
	Remarks

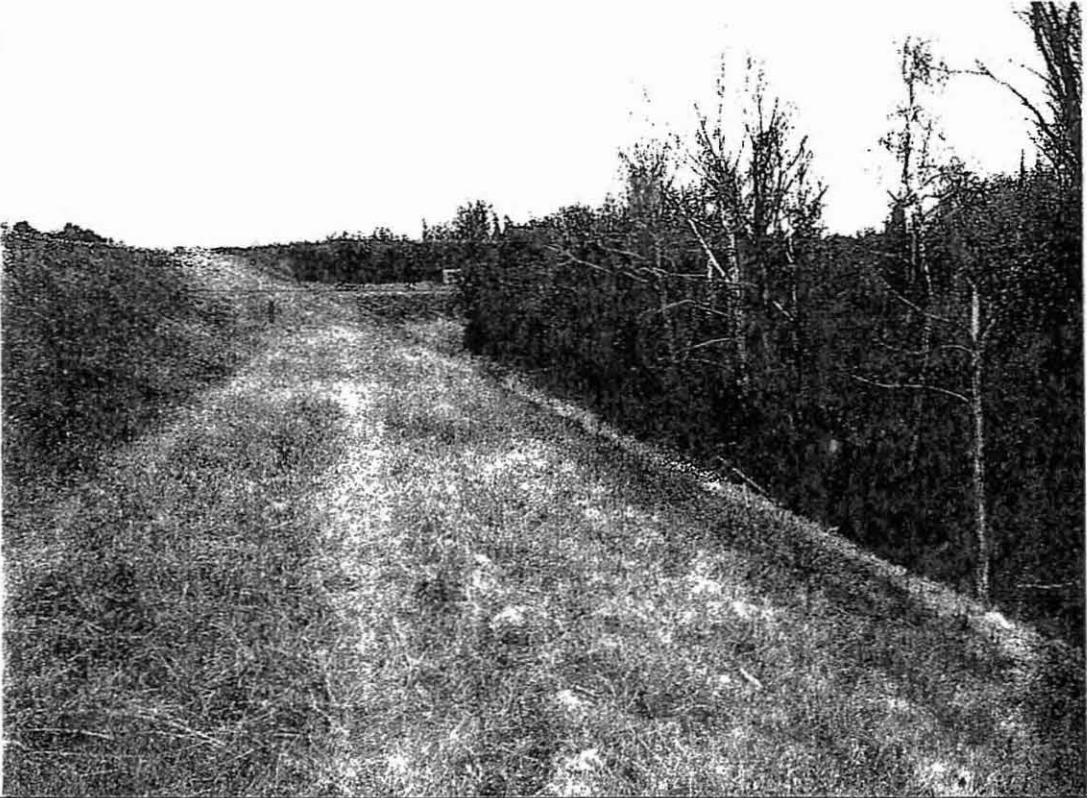
<p>Photograph 21</p> <p>Downstream slope of primary basin just before intersection with intermediate dike. Note vegetation has been removed from riprap since 2001. Significant seep halfway between berm and road. See test for additional significant features observed in this vicinity.</p>

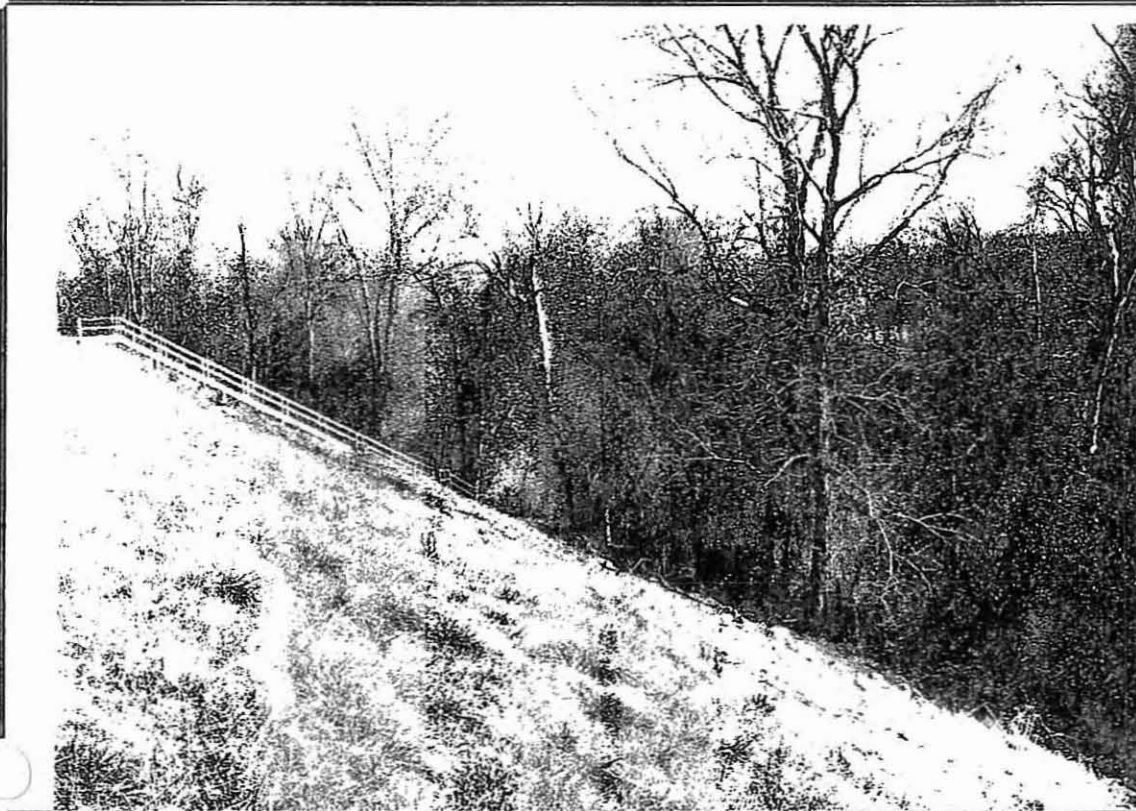
Photograph 23A

Riverbank is steep (active) and located nominally 10 ft from toe of dike in this vicinity.

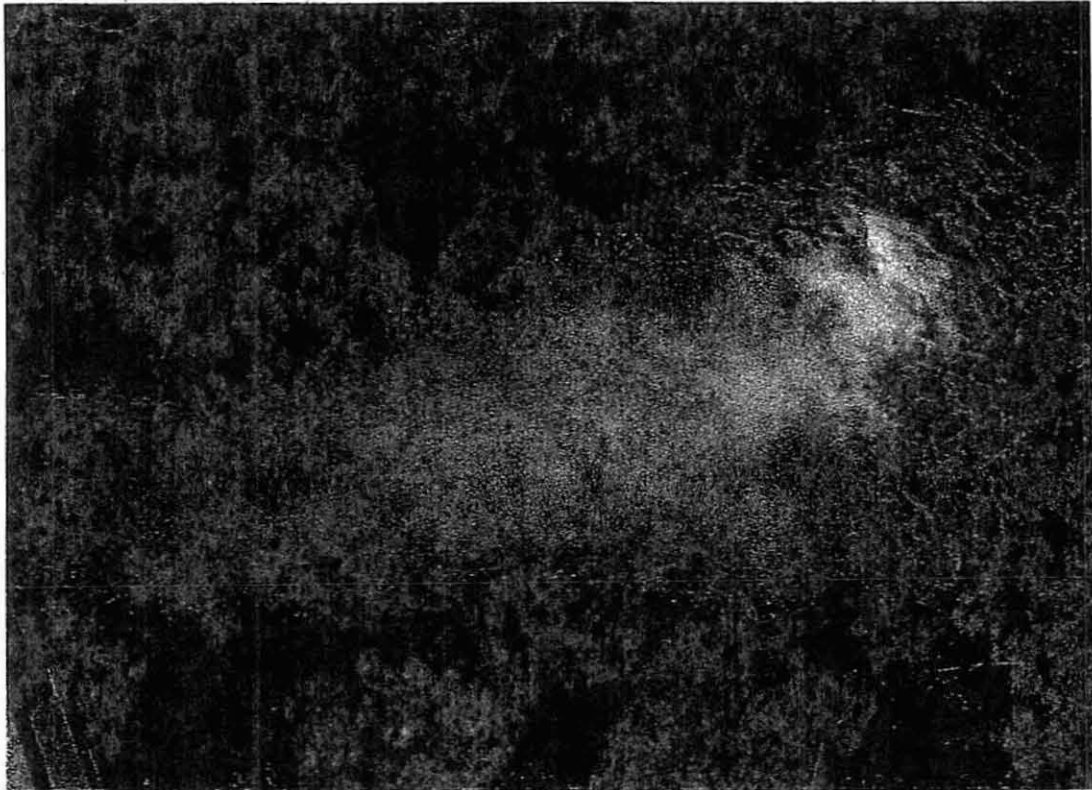
<p data-bbox="1290 1144 1483 1181">Photograph 27</p> <p data-bbox="1290 1208 1579 1442">Discharge path to Dan River. Straight edge on concrete (1996) now somewhat eroded, but apparently no significant change since 2001.</p>

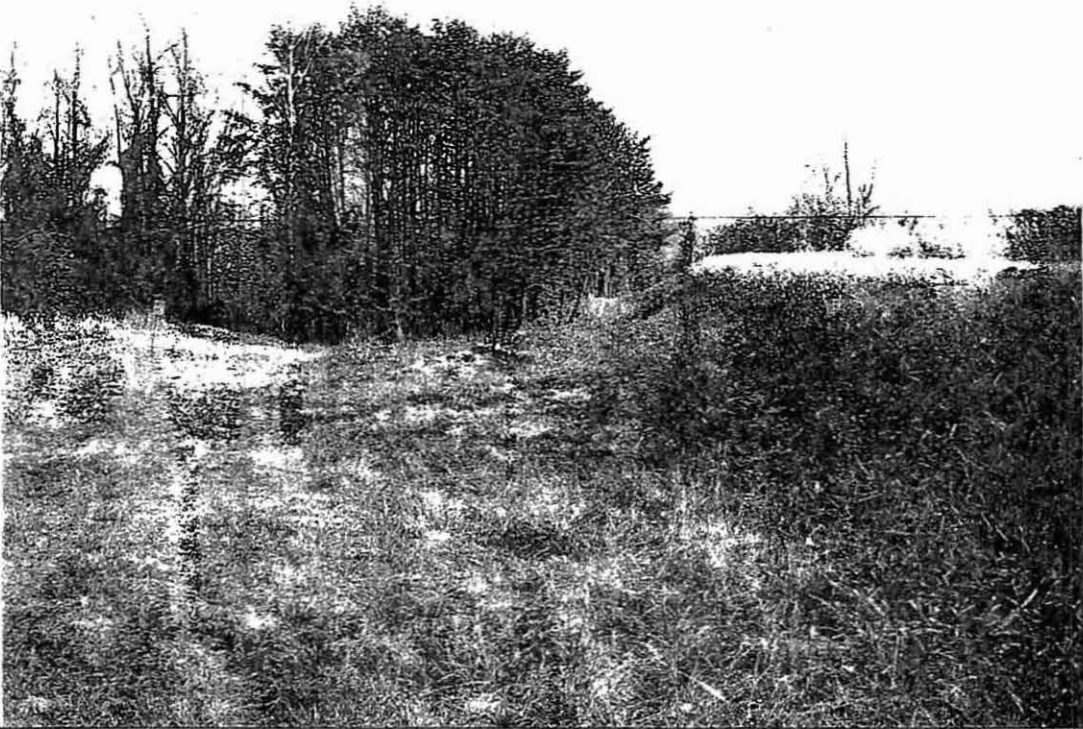
<p>Photograph 28</p> <p>Downstream slope north embankment for secondary basin, looking S-SE. Wet area beyond toe still visible and may be surface drainage. No change since 2001.</p>

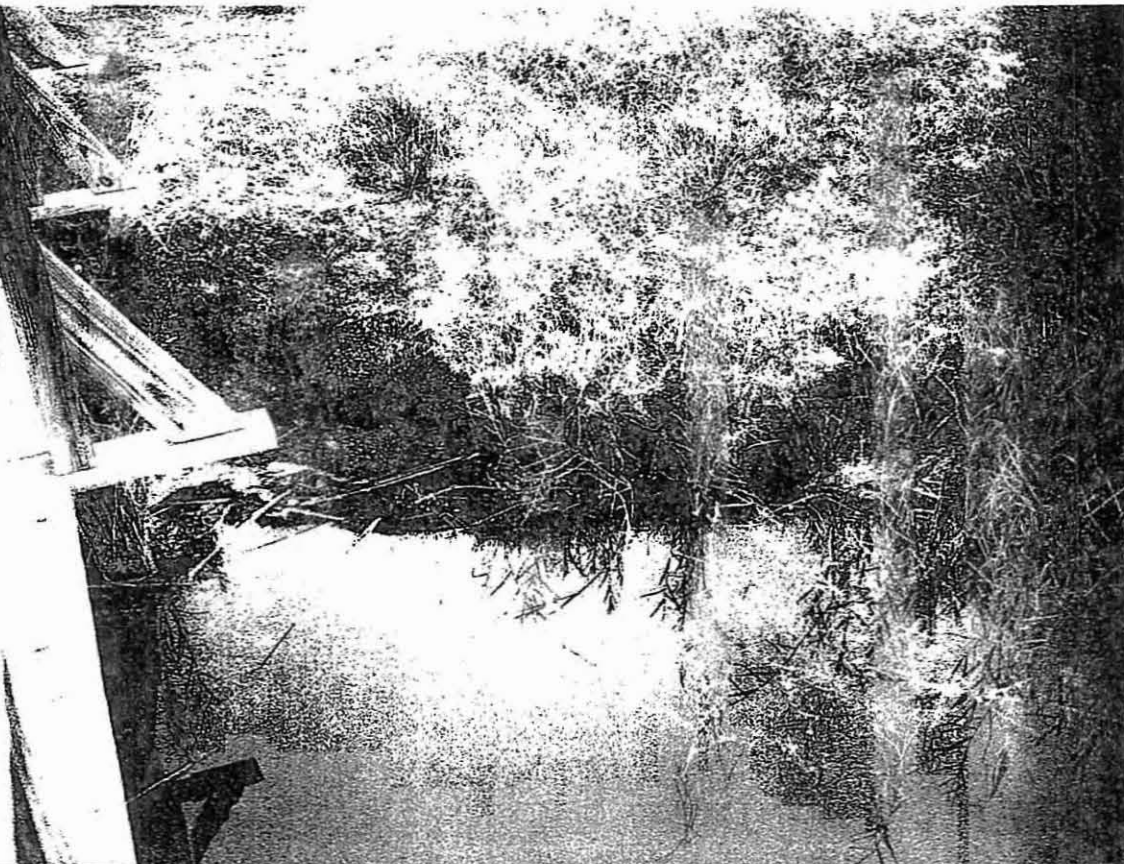
<p>Photograph 28A</p> <p>Upstream slope of secondary basin at discharge structure; note erosion or wave cutting first visible in 1996 that was not visible in 2001 due to vegetation.</p>
