Thank you for the opportunity to respond to your letter dated March 24, 2006 and your questions related to the North Slope oil spill from the Prudhoe Bay Unit Western Operating Area oil transit line (WOA OTL). This letter responds to those questions. We also look forward to meeting your staffs during their visit to Alaska next week to answer questions and ultimately to provide you with a better understanding of the issues related to this spill.

**BP Exploration (Alaska) Inc. (BPXA) - Corrosion Monitoring and Prevention Program****Background**

## ATTACHMENT 2 Responses to Questions

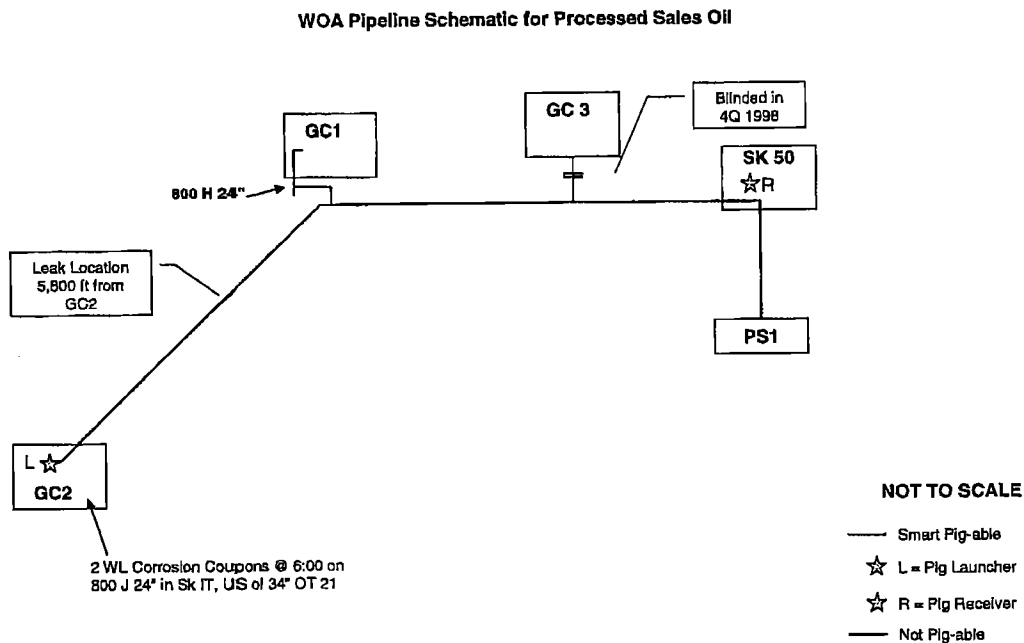
The schematic below provides an illustration of the Prudhoe Bay Unit Western Operating Area Oil Transit Line (WOA OTL).

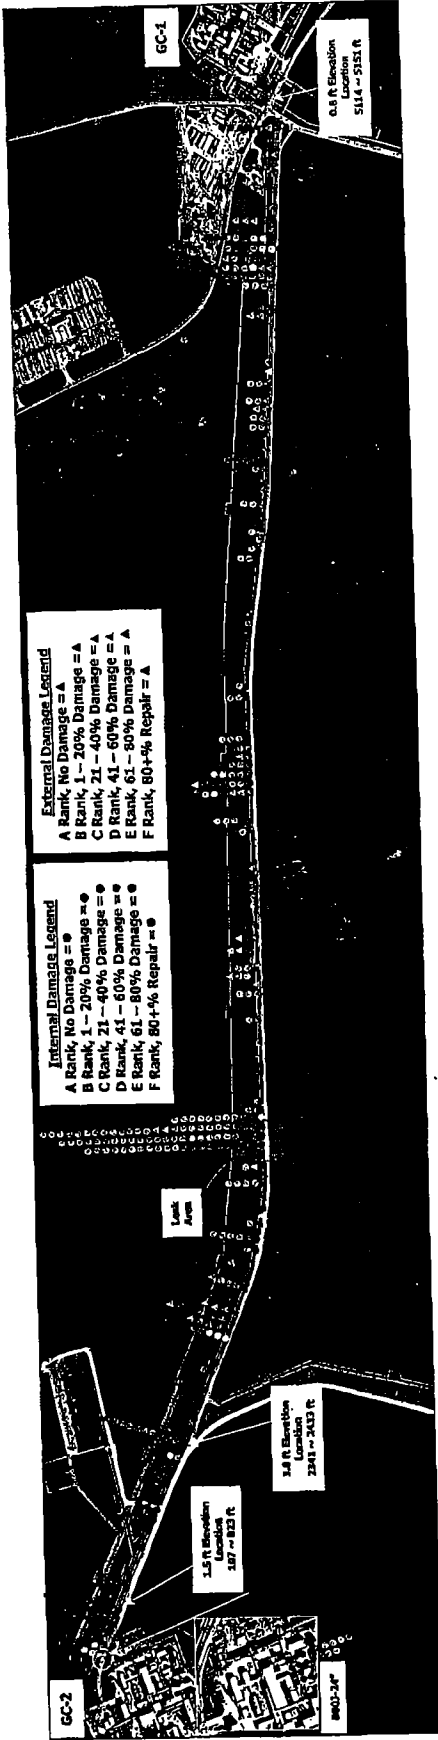
- (b) **Ultrasonic (UT) Inspections** – BPXA completed 1,122 individual UT inspections at both fixed and variable locations on the WOA OTL between July 23, 1998 (the date of the last smart pig run) and February 2006. “Fixed locations” are known damage sites where recurring inspections are performed to monitor corrosion growth. “Variable locations” are new locations added to discover potential areas of new corrosion. Table I above shows which section of the GPB OTL was inspected between August 1998 and February 2006. Table II shows the number of inspections between August 1998 and February 2006 relative to the geographic segment of pipeline. In addition, from March 2, 2006 through March 28, 2006, BPXA has completed over 2,000 inspections on the WOA OTL alone.

Exhibit A is an aerial overview of the WOA OTL with detailed inspection locations.
- (c) **Guided Wave Inspections** – BPXA completed 20 guided wave inspections on the WOA OTL between August 1998 and February 2006. Table II shows the number of inspections and the year when they occurred. The guided wave inspections occurred at the road and caribou crossings along the WOA OTL.

Aerial overview of the WOA OTL from GC2 to GC1 with the locations of the inspection points.

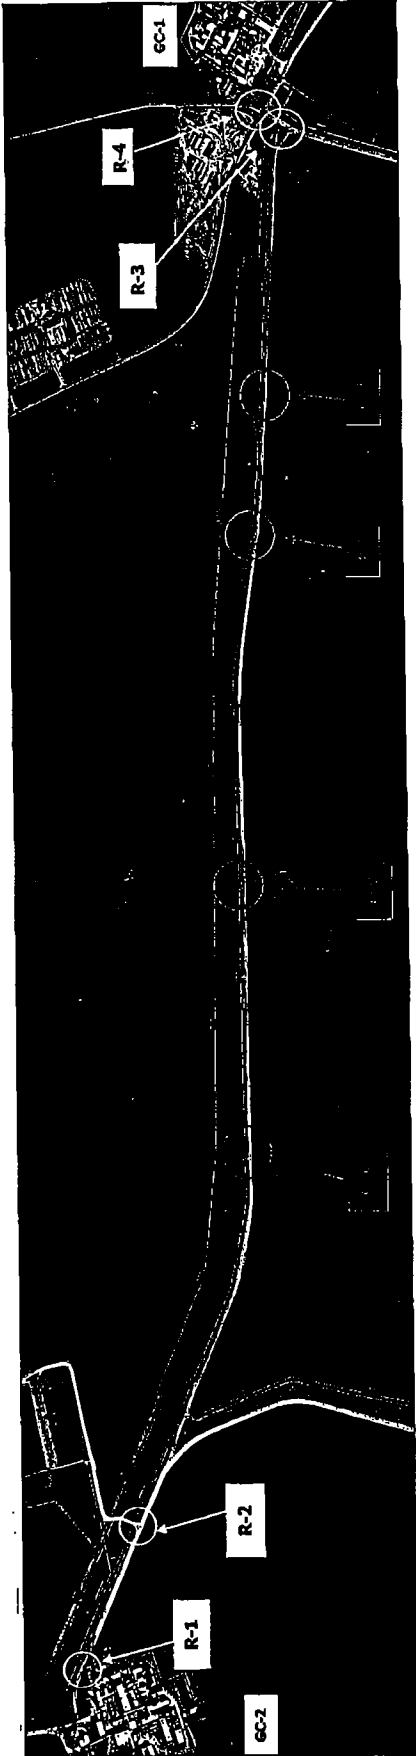
Exhibit B is an aerial overview of the WOA OTL with crossing locations specified where the guided wave inspections were conducted. Guided wave inspections had been conducted at all of the road and caribou crossing locations from GC-2 to GC-1 with the exception of crossing R-1 at GC-2.

Conventional UT was not taken at the leak location because it was in a buried crossing. The crossing had been tested using guided wave technology both prior to and post leak at the leak location. Guided wave technology provides a volumetric assessment of pipe-wall condition more suitable for broad areas of external corrosion metal loss rather than internal pitting. While the technique may have detected the corrosion pitting on the internal surface, guided wave technique does not provide quantitative information with exact measure of wall loss. The guided wave technique is used to screen for anomalies, monitor for active corrosion and where active corrosion is determined, corrective action is taken.

Aerial overview of the WOA OTL from GC2 to GC1 with the locations of the caribou crossings (C-Crossing Number) and road crossing (R-Crossing Number).
