GUIDELINES
for
ESTIMATING
LOADS in TRUCKS

SUBJECT: Internal Review Observation - Katrina LA-RFO 142 - Ceres - Improper Tailgate & Questionable QA Practices

1. Audit Observation No. 142 - Ceres - Improper Tailgate & Questionable QA Practices

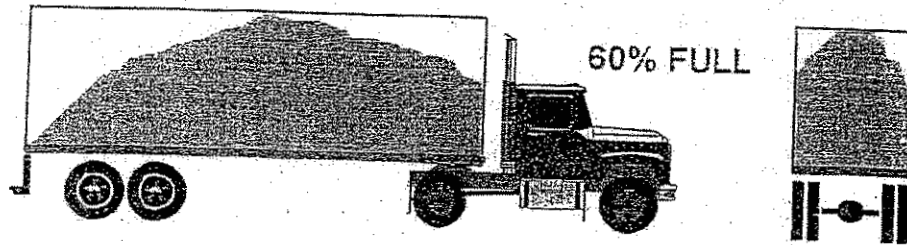
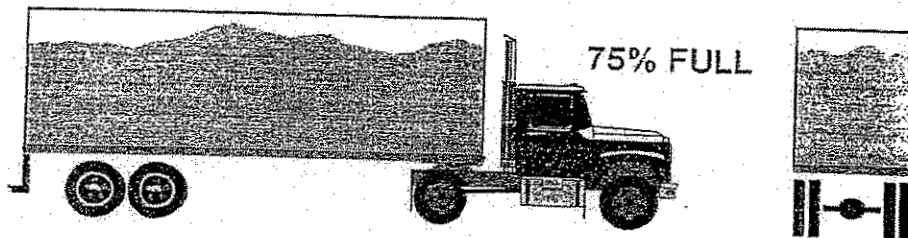
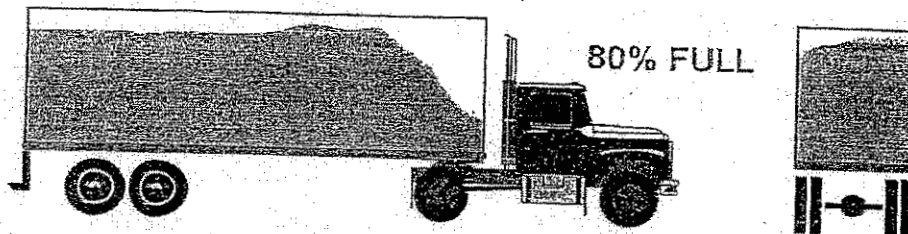
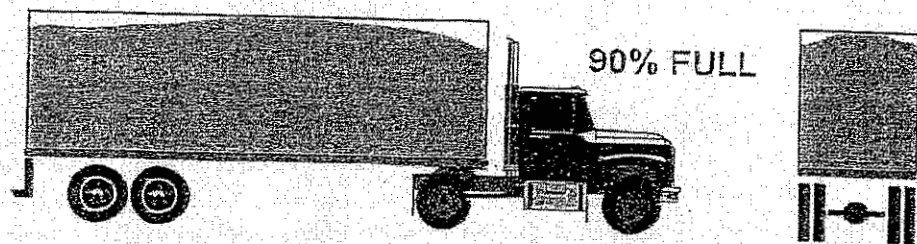
Exhibit L
Attachment A

4. Ensure that the truck is empty when it leaves the disposal site.
5. If there is not a tailgate on the truck, the truck is not full.
6. If the truck is half full, in the Debris Quantity Section of the load ticket note that the load is 50% full. (See Attachment "A" for percentage example of loaded trucks).
