# CALLBACK

From NASA's Aviation Safety Reporting System

Number 232

October 1998

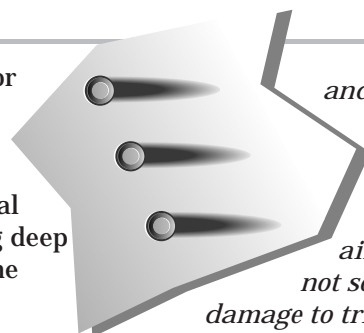
■ *The foreman called for the deferral of a working rivet and edge delamination on the aileron trim tab. The foreman stated that the rivet was smoking and delamination was within limits per the SRM for deferral for repair. I instructed the foreman to verify the limits*

*and make an interim repair. The time limit was 25 hours for [final] repair. While researching a similar problem [later], I found a reference that states the [deferral] does not apply to the aileron trim tabs. The foreman either did not see the note or missed the limitations of damage to trim tabs.*

Maintenance personnel must ensure that they are looking at the appropriate section of the SRM for the **exact** problem being researched. Careful reading of all limitations and instructions—including footnotes—should prevent misinterpretation of the corrective action. ▲
