CALLBACK

From NASA's Aviation Safety Reporting System

Number 284

The Case of the Unstable Approach

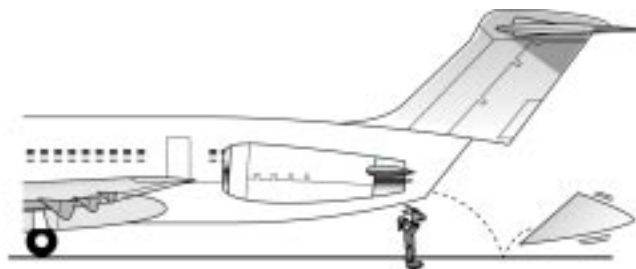
■ *Ramp personnel told us that there was no passenger stair available and that they could not fuel the aircraft with passengers on board unless an exit door was available. Someone on the ground asked about lowering the aft stairs.... We found the procedure for exterior aft stair operation in the aircraft manual. We gave the ramp personnel the page from the manual. They had no questions and indicated that they could do the procedure.... They pulled the emergency jettison handle and jettisoned the tail cone.*

■ *[We] taxied to the maintenance ramp for a one-hour ATC and weather delay. Six passengers deplaned via the aft stair because they did not wish to continue due to the delay. The First Officer thought that you could raise the stair from inside the cabin. I went aft and while I was looking at the panel, the Number Two Flight Attendant, trying to help, pulled the handle above the emergency exit door releasing the tail cone. The tail cone fell to the ground causing some damage....* ▲
