US Army Corps
of Engineers
Construction Engineering
Research Laboratories

USACERL Technical Report 98
SFIM-AEC-ET-CR-98009
July 1998

Evaluation of Two Washrack Recycle Treatment Systems

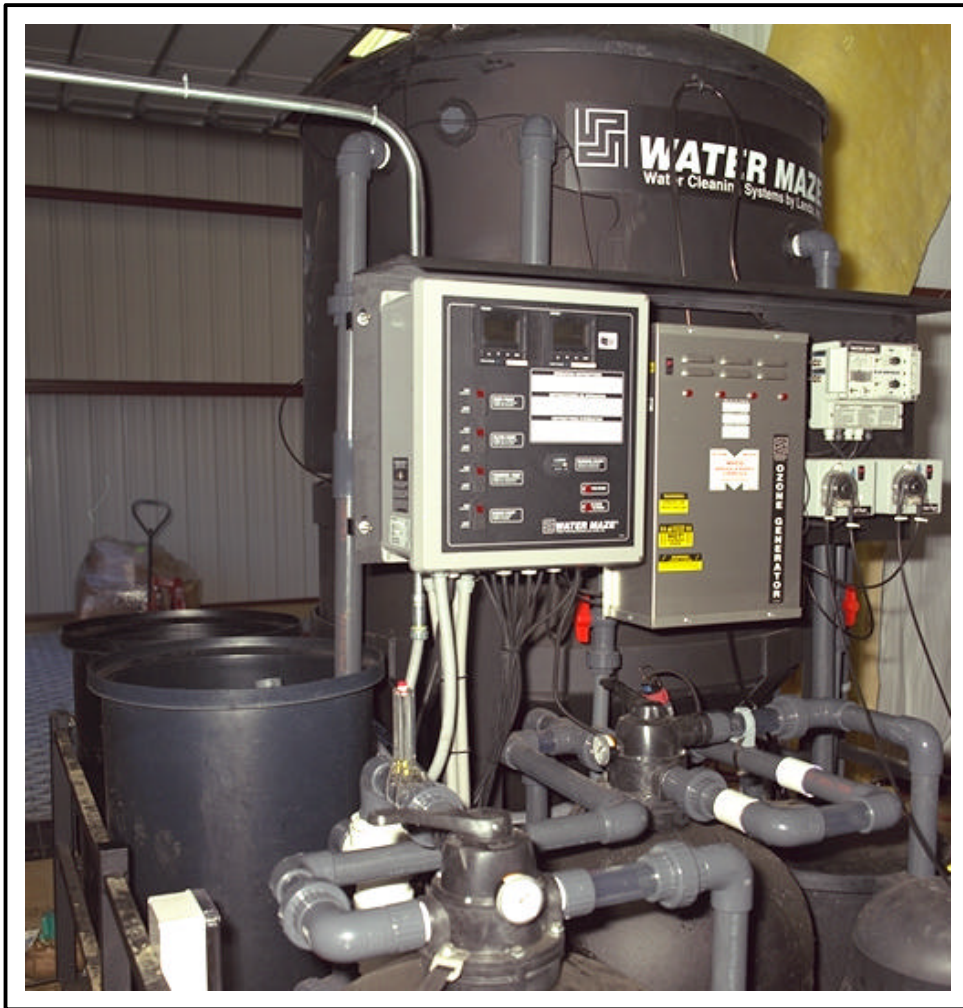
Figure 1. Landa System in Building 338, Aberdeen Test Center.

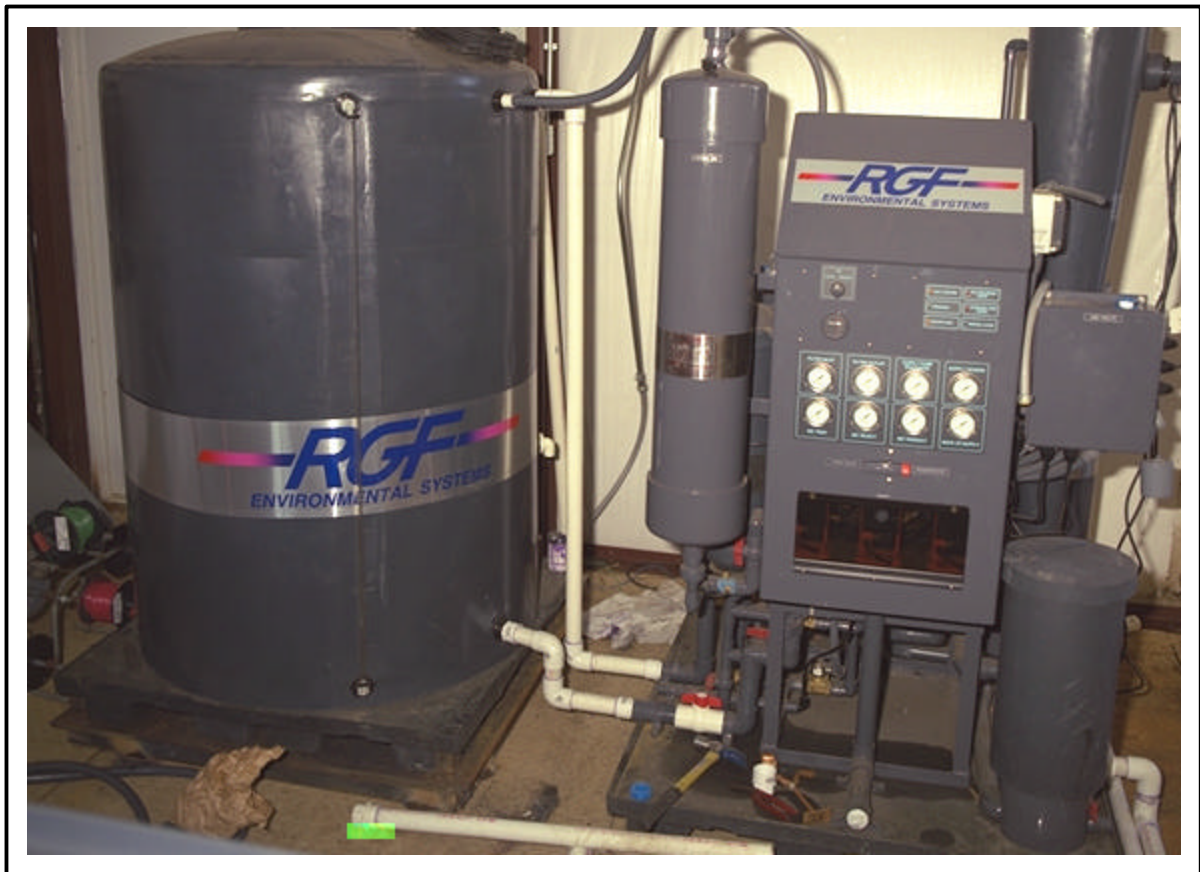
Figure 3. RGF system in Building 338 washrack, Aberdeen Test Center.

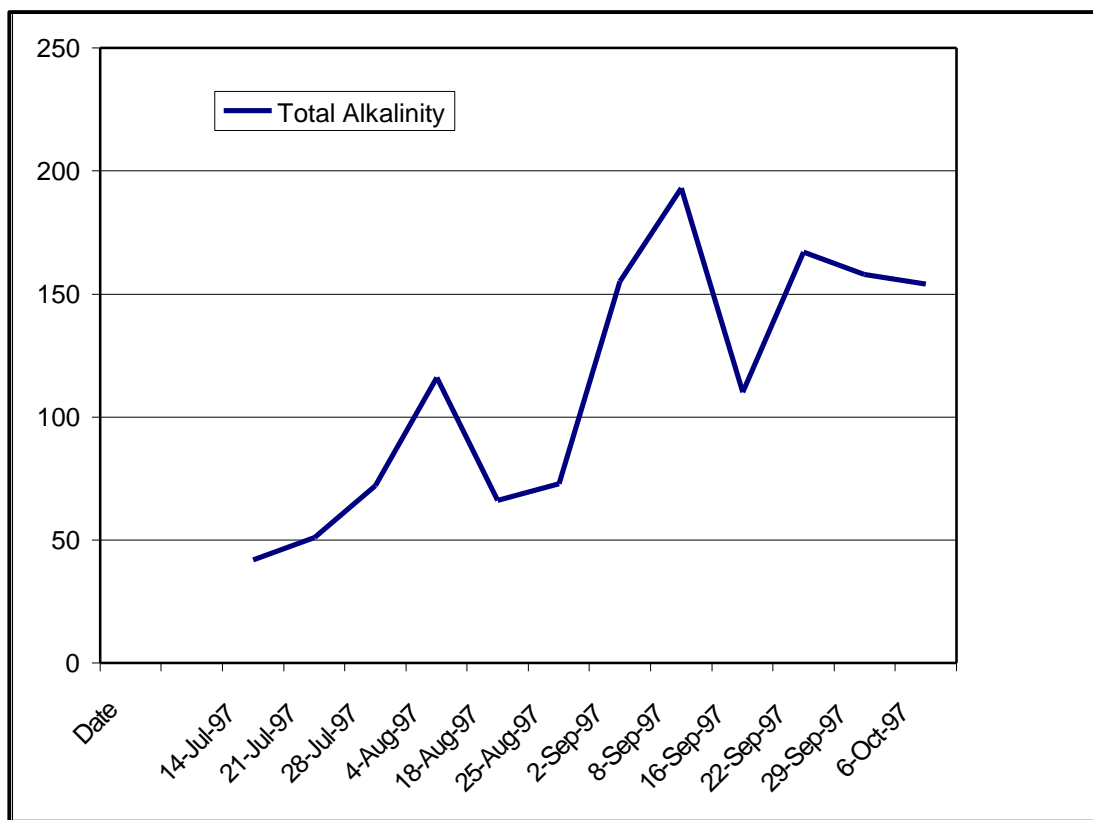
Figure B1. Alkalinity data, RGF treatment system (corresponds to data listed in Table B5).

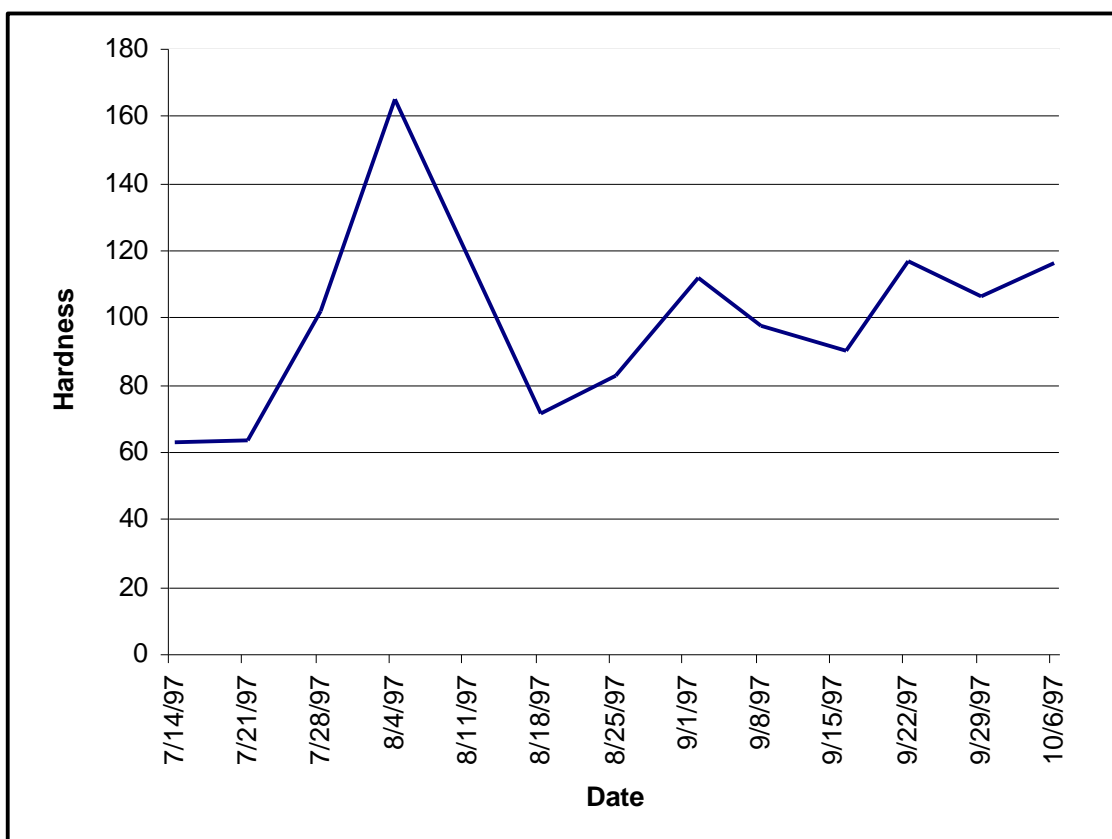
**Figure B2. Hardness vs. Time, RGF treatment system (corresponds to data listed in Table B6).**

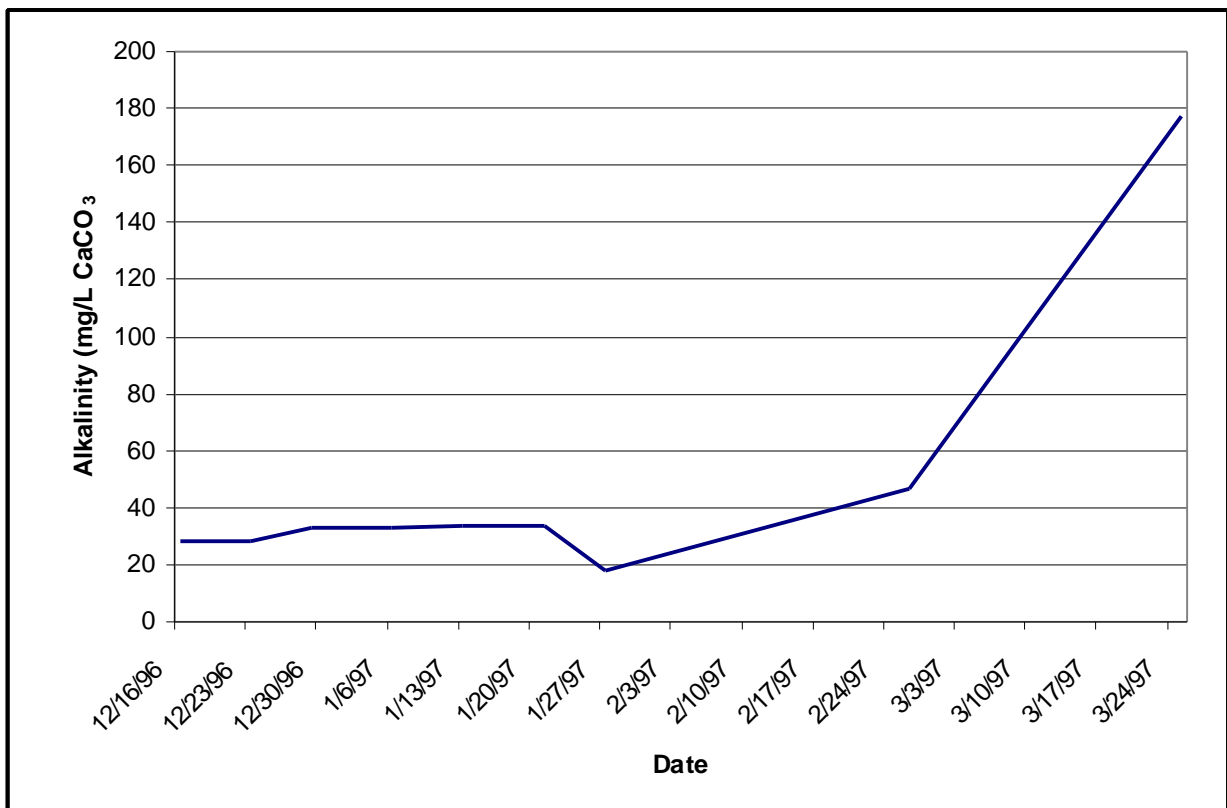
Figure B3. Alkalinity vs. time, LANDA treatment system (corresponds to data listed in Table B12).

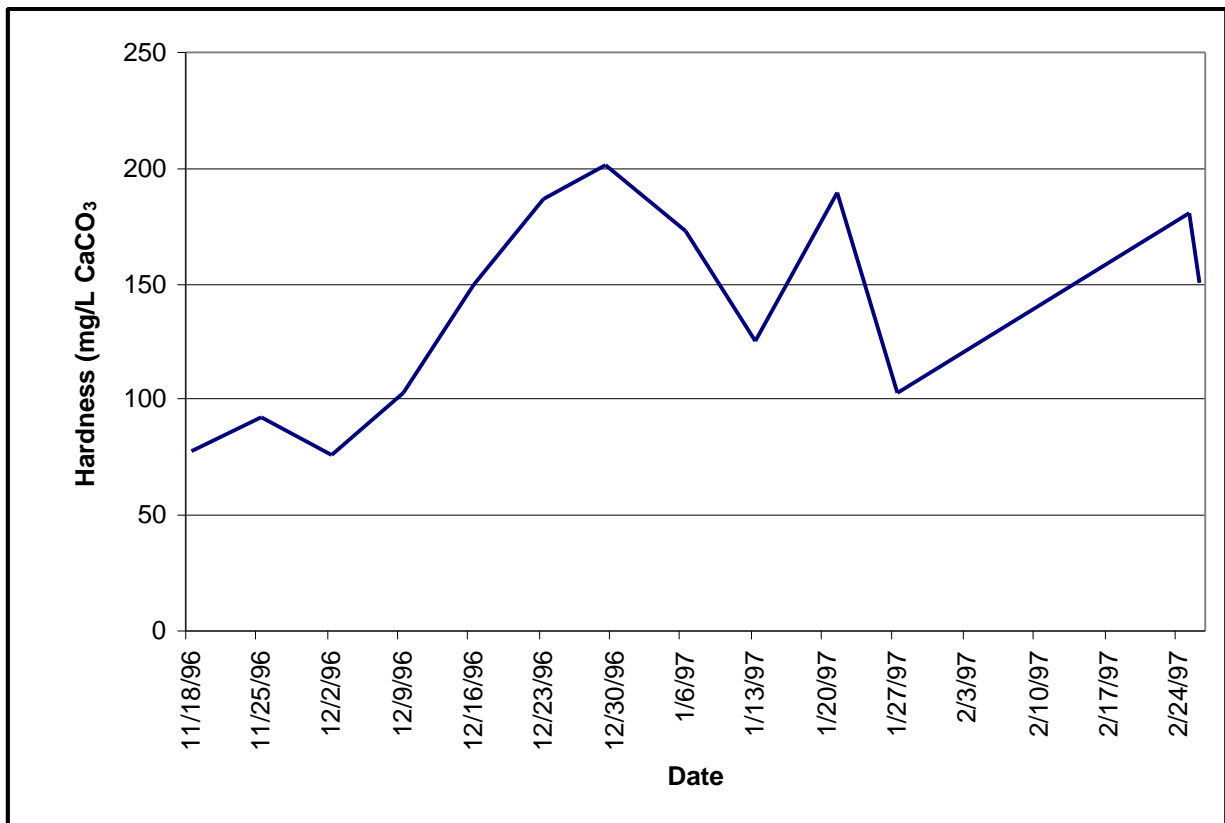
**Figure B4. Hardness vs. time, LANDA treatment system (corresponds to data listed in Table B13).**
