NOAA Abandoned Vessel Program Removal Case Study: *Nago No. 15*

Contributing Agency: CNMI Coastal Resources Management Office

NOAA AVP #: 1253

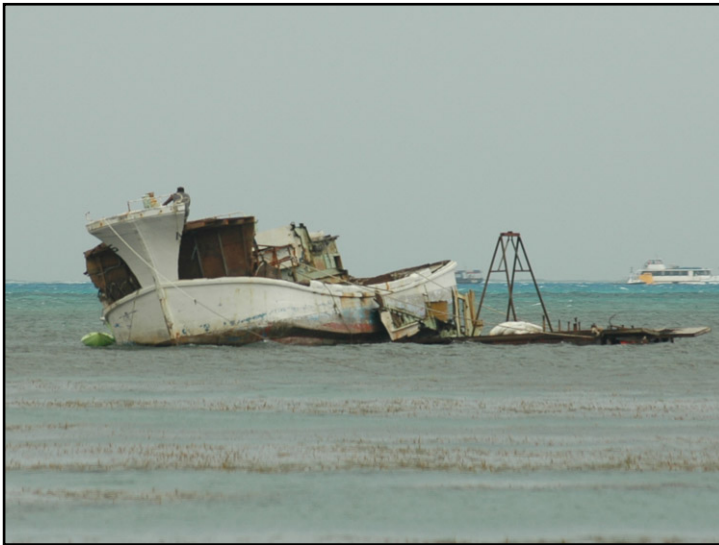
Vessel dismantled in place

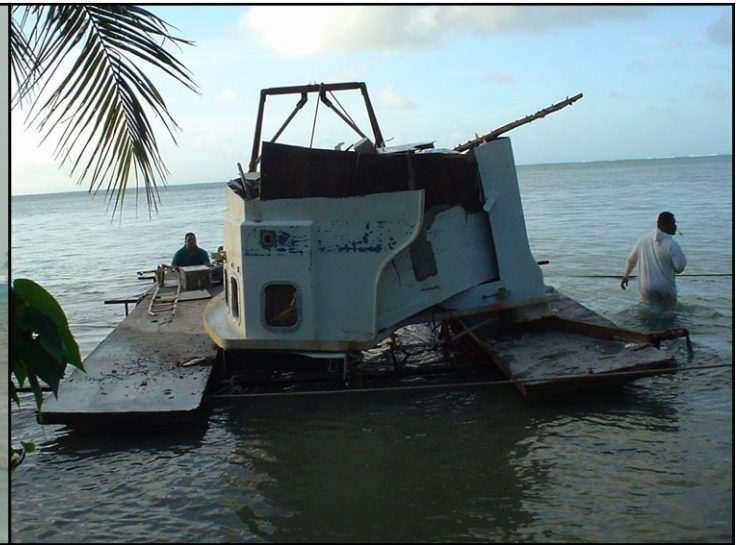
Large section of house brought to staging area on barge

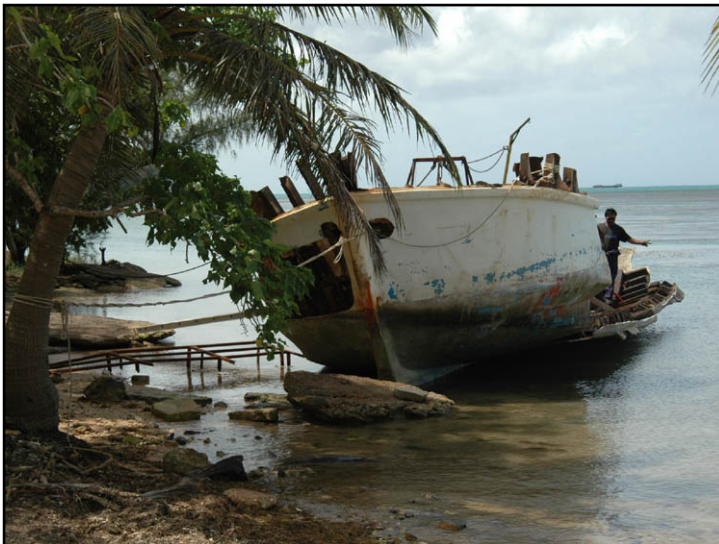
Remainder of vessel getting cut up at staging area

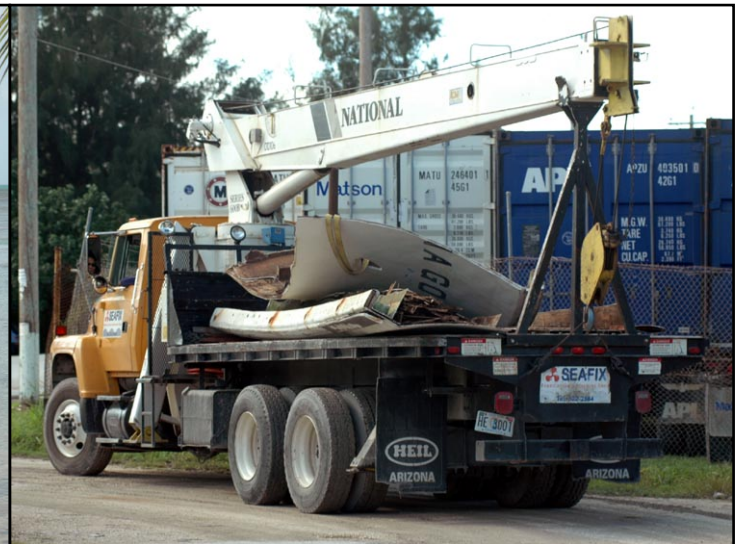
Hull fragments hauled to landfill

A total of 34,441 lbs of metal was separated and given to Errico Enterprises for scrap. The remaining 77,920 lbs of non-recyclable debris was sent to Saipan's Marpi landfill for final disposal. No dangerous waste was found onboard; all the fuel tanks were empty.

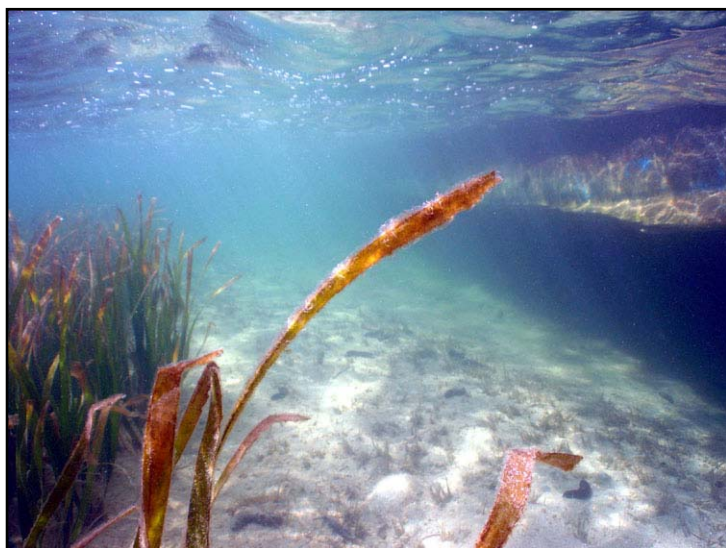
CNMI sent another clearance letter to the local agent in August 1997 emphasizing the threat from typhoon season and the need to remove the vessels. The owners did not take action and Typhoon Winnie hit less than a week later. The Nago No. 15 grounded in 3-5' of water the middle of a vast shallow seagrass bed in Tanapag lagoon. Reflected wave energy then created and maintained 8' wide scour on the portside and 20' wide scour off the bow.

Scoured bottom around the vessel prior to removal

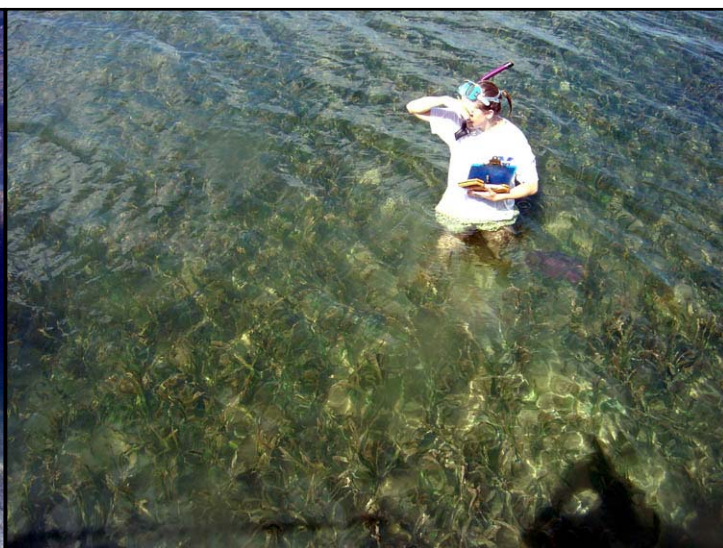
Representative seagrass surrounding vessel

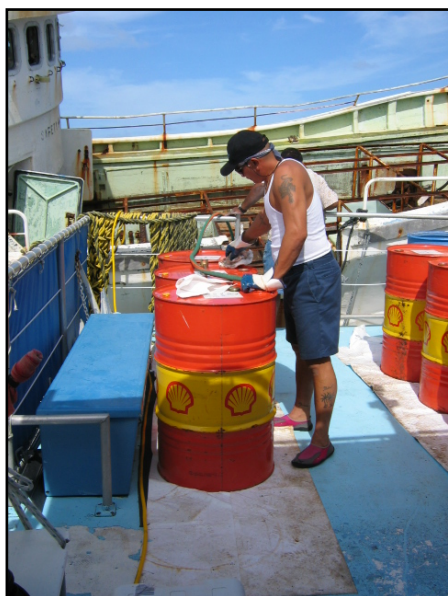
Pumping fuel from vessel into barrels

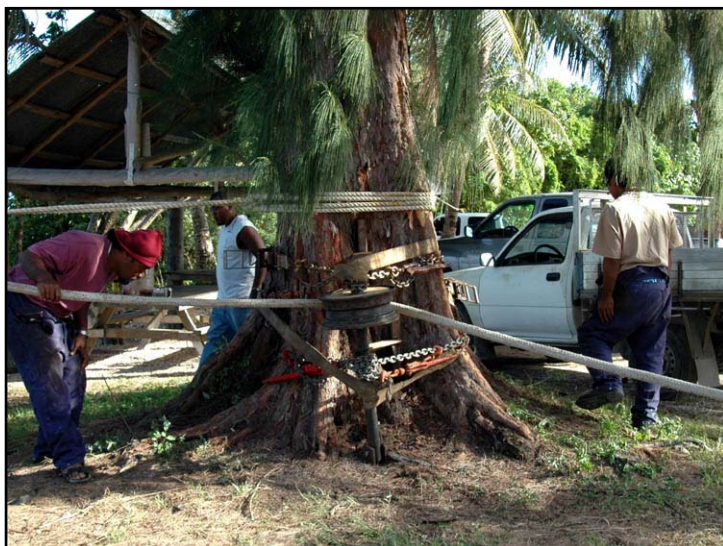
Pulley system for redirecting tow from truck to vessel
