# Surveys of Abandoned Vessels: U.S. Caribbean Region

Jacqueline Michel, Scott Zengel, Christine Lord, and Zach Nixon  
Research Planning, Inc.  
Columbia, South Carolina 29202

September 2002

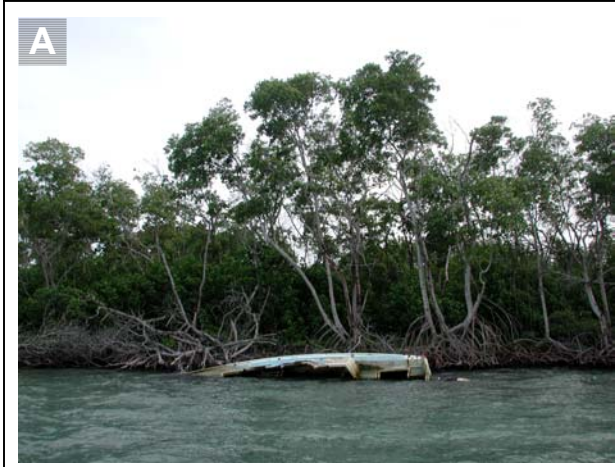
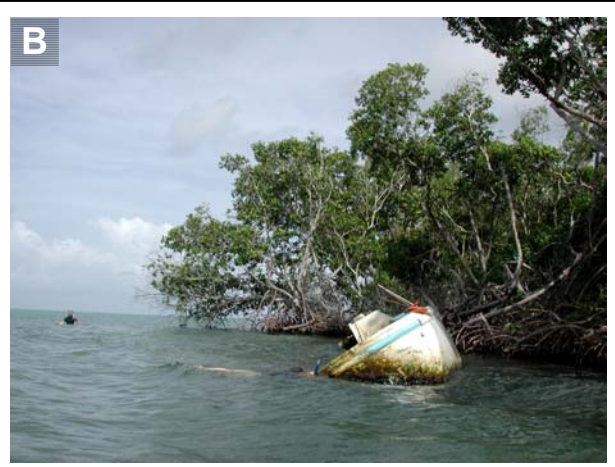
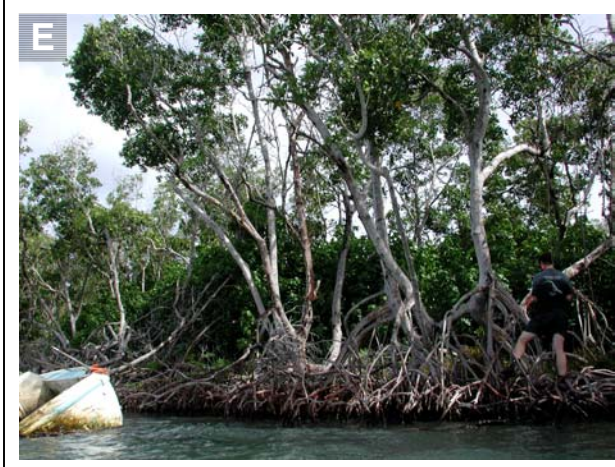
**Photographs of *Be??trix* (3 June 2002):**

**Comparison to Other Vessels:** This vessel is typical of sites consisting of sailboats that were stripped and not removed after they sank during a hurricane. It is one of three sailboats lodged against the mangrove fringe that were surveyed in Boqueron Bay. In other areas, such as Culebra Harbor and Ensenada Honda at Roosevelt Roads, the sailboats sank a further distance offshore and sit on seagrass or mud bottoms.

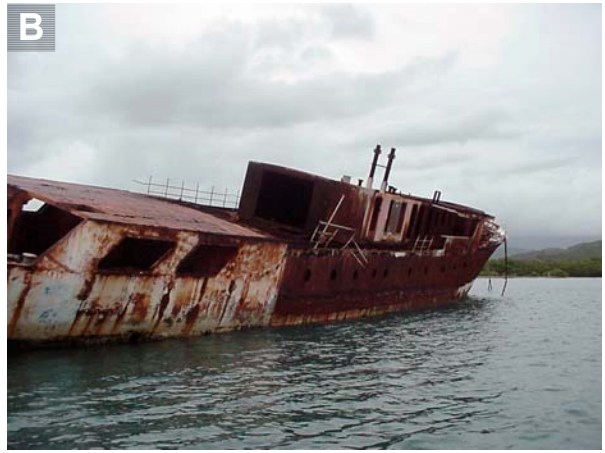
**Photographs of the *Pawnee* and *Princess I* (4 June 02):**

**Comparison to Other Vessels:** There are many sites with multiple grounded vessels that were not removed. The *Princess I* and *Pawnee* sites are characteristic of the type of seagrass damages expected for larger vessels grounded in open bays.

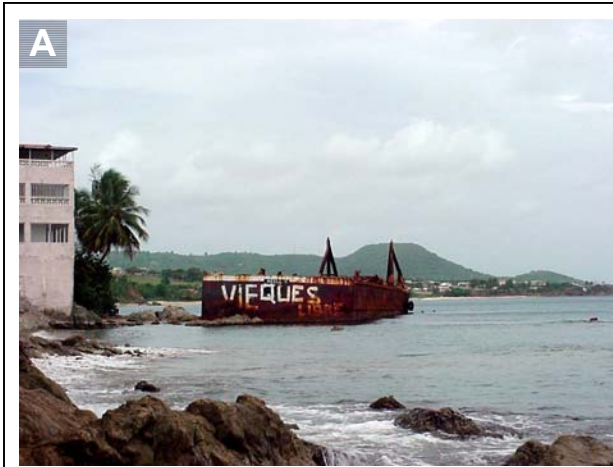
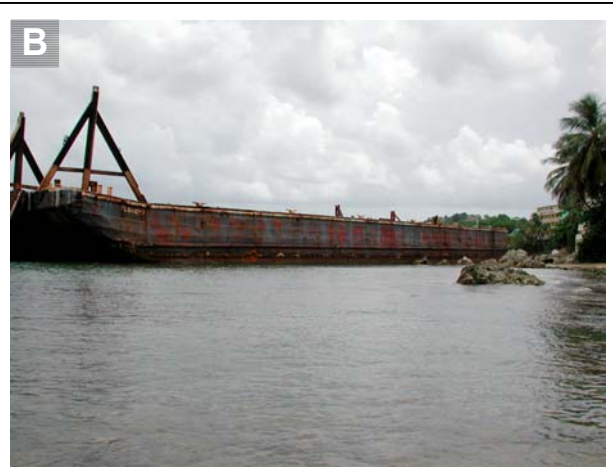
**Photographs of the *Hosll II* (6 June 02):**

**Comparison to Other Vessels:** Five abandoned barges were surveyed in Puerto Rico. Three (*El Canuelo*, one inside San Juan Harbor, and the *Hosll II*) were large, intact barges, whereas the other two were rusted out hulks.

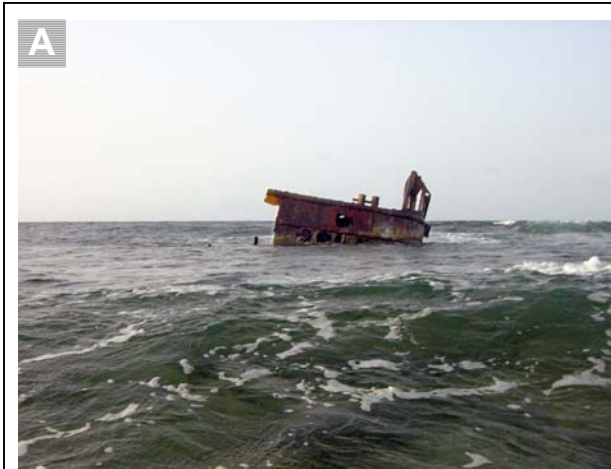
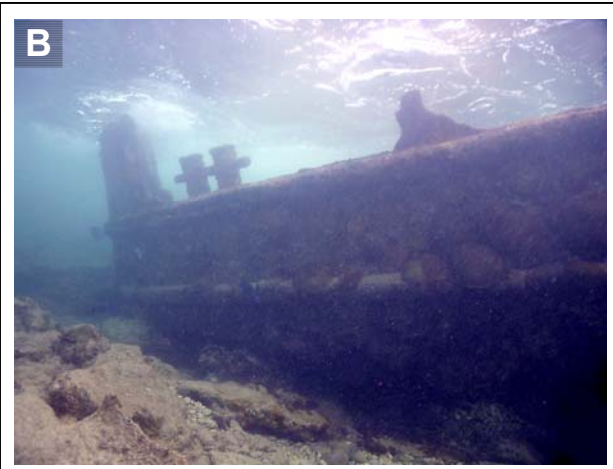
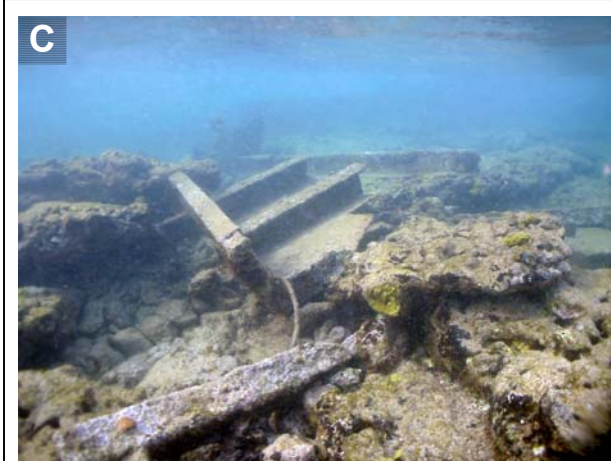
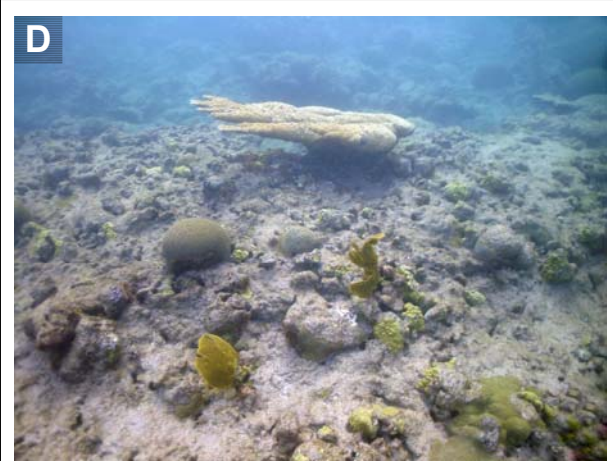
**Photographs of Unk2431 barge (25 June 02):**

**Comparison to Other Vessels:** This vessel is unique because it is aground on hardbottom and coral reef habitat in the surf zone, and because debris extends throughout a large area surrounding the vessel.

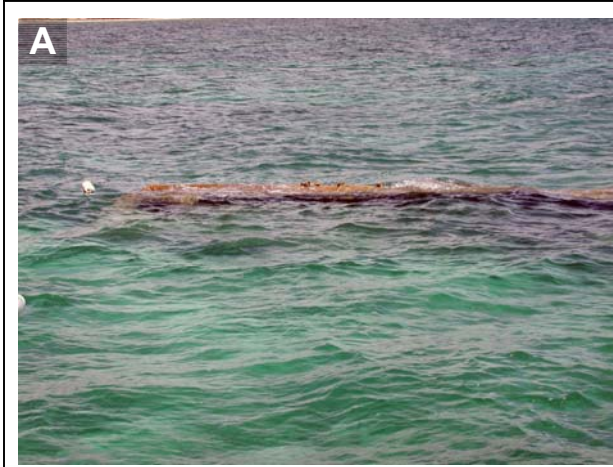
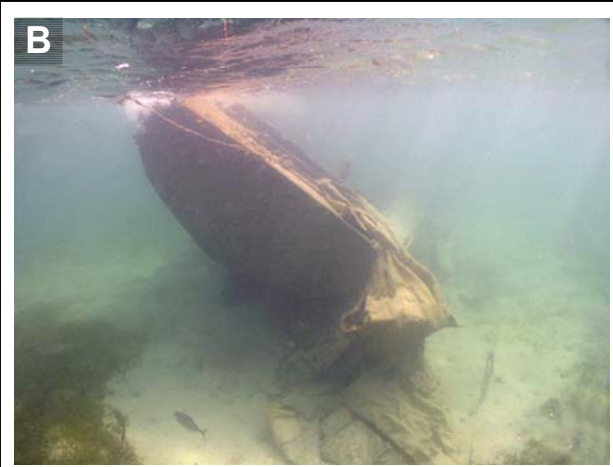
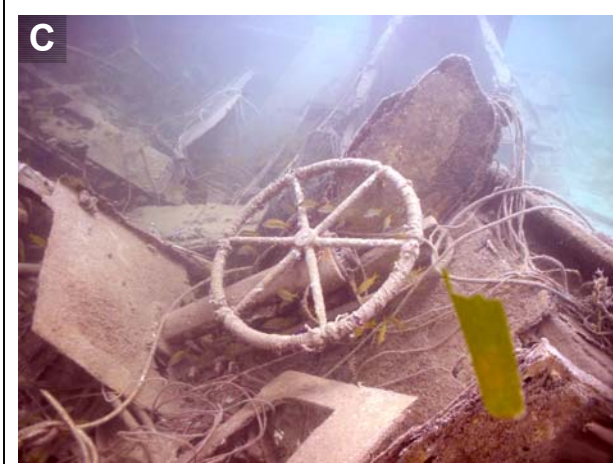
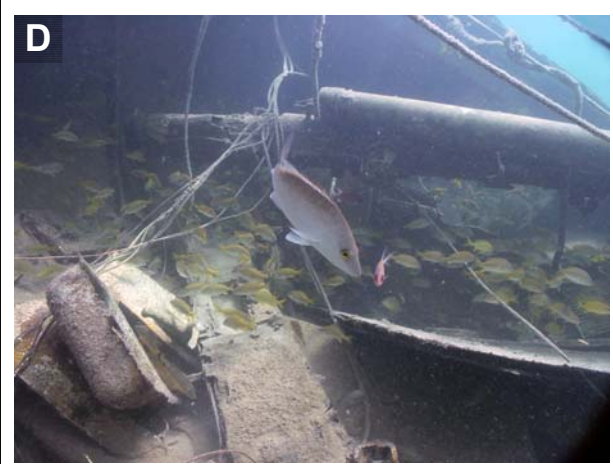
**Photographs of Unk1949 sailboat (26 June 02):**

**Comparison to Other Vessels:** This vessel is typical of several sailboats that sunk at their moorings during storms or unknown causes. Portions of the hull are exposed and visible, and a few buoys poorly mark the vessel, thus these vessels are potential hazards to local vessel traffic. This vessel is also typical of sailboats that sank in seagrass habitat.

- A. View of vessel as navigation hazard.
- B. Scour in seagrass habitat.
- C. Wheelhouse and debris.
- D. Vessel as artificial reef habitat.
- E. Seagrass habitat.

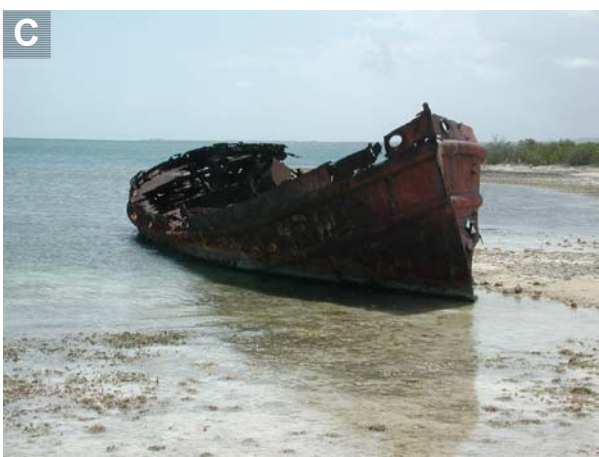
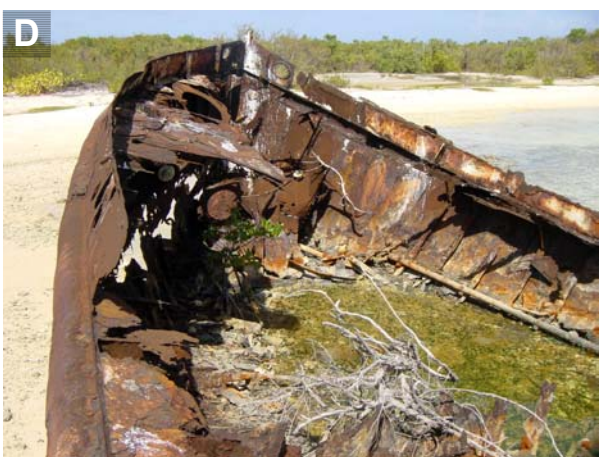
**Photographs of Unk2440, an ex-Navy supply boat (26 June 02):**

**Comparison to Other Vessels:** This vessel is unique because it is a large steel vessel, unlike the majority of sailboats that were surveyed, and it was grounded in a protected cove that is not heavily utilized. It is representative of vessels that are grounded onshore on sand beach and in intertidal seagrass habitat.

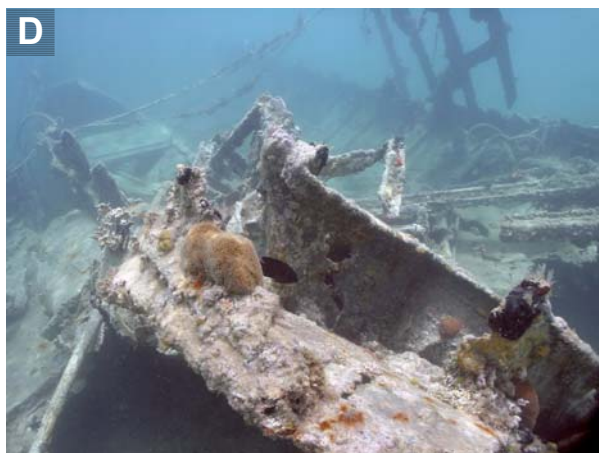
**Photographs of Unk2443, sailboat (27 June 02):**

**Comparison to Other Vessels:** This vessel is representative of sailboats that are grounded in seagrass habitat that leave an unvegetated scour area around a portion of the vessel.

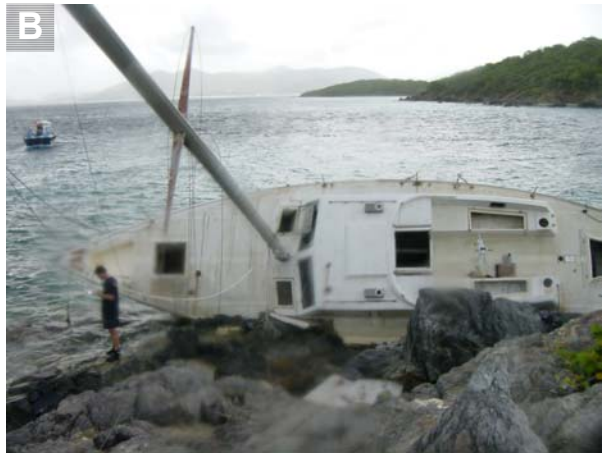
**Comparison to Other Vessels:** This vessel is unique among the vessels surveyed in the USVI because it is grounded near coral reef and hardbottom habitat.

**Photographs of *Serendipity* (28 June 02):**  
 A. View of vessel from starboard side.  
 B. View of deck.  
 C. Reef habitat.  
 D. Staghorn coral.  
 E. Pillar coral.

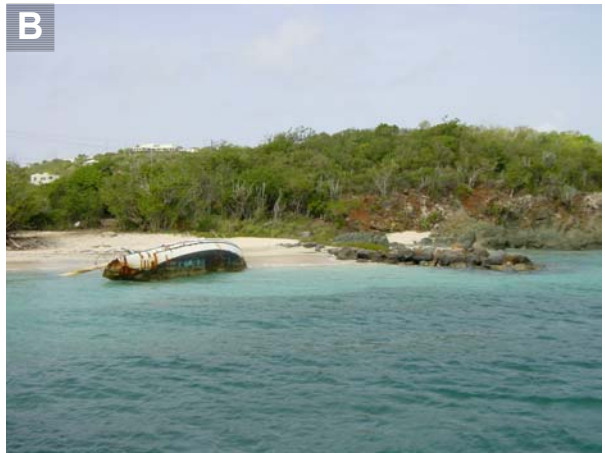
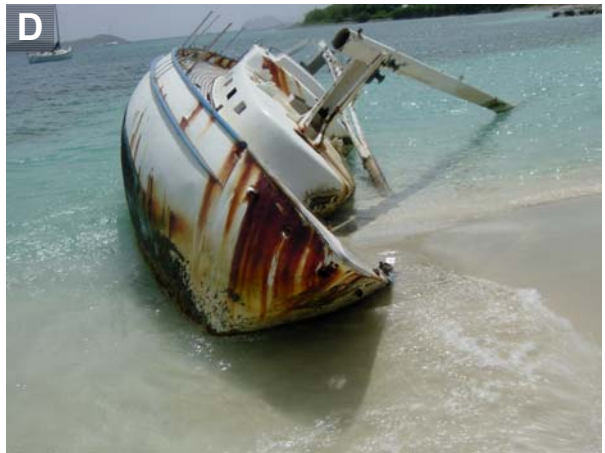
**Comparison to Other Vessels:** This vessel is unique among the sailboats surveyed in the USVI because it is aground at a public beach.

**Photographs of ORCA (28 June 02):**  
 A. View of vessel from starboard side.  
 B. Sand beach habitat.  
 C. Vessel deck.  
 D. Sandy intertidal zone.  
 E. Seagrass habitat.

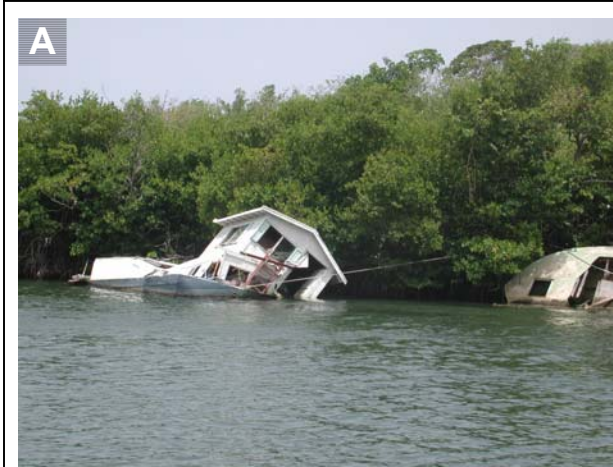
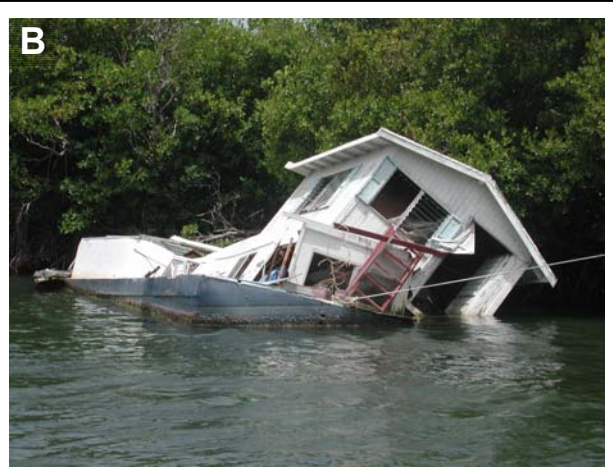
**Photographs Unk2465, houseboat in Benner Bay (26 June 02):**

**Comparison to Other Vessels:** This vessel represents the 20 plus vessels abandoned in Benner Bay, most in mangrove habitats.
