NOAA Abandoned Vessel Program Removal Case Study: *Seagull*

Contributing Agency: Guam Department of Agriculture

Vessel ID #: GU4962PU
NOAA AVP#: 2537

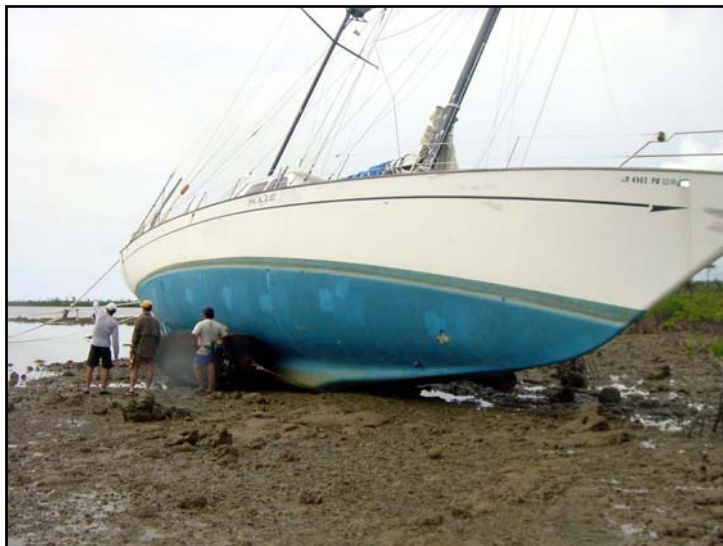
Surveying Vessel- June 2003

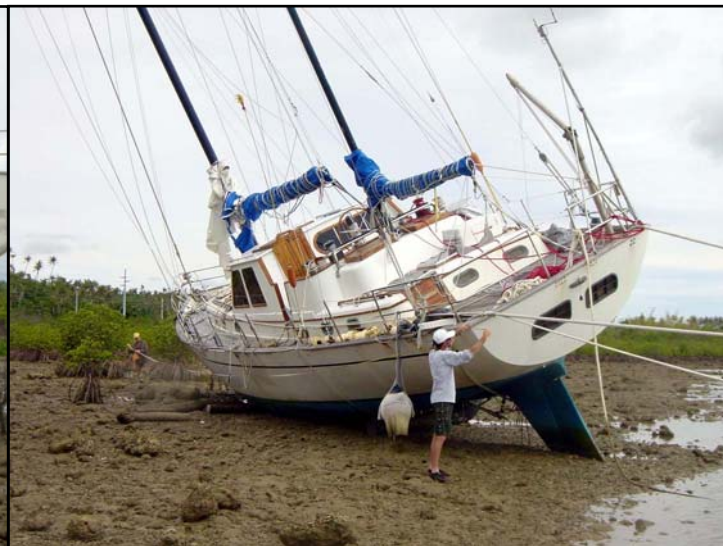
Measuring Port Side

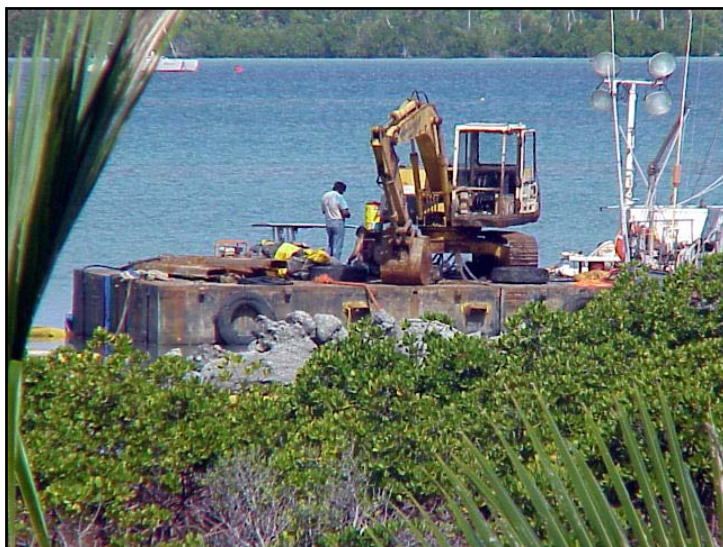
Backhoe on barge with excavated sediment between barge and

The owners contracted a local salvor to perform the operation. The excavator was brought in and used to cut the channel. The salvors were then able to right the vessel and move it into deeper water. *Seagull* was then guided back into the main channel through a small cut in the reef made by a prior grounding. The temporary trench in then bottom was refilled and the barge and machinery were then lifted back over the reef.

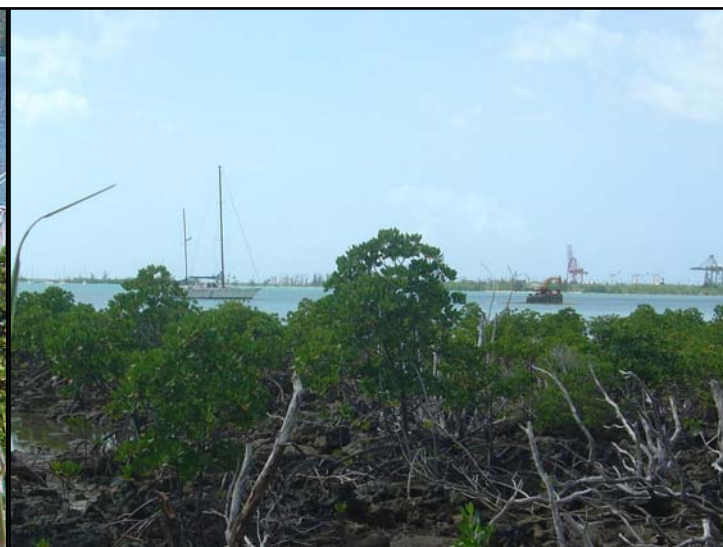
Seagull & Barge after refloating and before moving vessel back to channel
