Reduce Dangers to Aircraft Flying in Icing Conditions

NTSB **MOST WANTED**

Cessna 560 **Pueblo, CO – February 16, 2005**

Saab 340B

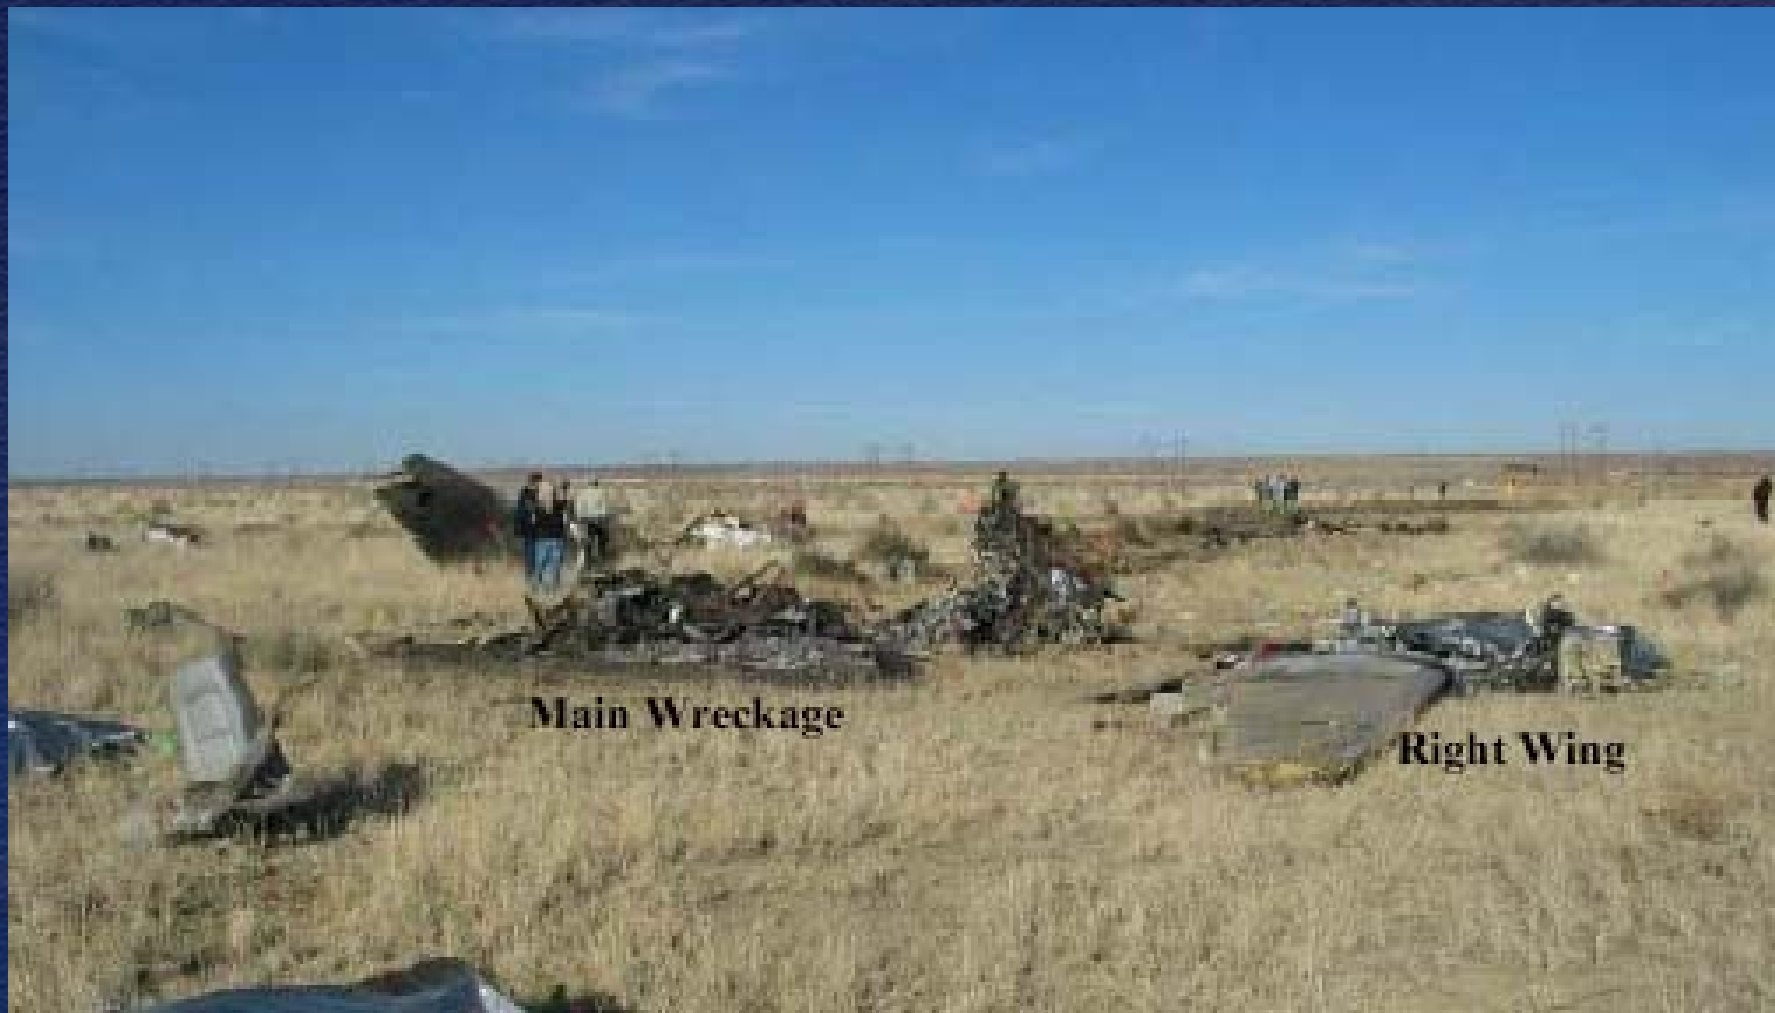
Main Wreckage

Right Wing

- Airplane slowed below $V_{approach}$
- Aircraft encountered two icing layers, the second during the final approach
- Presence of estimated 1/6 inch or less of ice accreted in SLD conditions caused airplane to stall prior to stick shaker
- Airplane entered a rapid left roll prior to stall warning
- Airplane did not recover in the 1,500 feet agl available

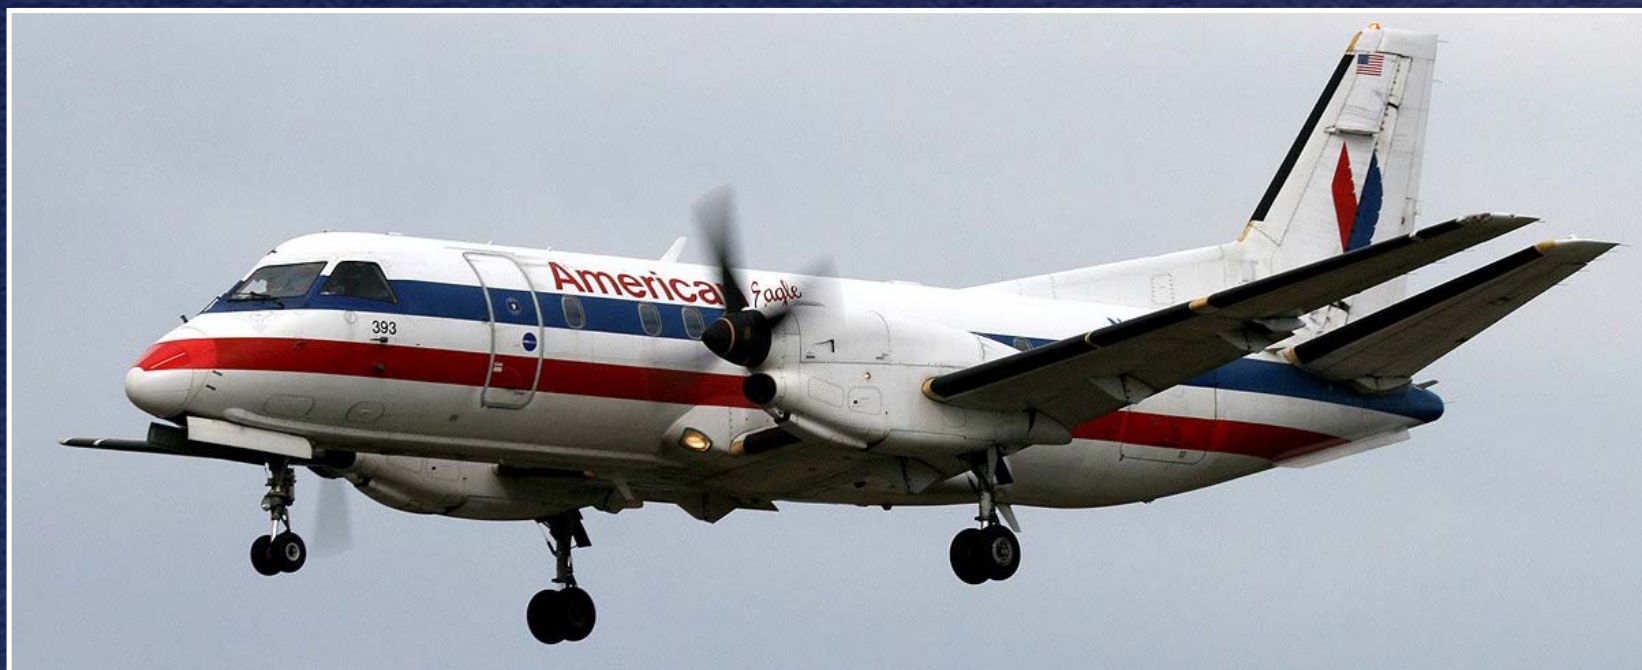
- Loss of Control Incident
 - Departed controlled flight in icing conditions
 - Lost 5000 feet altitude
 - Nearly inverted
