US Army Corps
of Engineers
Kansas City District

Monolith Leakage Repair Update

Harry S. Truman Project

Warsaw, Missouri

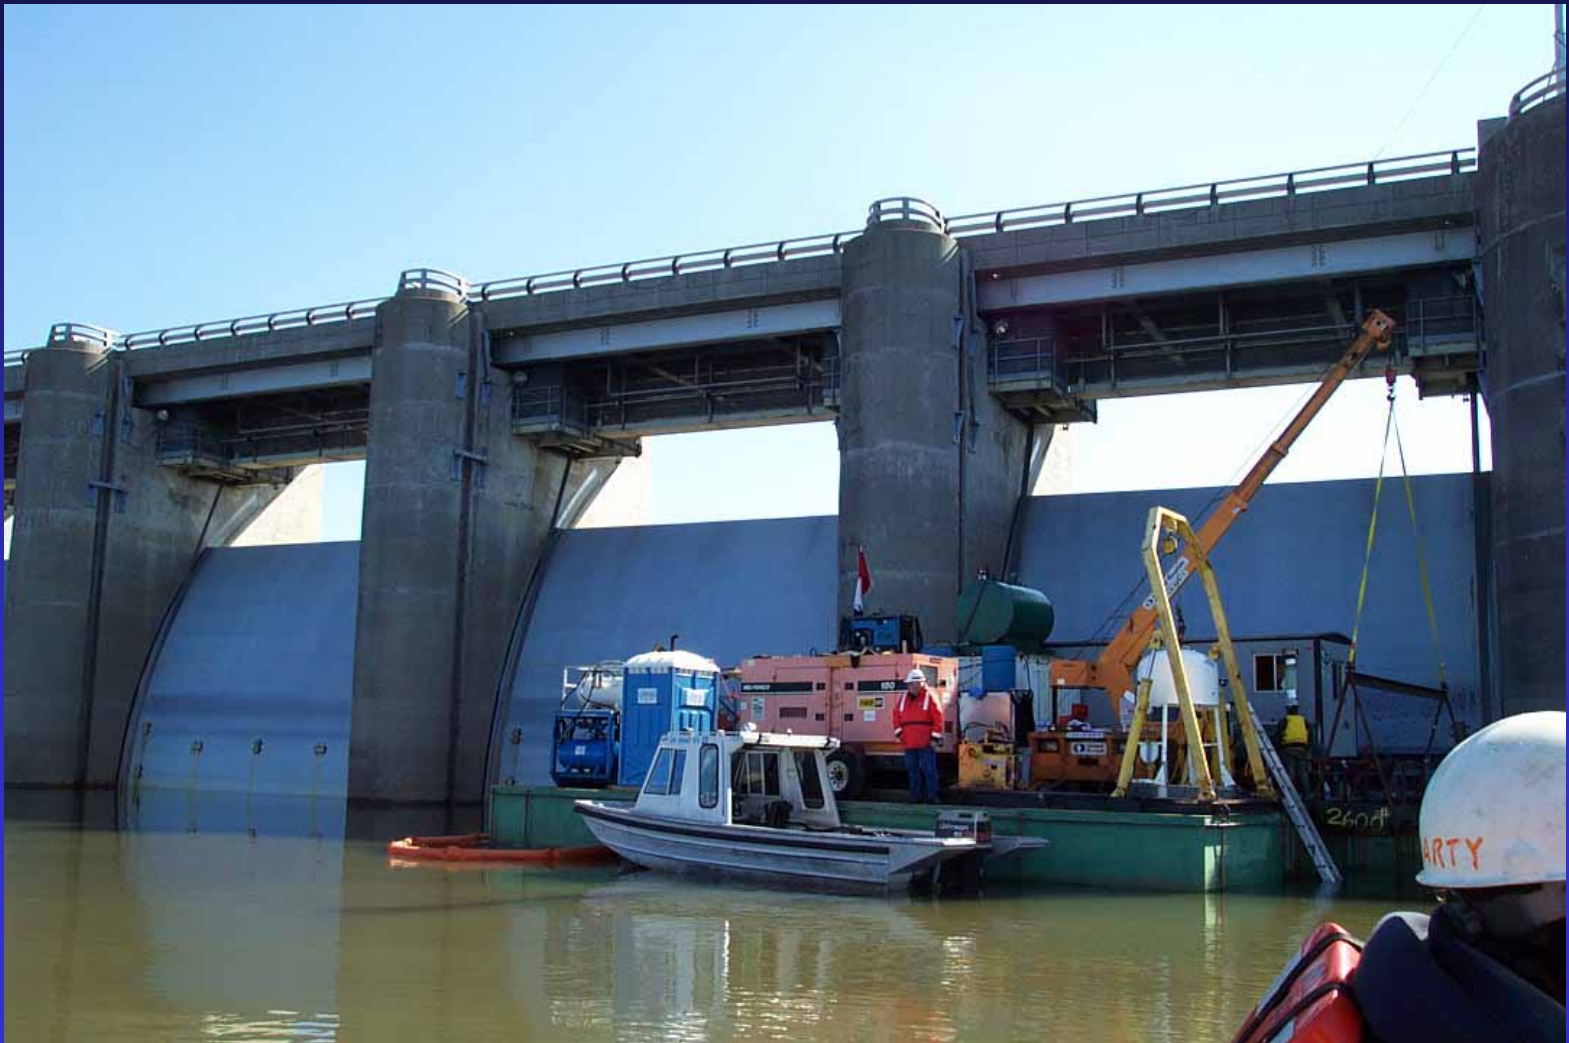
Monolith Joint 8/9 and 9/10 Repair

- Chemical grout injection into the MJ's was chosen as the most viable repair alternative due to configuration of MJ's
- Contract was awarded that included diving and chemical grout injection performed on the upstream face of the powerhouse and spillway
- Repair work was performed in February/March 2005 when the water temperature was colder so the chemical grout would fully penetrate into the MJ's and intercept the leakage points
- The repairs were successful, reducing MJ 8/9 leakage from 250 gpm to 20 gpm and MJ 9/10 leakage from 50 gpm to less than 5 gpm
