PROPOSED

FY 2008

**NON-ROUTINE
MAINTENANCE
LIST**

MAY 24, 2007

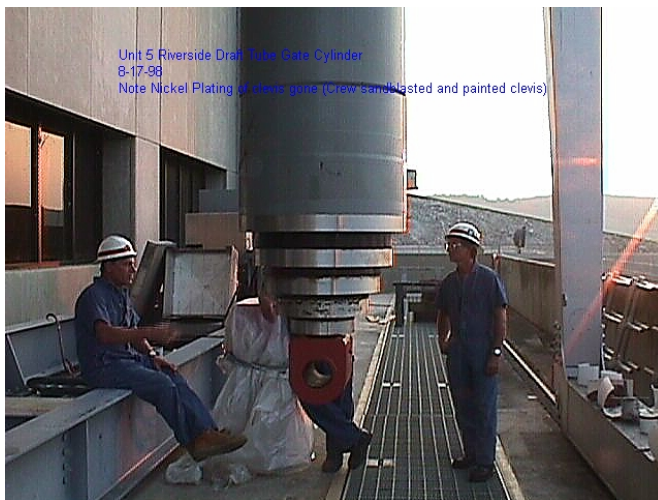
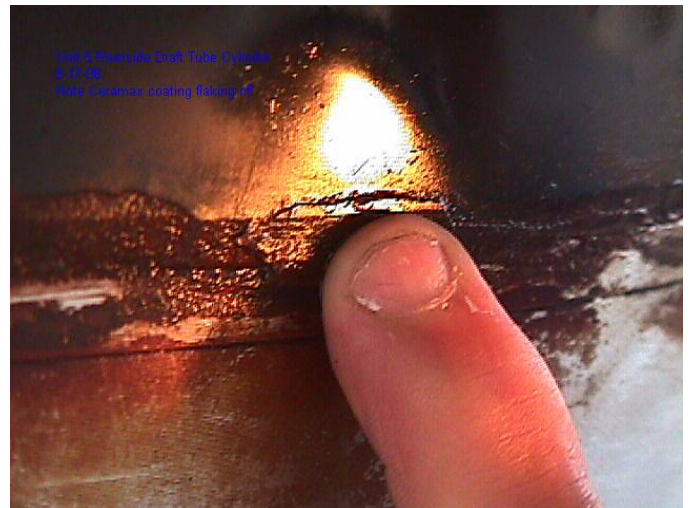
History of Outages/Deficiency: The draft tube liners are fabricated of carbon steel and are subject to corrosion and cavitation damage. The water at the project is highly corrosive and is detrimental to the liner, turbines, and structural supports resulting in corrosion damage and measurable reductions in unit efficiency. Sand blasting and vinyl painting of the liners will stop or greatly reduce the corrosive effect of the lake water, increase efficiency, and significantly reduce annual outage times by minimizing the amount of future cavitation repair work. Unit 6 was painted in 1993, but some repairs will be required to the existing vinyl paint. In order to perform the liner corrosion and cavitation repair work, the draft tube bulkheads will need to be inspected and repaired (if required) in accordance with Corps of Engineers' (COE) criteria outlined in Engineering Regulation (ER) 1110-2-8157, Responsibility for Hydraulic Steel Structures (HSS). ER 1110-2-8157 requires all HSS (bulkheads, stoplogs, gates, etc.) to receive a full initial inspection and follow-up periodic inspections every 25 years. The purpose of these inspections is to ensure the bulkheads are structurally sound and safe to use before Government or contractor personnel enter a dewatered area to perform maintenance or repair work. To ensure compliance with the ER and provide safety for Government and contractor personnel, a qualified structural engineer must inspect the bulkheads, determine their safety, and document the inspections. Structural and/or weld defects found during the inspections must be repaired before the bulkheads can be certified for use. The hydraulic power units and cylinders will have to be dismantled so the bulkheads can be removed from their slots and placed on the draft tube deck for these inspections. The operating stems and eye ends of the hydraulically operated draft tube bulkhead hoists (total of 12 hydraulic cylinders) are corroding and need to be repaired. Corrosion is occurring underneath the ceramic coating which protects the operating stems and provides a sealing surface for the cylinders' internal seals and the nickel plating on the eye ends has failed. Continued corrosion of the operating stems will cause the protective ceramic coating to flake off and the hydraulic cylinders will no

longer be able to operate and retain hydraulic oil. There is a potential of losing 900 gallons (from one cylinder) of hydraulic oil into the tailrace (Lake of the Ozarks) downstream of the power plant. Cylinder drift and cycling has also become a problem due to leakage past the internal piston seals. The number of cycles per day depends on the individual cylinder and fluid temperature, but some of the cylinders are cycling over 300 times a day to keep the draft tube bulkheads from drifting into the water passageway. Repair of the cylinders and installation of an automatic latching (dogging) mechanism is needed to prevent the bulkheads from drifting into the water passageways.

Solution: The draft tube bulkhead cylinder work will include redesign of the ceramic protective coating system, repair/rebuilding of the hydraulic cylinders with the redesigned ceramic coating system, and design and installation of an automatic dogging mechanism to prevent cylinder drift. **The draft tube bulkheads will be removed from their slots and inspected and repaired in accordance with COE criteria in concurrence with the hydraulic cylinder repair contract to avoid a duplication of work effort.** The anodes on the bulkheads will also be replaced. Cavitation repair and painting of the draft tube liners and turbines will be performed after the draft tube bulkheads cylinders have been repaired and the draft tube bulkheads inspected/repared and certified for service.

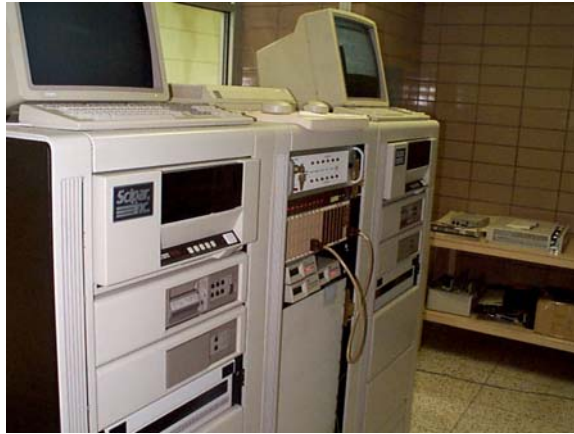
History of Outages/Deficiency: Little Rock District has two SCADA systems. The SCADA system for Table Rock and Beaver power plants was purchased in 1991. The SCADA system for Bull Shoals, Norfolk, and Greers Ferry was replaced in 1995 and the system for Dardanelle and Ozark was replaced in 1997. The workstations and master station computers for the Table Rock system are obsolete and are no longer supported by the manufacturer. The spare parts supply is running low and new spare parts are becoming very difficult to obtain. Numerous failures of the main servers have occurred, and the systems installed at the other plants are nearing the end of their expected life.

Solution: Replace master station workstations, computers, and peripheral equipment and software. Hardware and software will be compatible with the new Centralized SCADA Control system. The replacement will start with the Table Rock and Beaver power plants system. The Bull Shoals and Dardanelle systems will be replaced over the next three years.

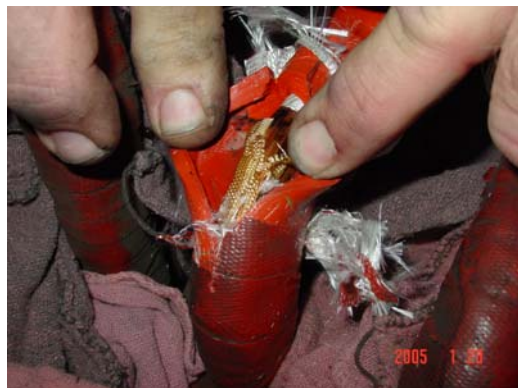
History of Outages/Deficiency: The Generators are 34 years old. The Generator tests are showing degradation in the windings and one unit has had a coil removed and has Iron damage.

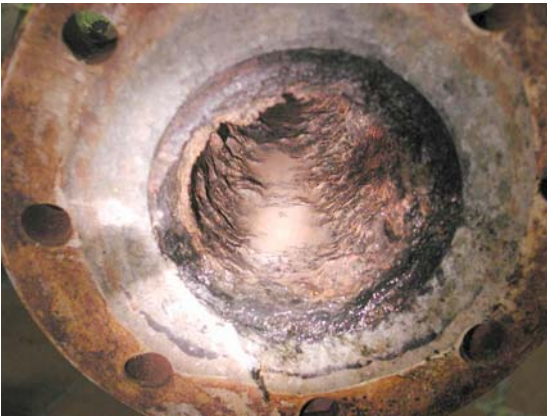
History of Outages/Deficiency: The unit cooling water discharge line is a 3" line in which the internal diameter has been significantly reduced with mineral deposits. These deposits are reducing the cooling water flow and will ultimately reduce the unit output capacity because of over heating. These lines are imbedded in concrete. Inspection of the generator air coolers revealed the cast iron water box and end boxes to be deteriorating almost to the point of failure. The boxes were blast cleaned which revealed approximately 75% loss of the diverter partition on the end boxes. Interim actions were taken to delay failure and allow time to replace the coolers before a forced outage occurs. The raw water strainers have reached their service life and no longer function as designed. The bypass capability in the strainers has been lost and thereby prevents maintenance on the strainers without valving off the cooling water to the strainers and stopping cooling water flow to the units.

Corroded Cooling Water Line

Solution: Replace the generator air coolers and raw water strainers. Contract to have the cooling water lines water blasted to remove internal deposits.

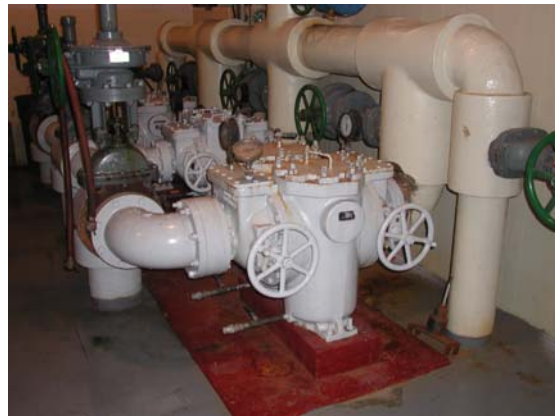
Raw Water Strainers

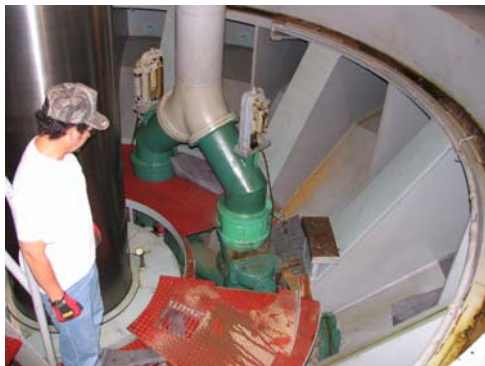
History of Outages/Deficiency: The turbine vacuum breakers and local piping have deteriorated to the point where the piping occasionally leaks water. The four raw water strainers are used to filter the lake water before the water can enter the generators' coolers. The cooling water header piping, strainers, pumps, and valves have deteriorated.

Vacuum Breaker Piping

Solution: Replace deteriorated cooling water piping system, pumps, and valves.

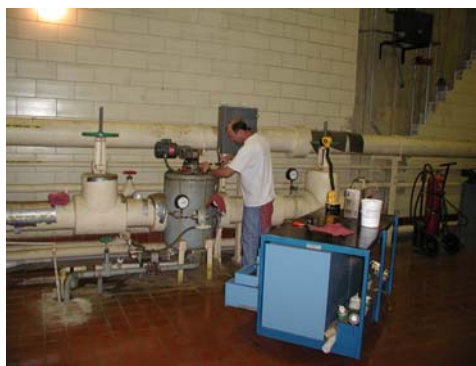
Main Cooling Water Piping

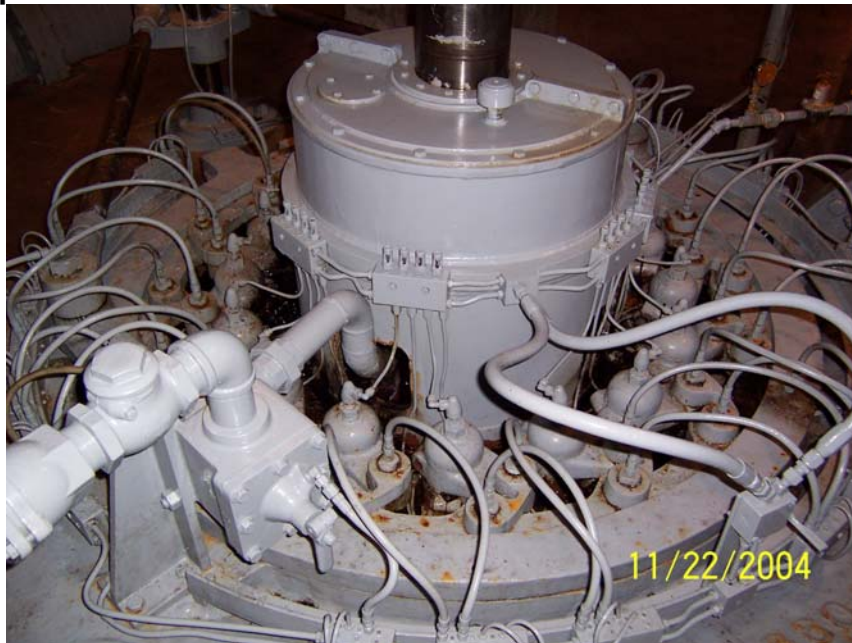
The station service units are the original equipment and they are in need of repairs to the wicket gate assembly and replacement of the outdated governor controls.

Solution: Replace station unit governors and repair wicket gate stems. Equipment is the original equipment and is about 50 years old.

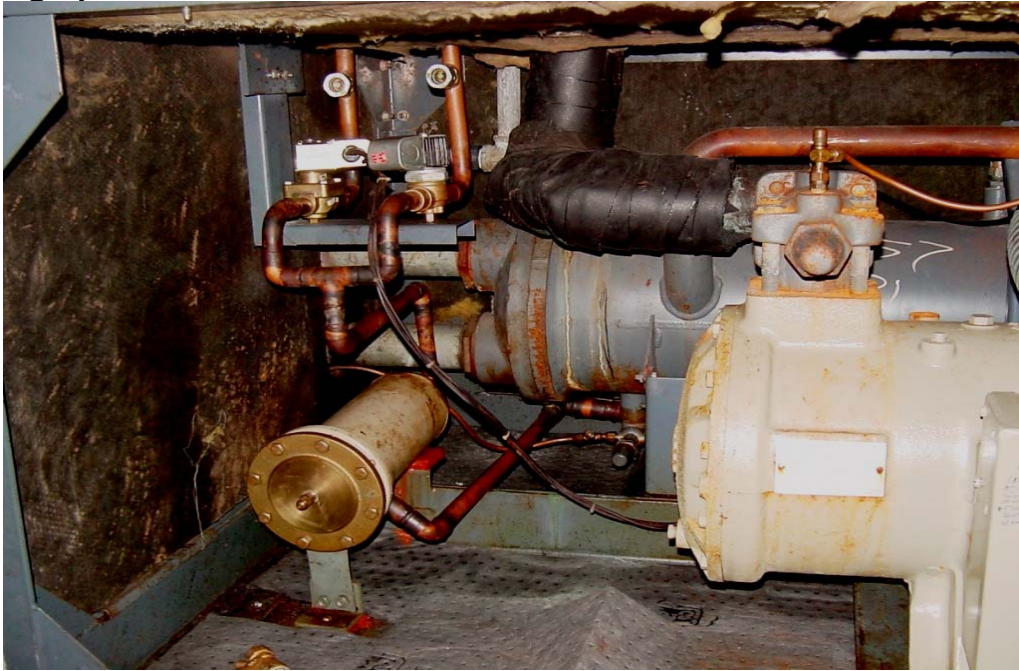
History of Outages/Deficiency: The existing HVAC system was manufactured by TRANE Corp. and has been in operation since 1984. Although operational, annual upkeep and maintenance the last two years has exceeded \$10,000 per year. Compressor, plumbing system, and other components are at the end of their normal service life. Failure of either the heating or air conditioning component could result in control room and employee office area temperature extremes. Depending upon time of year, temperature extremes would result in over-heating of the control room area or refrigerator like temperatures in the employee office and main work area. Overheating and high humidity would result in failure of switches and relays resulting in non-operational status of both units.

Aged Compressor & Plumbing

Solution: Replace the existing HVAC system, compressor, heating unit, water system, controls, and miscellaneous parts. Existing ducts and duct controls and motors are in good condition and do not require replacement.

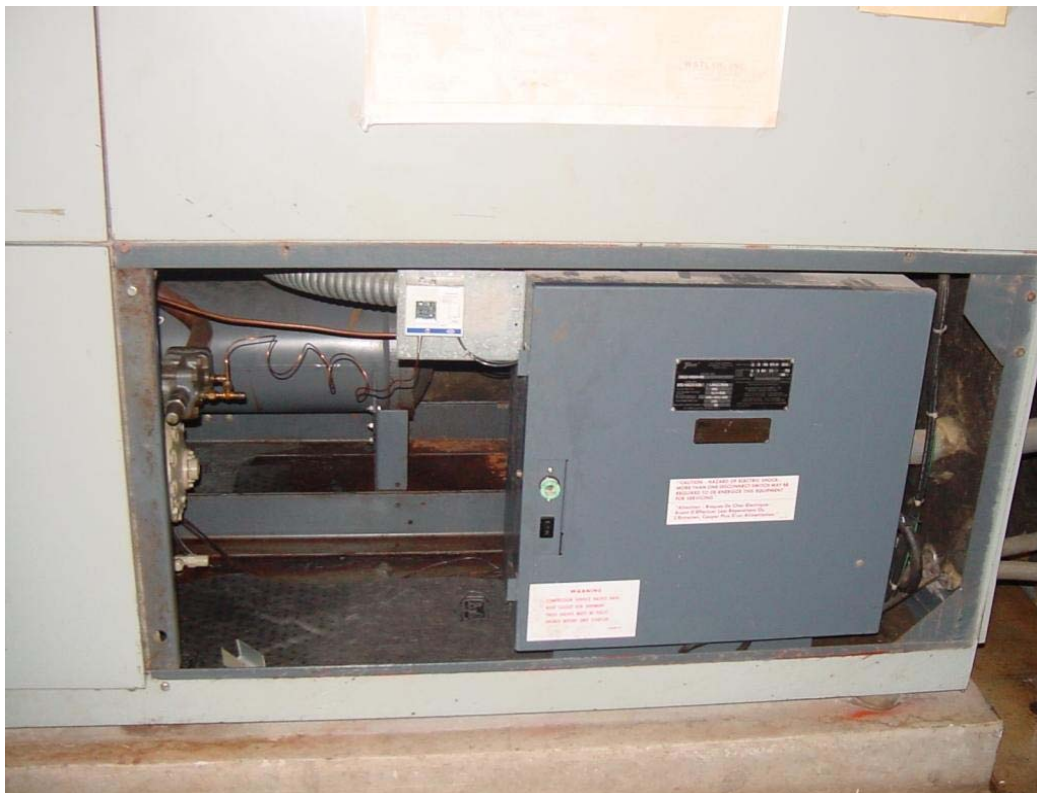
Aged Controls
