# John F. Kennedy Space Center, FL Hurricane Frances Damage Assessment Photos

Kennedy Space  
Center

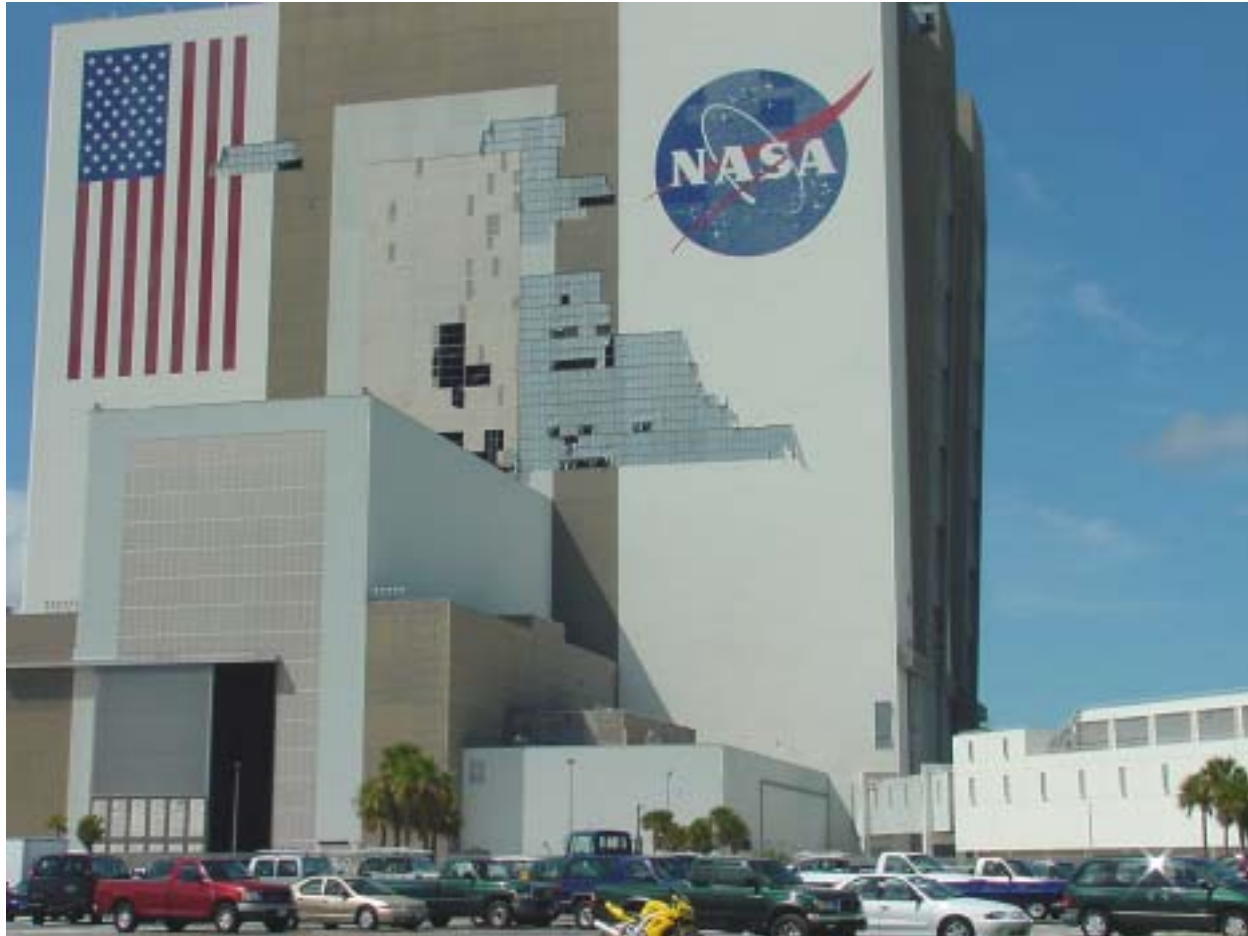
Vehicle Assembly Building (VAB) (K6-0848) – exterior panel damage (south side)

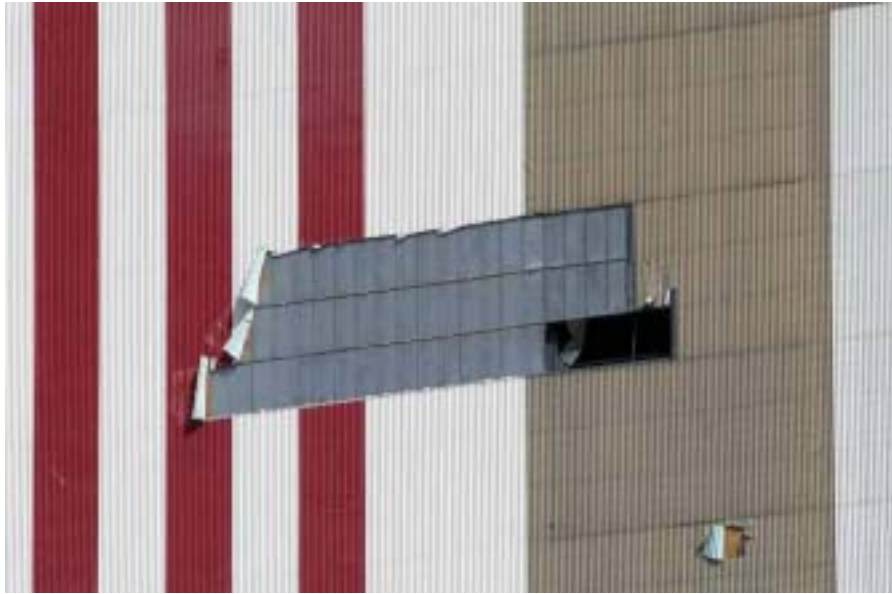
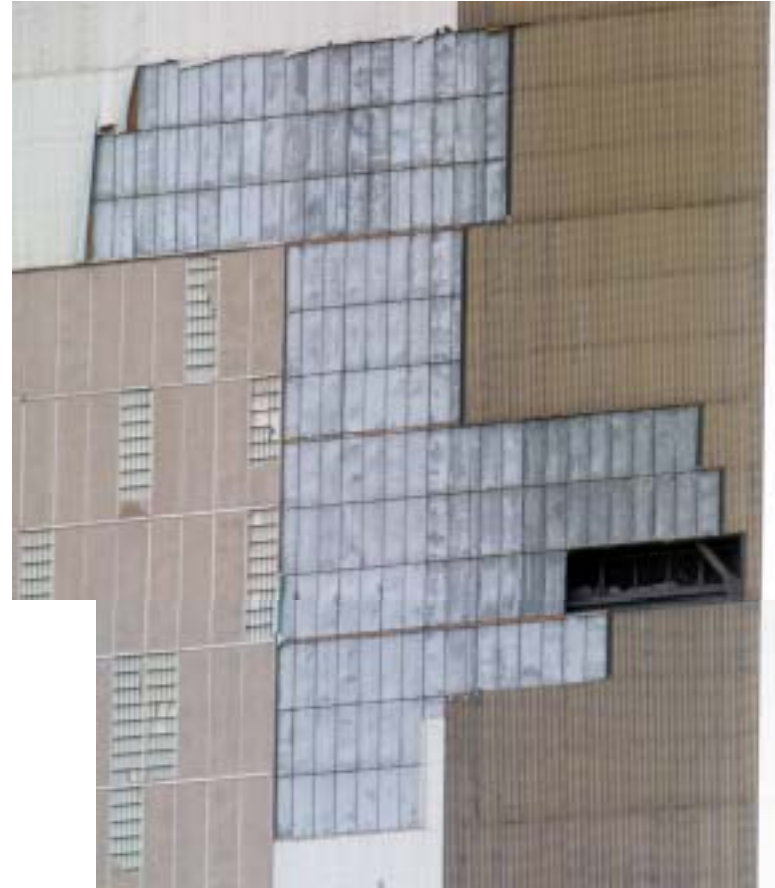
LC39 Area:

Vehicle Assembly Building (VAB) (K6-0848) – side panel damage above low bay south side

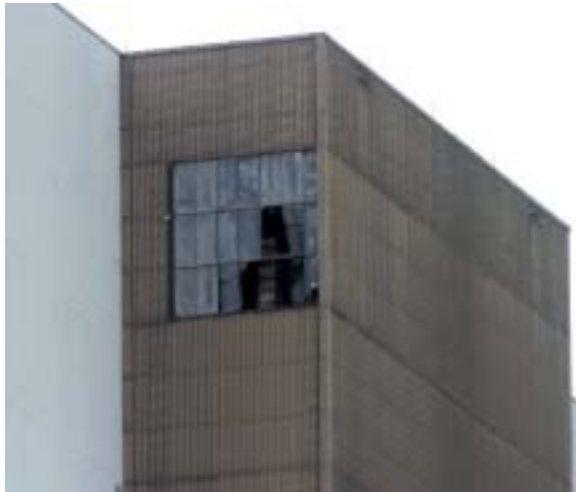
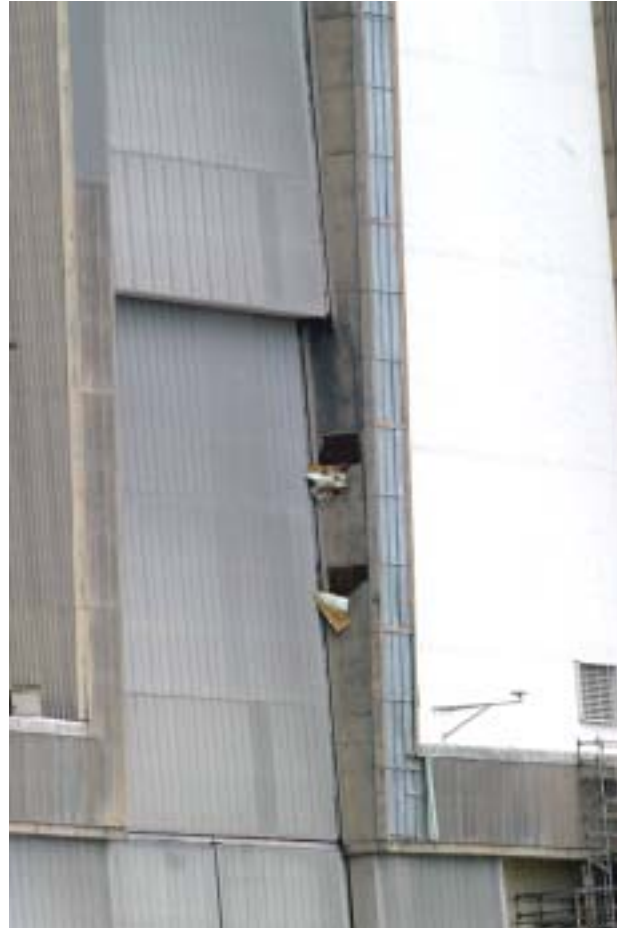
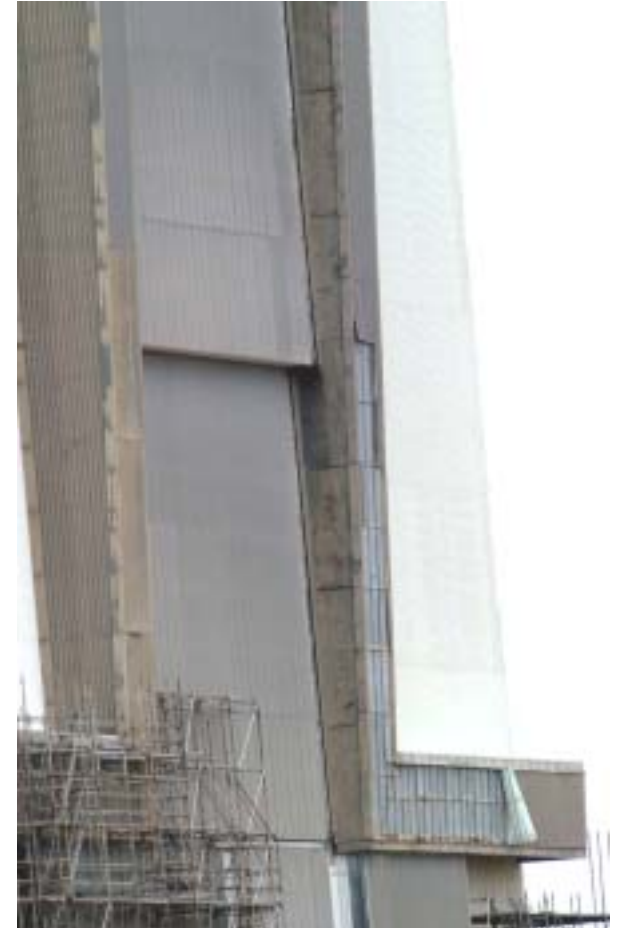
LC39 Area:

Vehicle Assembly Building (VAB) (K6-0848) – panels near east side doors damage

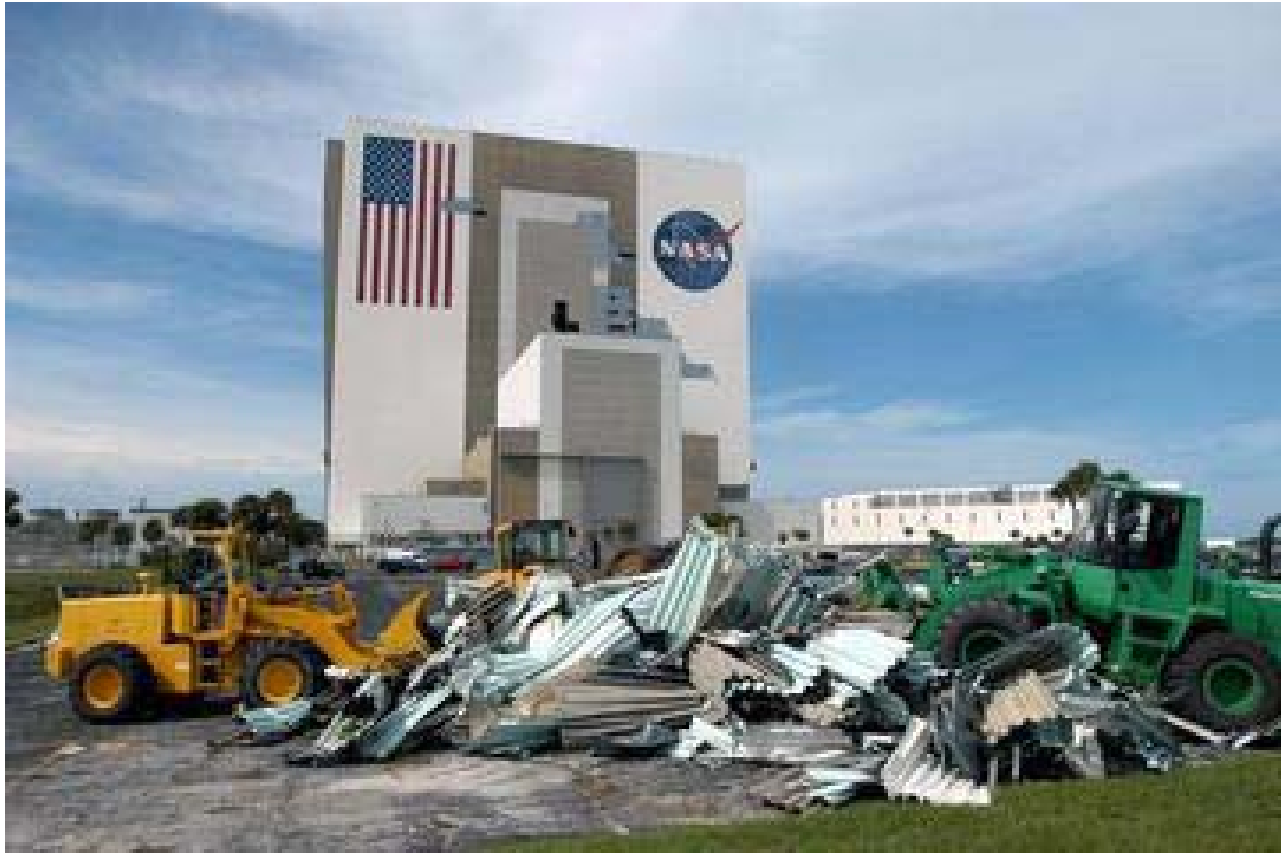
Vehicle Assembly Building (VAB) (K6-0848) – debris pile from exterior panels

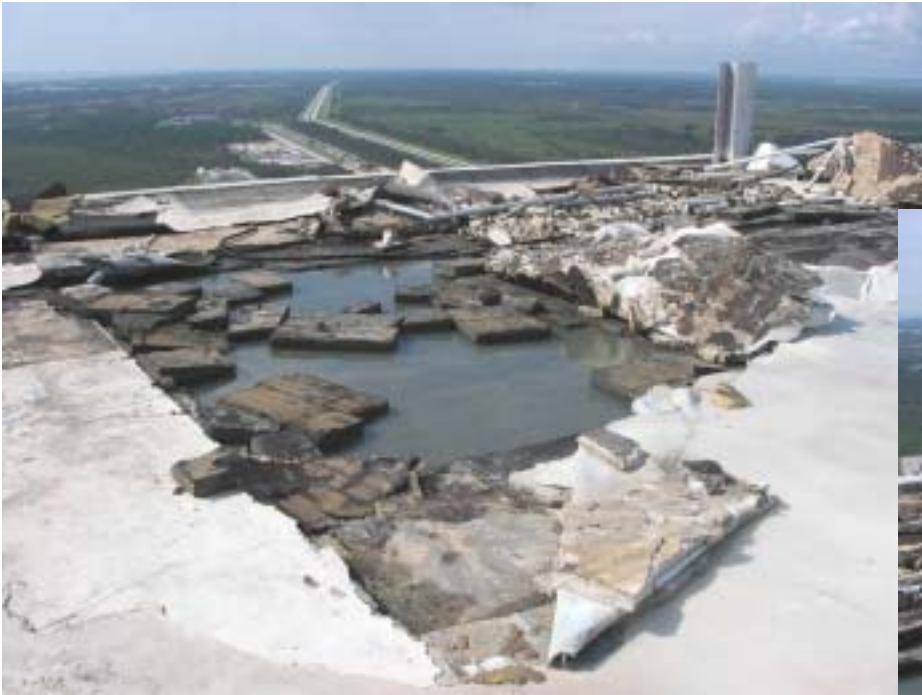
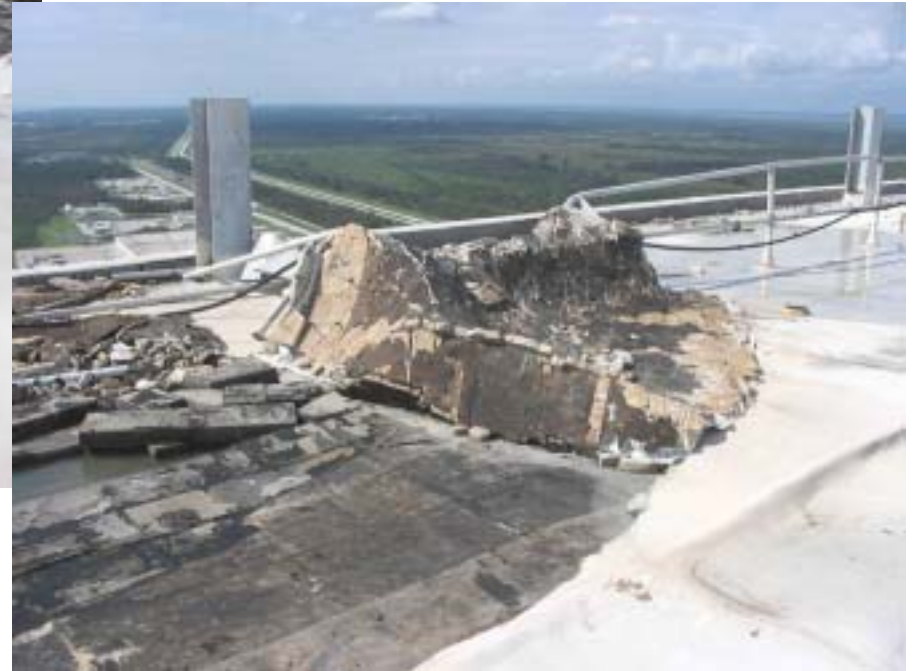
LC39 Area:

Vehicle Assembly Building (VAB) (K6-0848) – exterior roof damage

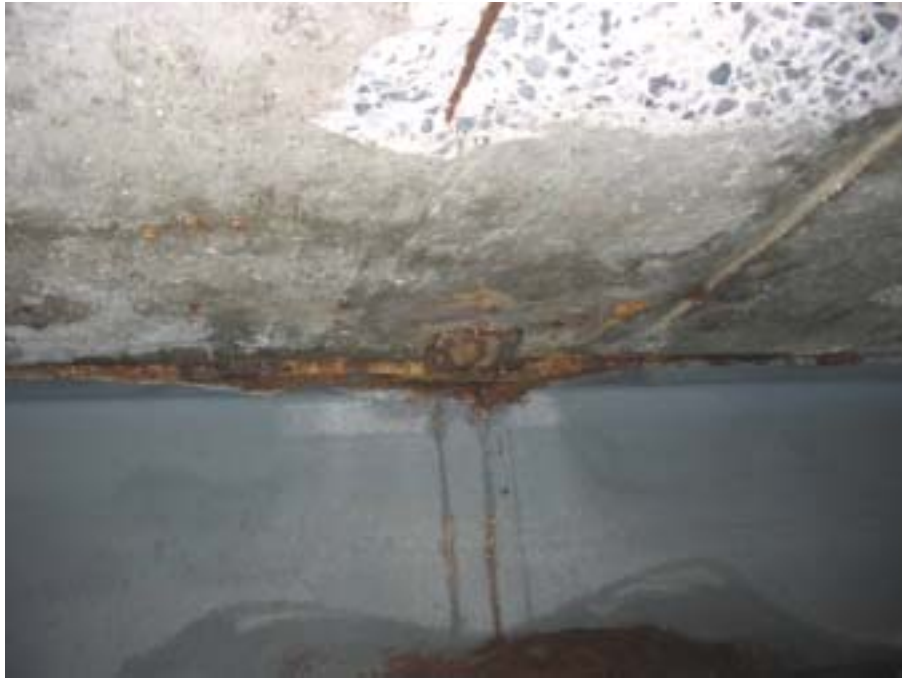
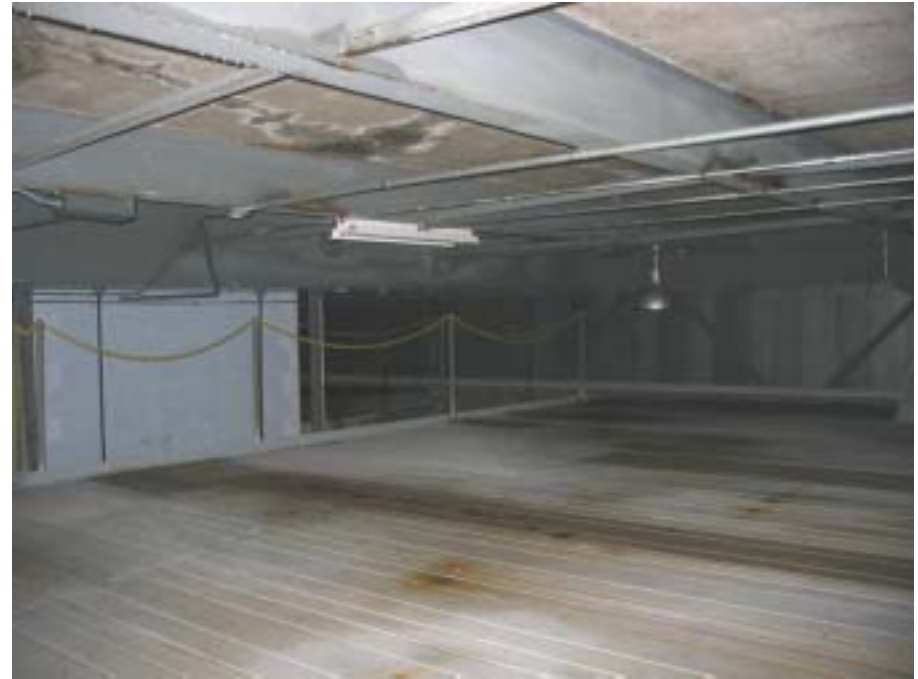
LC39 Area:

Vehicle Assembly Building (VAB) (K6-0848) – interior roof damage

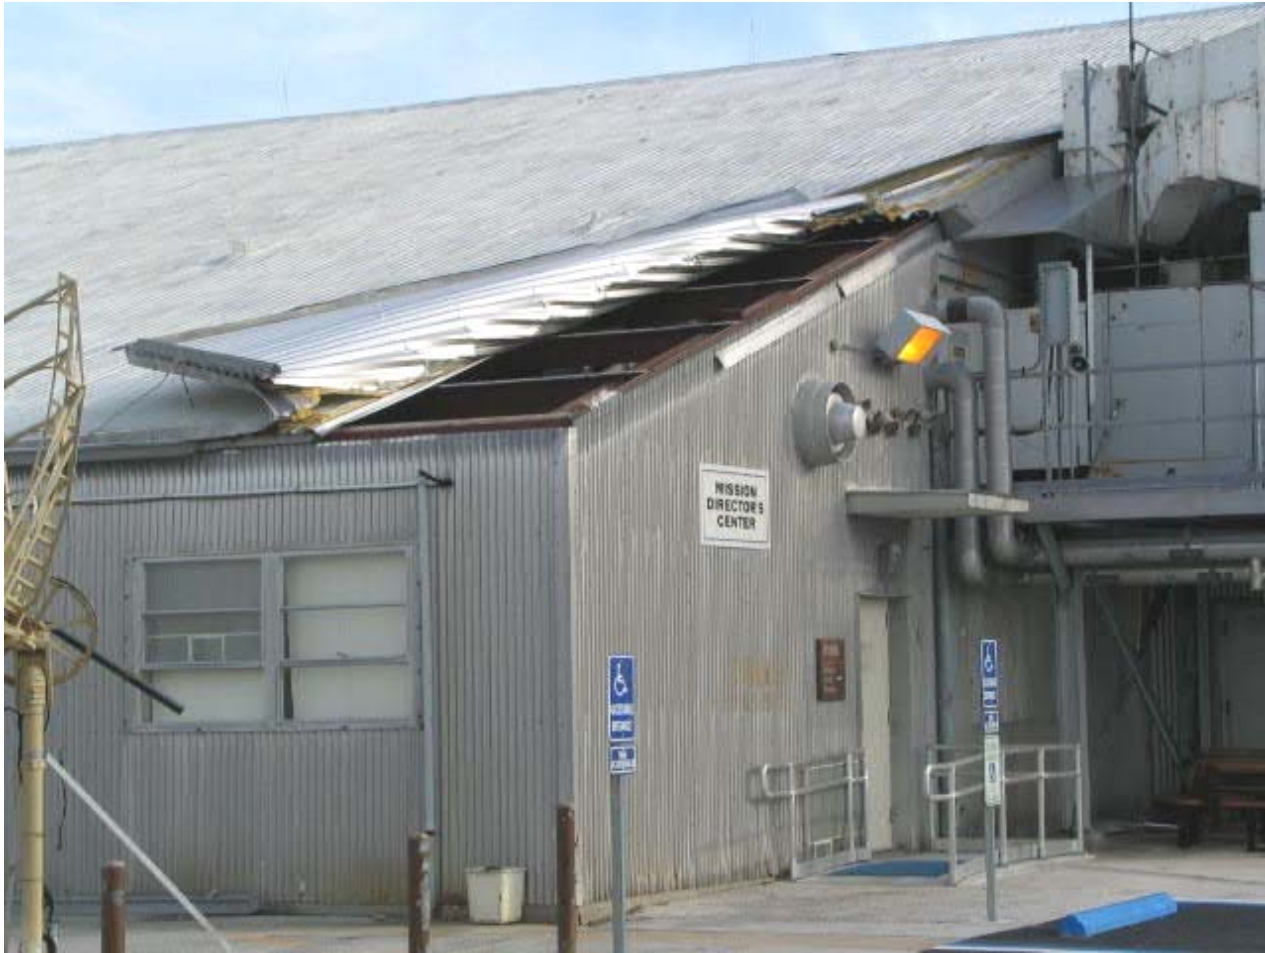
NASA facilities on Cape Canaveral Air Force Station  
Hangar AE (60680) – SE corner exterior

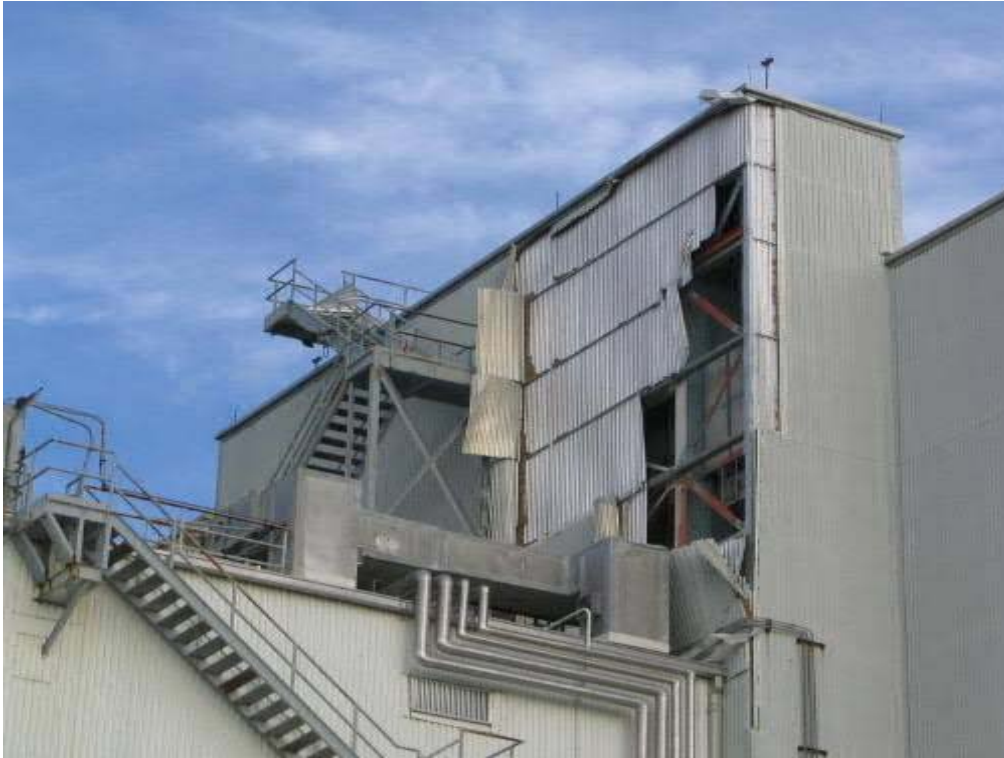
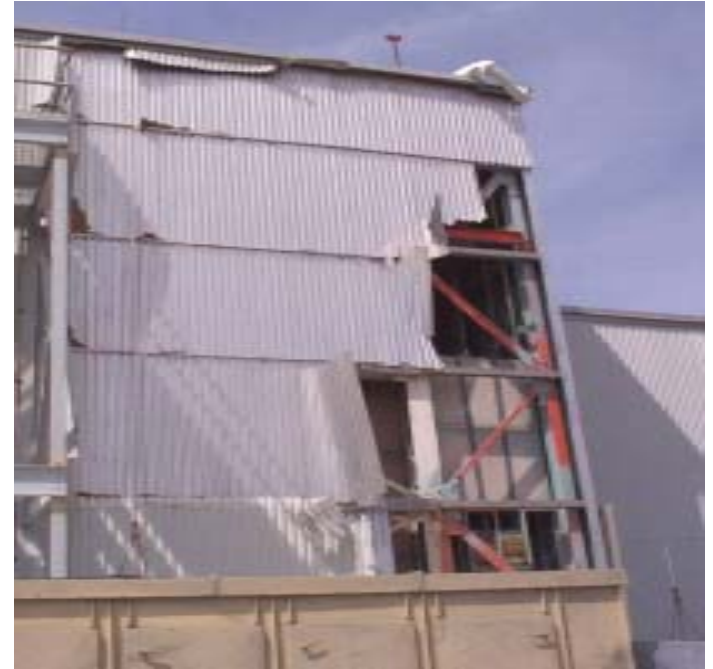
KSC Industrial Area

Vertical Processing Facility (VPF) (M7-1469) – Side panel damage south side

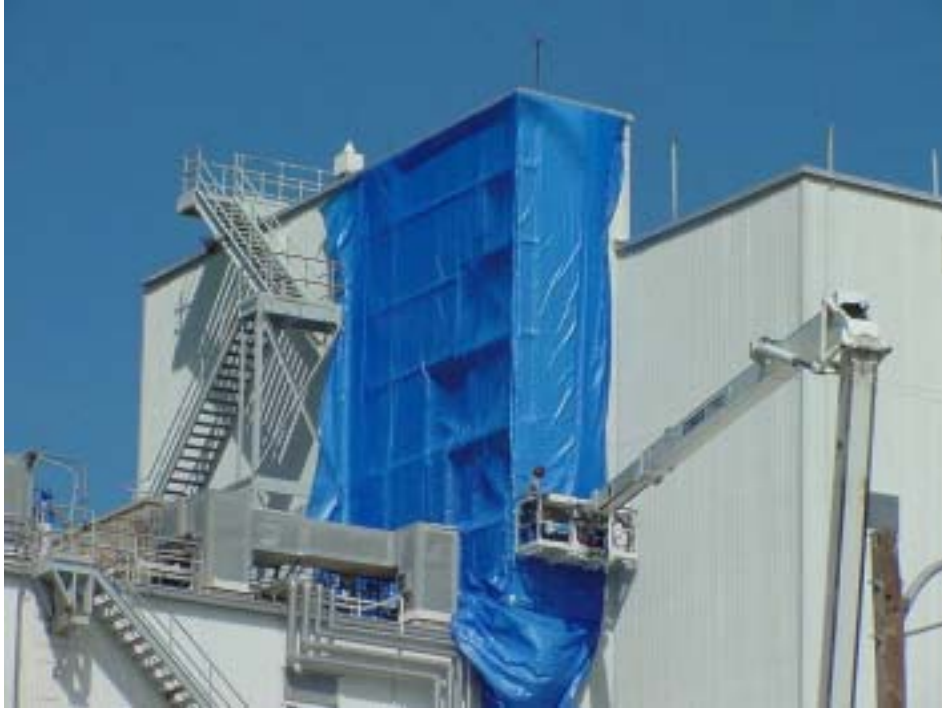
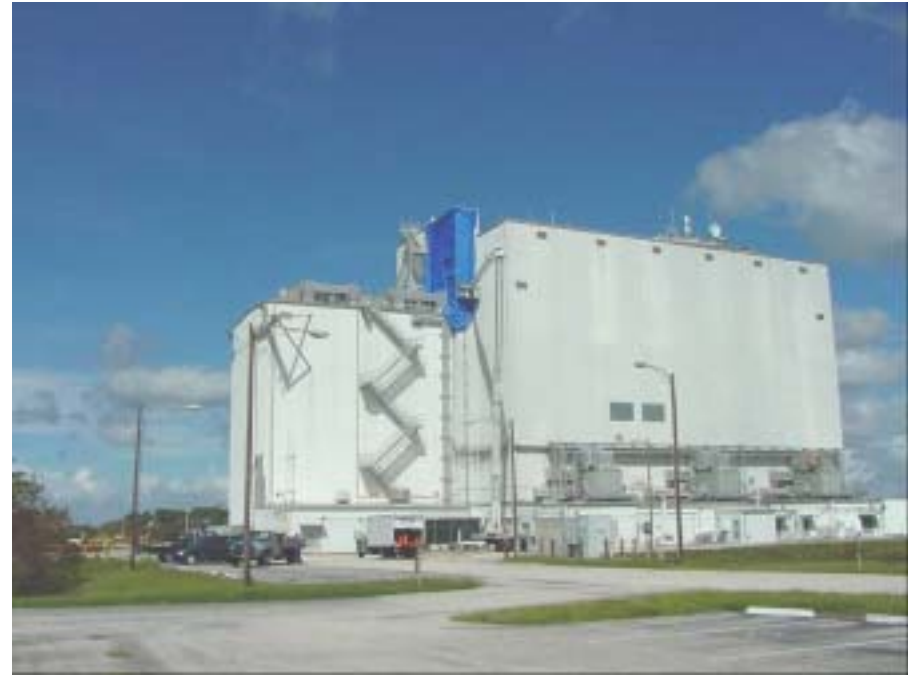
KSC Industrial Area

Vertical Processing Facility (M7-1469) – tarps cover panel damage

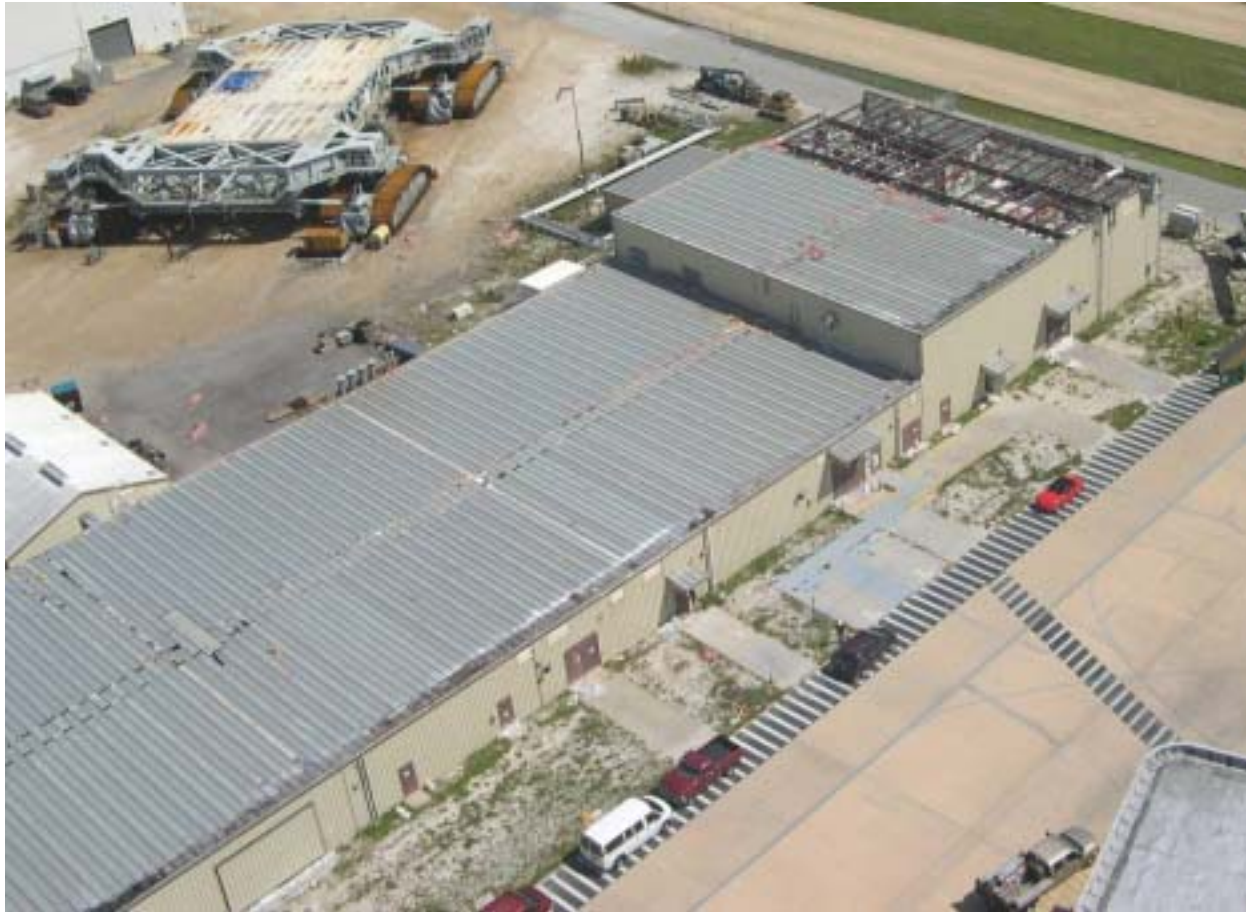
Launch Complex 39 Area

Thermal Protection System Facility (TPSF) (K6-0744) – extensive roof damage on 2<sup>nd</sup> floor east end of facility

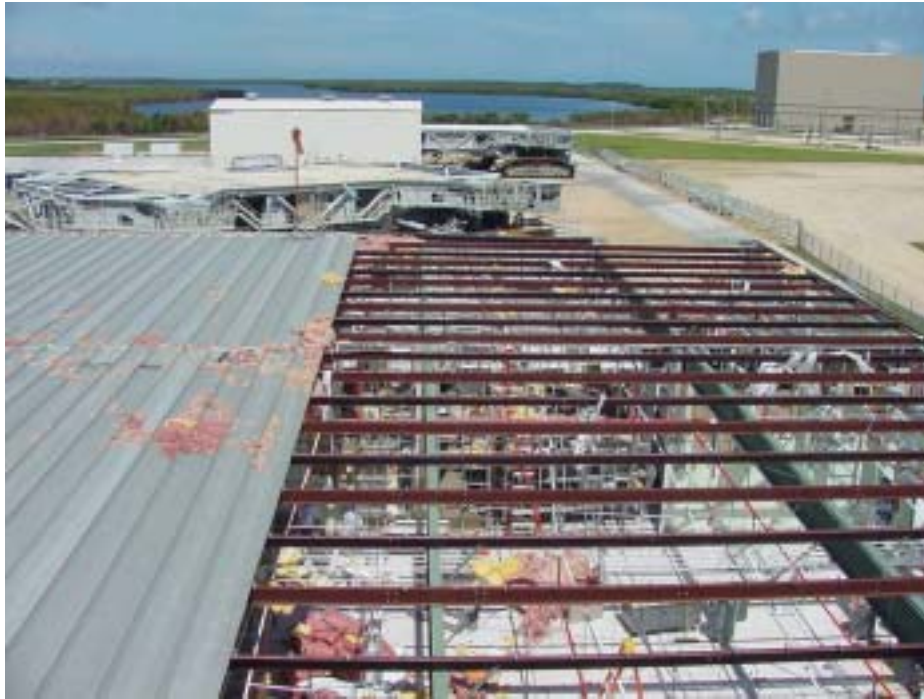
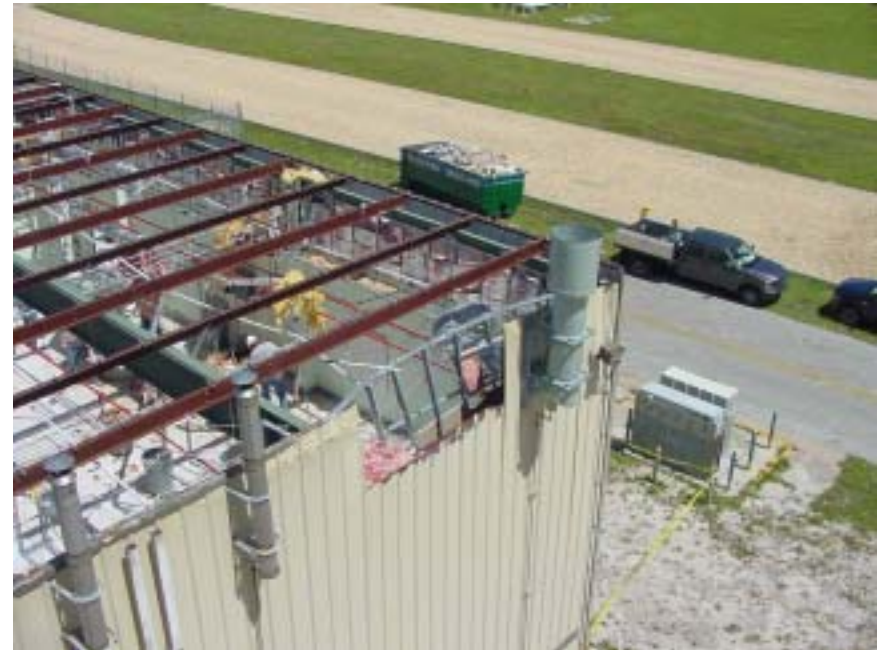
Launch Complex 39 Area  
Thermal Protection System Facility (TPSF) (K6-0744) – extensive  
roof damage on 2<sup>nd</sup> floor east end of facility

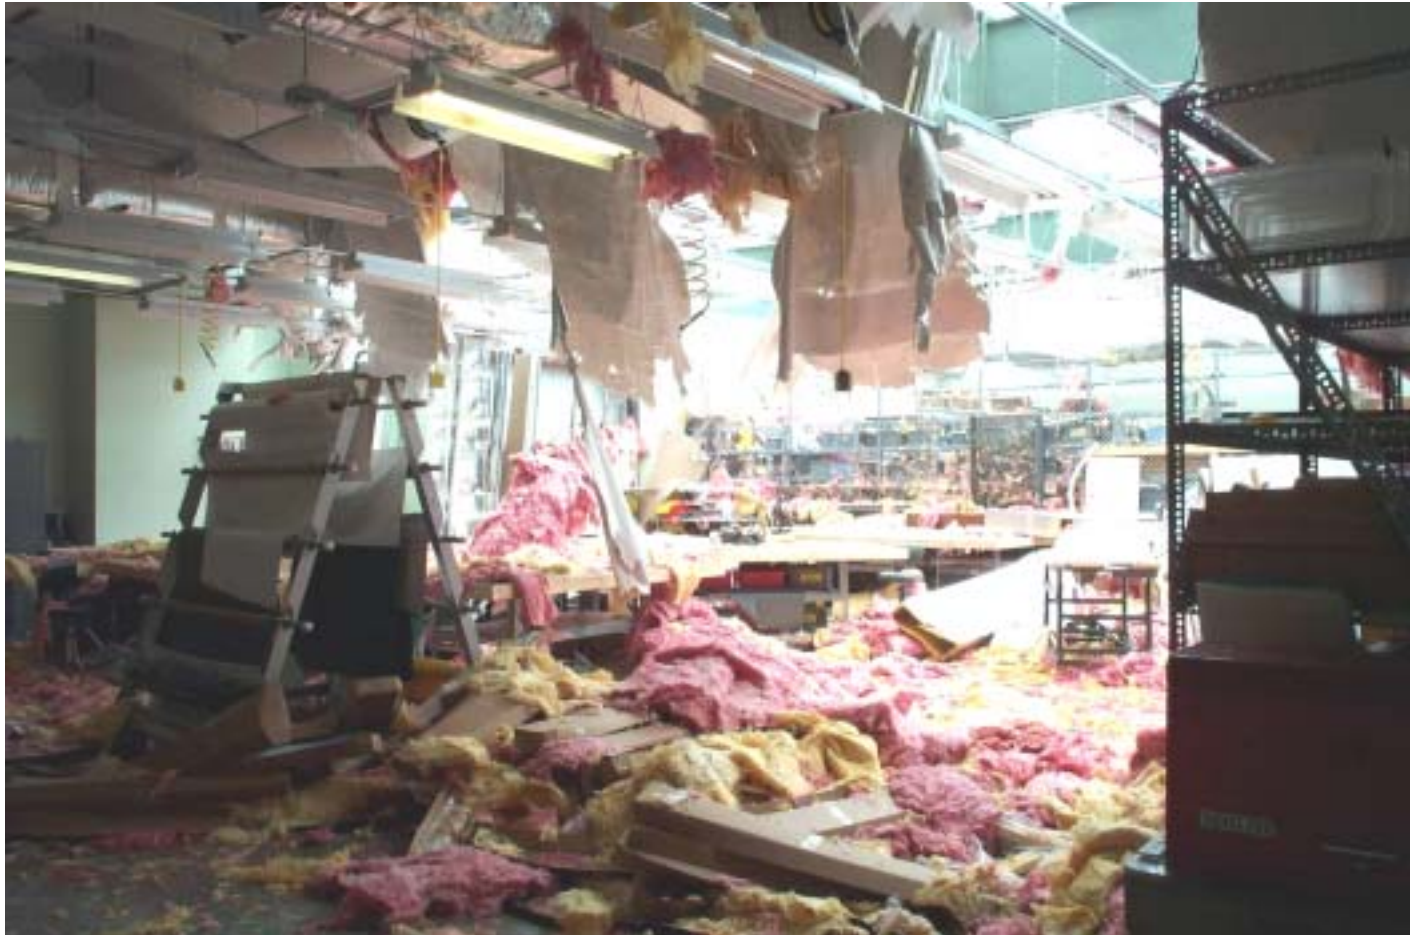
Launch Complex 39 Area

Thermal Protection System Facility (TPSF) (K6-0744) – interior damage  
– 2<sup>nd</sup> floor soft goods area

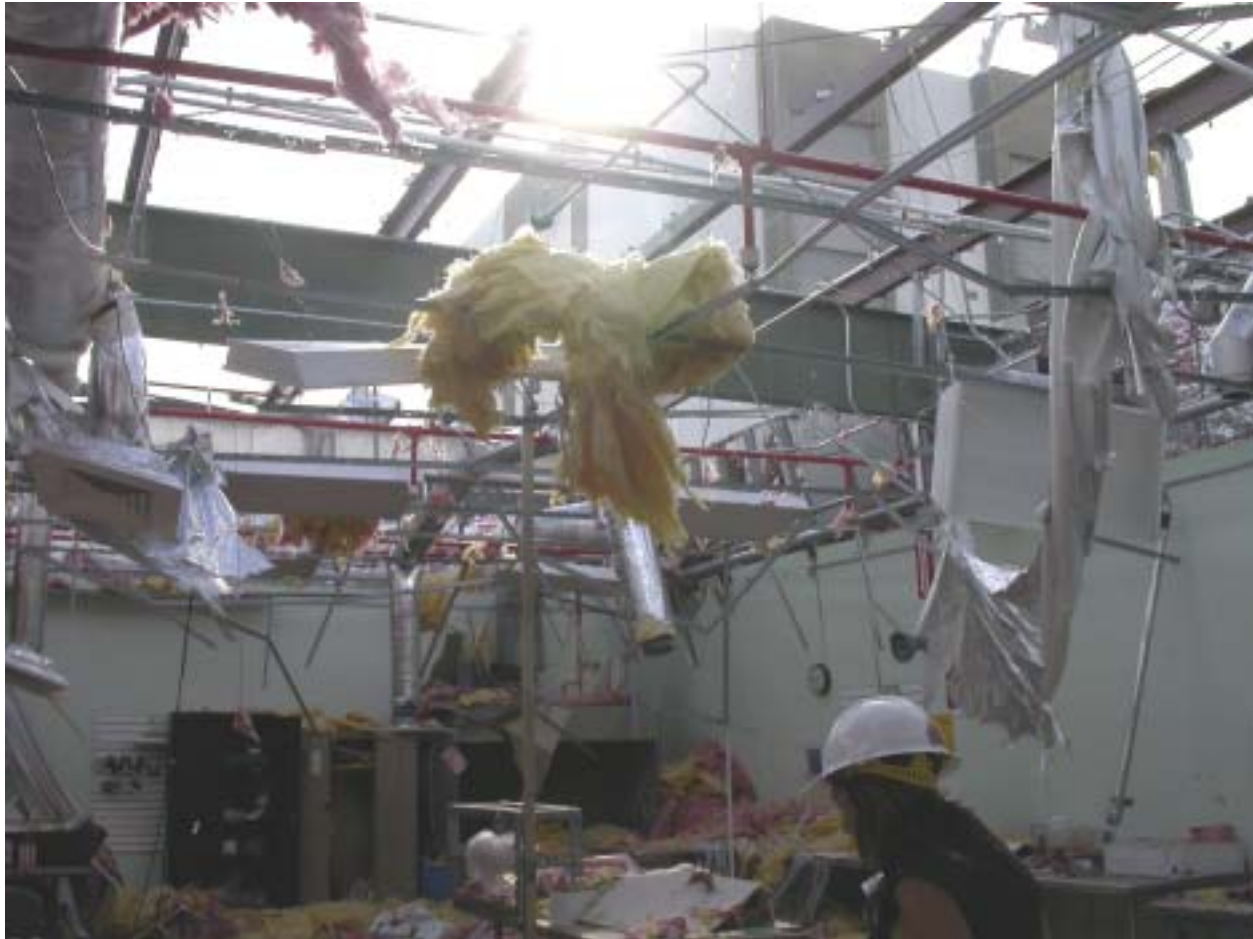
Launch Complex 39 Area

Thermal Protection System Facility (TPSF) (K6-0744) – interior damage

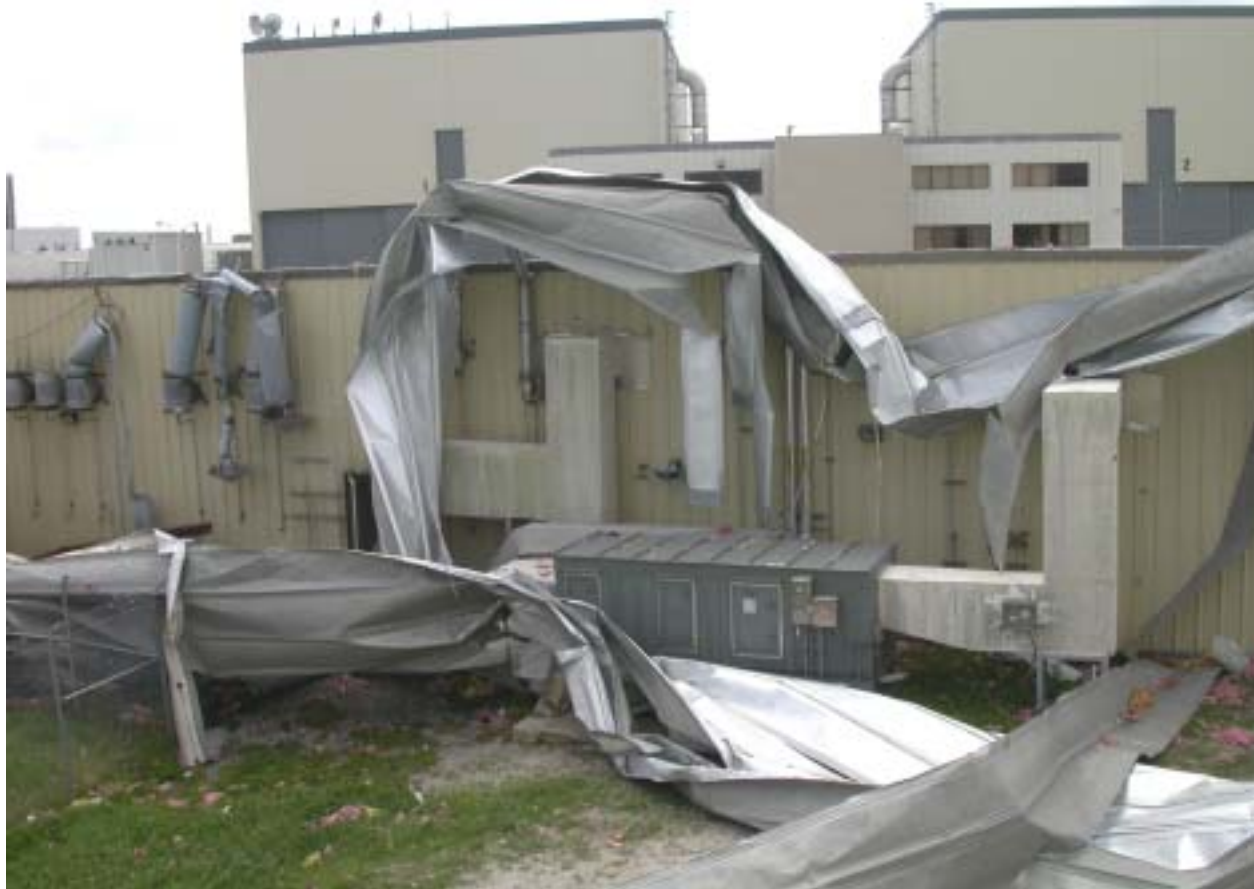
Launch Complex 39 Area

Thermal Protection System Facility (TPSF) (K6-0744) – damaged roof sections on north side of facility

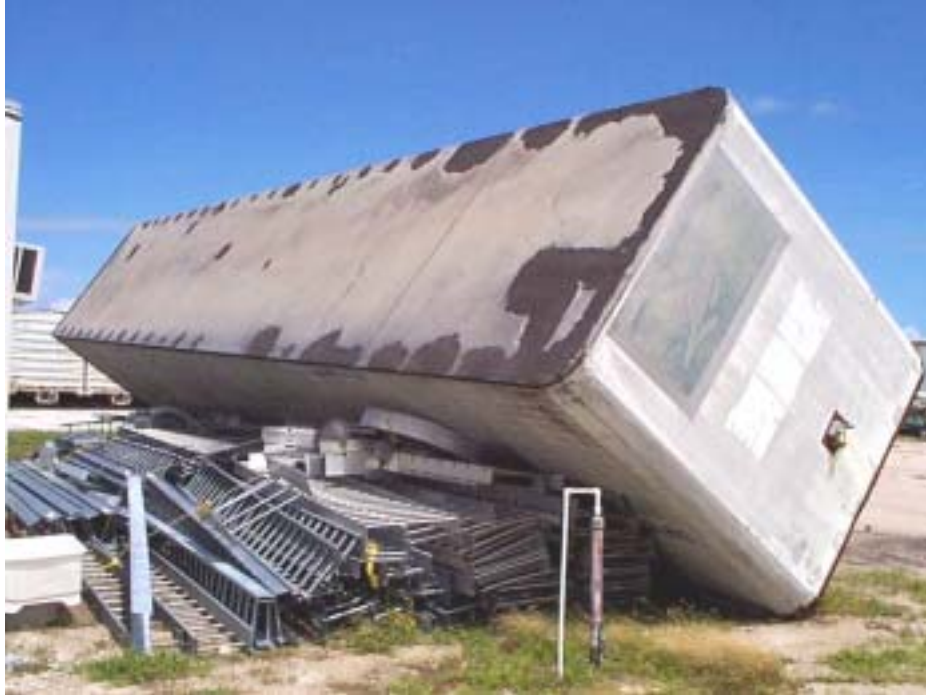
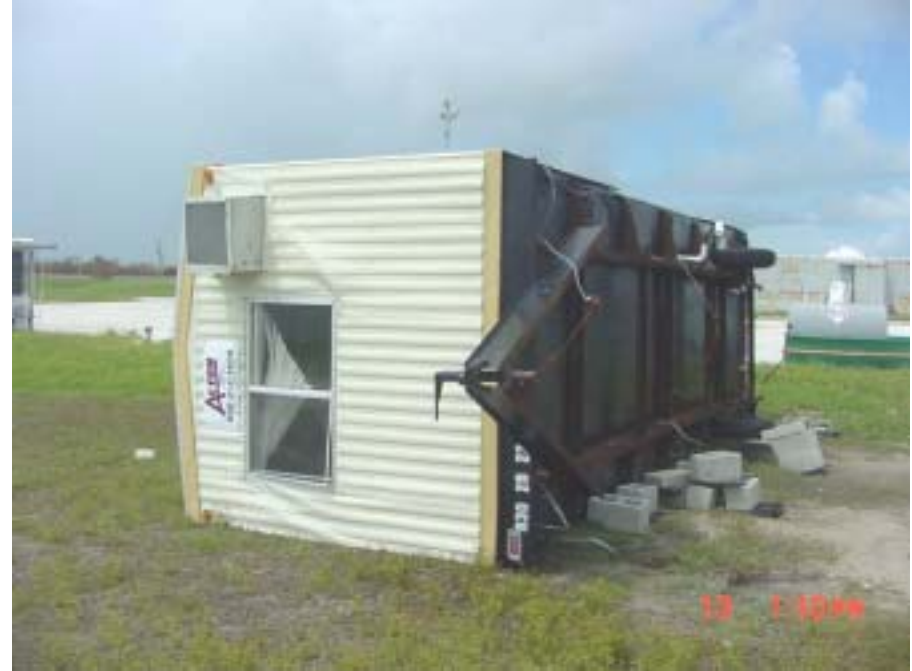
Trailers at various construction sites overturned

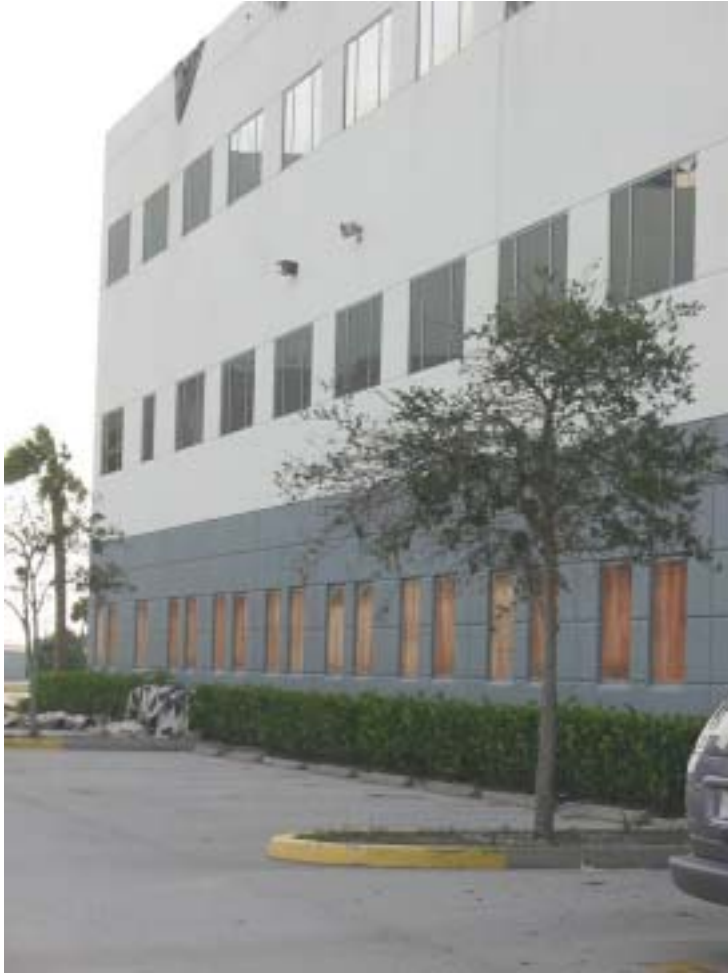
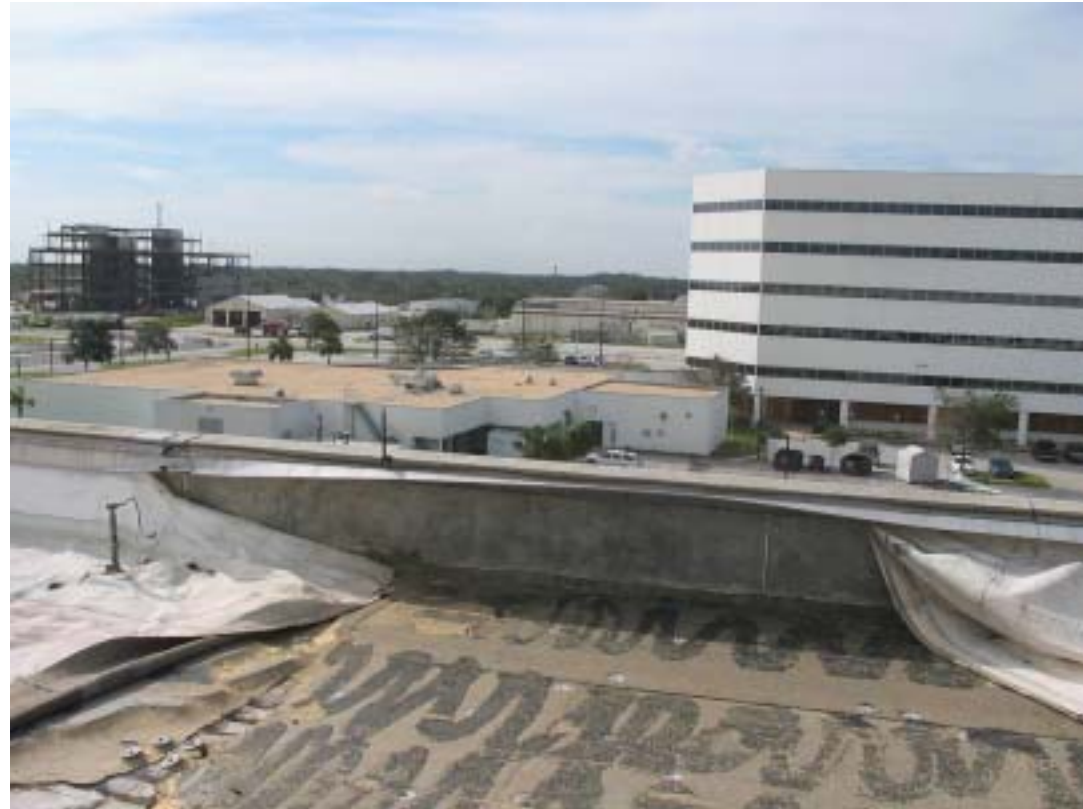
Launch Complex 39 Area  
Processing Control Center (PCC) (K6-1094) – exterior roof damage (roof  
on ground in left photo)

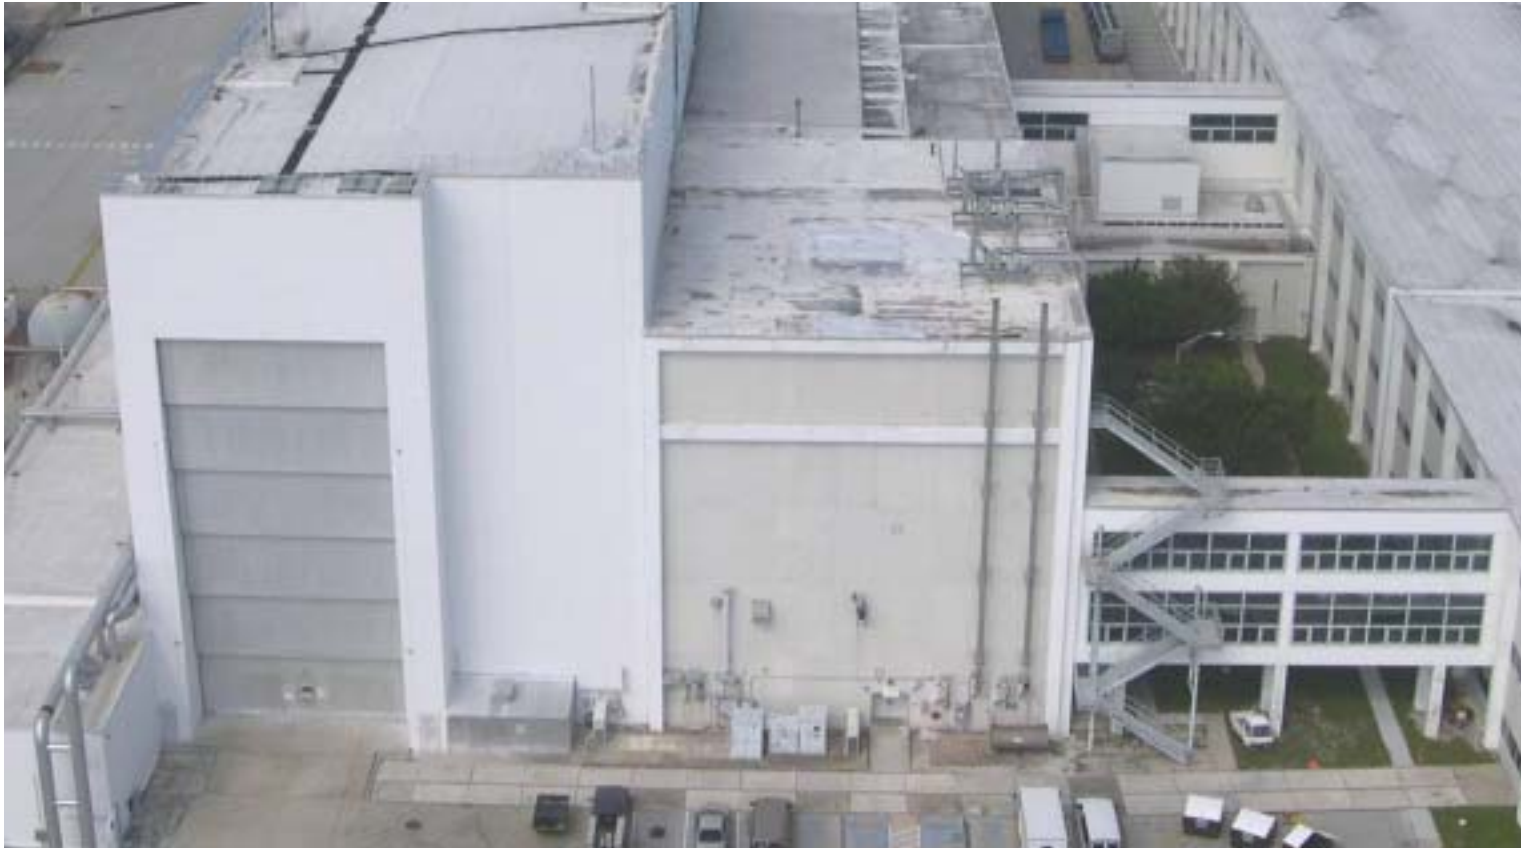
## KSC Industrial Area

Operations and Checkout (O&C) Building (M7-0355) – initial exterior roof damage east end high bay and 5<sup>th</sup> floor (covered with visqueen)

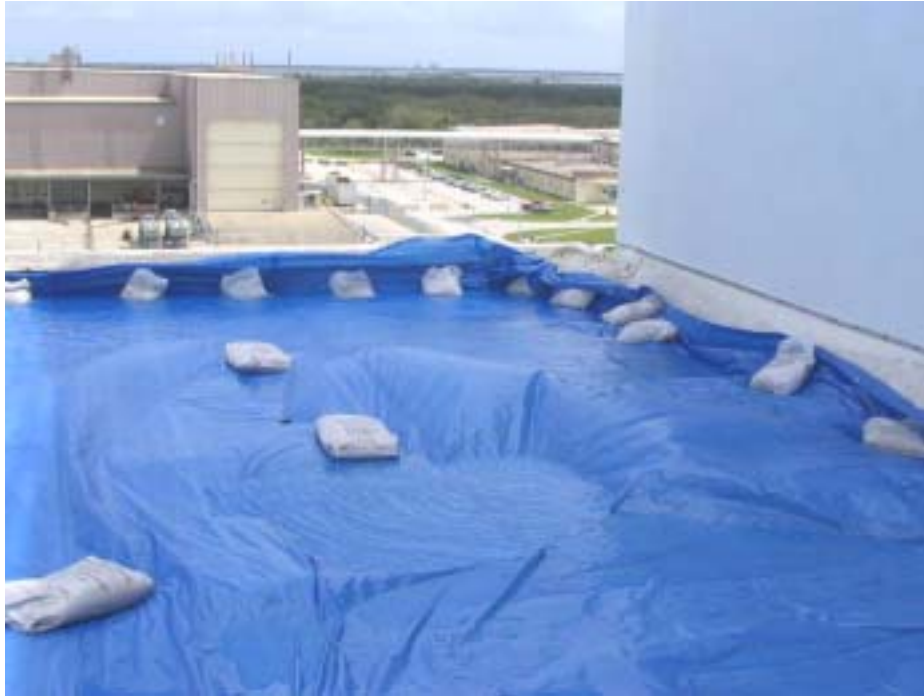
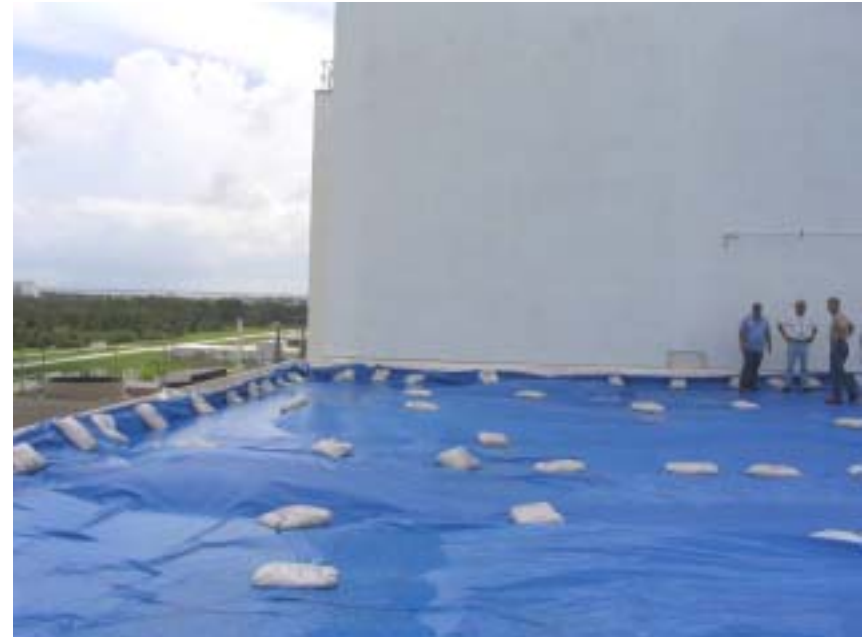
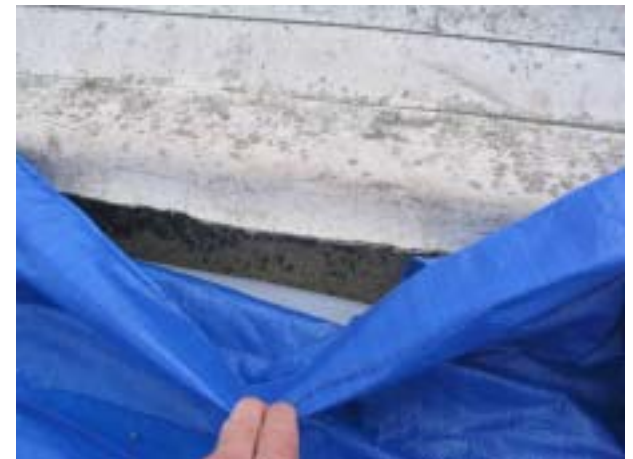
KSC Industrial Area

Operations and Checkout (O&C) Building (M7-0355)  
– tarps cover roof on east end
