# John F. Kennedy Space Center, FL Hurricane Frances Damage Assessment Photos

Kennedy Space  
Center

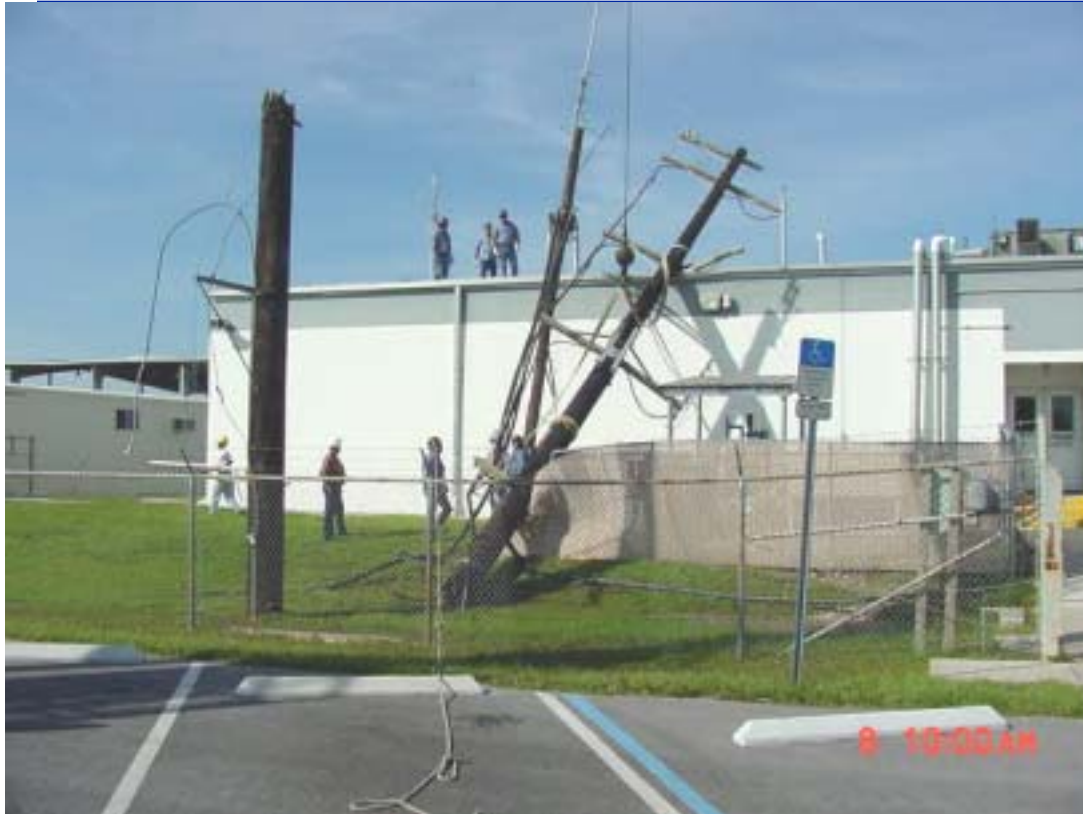
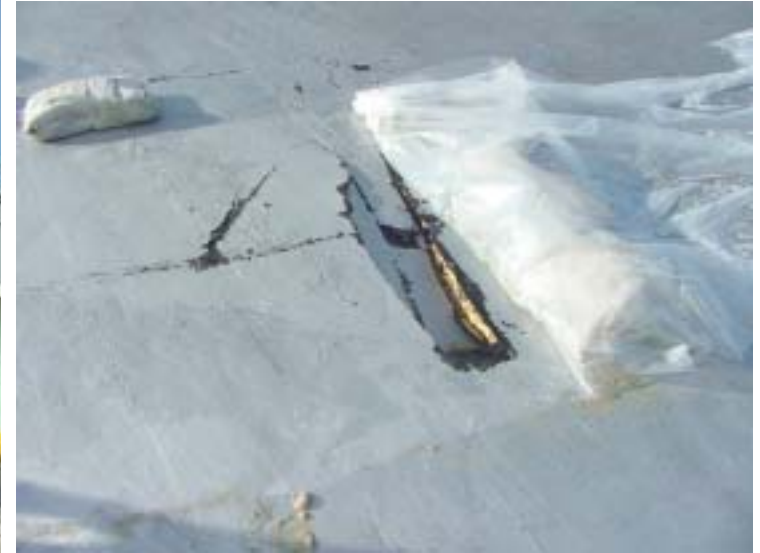
Shuttle Landing Facility

Landing Aids Control Building (J6-2313) – power/communications pole damage, exterior roof damage

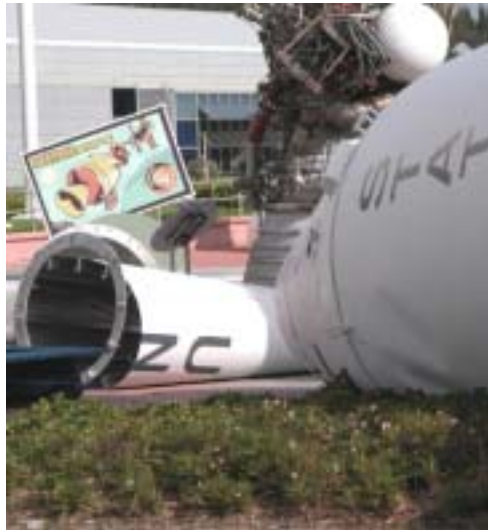
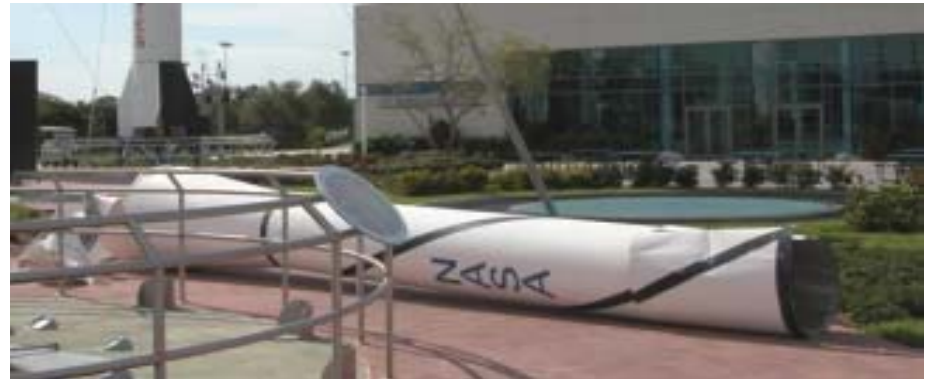
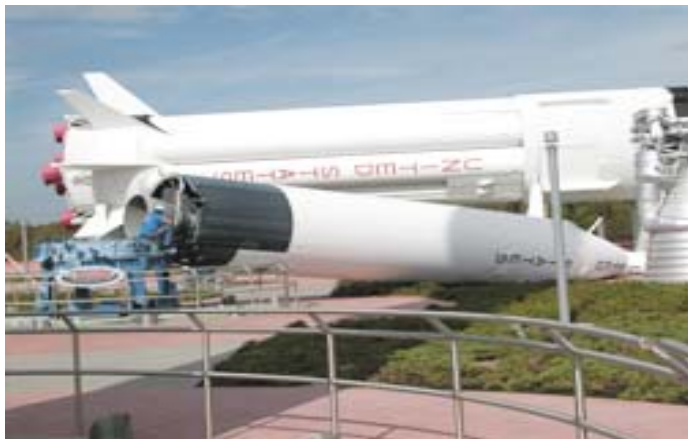
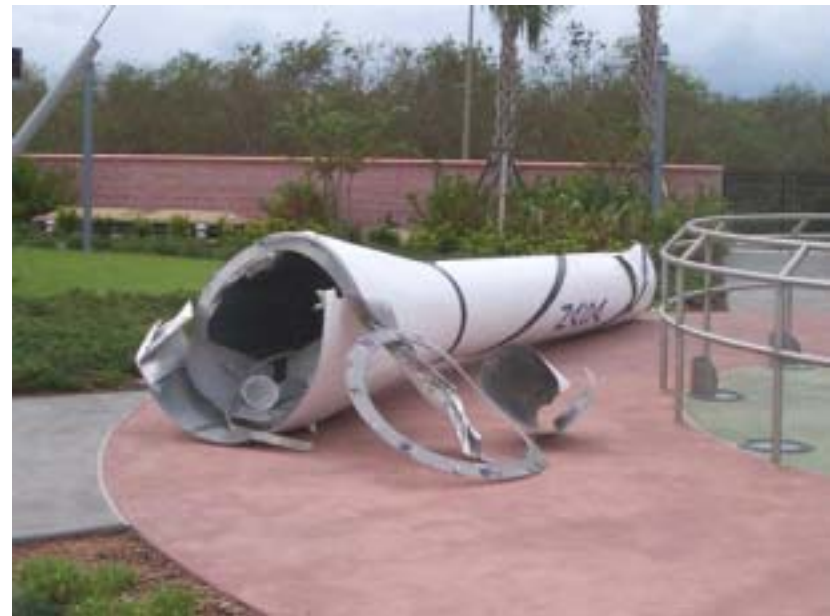
KSC Visitor Complex

Rocket Garden (M6-0409) – Rocket displays damaged, including Juno and Delta

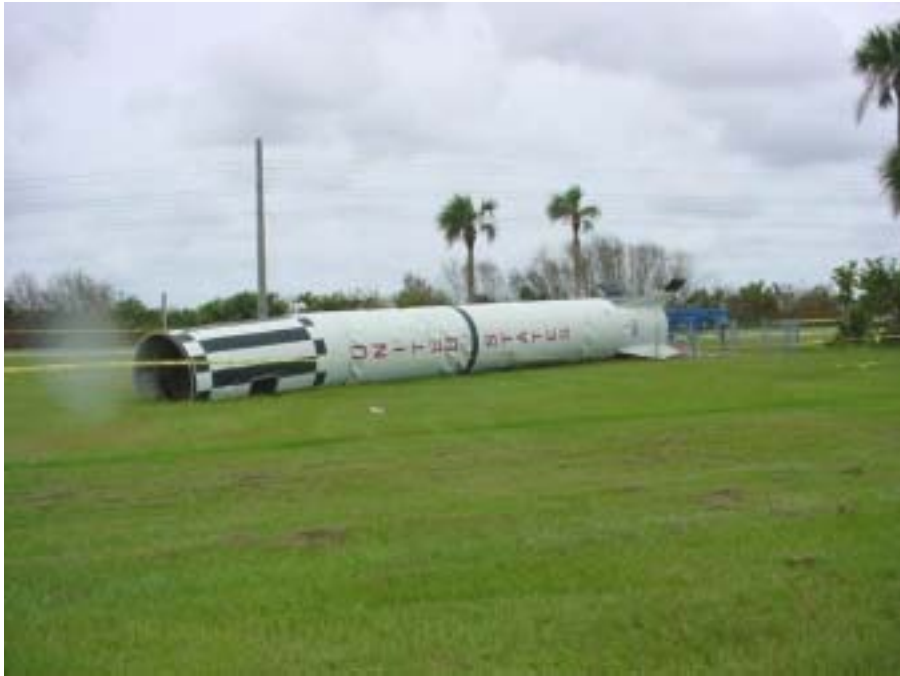
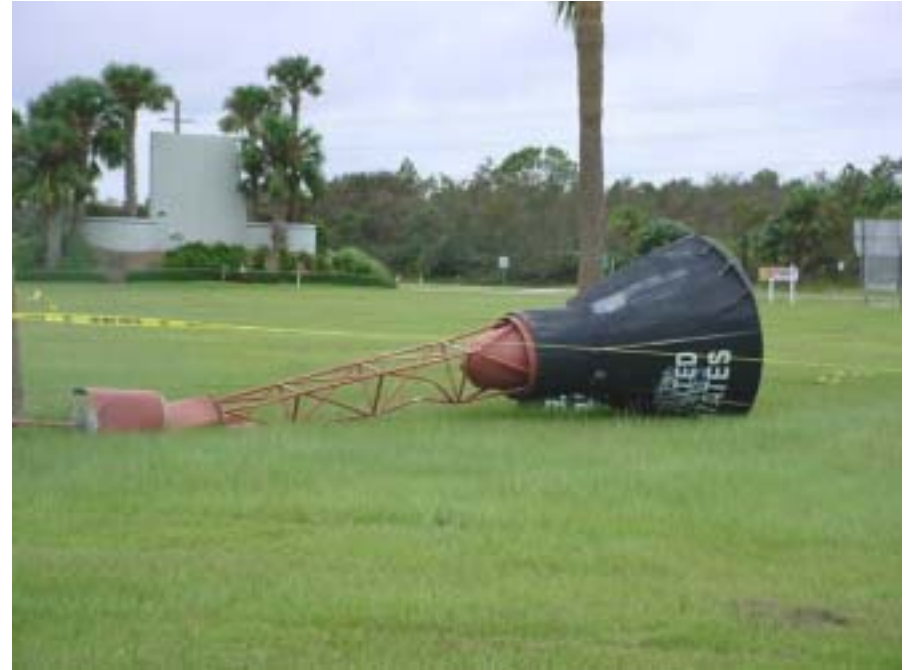
Pass and Identification Building #3 (M3-0002)

Redstone rocket display damage

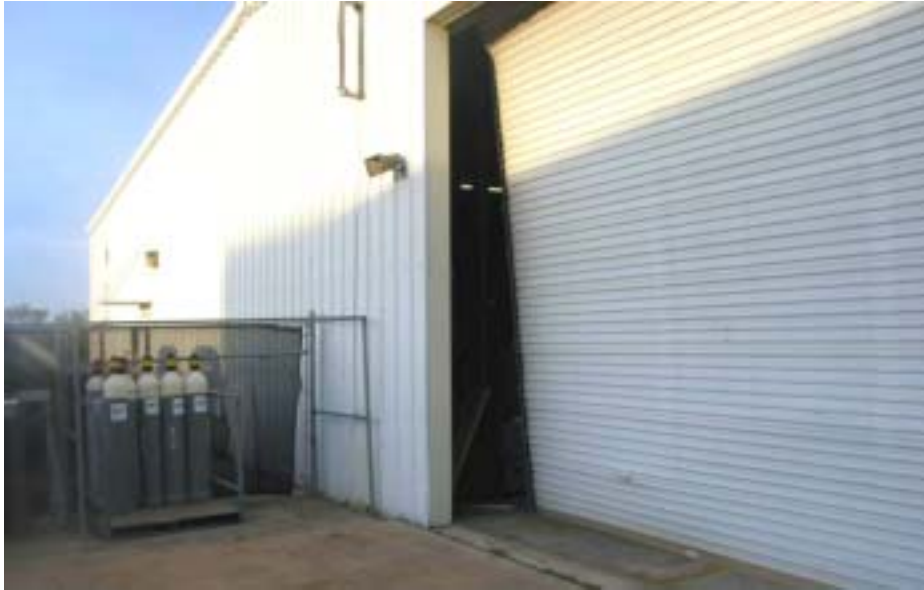
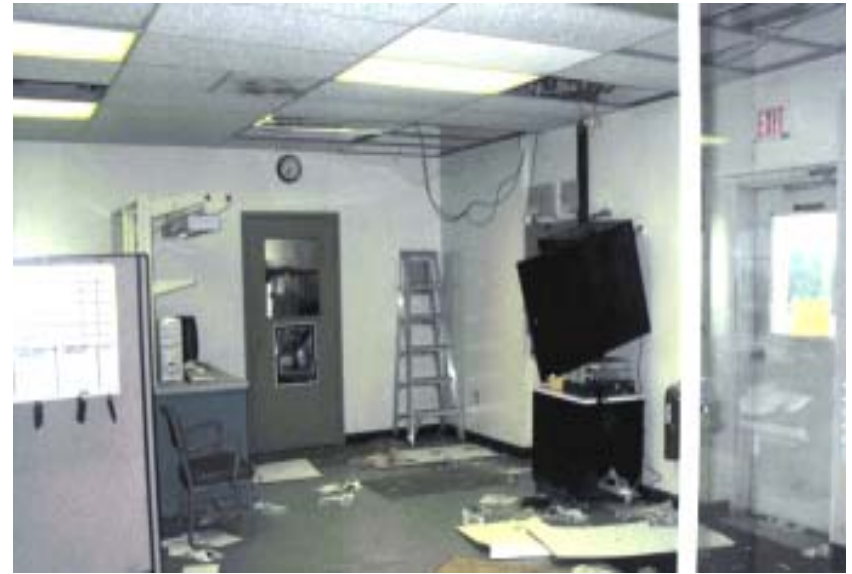
KSC Industrial Area

Prototype Shop (M7-0581) – roll up door damage and interior damage

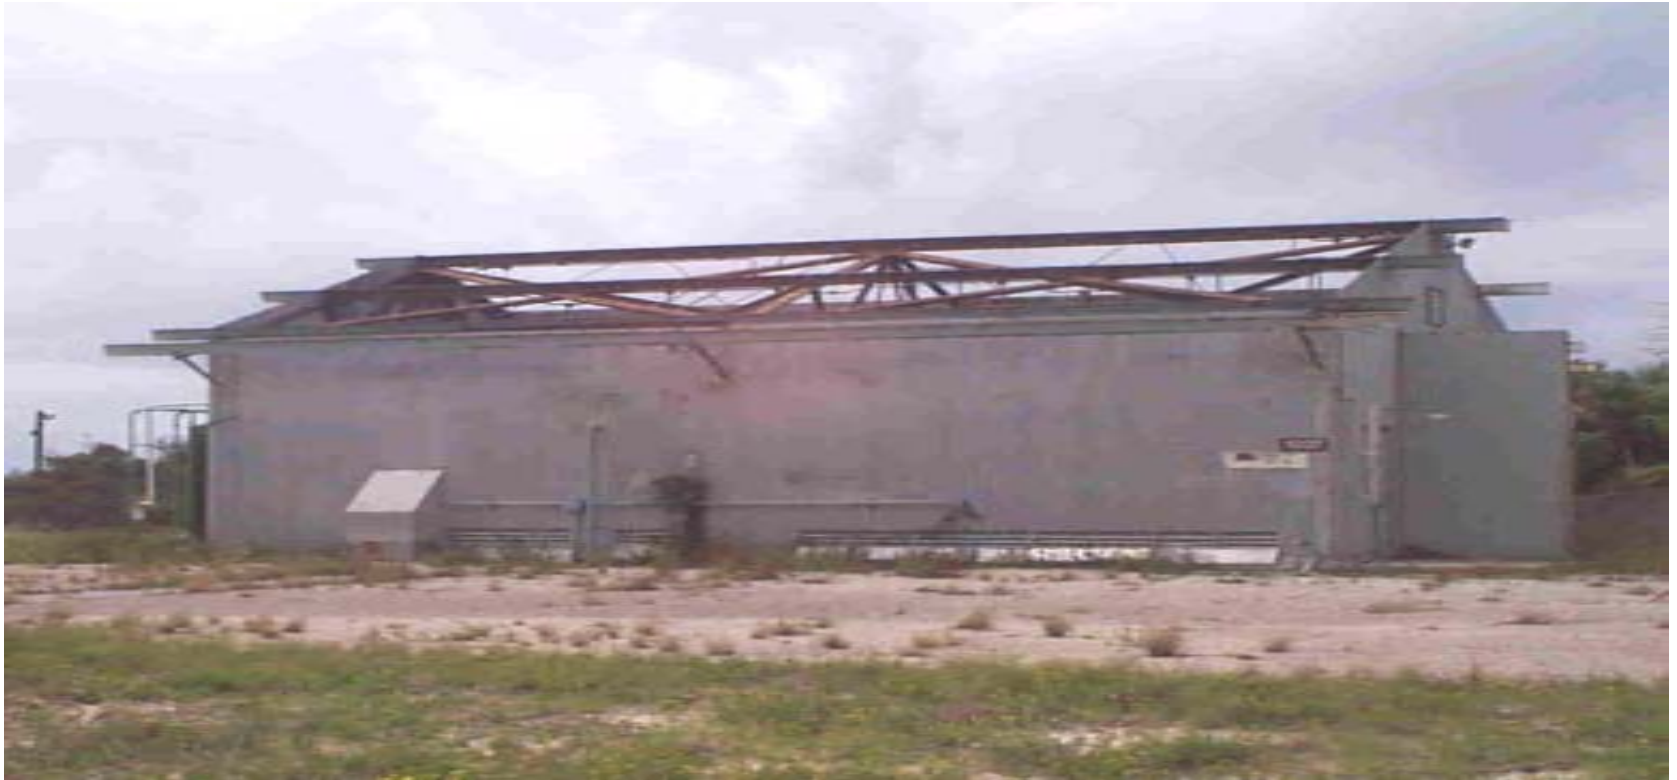
NASA Facilities on Cape Canaveral Air Force Station

Fuel Storage Area #1 (01037) – warehouse roof damage
