REPORT OF APOLLO 204 REVIEW BOARD

APPENDIX D

PANEL 5

**REPORT OF PANEL 5
ORIGIN AND PROPAGATION OF FIRE
APPENDIX D-5
TO
FINAL REPORT OF
COLLO 204 REVIEW BOARD**

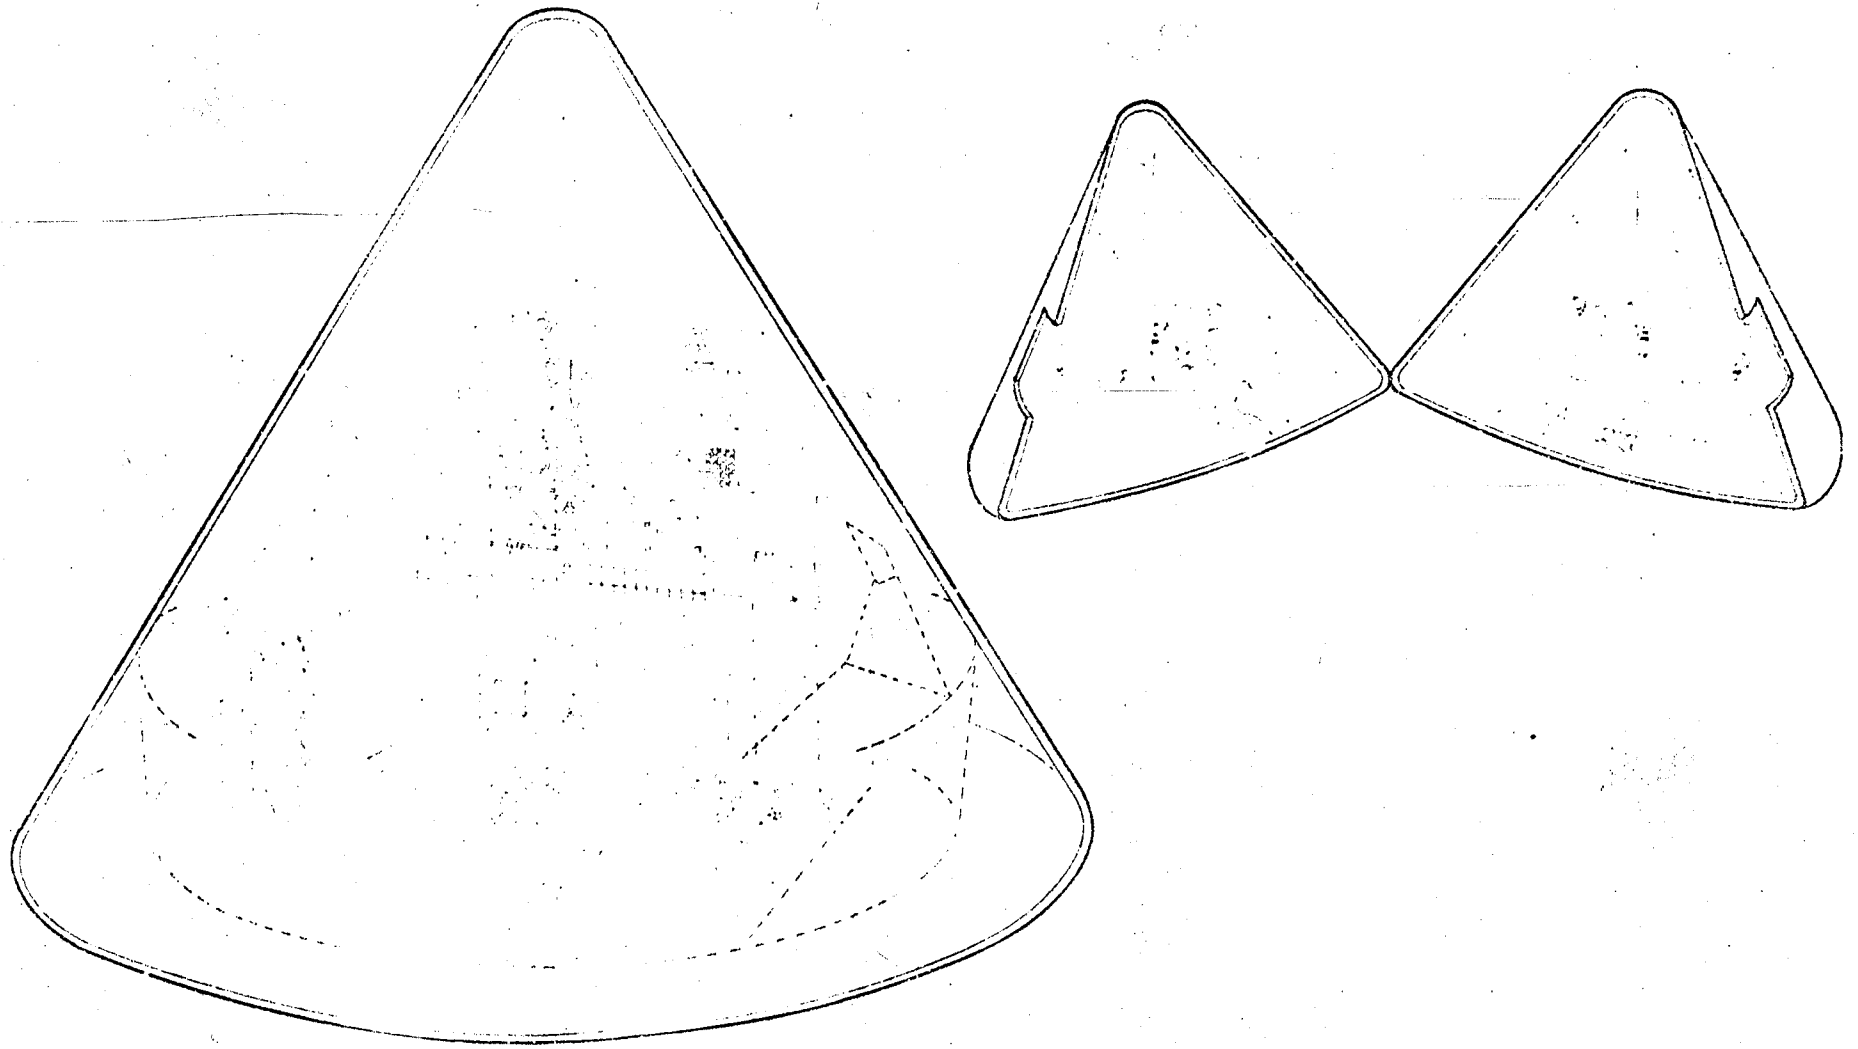
ENCLOSURE 5-7

b. From observations of post-fire damage and witness statements, the fire first appeared to be at the lower portion of the left side of the C/M, presumably near the lower left corner (Enclosure 5-7). The slow rate of rise of recorded cabin pressure caused by the heat released by the fire suggests that the fire was not intense until about 23:31:12 GMT (Enclosure 5-8). This slow rate of pressure rise is consistent with the view that the early fire was either located in a zone containing little combustible or one containing much bare aluminum structure which could absorb an appreciable portion of the heat. The first significant indication of pressure rise was shown by telemetry data at 23:31:08.4 GMT.

VIEW OF LOWER LEFT HAND CORNER

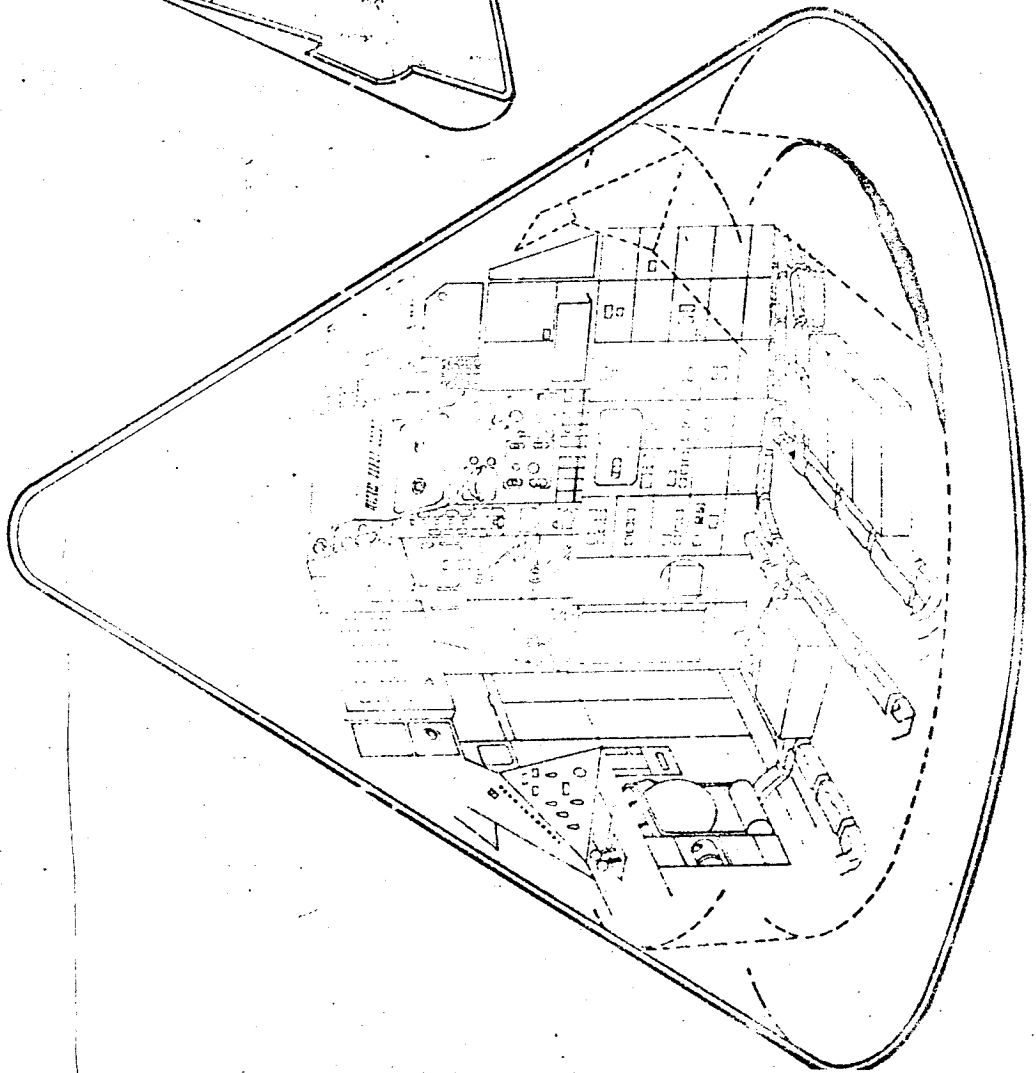
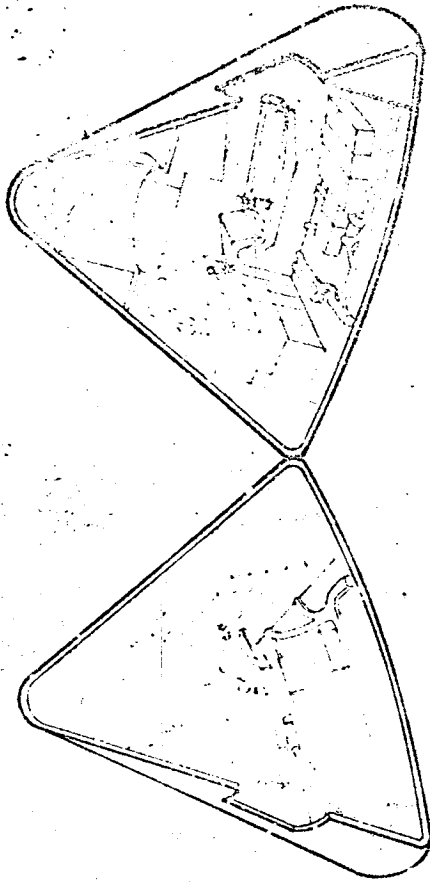
f. A major failure in the aft bulkhead occurred at the junction of the wall and aft bulkhead in the vicinity of the umbilical (Enclosure 5-12). Cabin gases and flame flowed in the direction of the break in the floor. The flames, debris, and oxygen flowed into the toroidal space between the pressure shell and the heat shield where the thermocouples registered rapidly rising temperature at 23:31:20 GMT. Flames in the toroidal space burned and melted components of the Reaction Control System and the insulation and honeycomb structure of the aft heat shield. These flames also poured from access hatches in the crew compartment heat shield and set fire to combustibles situated on and around the spacecraft at levels A-8 and A-7. These fires endangered pad personnel and impeded rescue.

FIRST PRESSURE VESSEL FAILURE

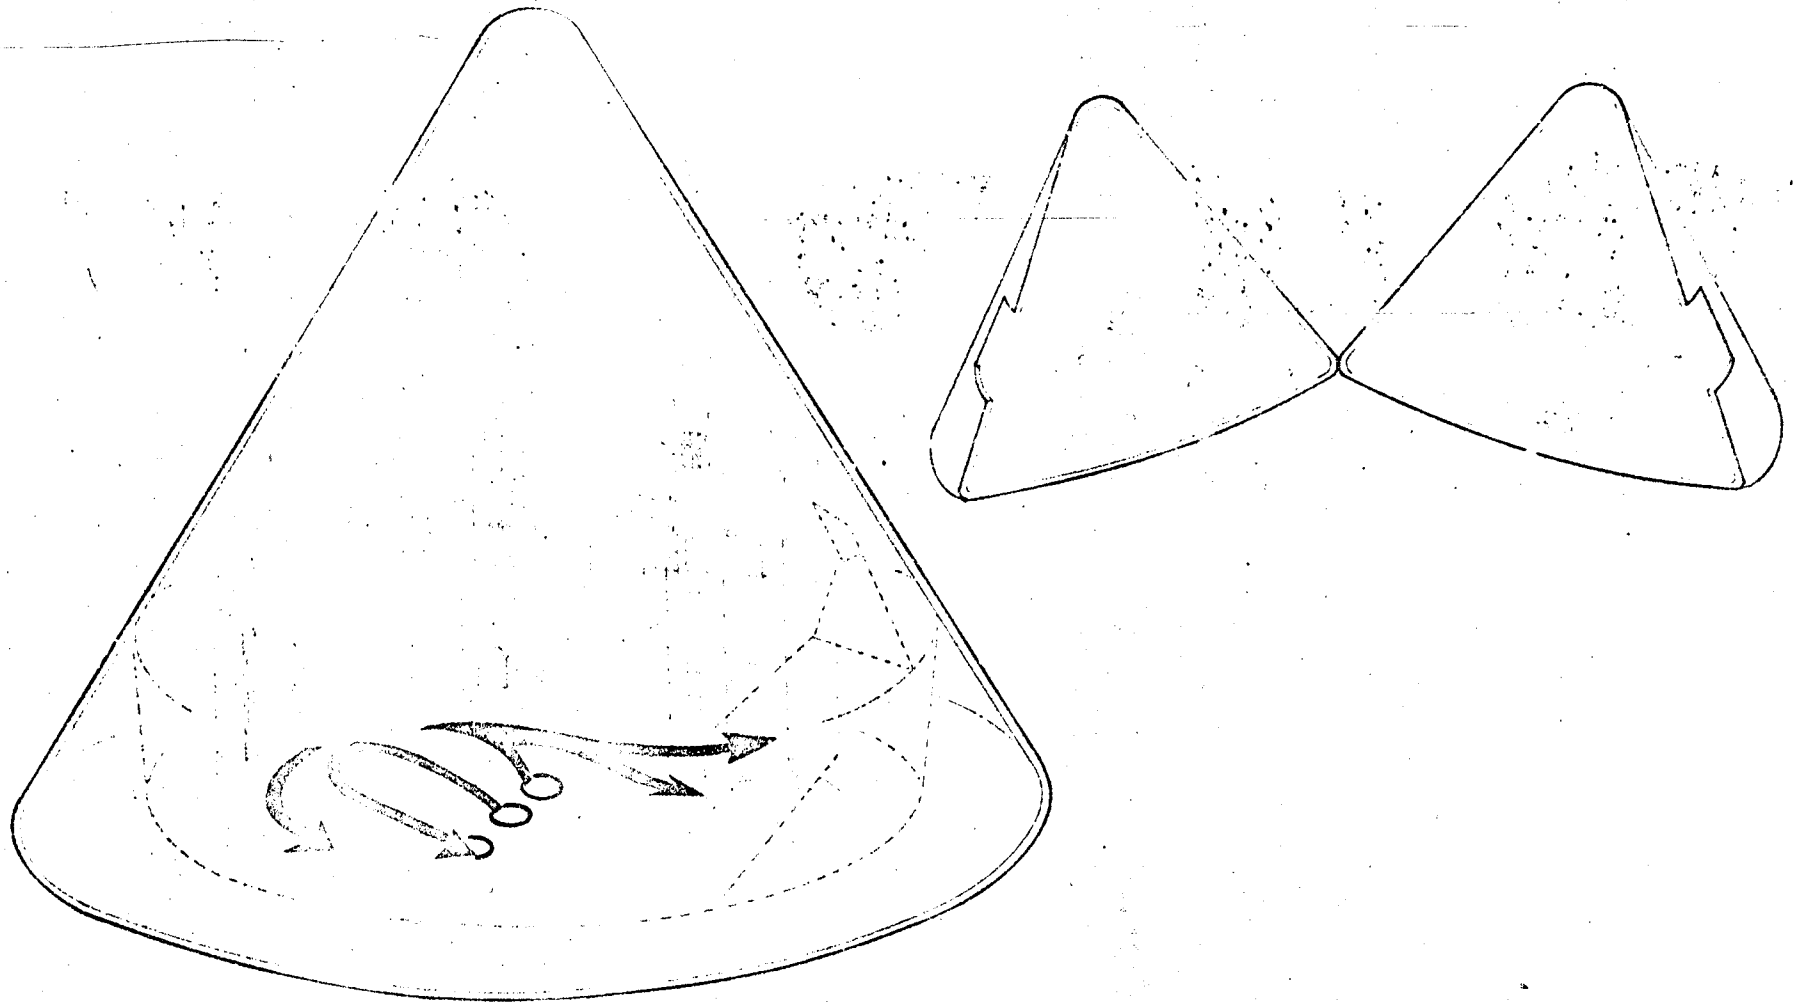
ENCLOSURE 5-15

j. Some of the fire below the couch also swept in the direction of the floor break (Enclosure 5-15). Fire damage to the three helmet covers lying on the floor below the Senior Pilot's (middle) couch indicated that some of this flame spread around the lithium hydroxide (LiOH) canister storage box to the left of the helmet covers (Enclosure 5-16). Fire damage to these covers is greatest on their left sides where the flames impinged. The fire damage to the helmet covers, shown in this photograph, is consistent with this view of the path taken by the flames at this location. Enclosure 5-17 is a view of the helmet cover which lies closest to the hatch. Because the camera faces the hatch, the left side of the C/M is on the viewer's right.

SECOND PHASE OF FIRE - ON THE FLOOR
