# **REPORT OF APOLLO 204 REVIEW BOARD**

**APPENDIX D  
PANEL 18**

INTEGRATION ANALYSIS PANEL

A P O L L O 2 0 4 R E V I E W B O A R D

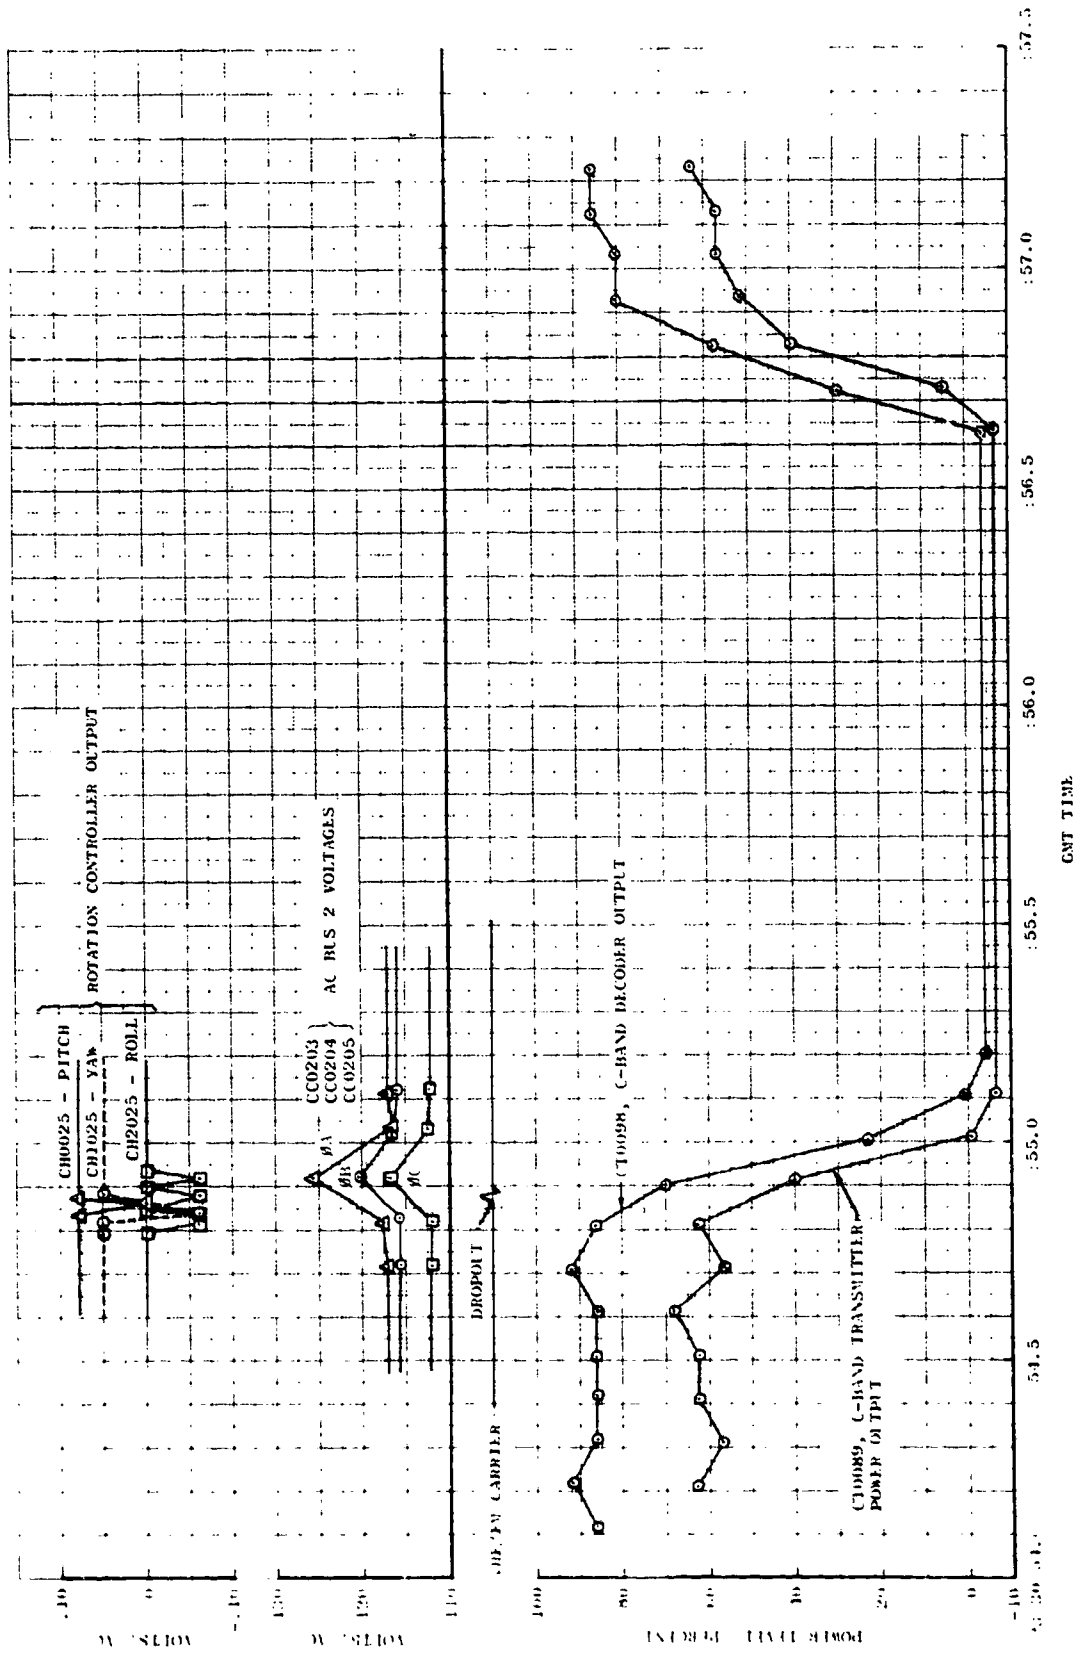
ENCLOSURE 18-8

A momentary increase in AC bus 2 voltage was noted at approximately nine seconds before the crew report of fire, and at the same time the recorded parameters monitoring the equipment powered from AC bus 2 showed abnormal indications. Enclosure 18-3 shows the parameters and changes, with the times of sampling by the telemetry system. These were:

It is concluded that the probable cause of the AC bus 2 transient and associated indications was a momentary short (2 to 25 milliseconds) of DC bus B affecting the input voltage to inverter 2.

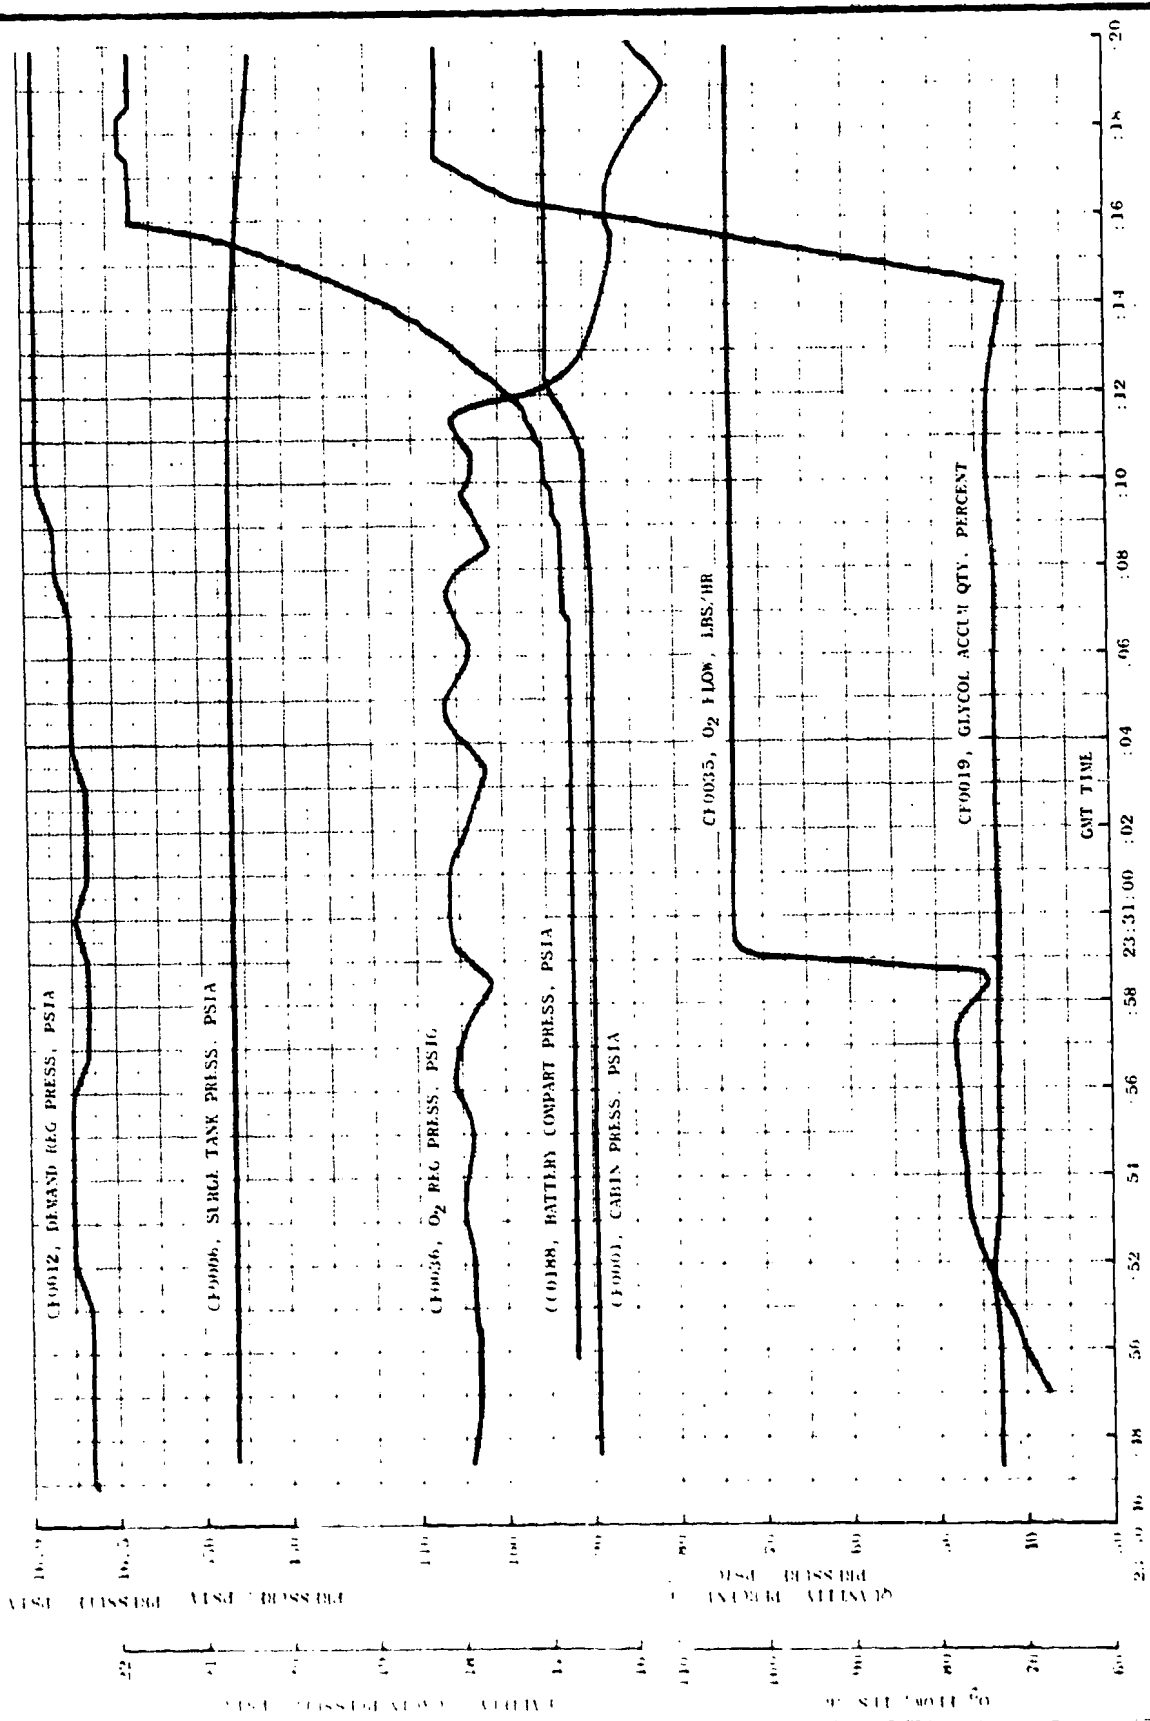
ENCLOSURE 18-9

At 23:30:59 GMT the oxygen flow rate measurement went to a saturated condition of 1.03 pounds per hour. Fifteen seconds later the caution and warning system master alarm was triggered. The oxygen ( $O_2$ ) flow stayed in a saturated condition until loss of signal (LOS). Oxygen flow rate and associated data are shown in Enclosure 18-9.

Telemetered data indicate that the high oxygen flow rate conditions for the last 30 seconds before the crew report of fire can be attributed to the apparent high level of prime crew suit leakage at low suit-to-cabin differential pressure, magnified by apparent crew activity. An analysis of S-band audio data also indicates that a face plate may have been open. An analysis was also conducted to determine if the high flow could be indicative of a sensor and/or associated wiring difficulty.

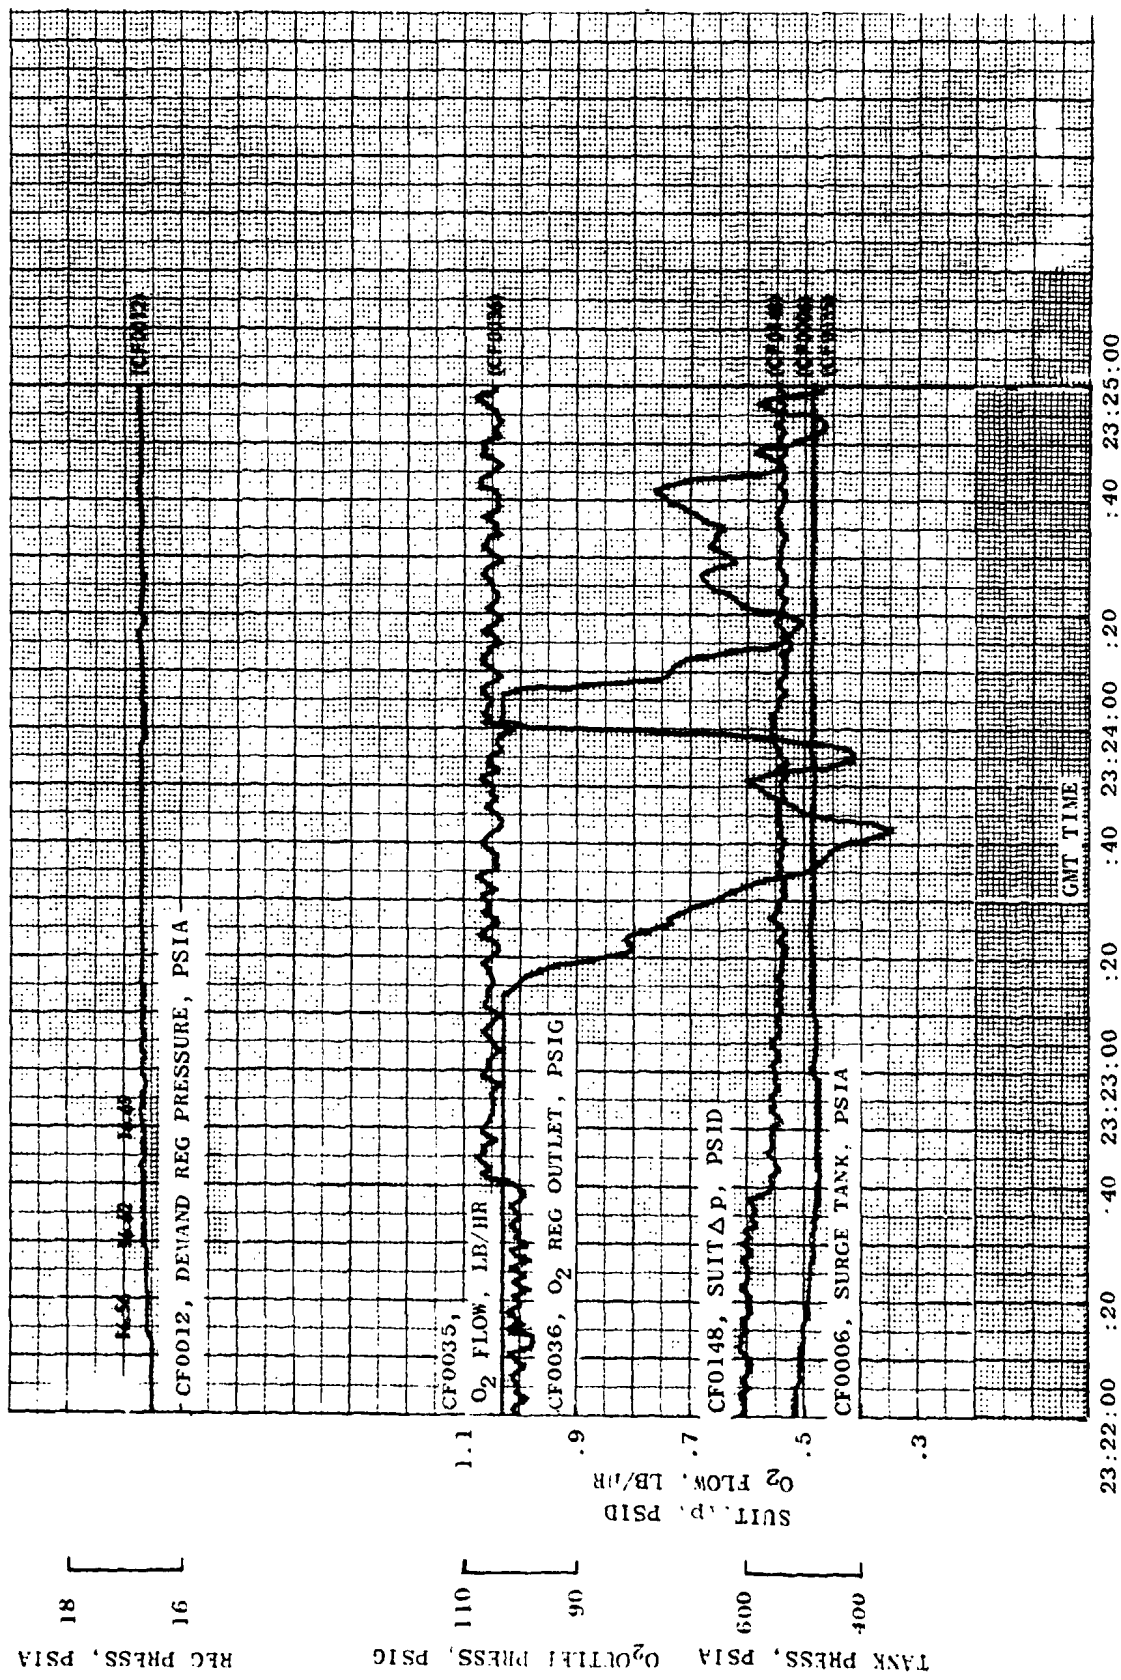
ENCLOSURE 18-12

(3) Open Helmet Visor - Enclosure 18-12 shows that with an open helmet visor (23:19:13 GMT), Surge Tank Pressure responds within about 5 seconds. For this condition the surge tank pressure decayed from 739 to 480.6 psig (see Enclosure 13-13 which shows the history of surge tank pressure for the entire test). During the last high-O<sub>2</sub> flow condition the surge tank does not start decreasing for 12 seconds.

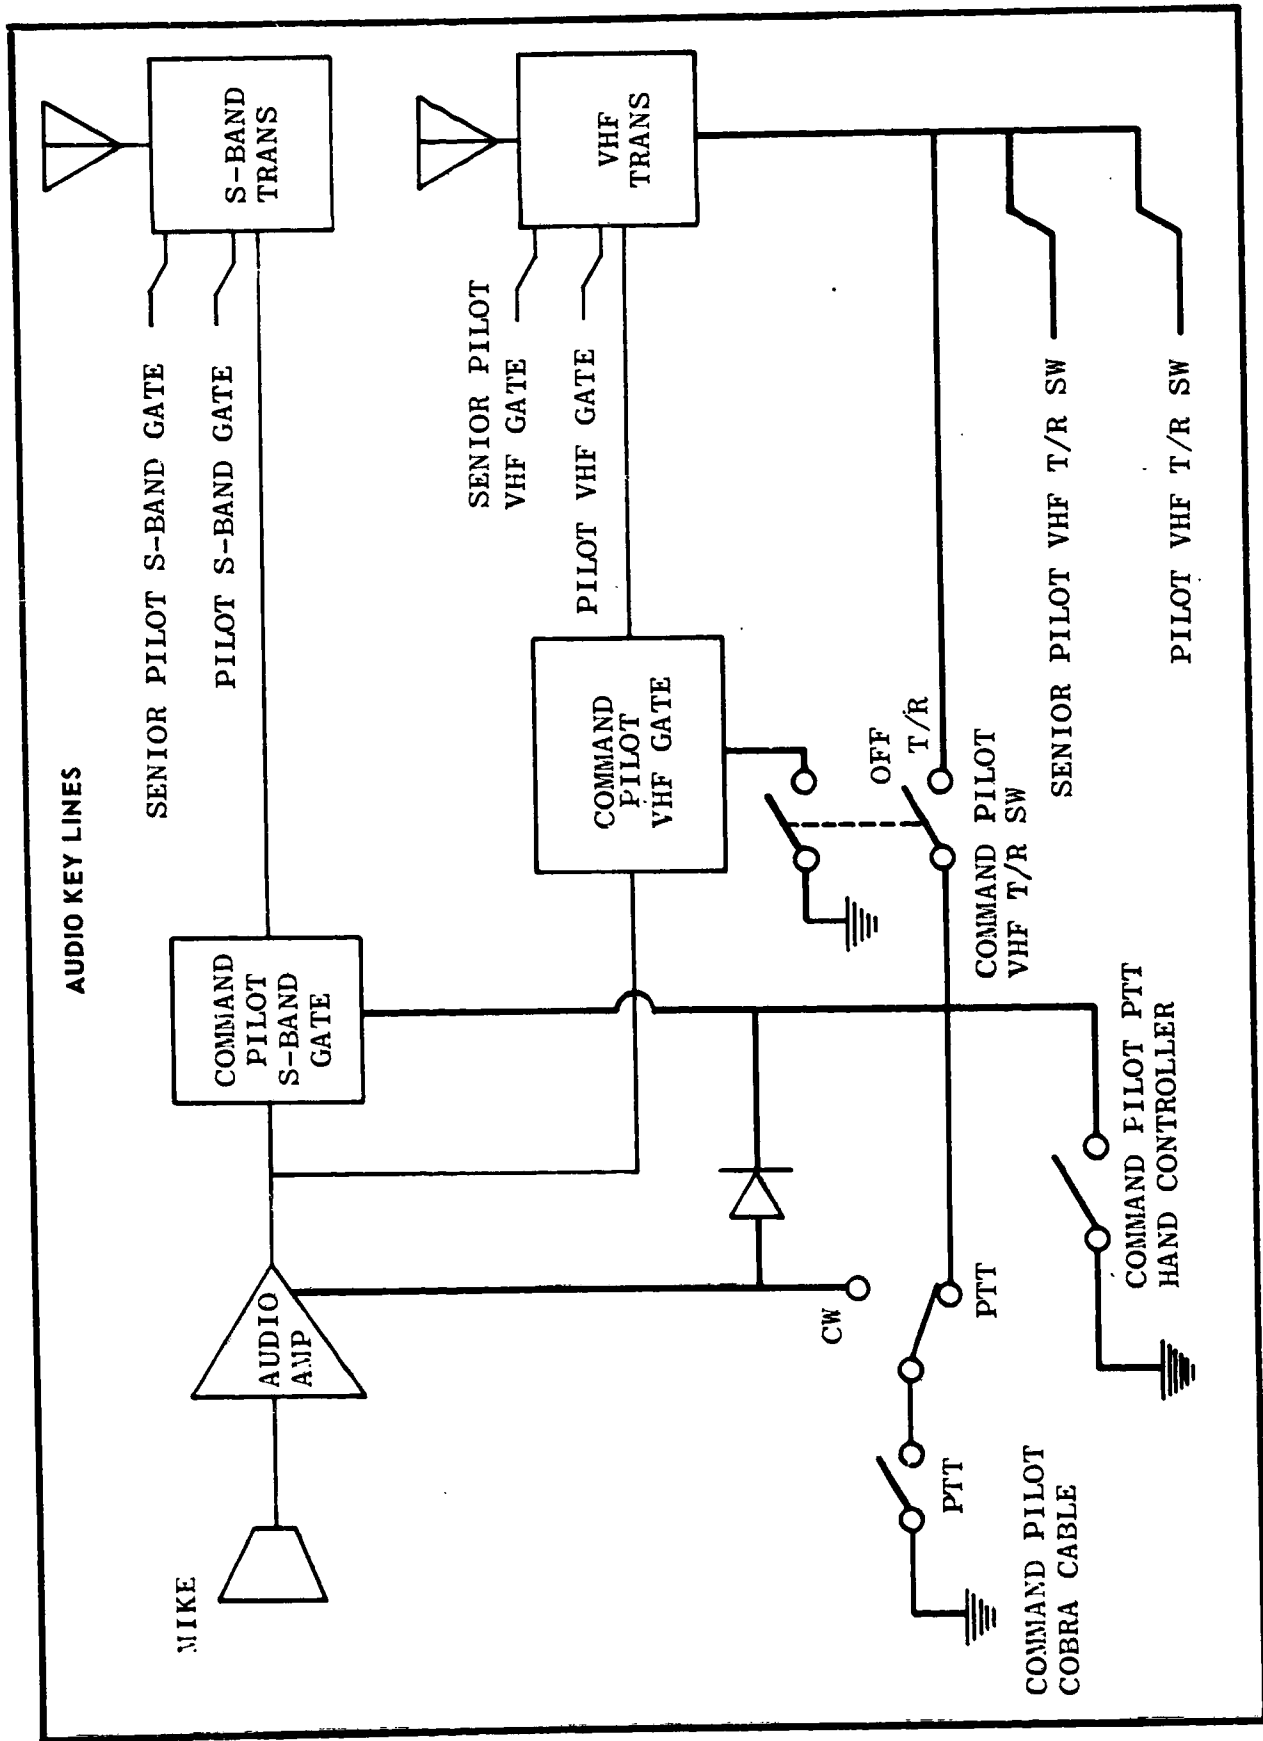
ENCLOSURE 18-24

The live microphone connotation means that the microphone amplifier in the audio center has received a ground, allowing 28 volts DC to energize the amplifier electronics, and the diode gates in the audio center on the S-band audio output have been grounded, allowing audio signals to modulate the S-band transmitter. These two conditions are normally effected by a crewman pressing his Push-to-Talk (PTT) button on the cobra cable, or in the Command Pilot's case, by pressing his translation controller PTT or his cobra cable PTT button. The PTT button, in addition to the above function, provides a ground for the VHF/AM Transmitter keying relay through the audio control panel VHF/AM T/R select switch. These VHF/AM T/R switches are connected together for all three astronaut positions which would cause a ground to be transferred among all positions in VHF/AM T/R mode. See Enclosure 18-24 for logic detail.

An analysis of this problem has isolated the cause to the PTT or keying line that runs between the cobra cable, translation controller, Command Pilot audio control panel, and the audio center (circuitry shown in Enclosure 18-24). The following has been determined:

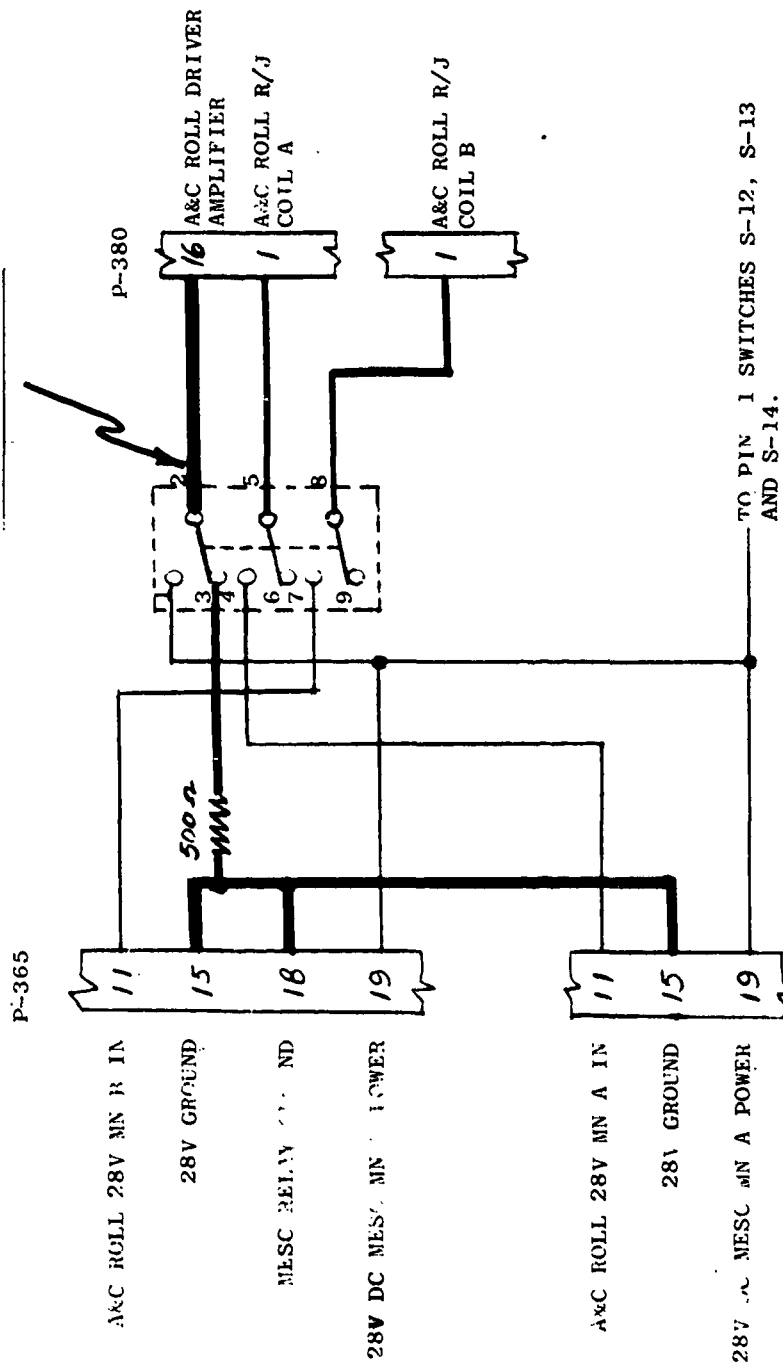
Enclosure 18-41: Main Display Console Panel Number 6 Switch S-11 Wiring

DAMAGED INSULATION
