STATUS OF INVESTIGATION ITEMS

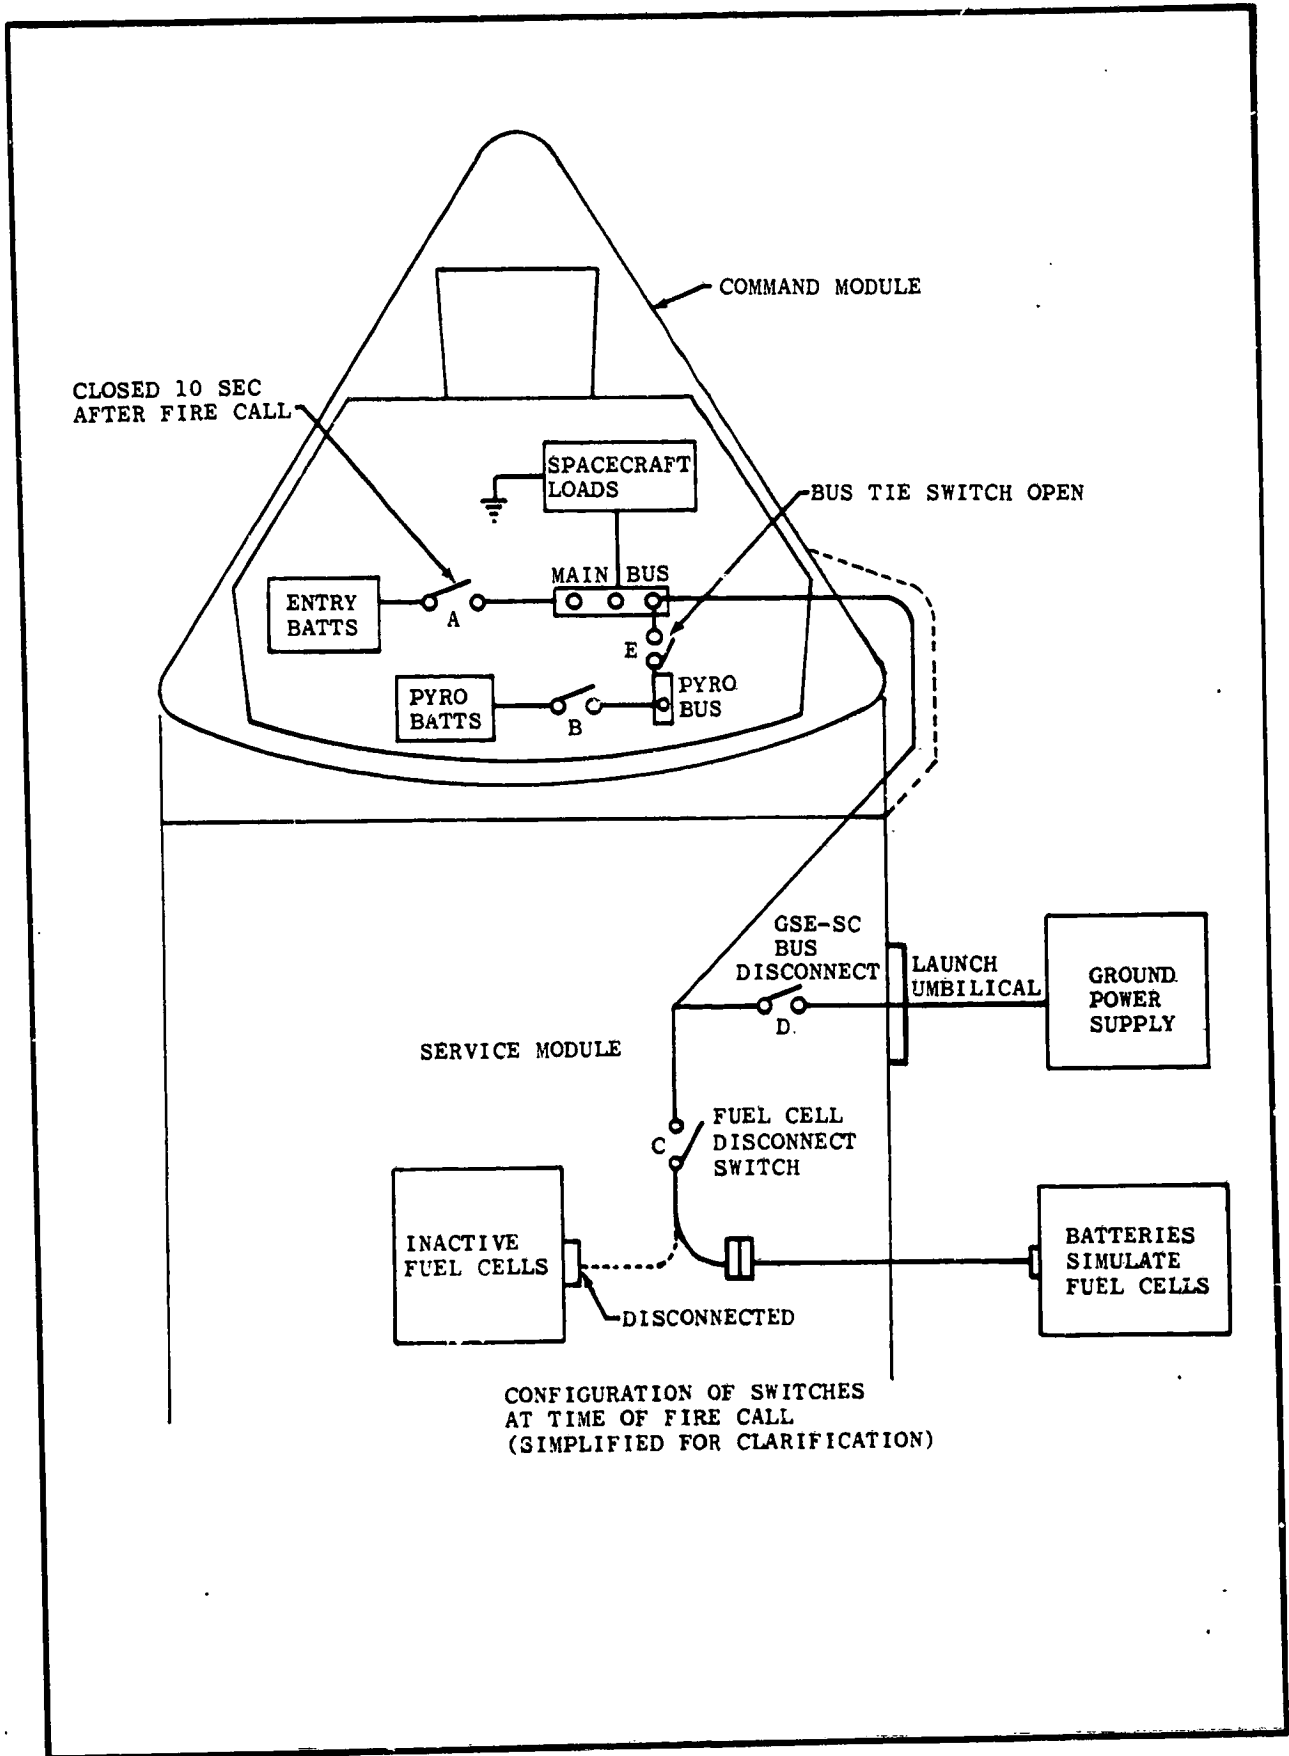
ENCLOSURE 18-54A

Open throughout the test. This switch would only be closed in the event of a pyro battery loss. Post inspection verified the switch to be in the open position.
