FULL SCALE ROOM BURN PATTERN STUDY

NIJ Report 601-97

Anthony D. Putorti, Jr.
Fire Safety Engineering Division
Building and Fire Research Laboratory
National Institute of Standards and Technology
Gaithersburg, MD 20899-0001

December 1997

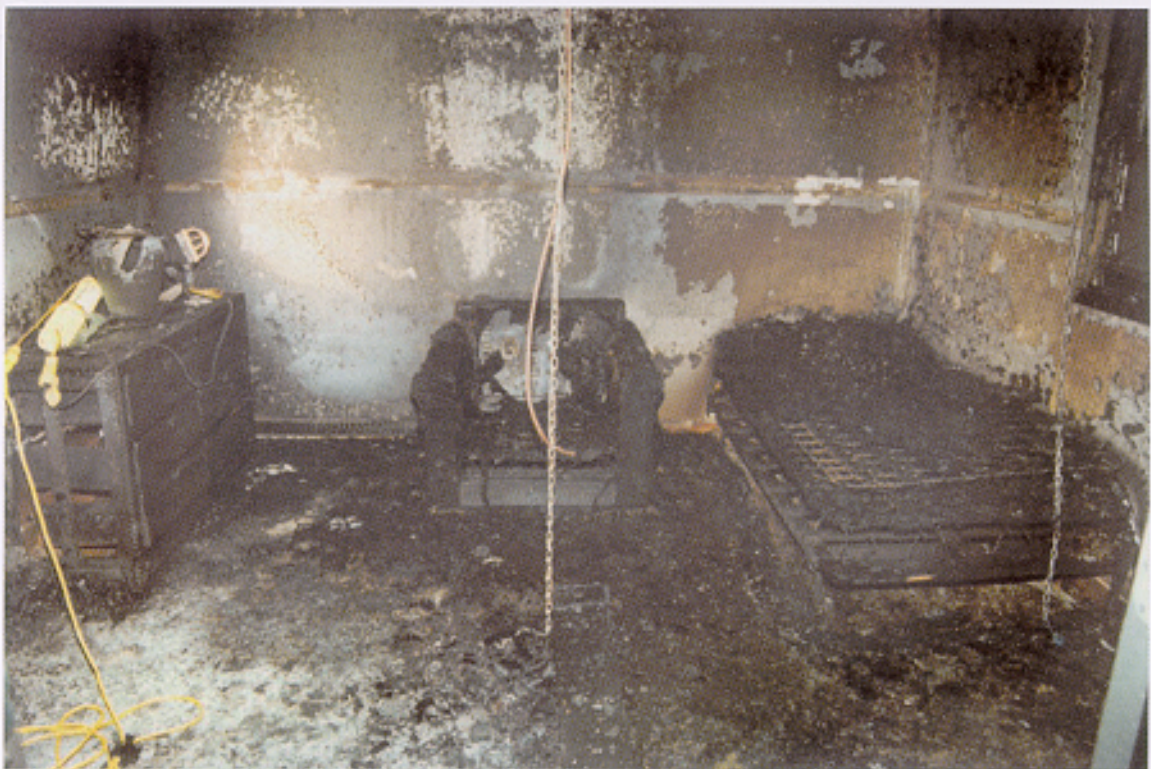
In both of the chair ignition fires, the chair was located against one of the walls. The areas around the chairs are shown in Figures 29 and 30, which correspond to experiments 1 and 2 respectively. These photographs were taken from the doorways of the rooms. In Figure 29, the wall directly above the chair is burned white, along with areas to either side of the chair. While the picture quality is poor, Figure 30, in contrast, shows less white area directly above the chair, with the white areas to the left of the chair at a significantly higher elevation than that shown in Figure 29. Also notice the height of the charring on the wood molding of the door to the room in Figure 30. Recall that the thermocouple array suggested that the neutral plane in the doorway was located between 0.6 m and 0.9 m during the post- flashover stage of the fire in experiment 2. The white area to the left of the chair in experiment 2 is further illustrated in Figure 31.

FIGURE 29. *Photograph of the chair as viewed through doorway. Experiment 1.*

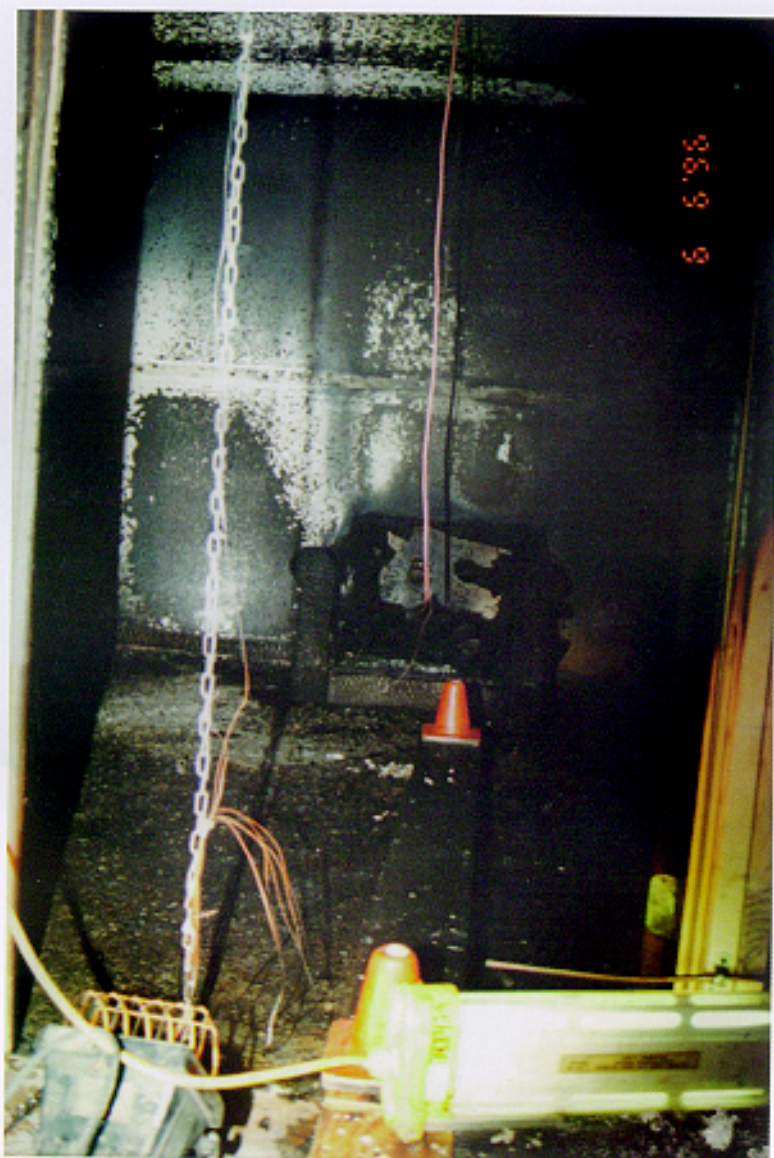
FIGURE 30. *Photograph of the chair as viewed through the doorway, Experiment 2.*

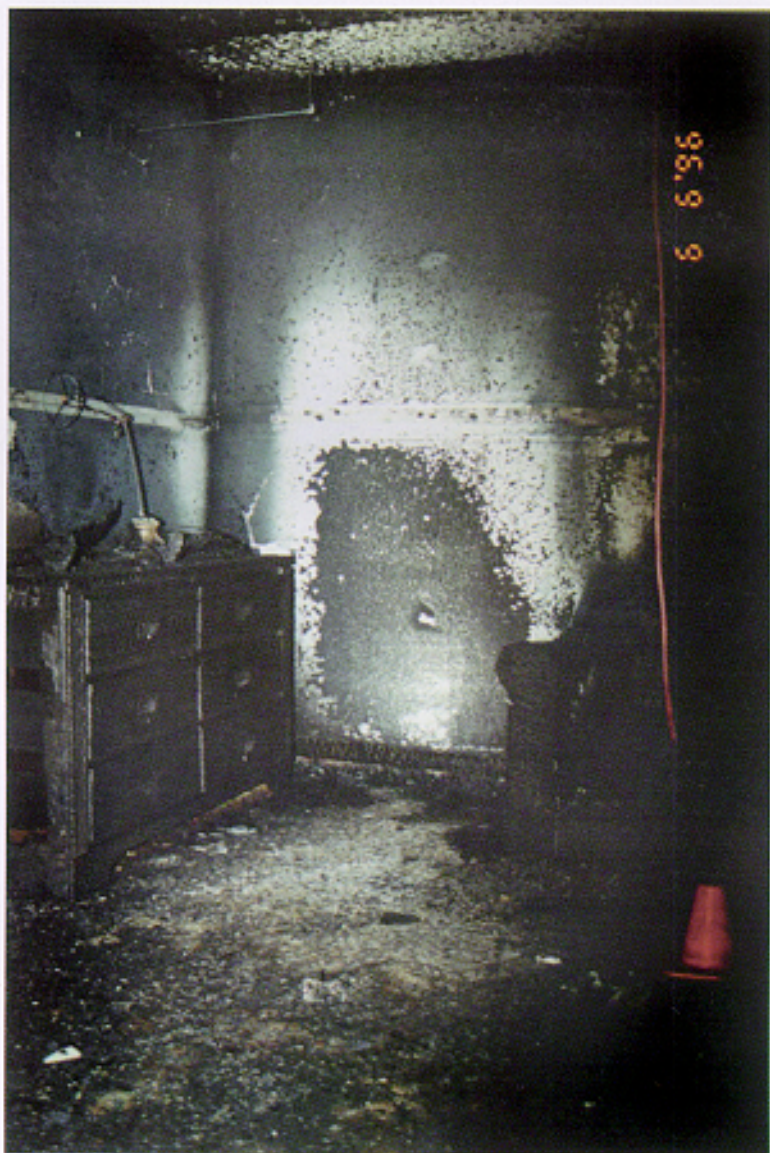
FIGURE 31. *Photograph of the clean burn on the wall between the chair and the dresser. Experiment 2.*

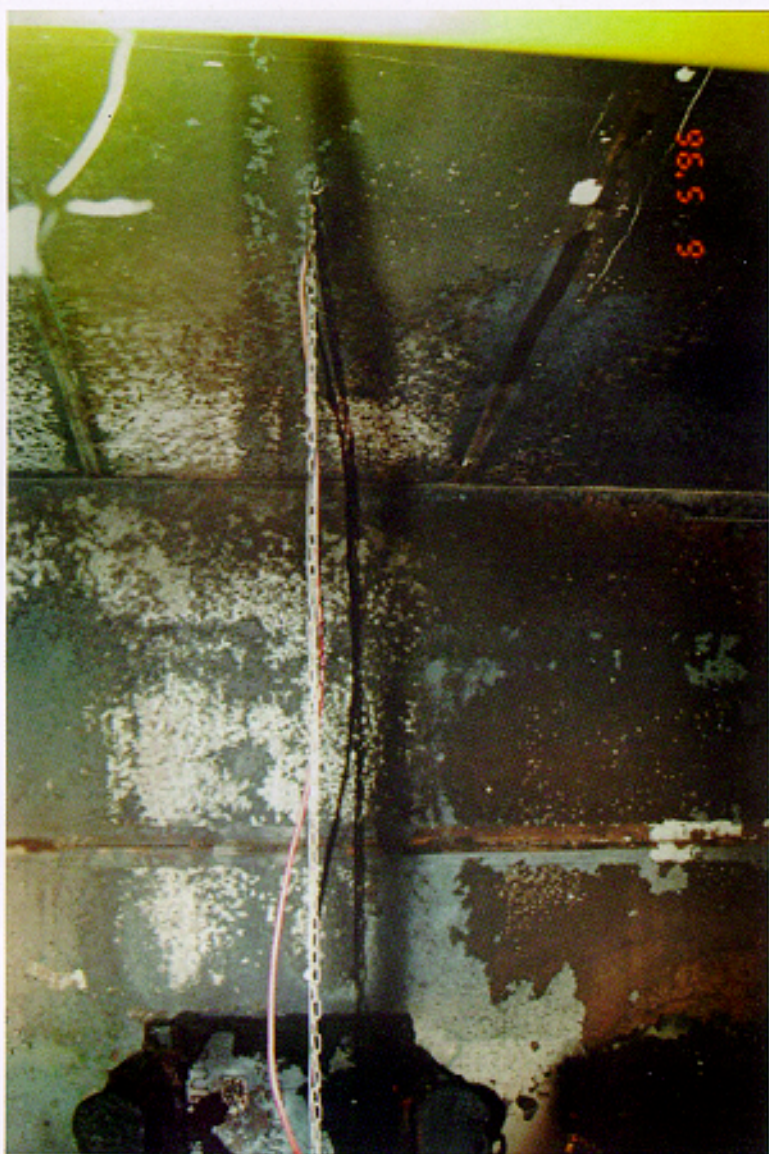
FIGURE 32. *Photograph of the ceiling and wall above the chair. Experiment 1.*

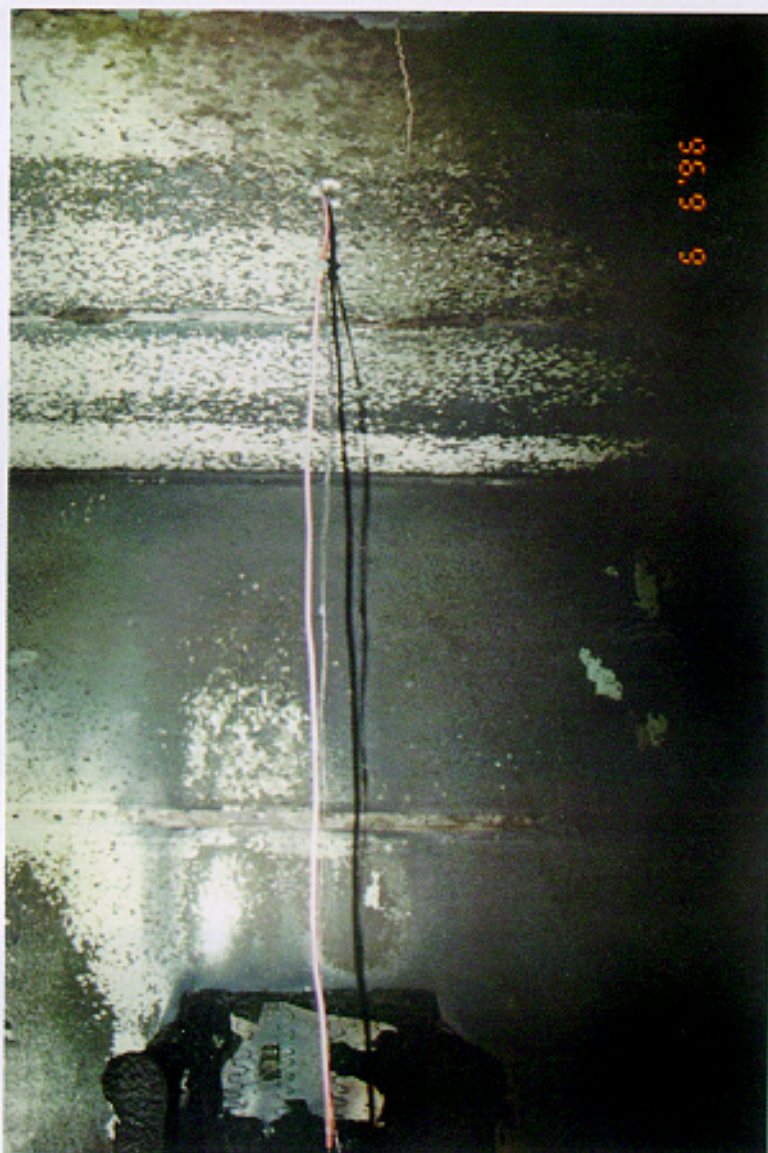
FIGURE 33. *Photograph of the ceiling and wall above the chair, Experiment 2.*

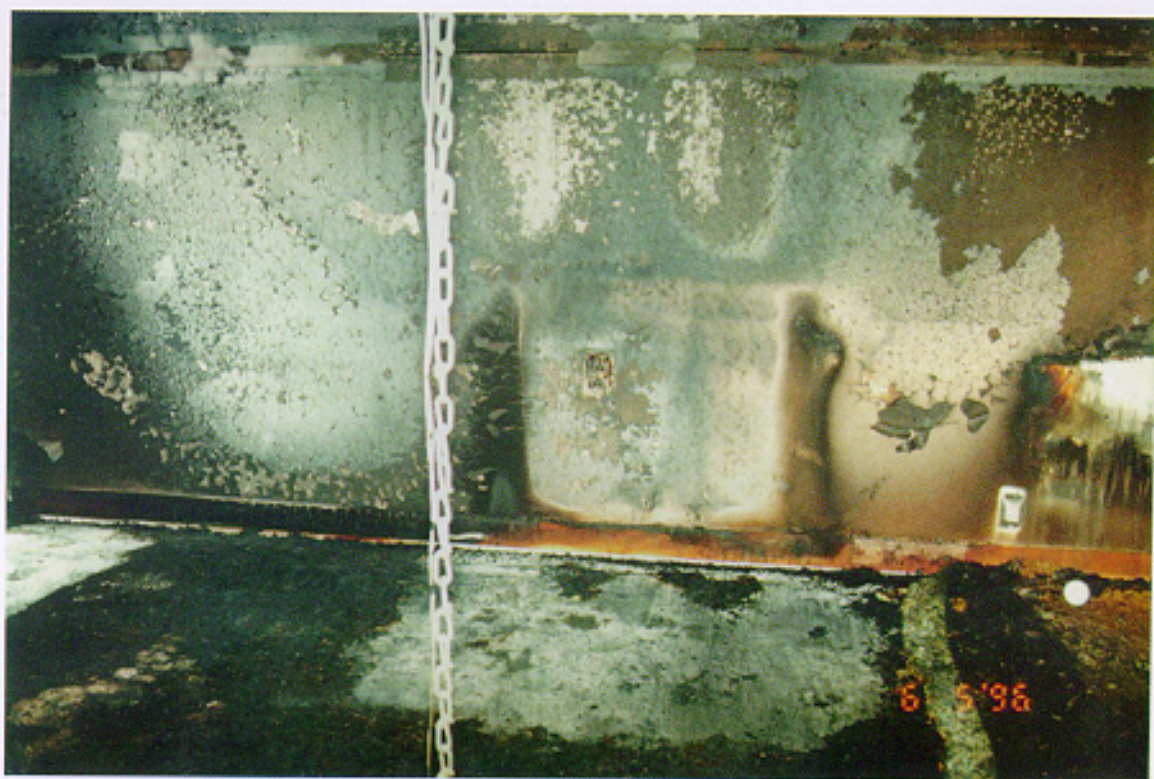
FIGURE 34. *Photograph of the wall behind the chair with furnishings removed. Experiment 1.*

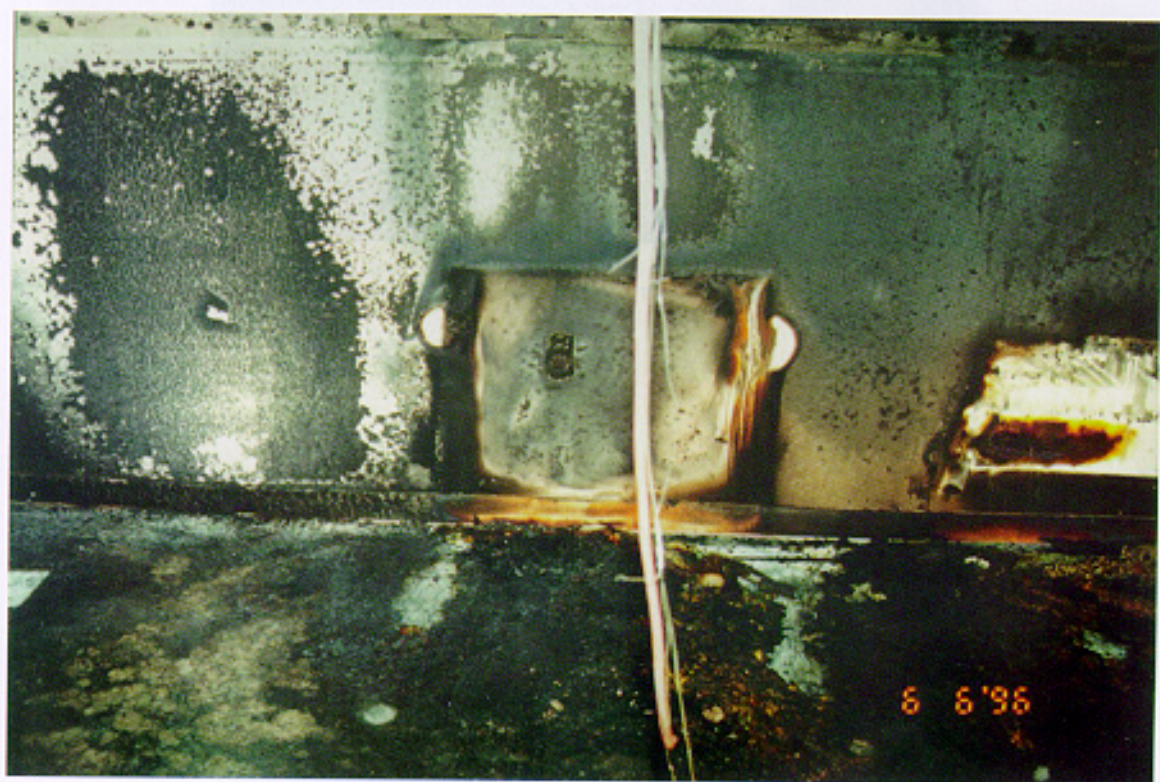
FIGURE 35. *Photograph of the wall behind the chair with furnishings removed. Experiment 2.*

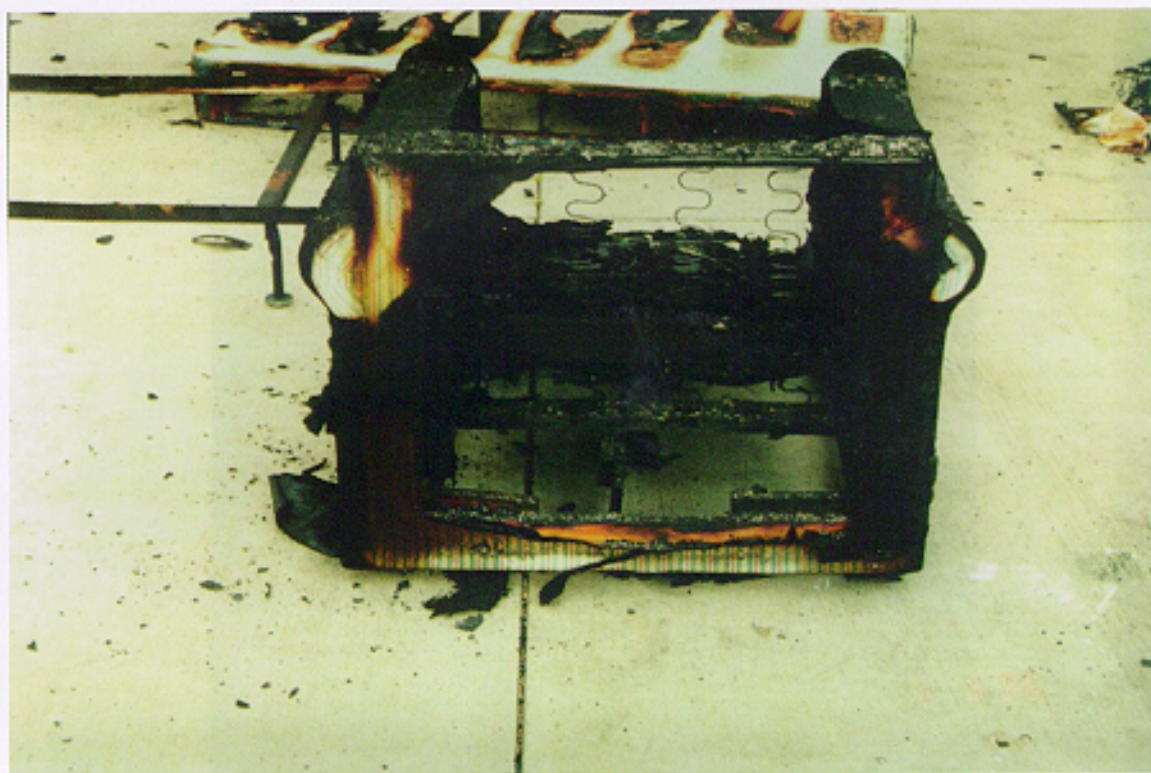
FIGURE 36. *Photograph of the rear surface of the chair, located against the wall. Experiment 2.*

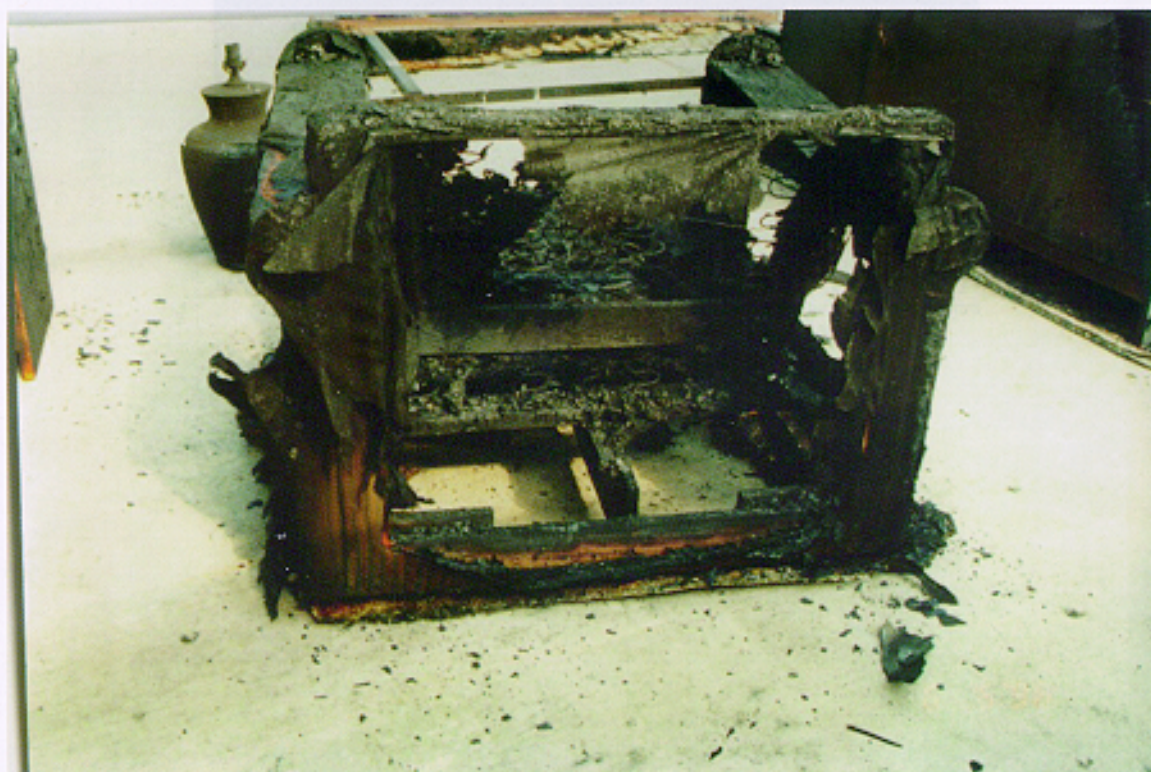
FIGURE 37. *Photograph of the rear surface of the chair, located against the wall. Experiment 1.*

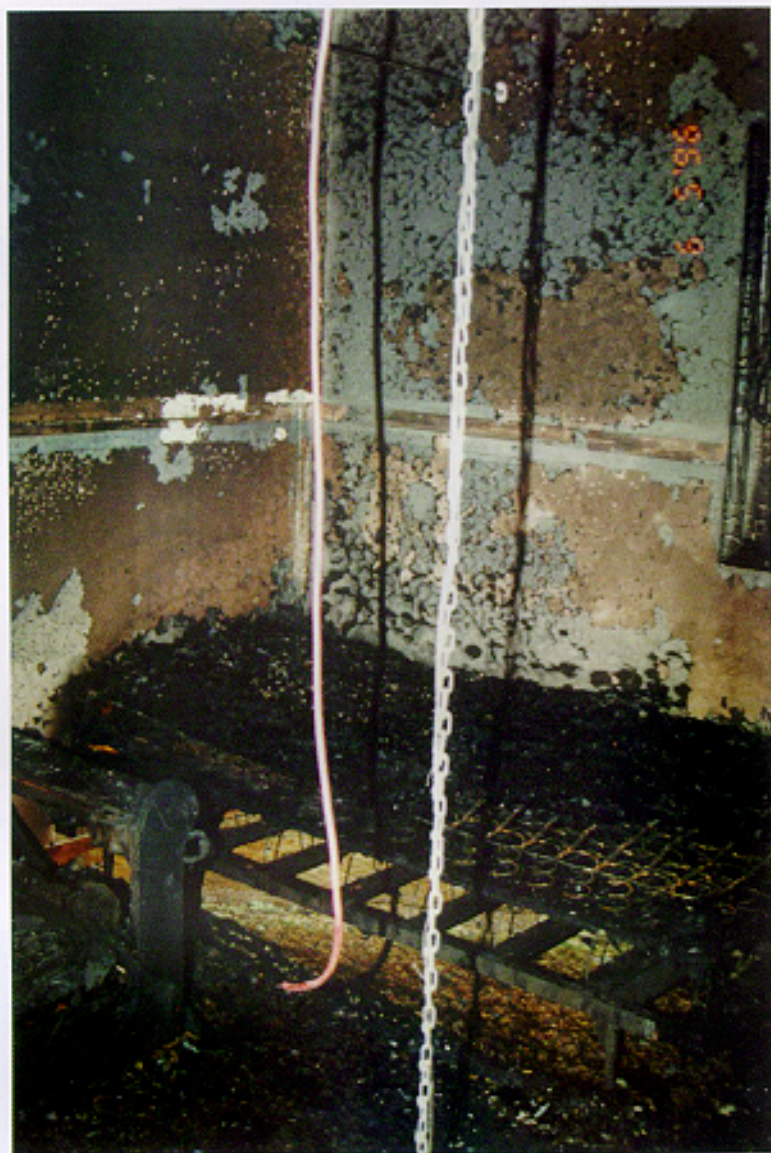
The aforementioned figures also illustrate the condition of the bed mattresses after the experiment. The springs from the mattress in experiment 1 have retained most of their original shape, while the springs in experiment 2 have relaxed and lost their shape. In both cases, the combustible portions of the mattresses were almost completely consumed. Recall that both experiments were of similar duration, burned in the post-flashover stage for the same period of time, and both mattresses were subjected to similar loads (their own weight). The thermocouple arrays in experiment 2, however, sustained higher temperatures than experiment 1, and the fire was possibly better ventilated, suggesting that higher temperatures within the room and/or greater radiative heat transfer from the hot gases in the room contributed to the relaxation of the mattress springs. This conclusion assumes, of course, that the properties of the steel in the mattresses, which were of the same model, were identical.

FIGURE 38. *Photograph of the condition of the bed and the protected floor area below. Experiment 1.*

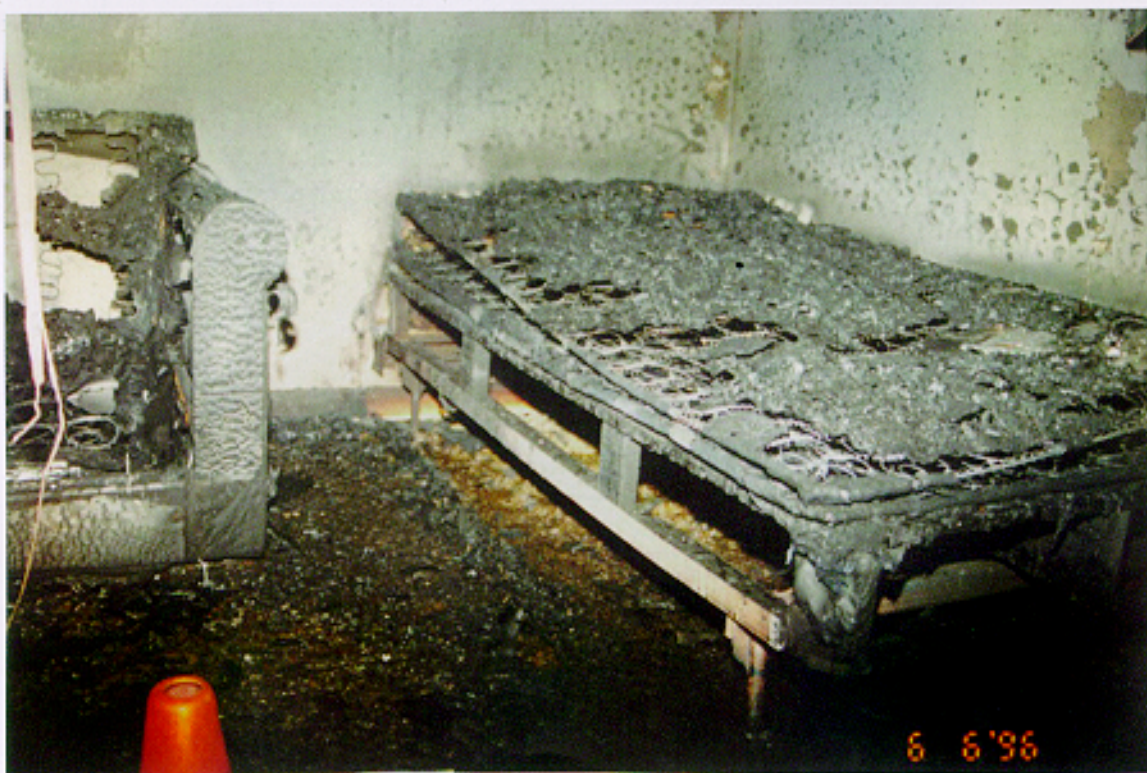
FIGURE 39. *Photograph of the condition of the bed and the protected floor area below. Experiment 2.*

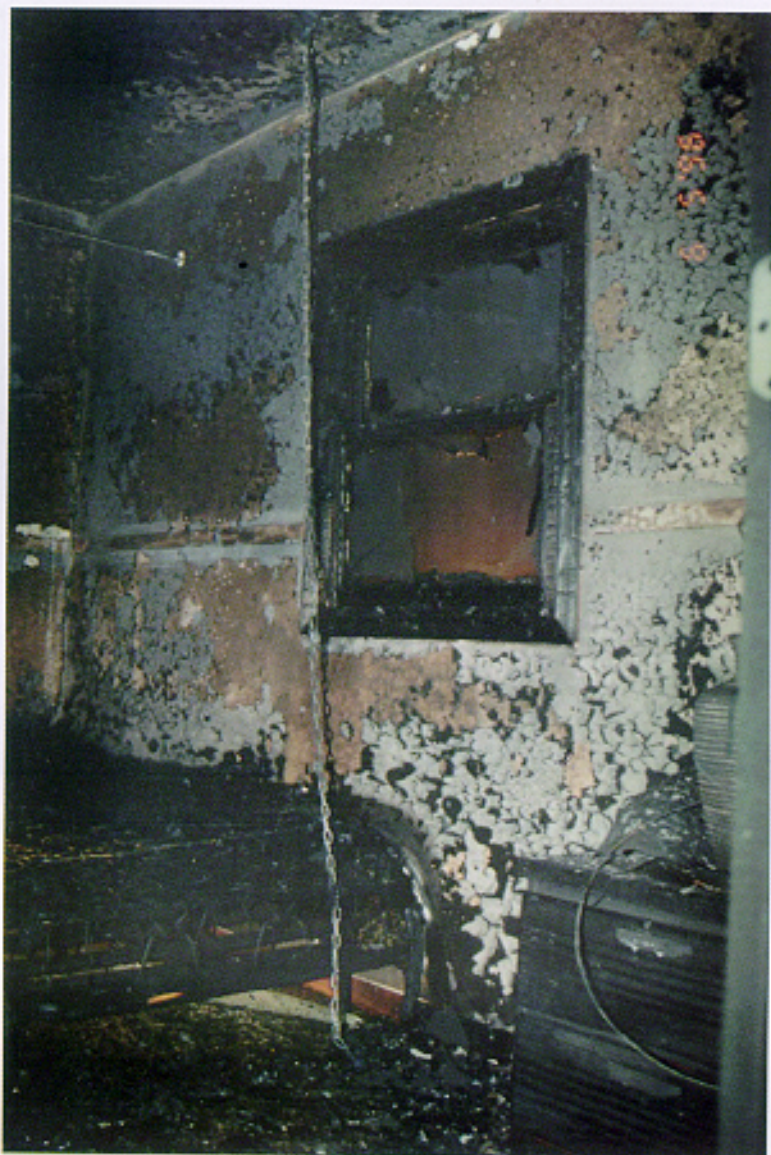
The window of the room in experiment 1 is shown in Figures 40 and 41. The figures illustrate that the window retained the second, outer panes of glass through the experiment. The window in experiment 2, however, as shown in Figure 42, broke out totally during the experiment, providing additional ventilation for the room during the post-flashover stage of the fire. The window conditions shown are consistent with observations made during the experiments.

FIGURE 40. *Photograph of the window and surrounding wall. Experiment 1.*

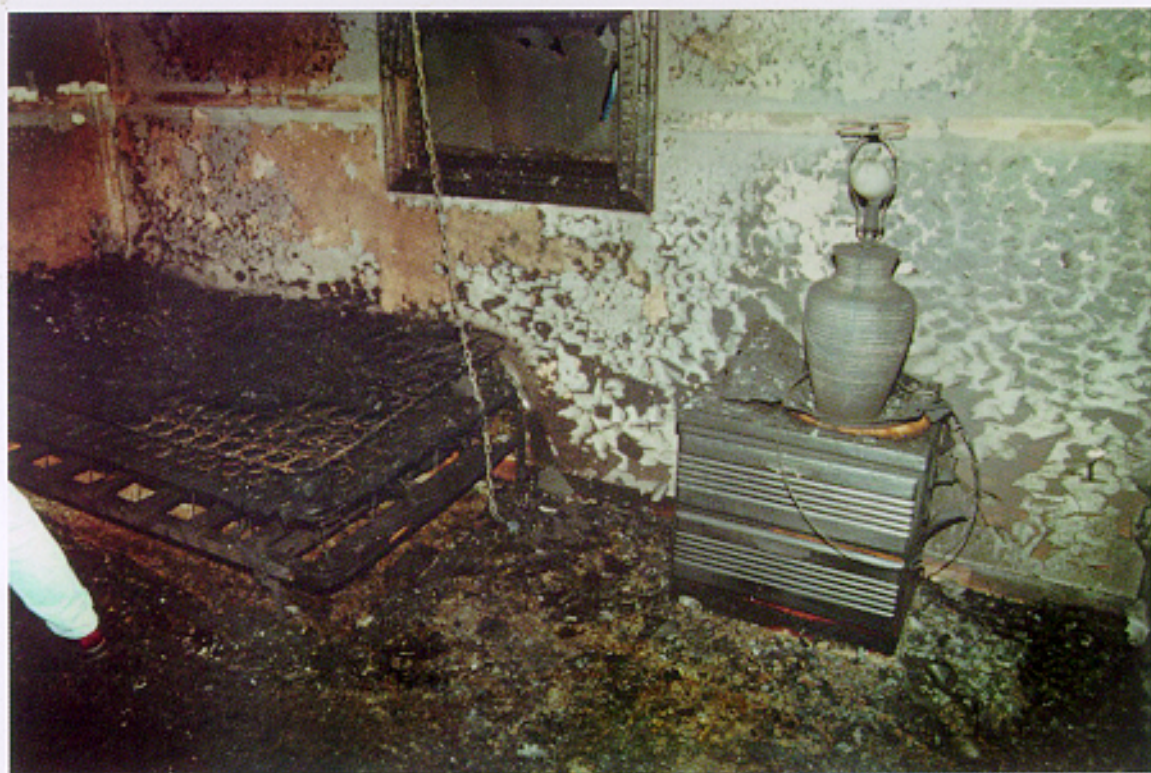
FIGURE 41. *Photograph of the window and surrounding wall. Experiment 1.*

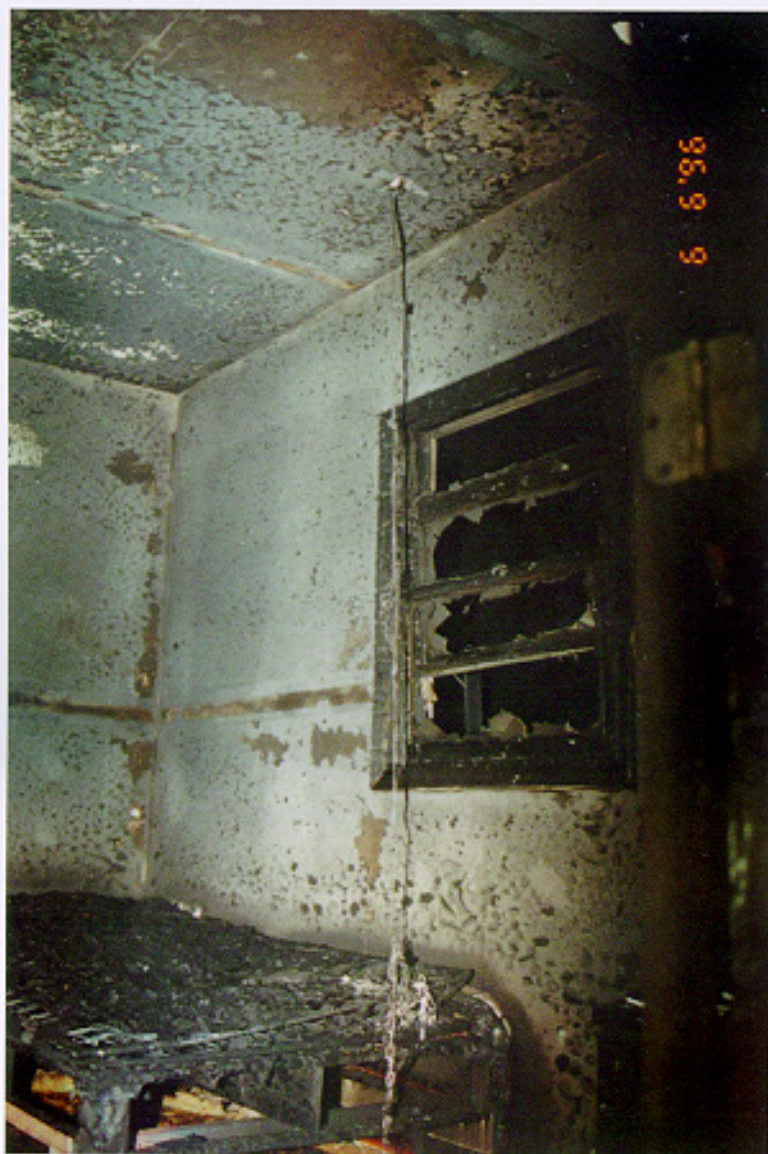
FIGURE 42. *Photograph of the window and surrounding wall. Experiment 2.*

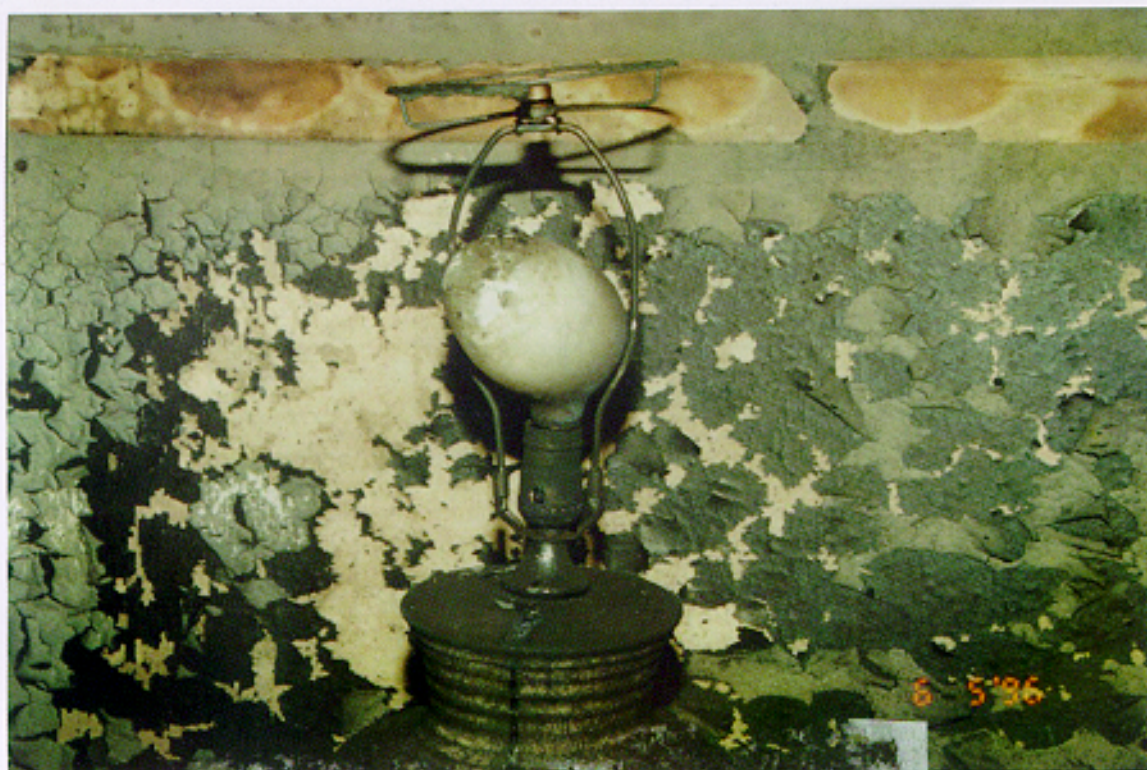
The conditions of the light bulbs in the lamps are shown in Figure 43 for experiment 1 and Figure 44 for experiment 2. The light bulb in the nightstand lamp of experiment 1 has deformed in the direction toward the upper middle of the room. The deformity in this direction suggests that radiation from the hot layer within the room affected the deformation of the bulb to a greater extent than individual fuel packages. The bulb in the nightstand lamp of experiment 2 was also deformed, but it has broken free of the bulb base, and the direction of the deformation is not clear.

FIGURE 43. *Photograph of a deformed light bulb located in the lamp on the nightstand. Experiment 1.*

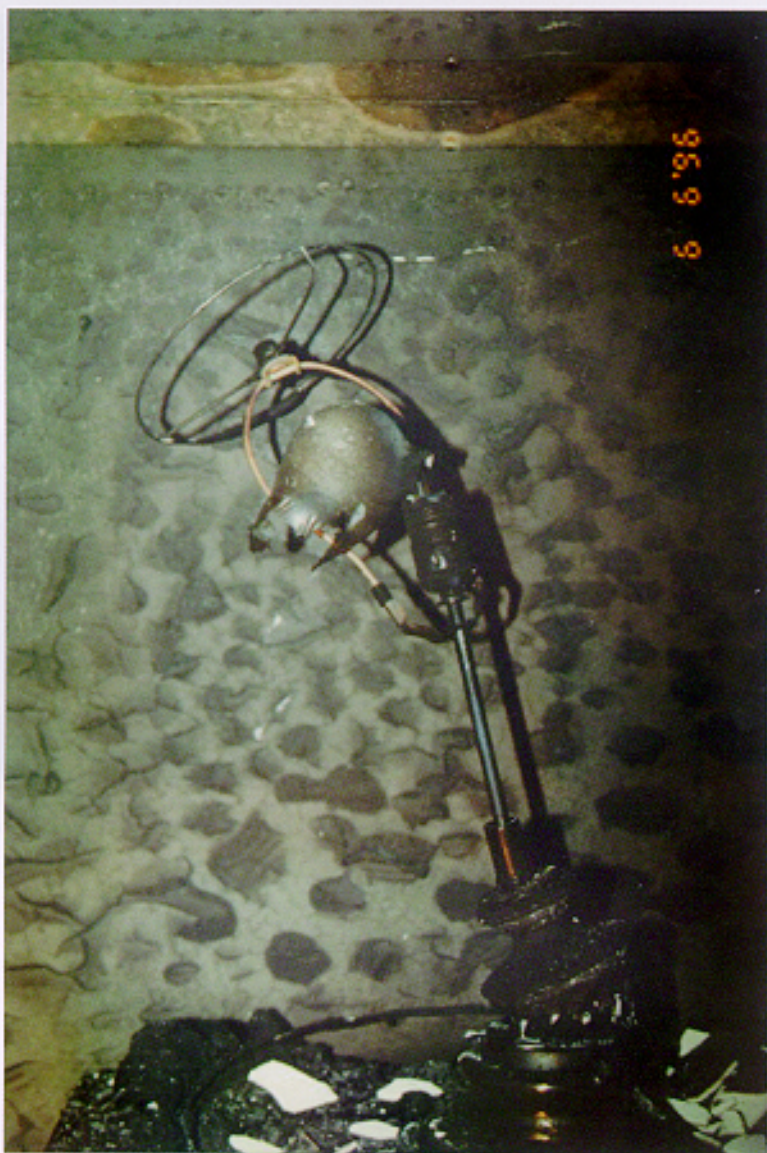
FIGURE 44. *Photograph of a deformed light bulb located in the lamp on the nightstand. Experiment 2.*

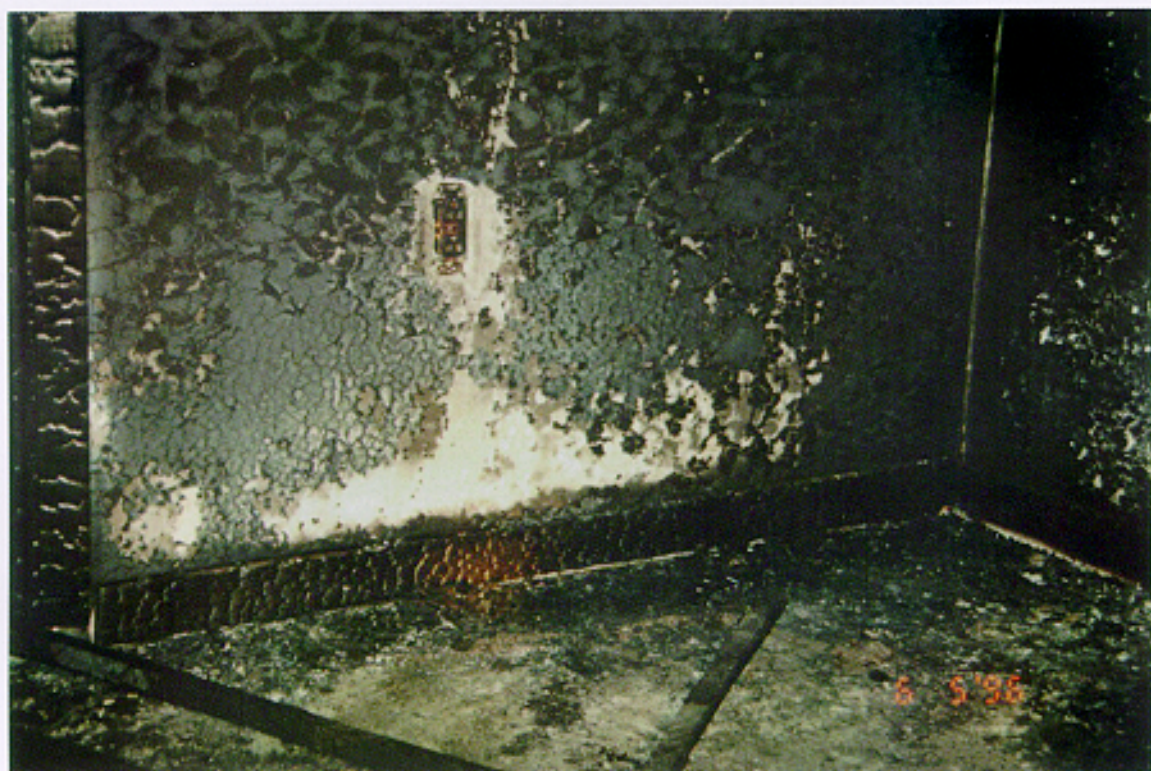
The walls to one side of the doorway in experiments 1 and 2 are shown in Figures 45 and 46. The doorway of the room can be seen in the far left side of the figures. Note that the amount of damage is greater in experiment 1, as suggested by the condition of the wallboard, the charring of the baseboard molding, the floor covering, and the electrical outlets. The remains of the wastebasket can be seen in the right side of Figure 46, near the baseboard.

FIGURE 45. *Photograph of the wall to the right of the doorway, viewed from inside the room. Experiment 1.*

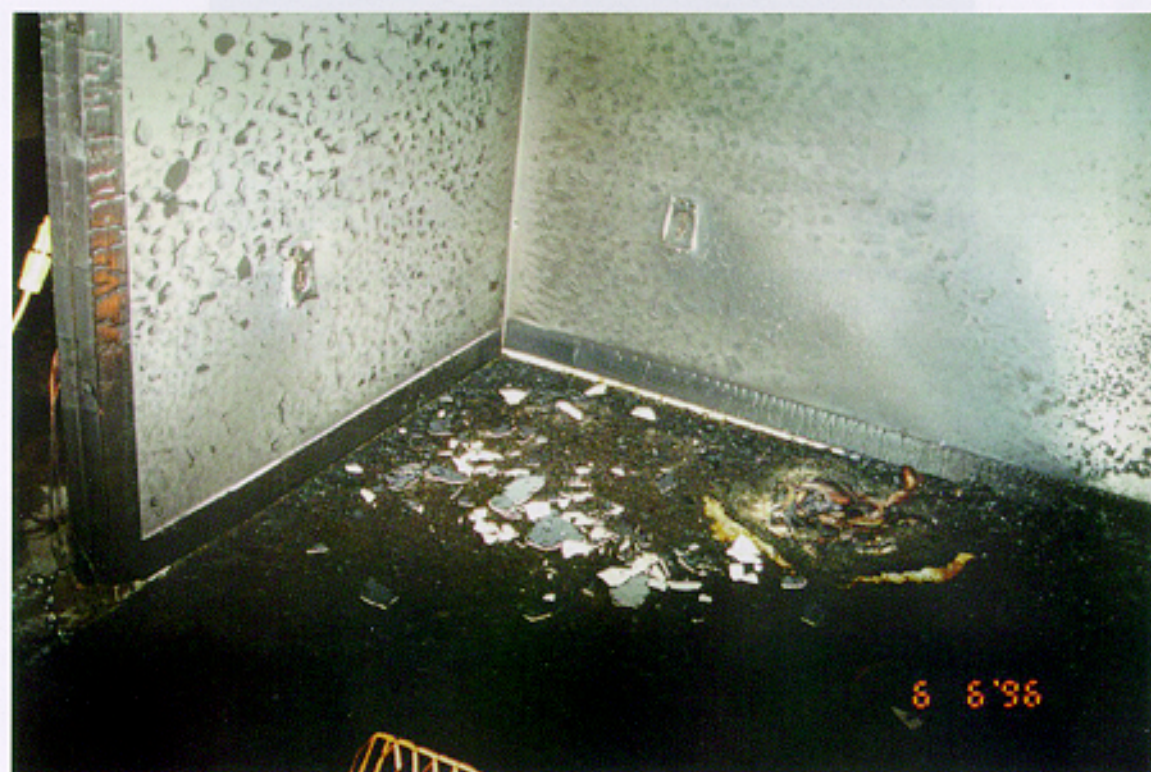
FIGURE 46. *Photograph of the wall to the right of the doorway, viewed from inside the room. Experiment 2.*

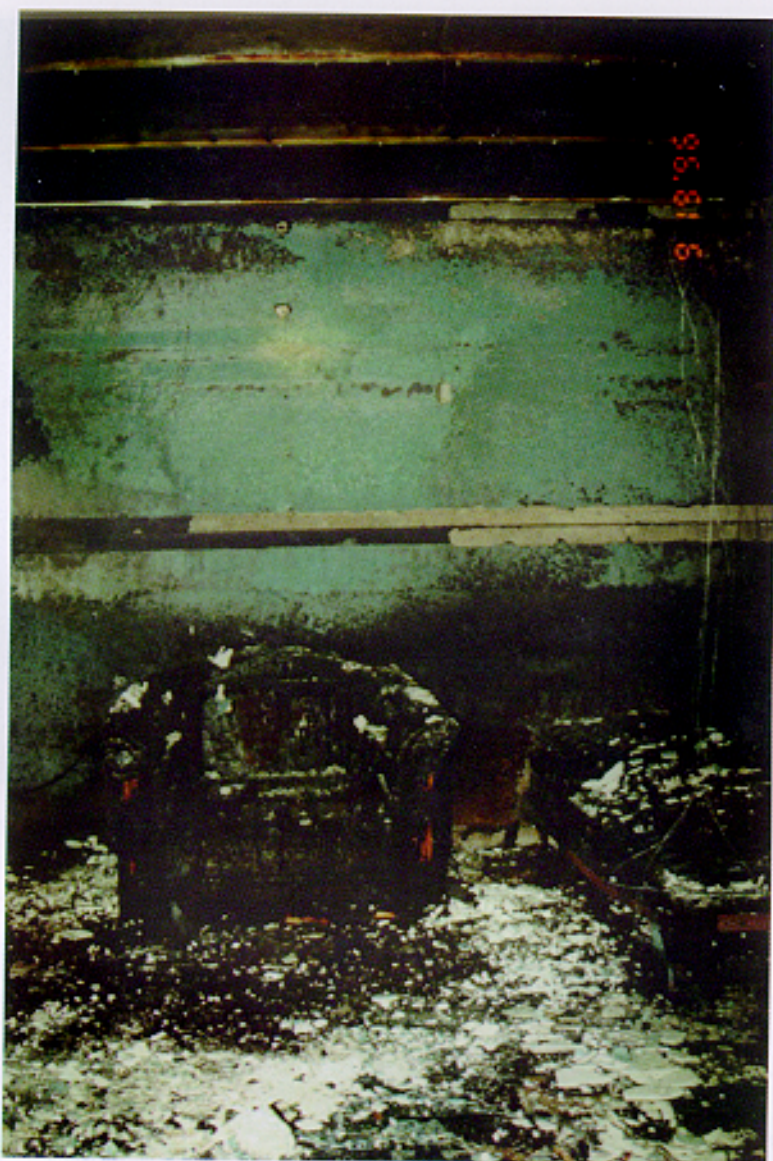
The upholstered chairs from experiments 3 and 4 are shown in Figures 47 and 48. Due to poor photo quality the conditions of the chairs cannot be closely compared. The patterns on the walls behind the chairs of the experiments are quite different. The white area ("burned clean") in Figure 47 covers much of the area of the wall above the chair. Figure 48, however, has the white area limited to a much smaller region located above the chair. Note that the ceiling in experiment 3, Figure 47, has fallen. The lack of heat damage and charring on the ceiling joists, as shown in Figure 49, suggests that the ceiling fell due to the weight of suppression water, or was knocked down during overhaul. Audio from the fire videotape confirms the falling of the ceiling and provides the time of the event.

FIGURE 47. *Photograph of the ceiling and wall above the chair as viewed through the doorway. Experiment 3.*

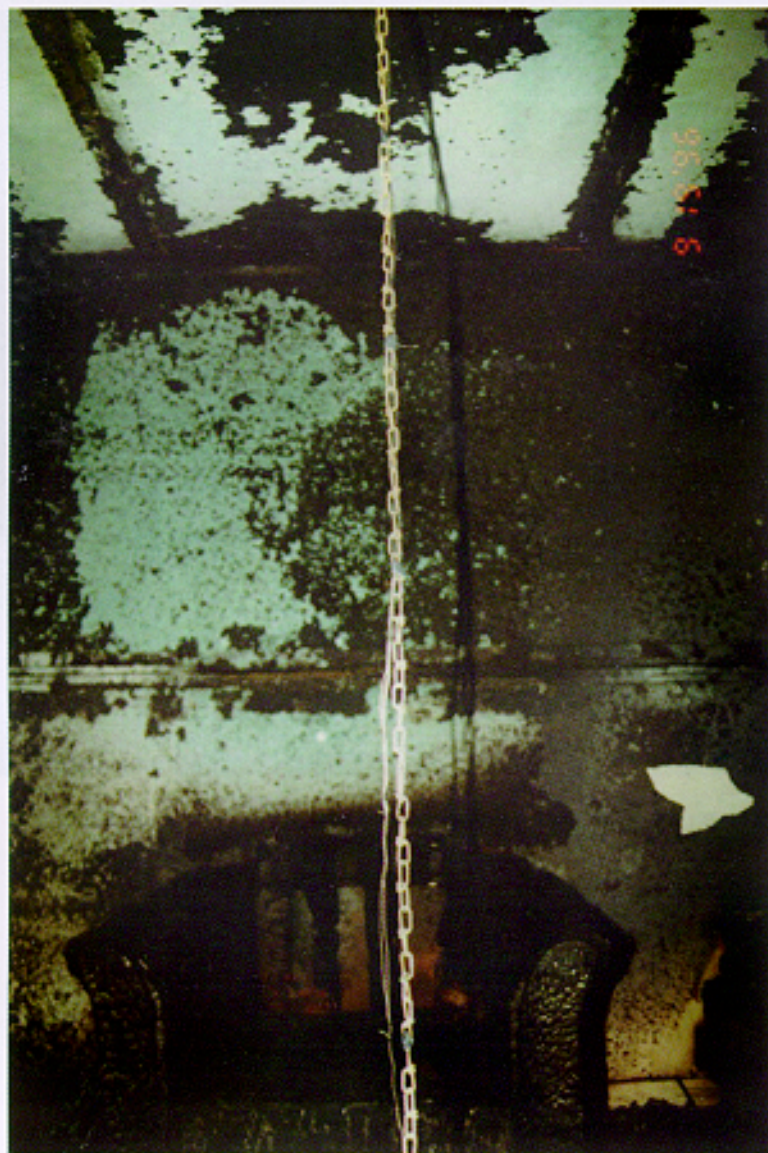
FIGURE 48. *Photograph of the ceiling and wall above the chair as viewed through the doorway. Experiment 4.*

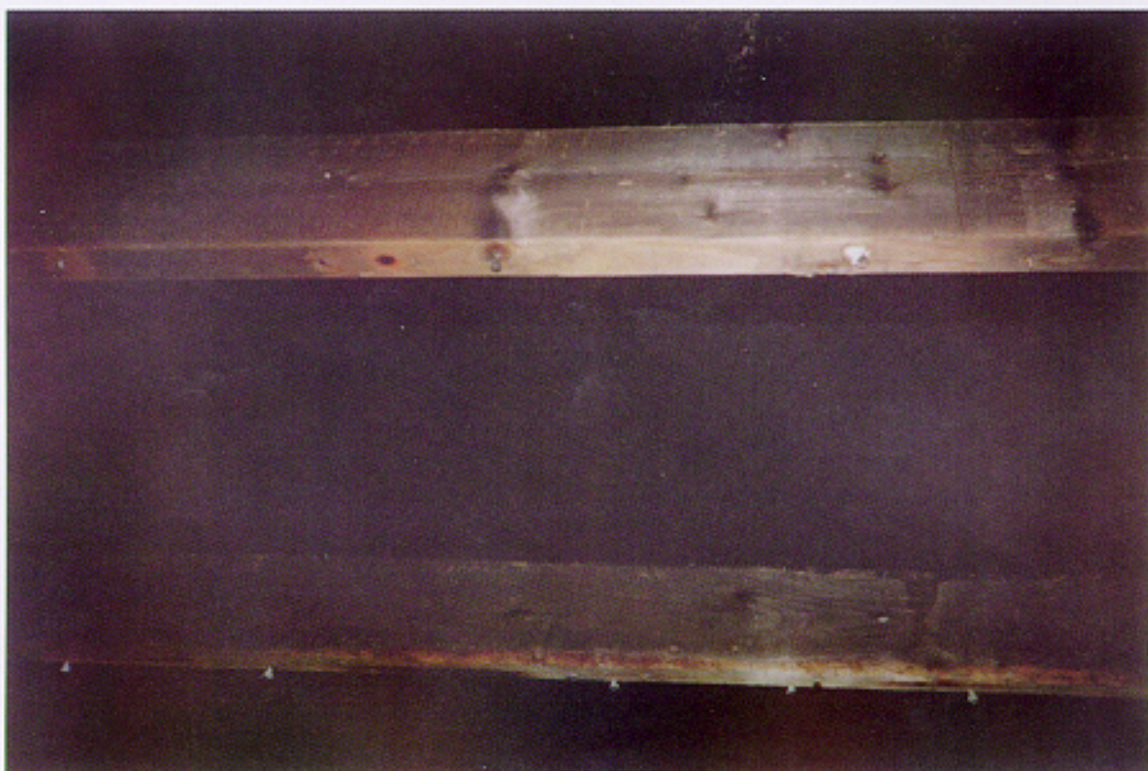
FIGURE 49. *Photograph of the ceiling joists after extinguishment. Experiment 3.*

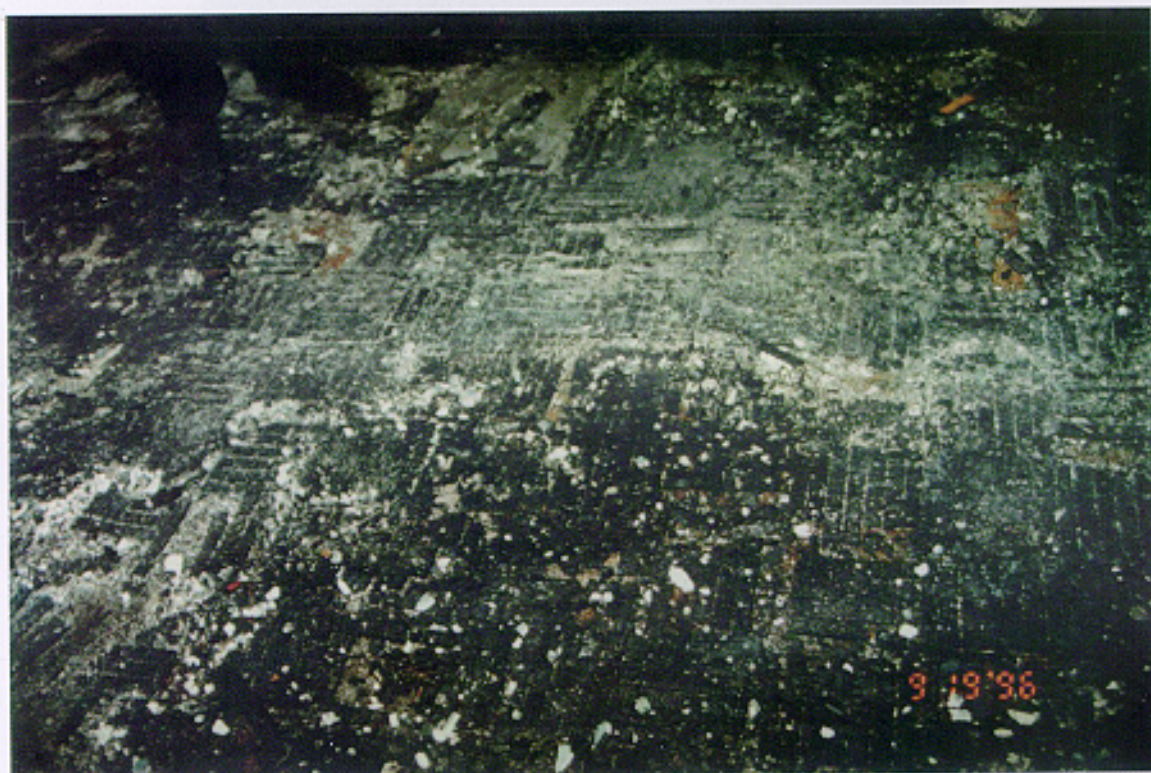
The condition of the flooring material is illustrated in Figures 50 and 51. The charring of the flooring materials was more severe toward the center of the room in both experiments. While the liquid accelerant was poured in the center of the rooms, the area that was actually covered by the accelerant is not known. In addition, the area of the floor near the center of the room would be expected to receive the most damage due to the radiative heat transfer view factor between the room floor and the layer of hot gases within the room, regardless of the presence of an accelerant. In order to compare to the areas of heaviest damage, the location of the accelerant after pouring should be compared to the damage patterns. In future experiments, the location of the accelerant after the pour should be monitored, perhaps with additional surface thermocouples or with infrared imaging, to facilitate the damage comparisons. The data available from these experiments are not complete enough to be able to draw conclusions as to the effect of the flammable liquid pour on the severity of the burn patterns on the floor.

FIGURE 50. *Photograph of the floor. Experiment 3.*

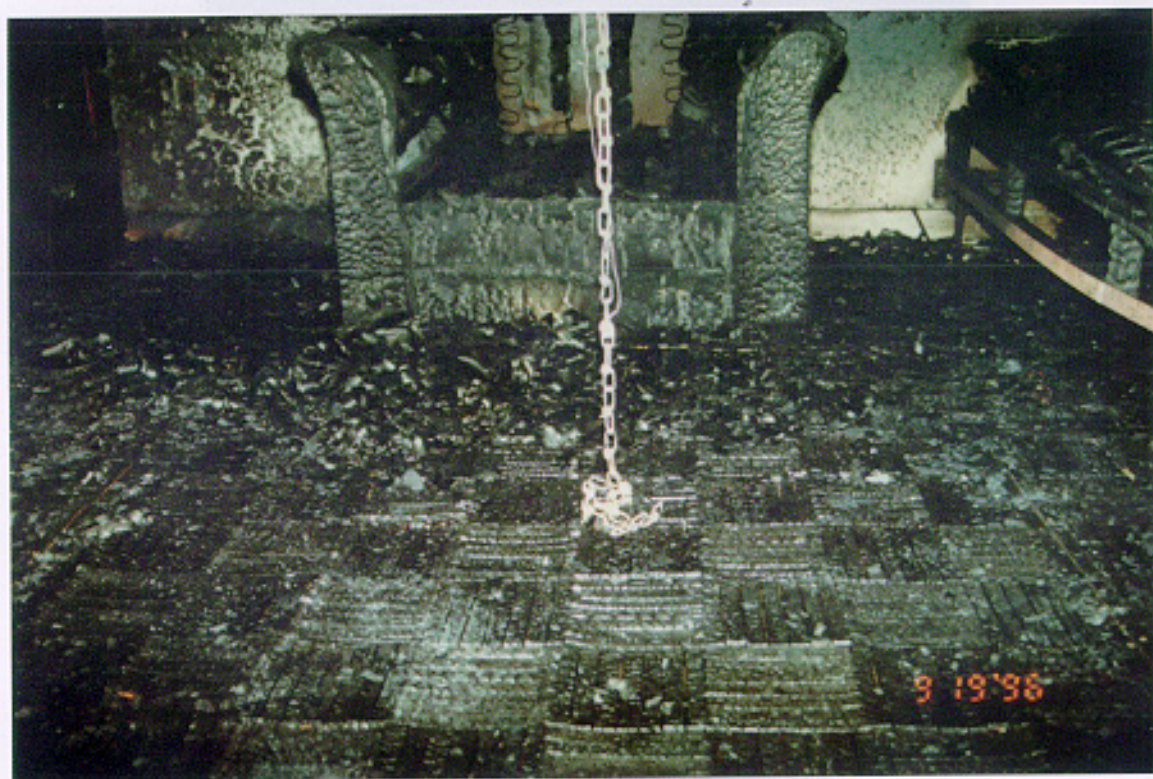
FIGURE 51. *Photograph of the floor. Experiment 4.*
