FULL SCALE ROOM BURN PATTERN STUDY

NIJ Report 601-97

Anthony D. Putorti, Jr.
Fire Safety Engineering Division
Building and Fire Research Laboratory
National Institute of Standards and Technology
Gaithersburg, MD 20899-0001

December 1997

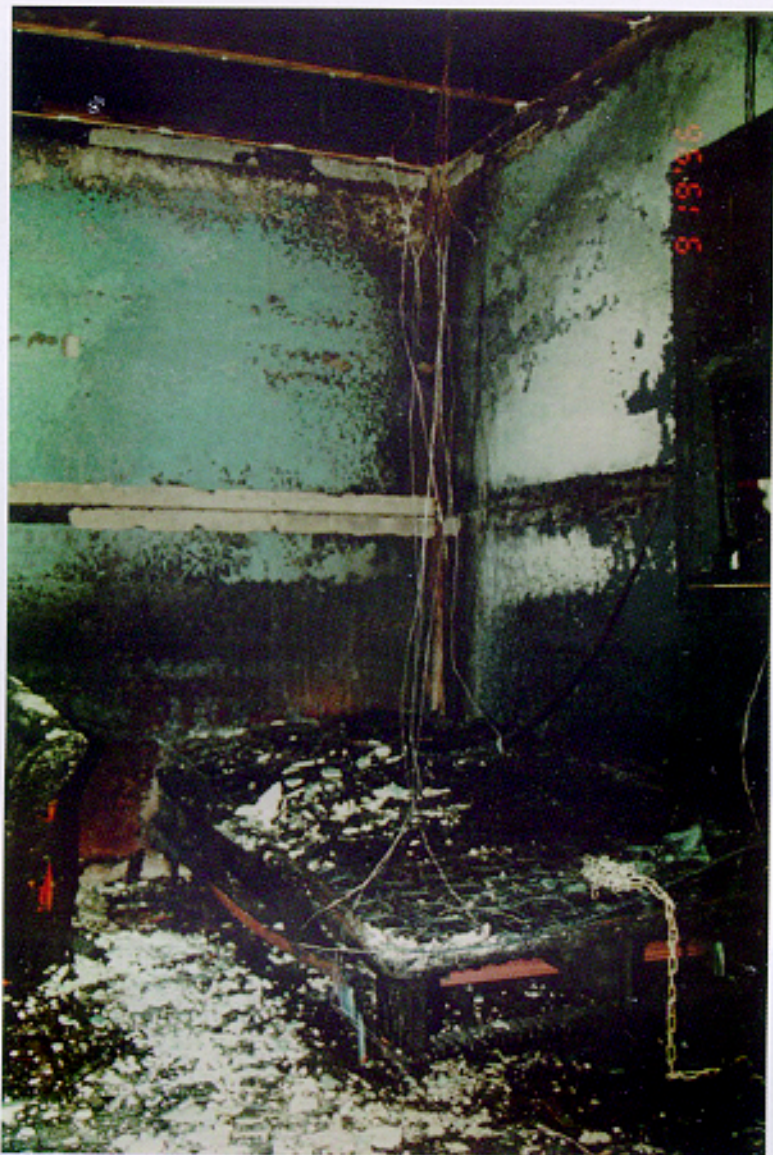
The bed mattresses from the experiments are shown in Figures 52 and 53. As discussed in the previous section, the condition of the mattress springs can provide an indication of the relative temperatures or durations of heating. The springs from mattresses in both experiments have relaxed and lost their shape in most areas except perhaps the edges along the walls of the room. The photos shown in Figures 54 and 55 illustrate that the bed frames have also deformed during the experiments. In addition, the combustible portions of the mattresses were almost completely consumed. Recall that both experiments were of similar duration, burned in the post-flashover stage for the same period of time, and both mattresses were subjected to similar loads (their own weight). This would suggest similar fire exposures in both experiments. This conclusion assumes, of course, that the properties of the steel in the mattresses, which were of the same model, were identical.

FIGURE 52. *Photograph of the condition of the bed mattress and frame, Experiment 3.*

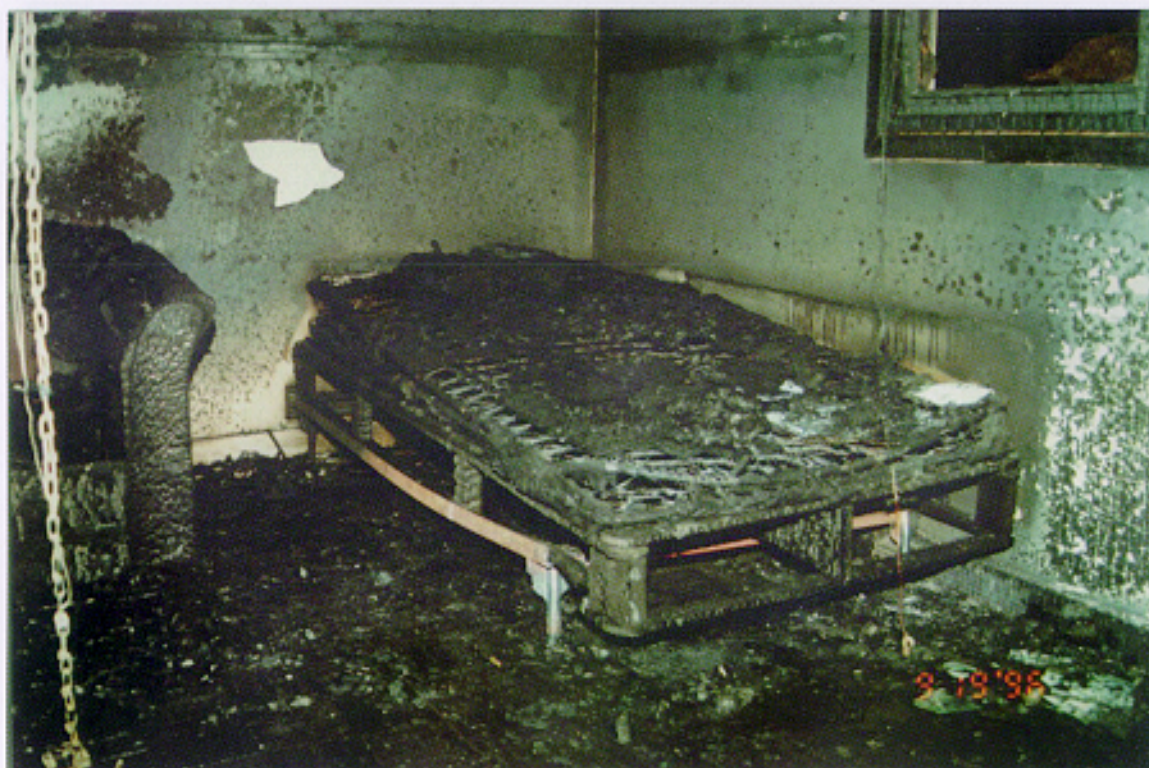
FIGURE 53. *Photograph of the condition of the bed mattress and frame. Experiment 4.*

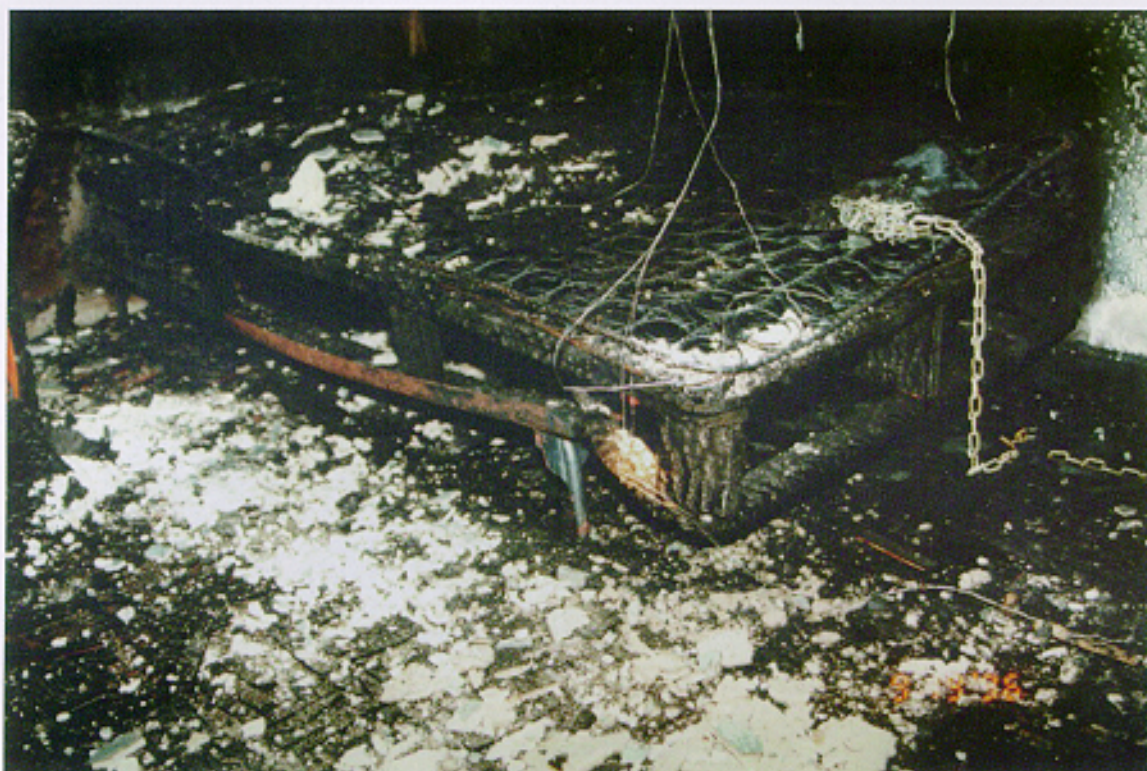
FIGURE 54. *Photograph of the bed showing bed frame deformation. Experiment 3.*

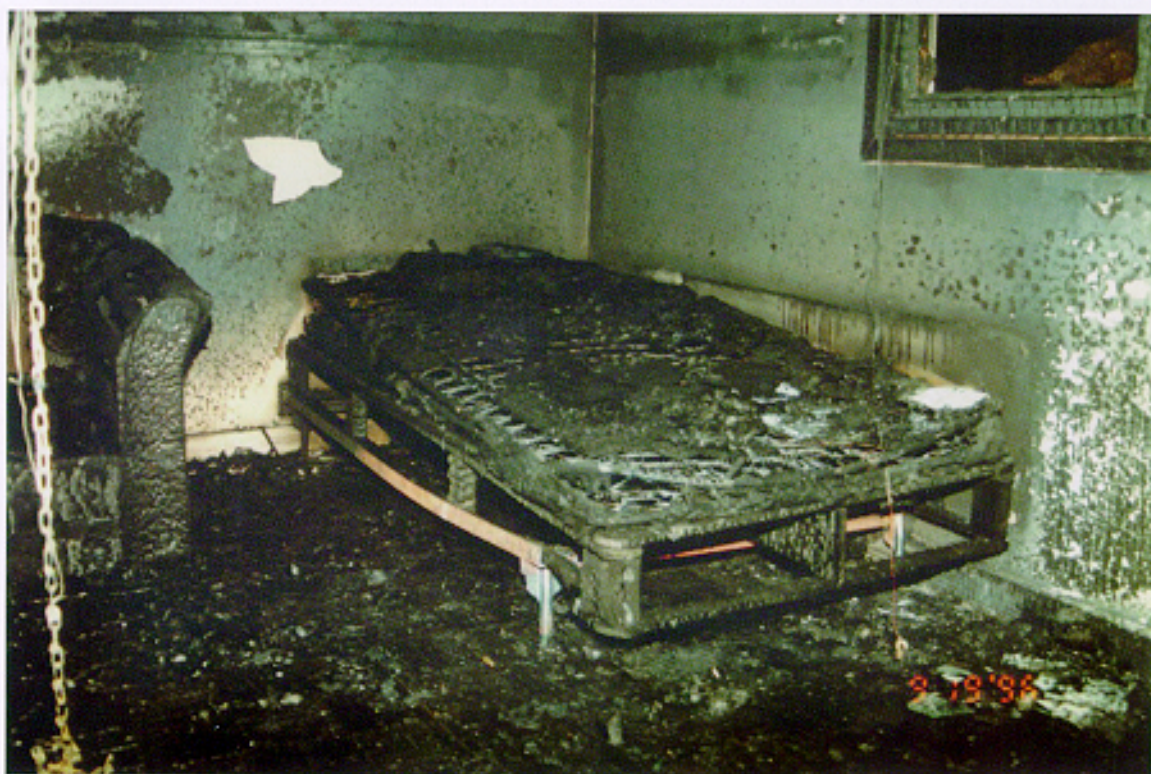
FIGURE 55. *Photograph of the bed showing bed frame deformation. Experiment 4.*

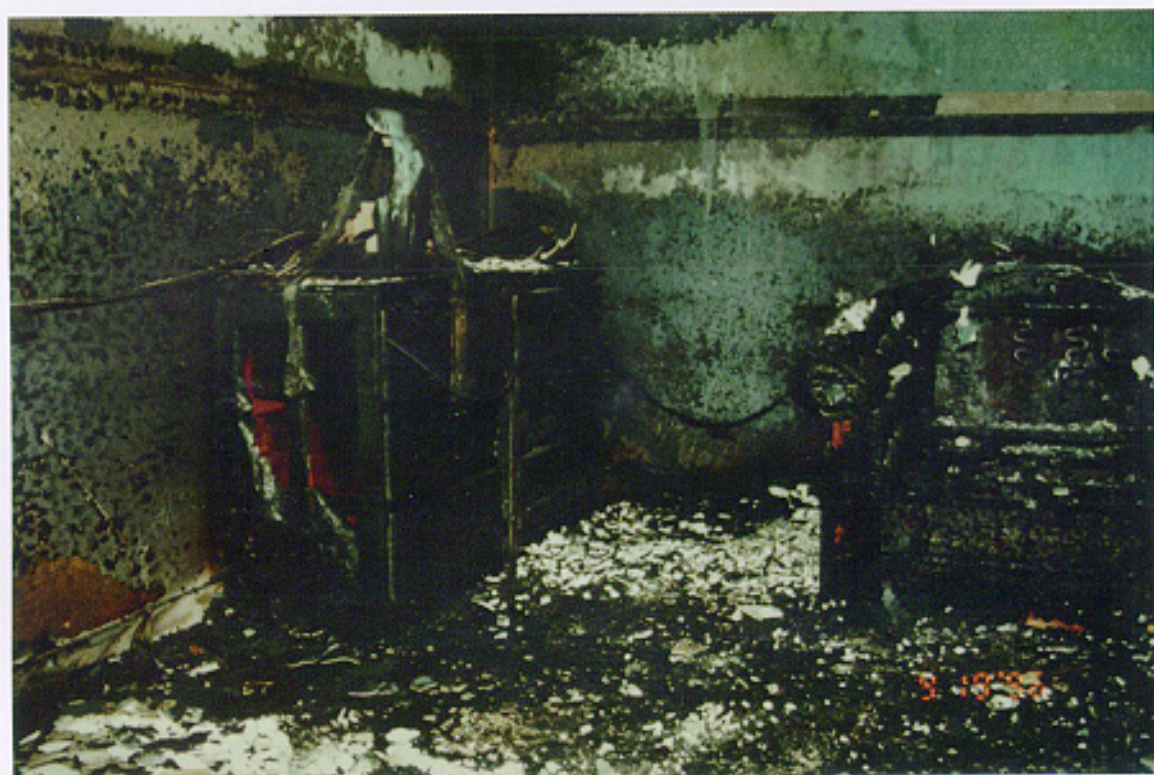
The dressers used in the rooms are shown in Figures 56 and 57 after the experiments. The side of the dresser in experiment 3 is more heavily damaged than from experiment 4. The side of the dresser in Figure 56 has burned through in several places, and the drawers inside of the dresser can be seen. The side of the dresser from experiment 4 is still intact, although heavily damaged. The nightstands in both experiments, as shown in Figures 58 and 59, are both heavily damaged on the side facing the bed. In both cases, the side of the nightstand is burned away, and the drawers inside can be seen.

FIGURE 56. Photograph showing damage to the side of the dresser. Experiment 3.

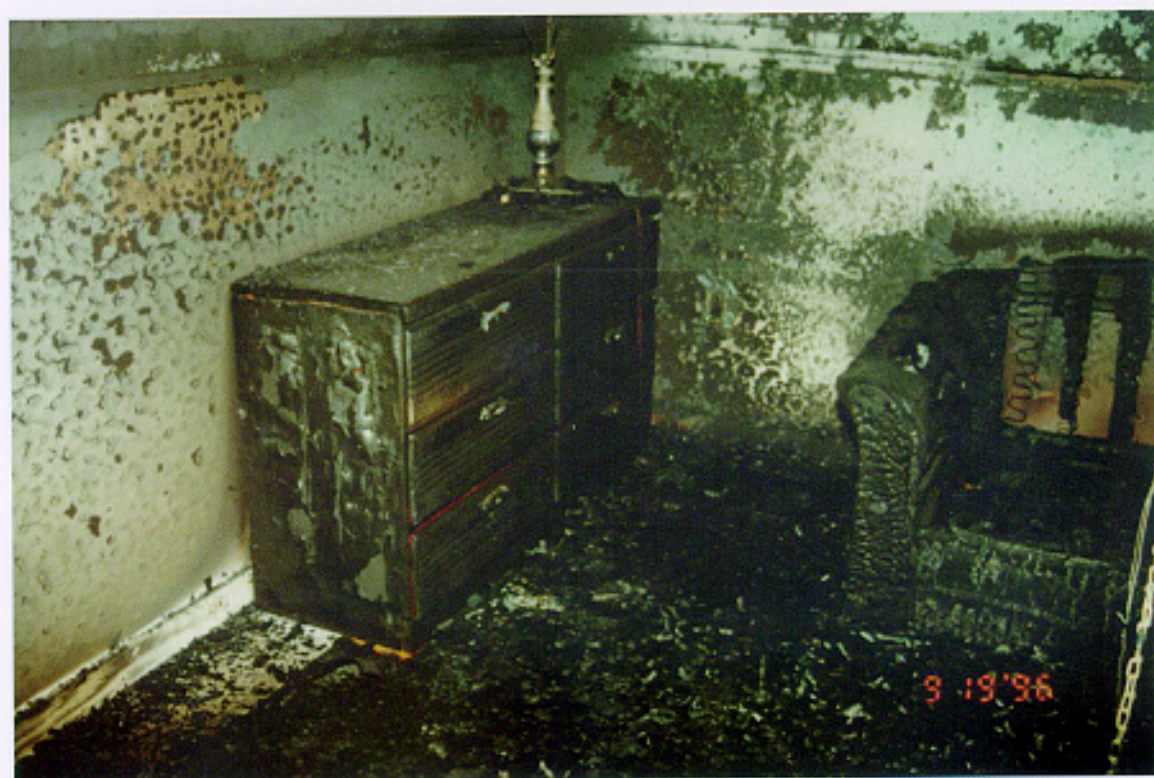
FIGURE 57. Photograph showing damage to the side of the dresser. Experiment 4.

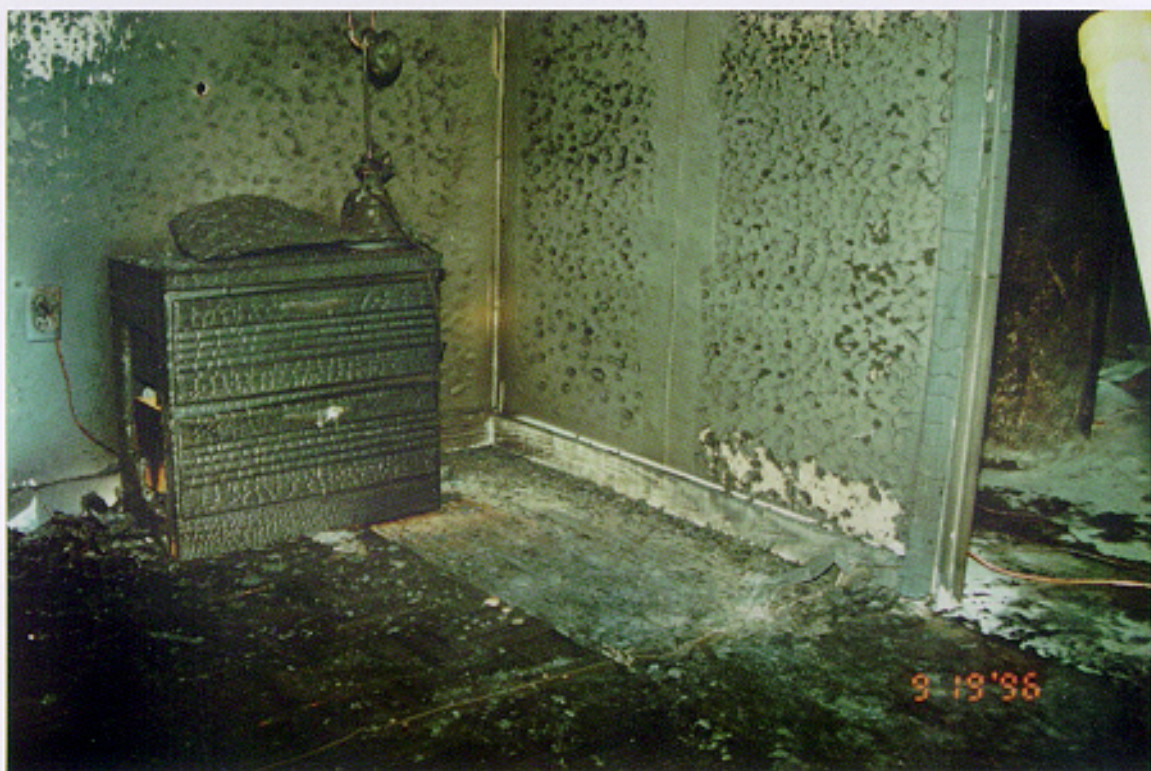
FIGURE 58. *Photograph showing damage to the side of the nightstand, Experiment 3.*

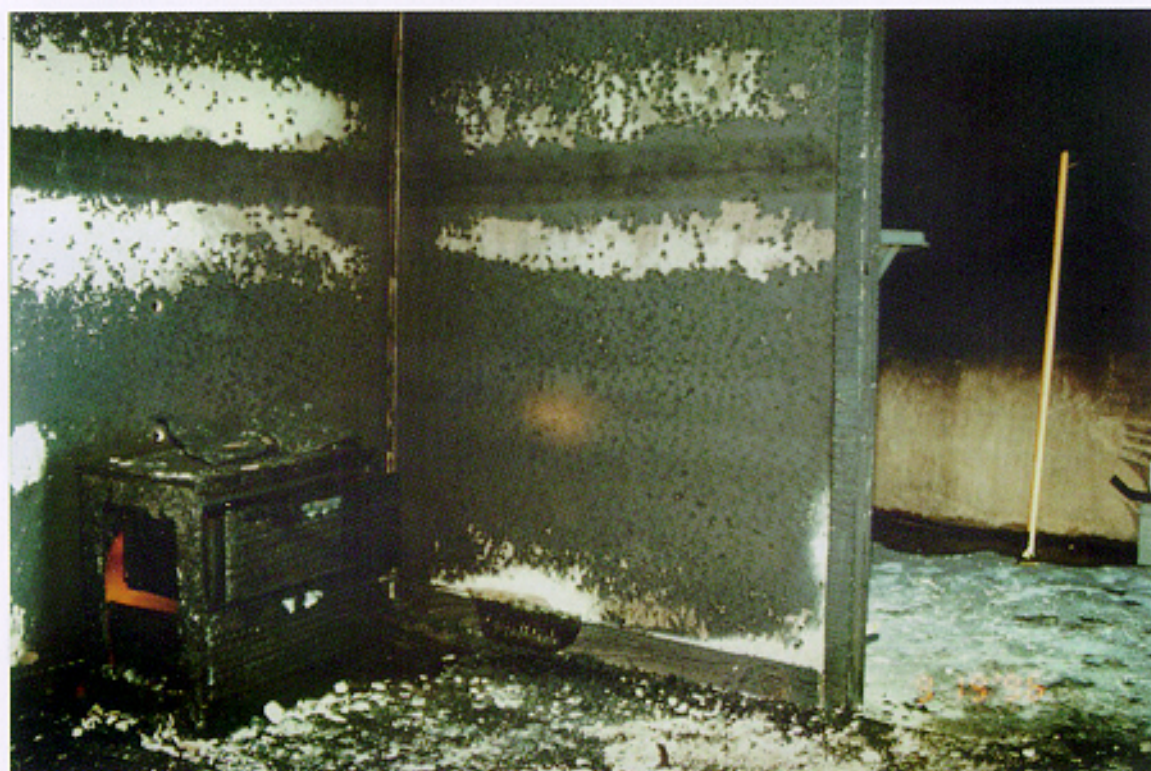
FIGURE 59. *Photograph showing damage to the side of the nightstand, Experiment 4.*

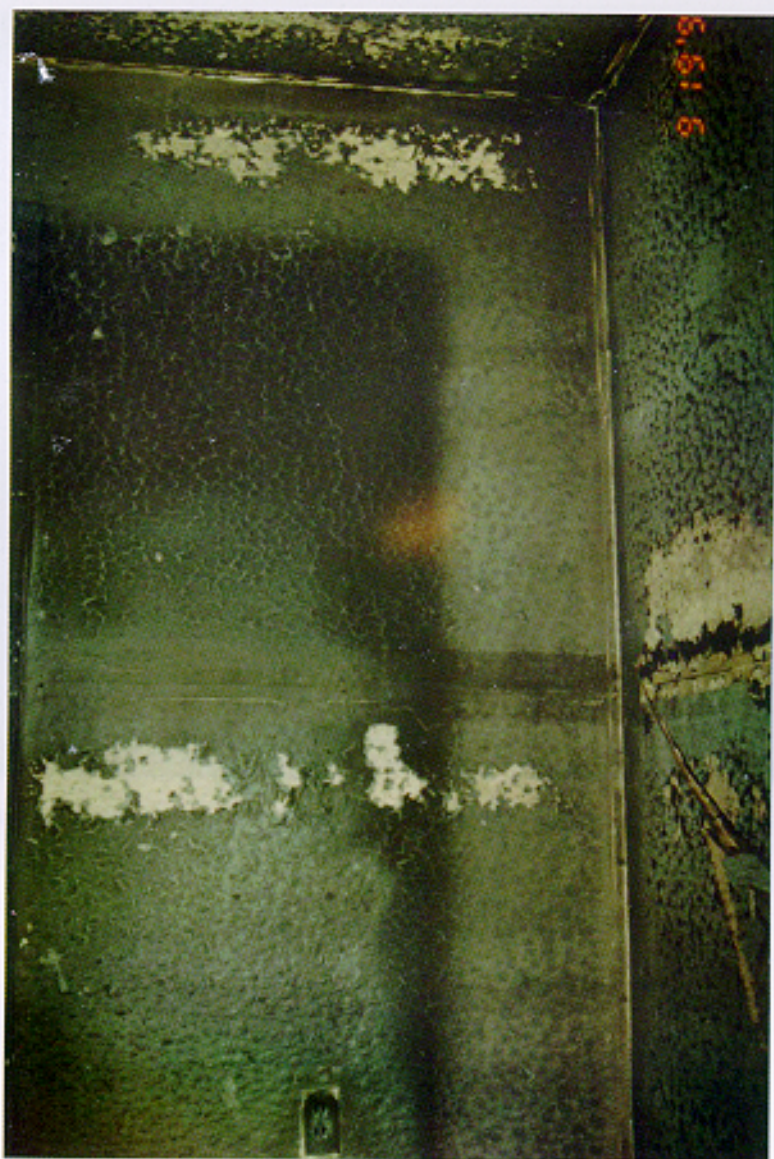
The areas behind the doors to the rooms in experiments 3 and 4 are shown in Figures 60 and 61. Although the doors have burned away, a line of demarcation can be seen on the wall where it was located in experiment 3. The location of the door is not clear from Figure 61, however.

FIGURE 60. *Photograph of the wall behind the door of the room, which was consumed by fire. Experiment 3.*

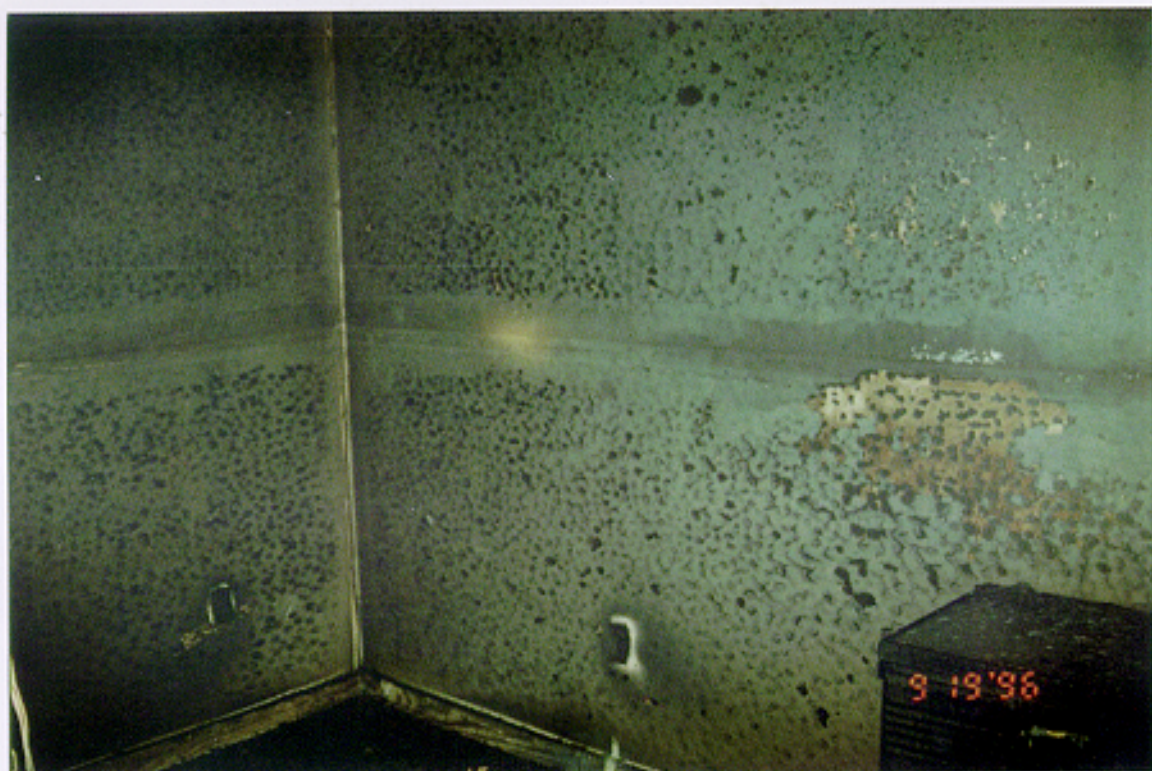
FIGURE 61. *Photograph of the wall behind the door of the room, which was consumed by fire. Experiment 4.*
