**Investigation of Drillship Draw Works Failure
Atwater Valley Block 116
OCS-G-13206
October 22, 1999**

**Gulf of Mexico
Off the Louisiana Coast**

**David Dykes
David Trocquet
Randall Josey**

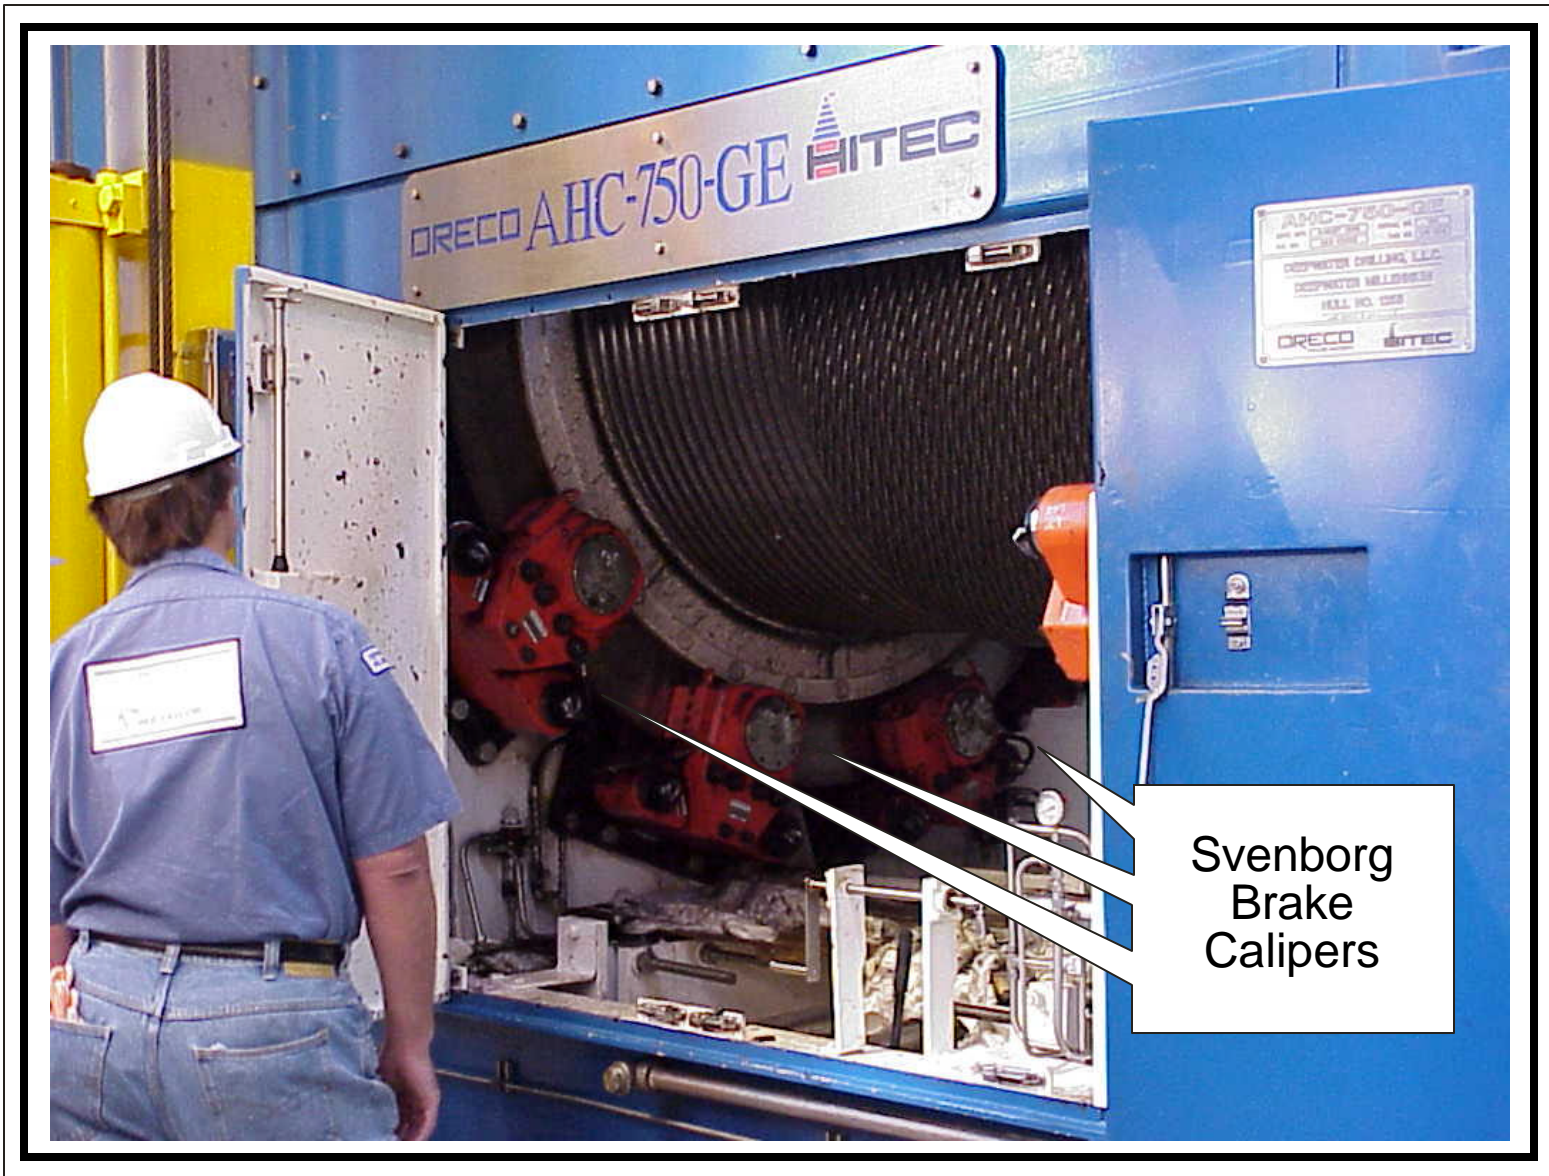
Dreco AHC 750 GE Draw Works with Svenborg Brake Calipers (*Deepwater Millennium*)

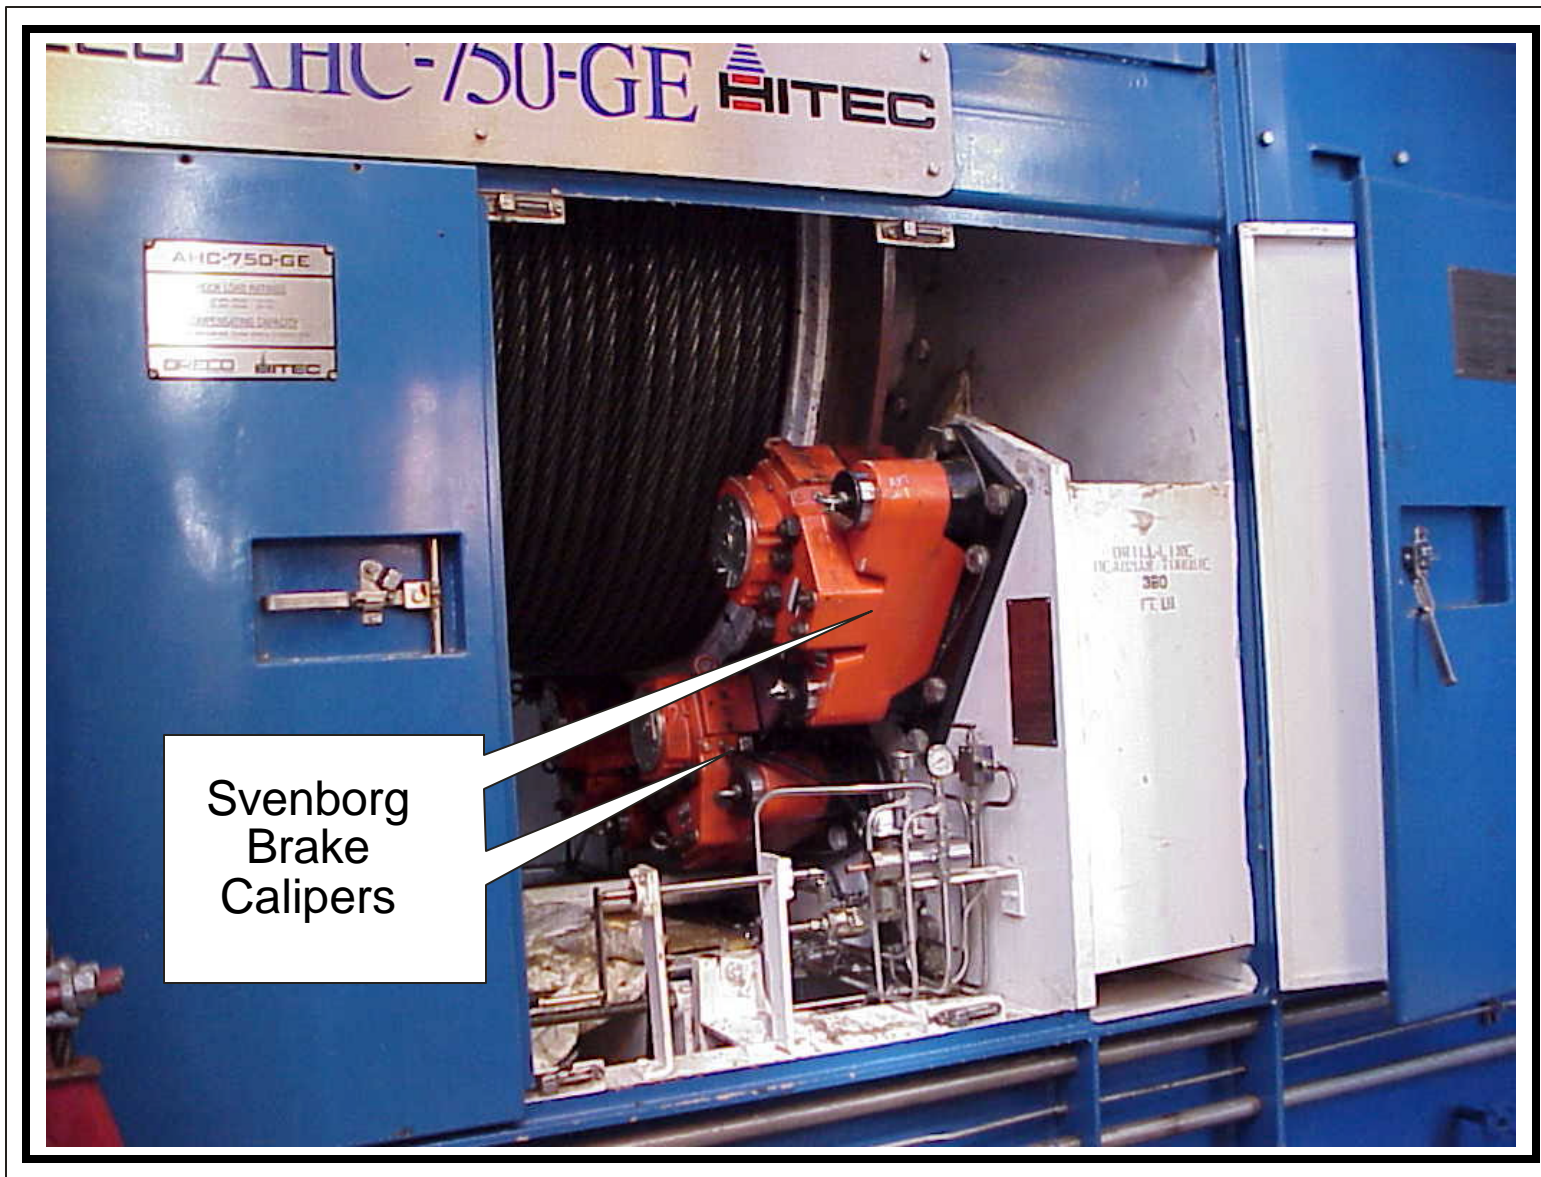
Drecto AHC 750 GE Draw Works with Svenborg Brake Calipers (*Deepwater Millennium*)

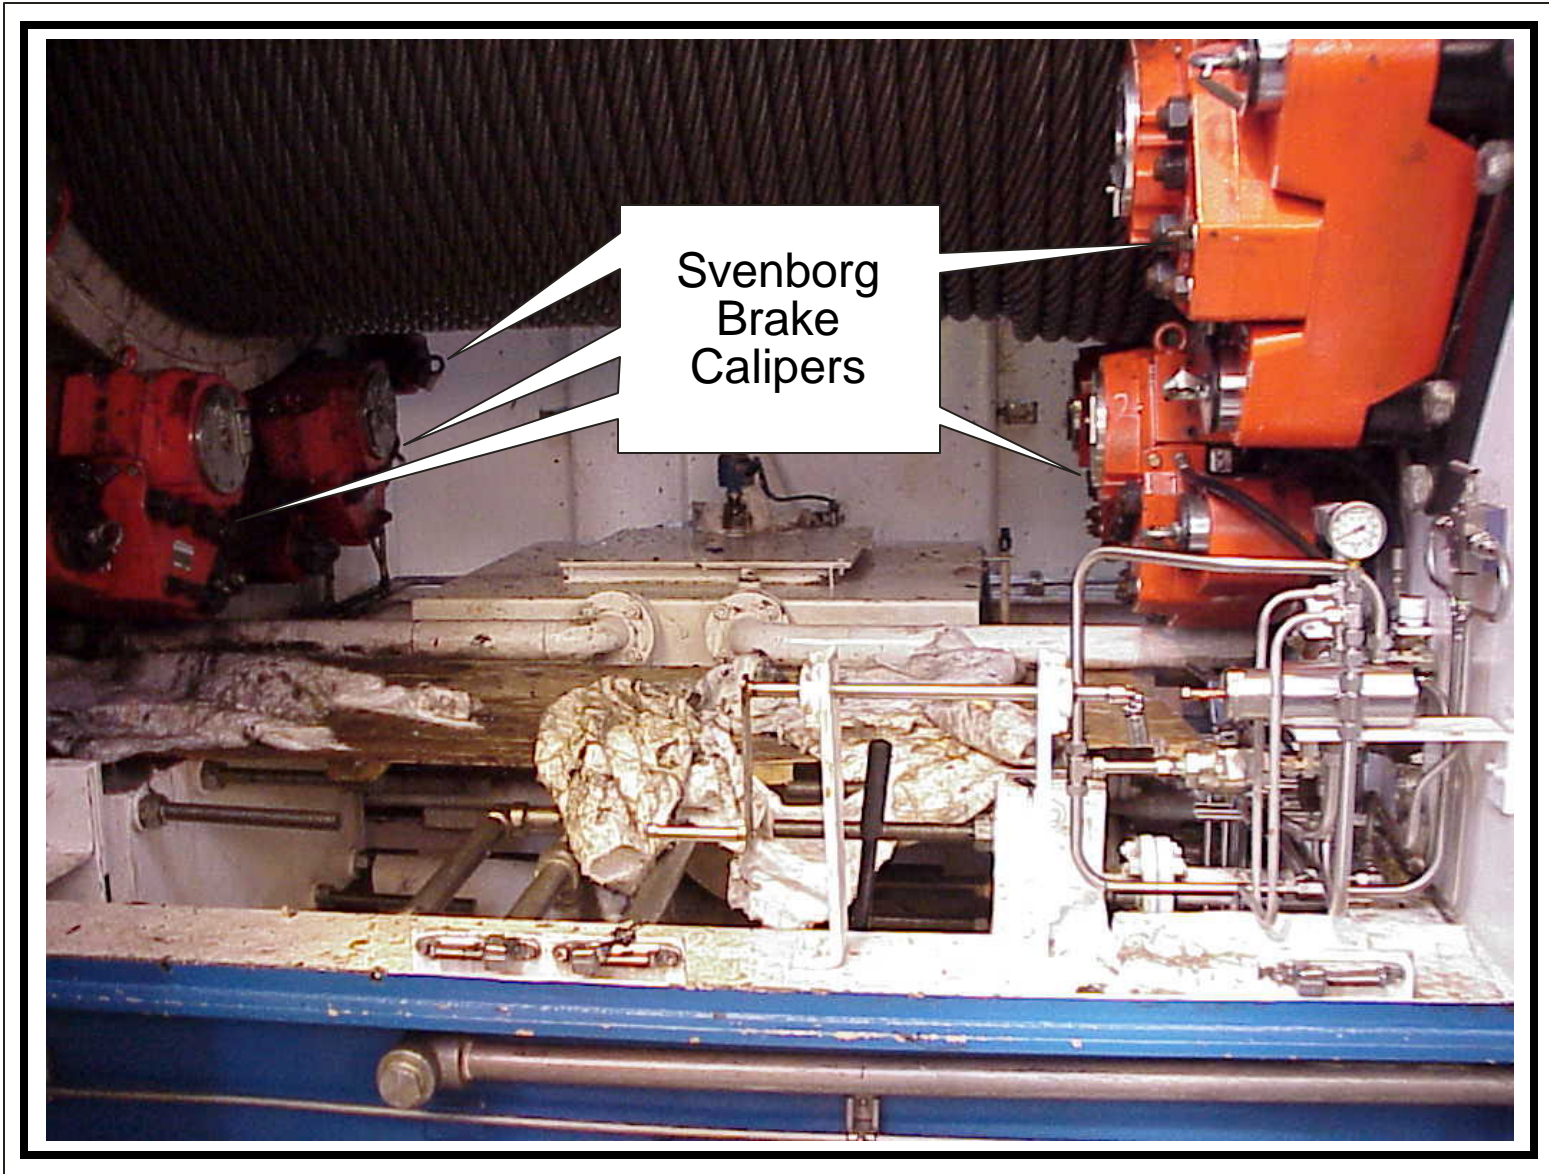
Dreco AHC 750 GE Draw Works with Svenborg Brake Calipers (*Deepwater Millennium*)

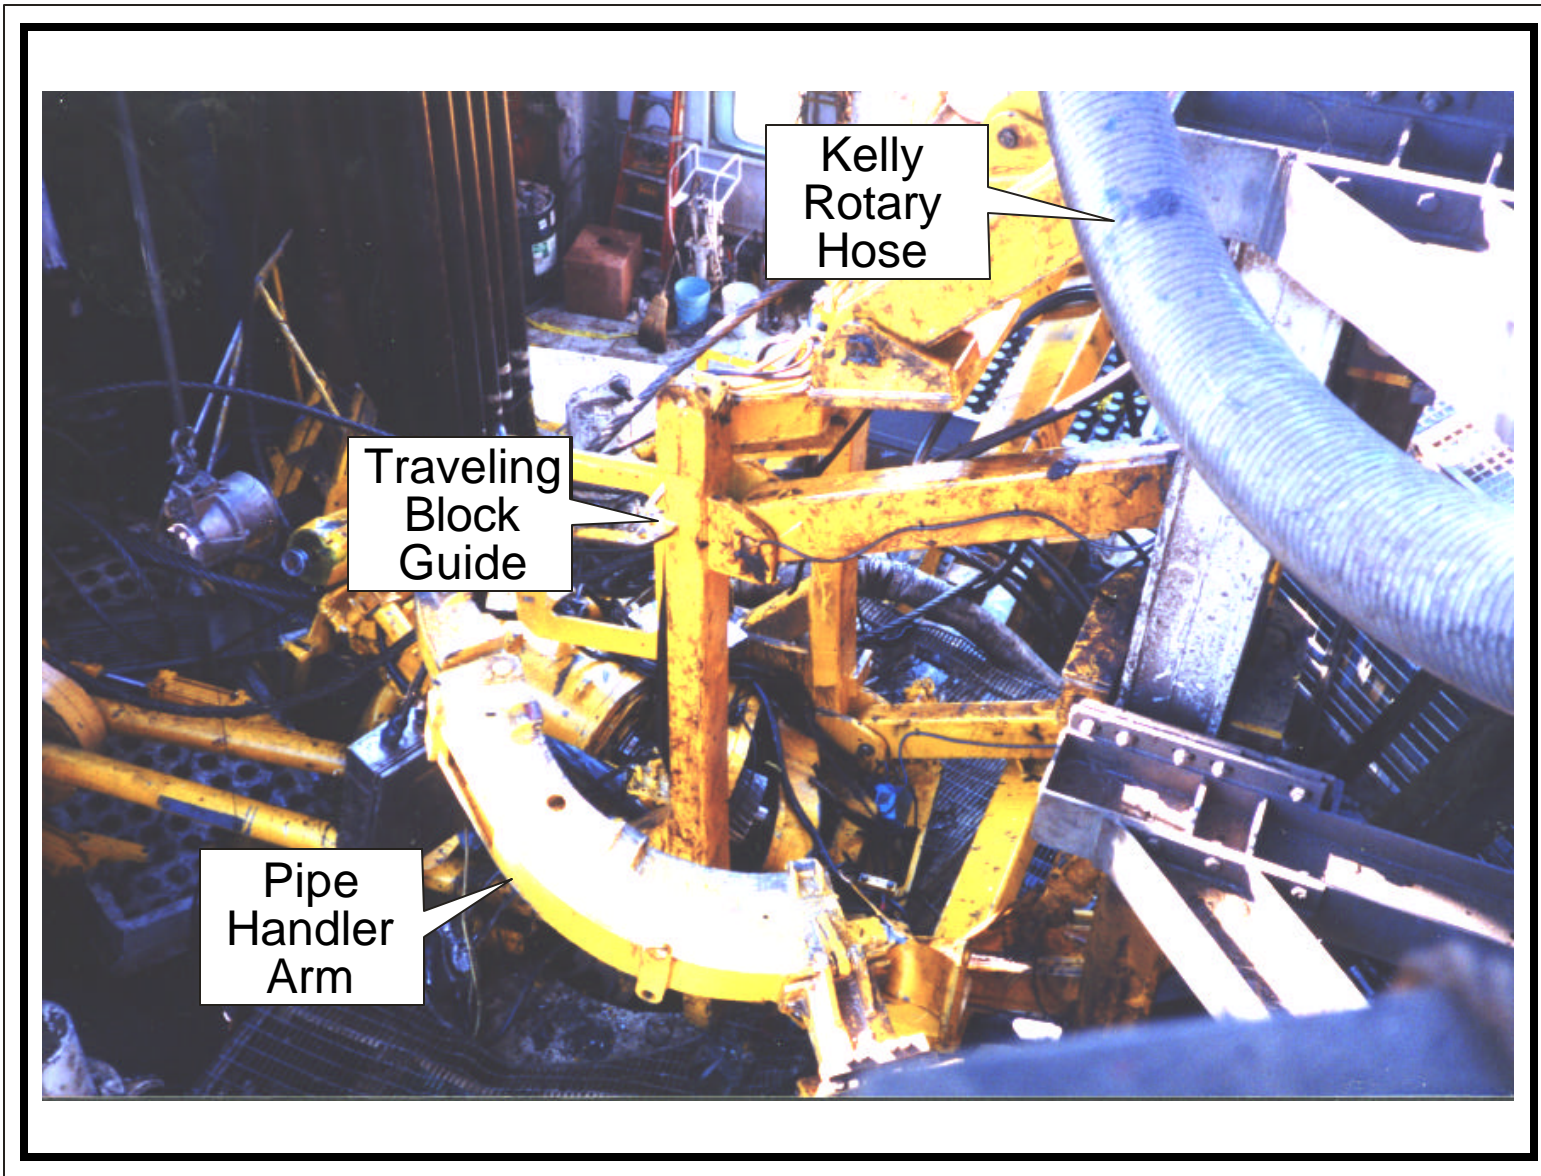
As a result of this accident, the draw works assembly and top drive assembly were damaged beyond repair. The main bearing of the rotary table was also damaged beyond repair. The riser spider and gimbal

sustained damage but not beyond repair. The bails, elevators, 20 joints of riser pipe, and the BOP/LMRP assembly were completely lost. The derrick, along with mux lines support equipment, sustained minor damage. Total estimate of damage and repair or replacement costs is approximately \$20 million. *For pictures of damages, see Attachments 7-9.*

Damages - *Deepwater Pathfinder* Drill Floor

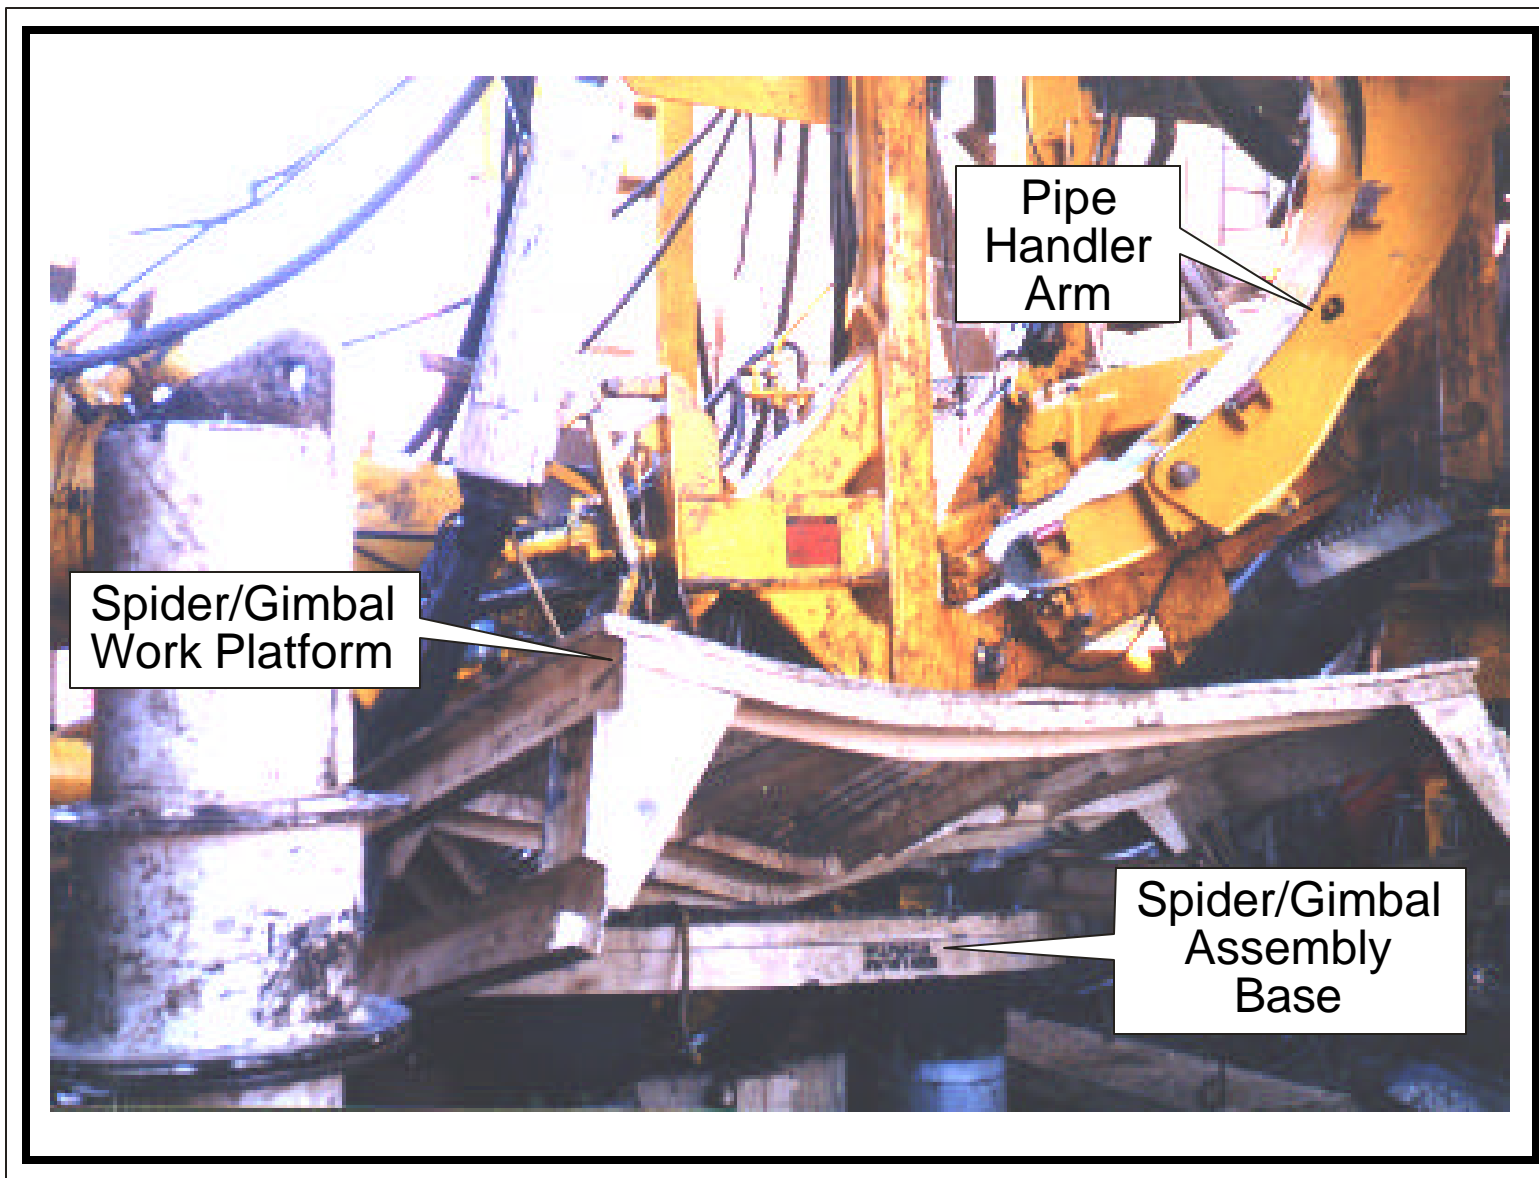
Damages - *Deepwater Pathfinder* Drill Floor

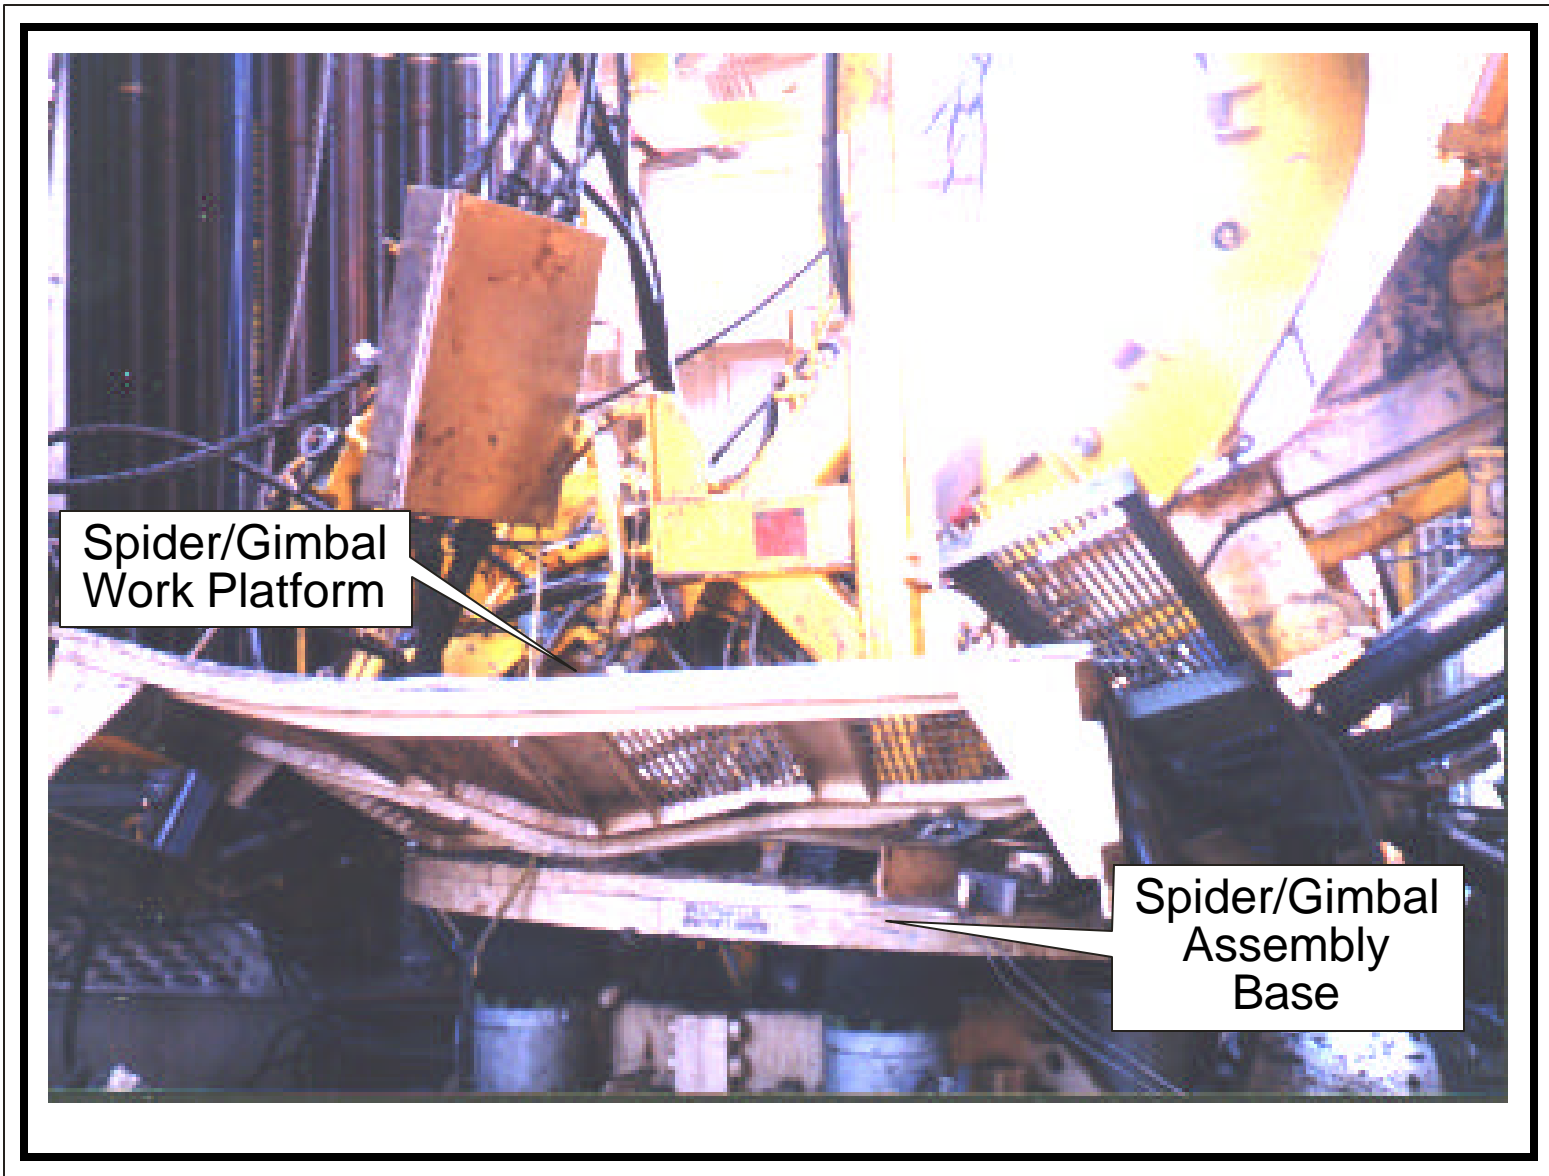
Damages - *Deepwater Pathfinder* Drill Floor
