**Investigation of Crane Accident and Injury
South Timbalier Block 185
OCS-G 1569
March 21, 2000**

**Gulf of Mexico
Off the Louisiana Coast**

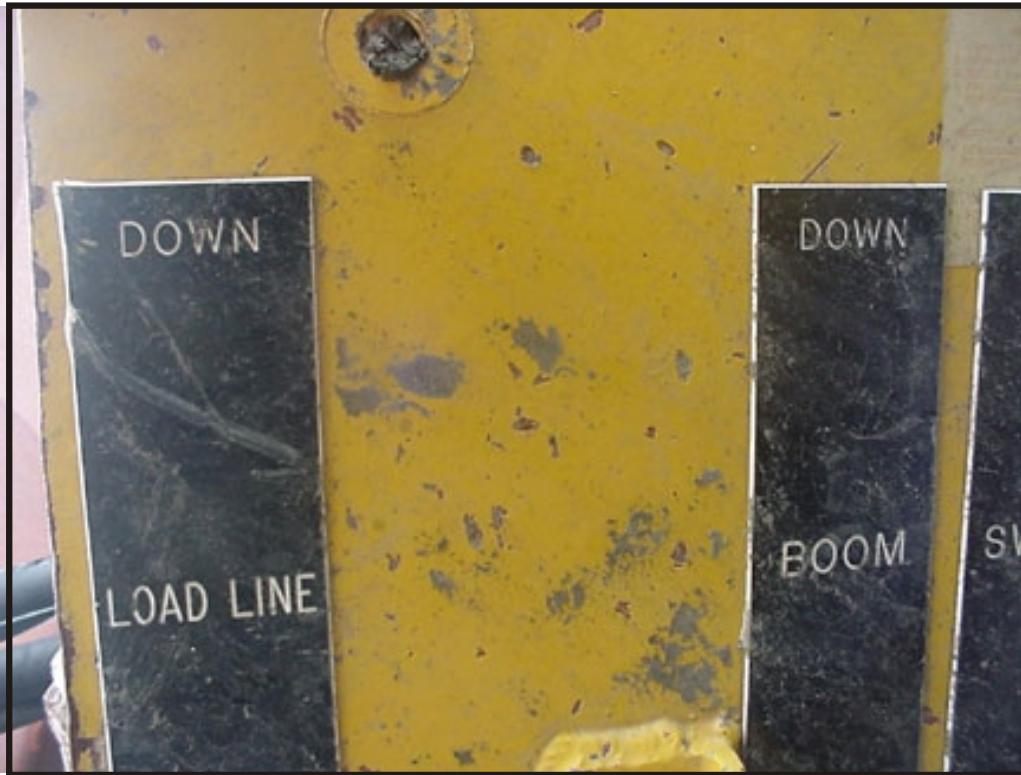
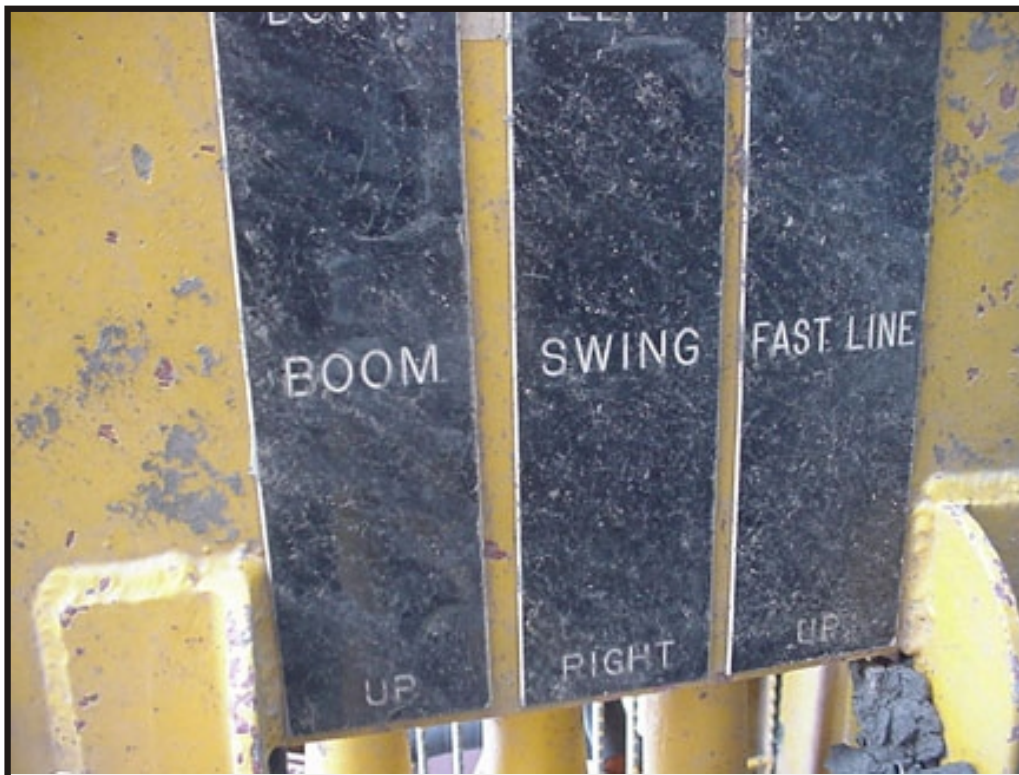
Photographs of Control Handles - ST185 Crane

- The configuration of the control handles was unique to this crane and not the typical control configuration as other cranes he had operated. *For pictures of the control handles, see Attachment 3.*
- The crane would rock on the pedestal at high boom angles.
- The operation of the crane was not smooth.

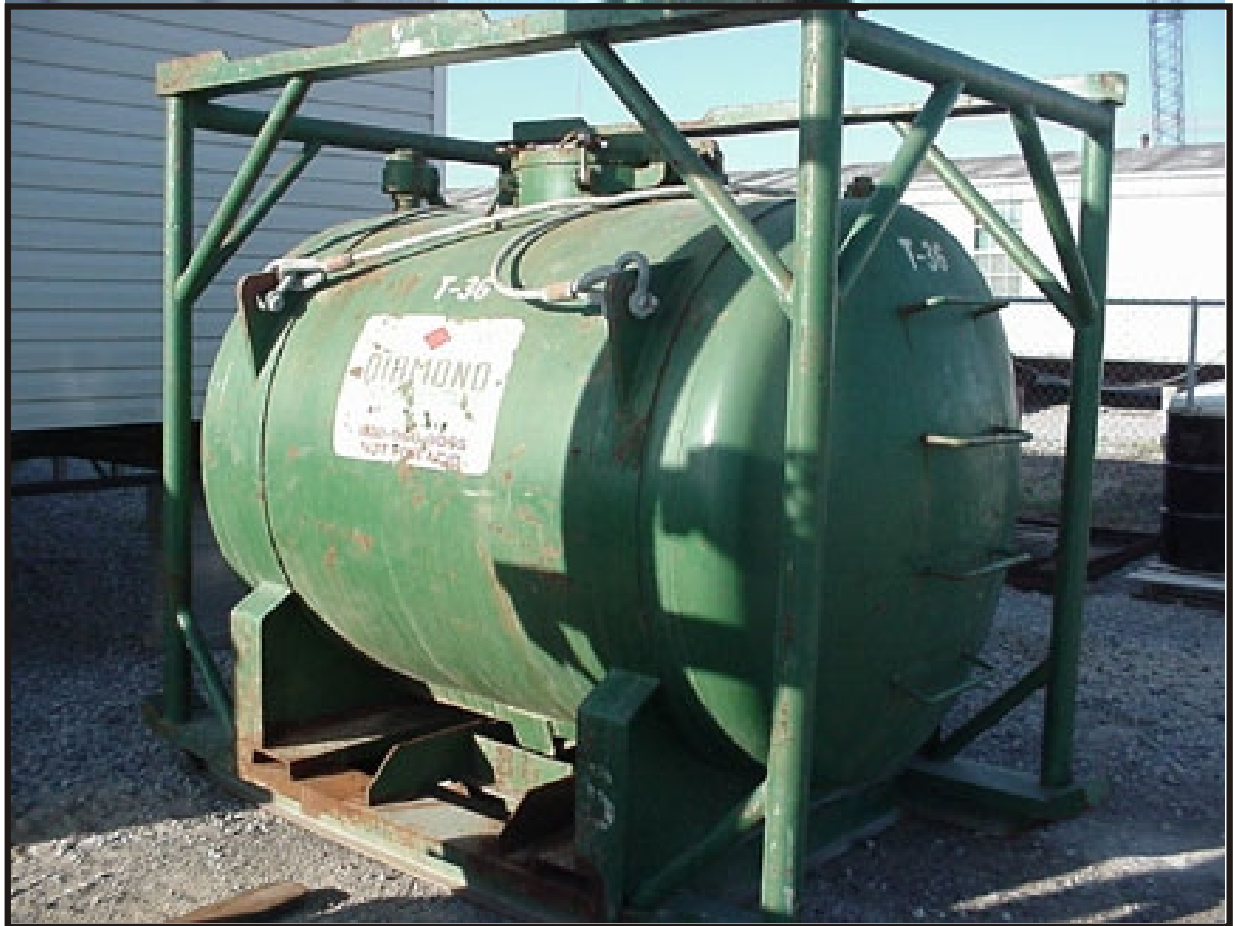
Photograph of Diamond Tank Rental 25-Barrel Tote Tank

The tank involved in this incident was a 25-barrel tote tank owned by Diamond Tank Rentals. *For picture of the tank, see Attachment 4.* The empty weight of the tank was 4,080 pounds. This weight is marked on the manufacturer's plate located on the inside support leg of the tank.

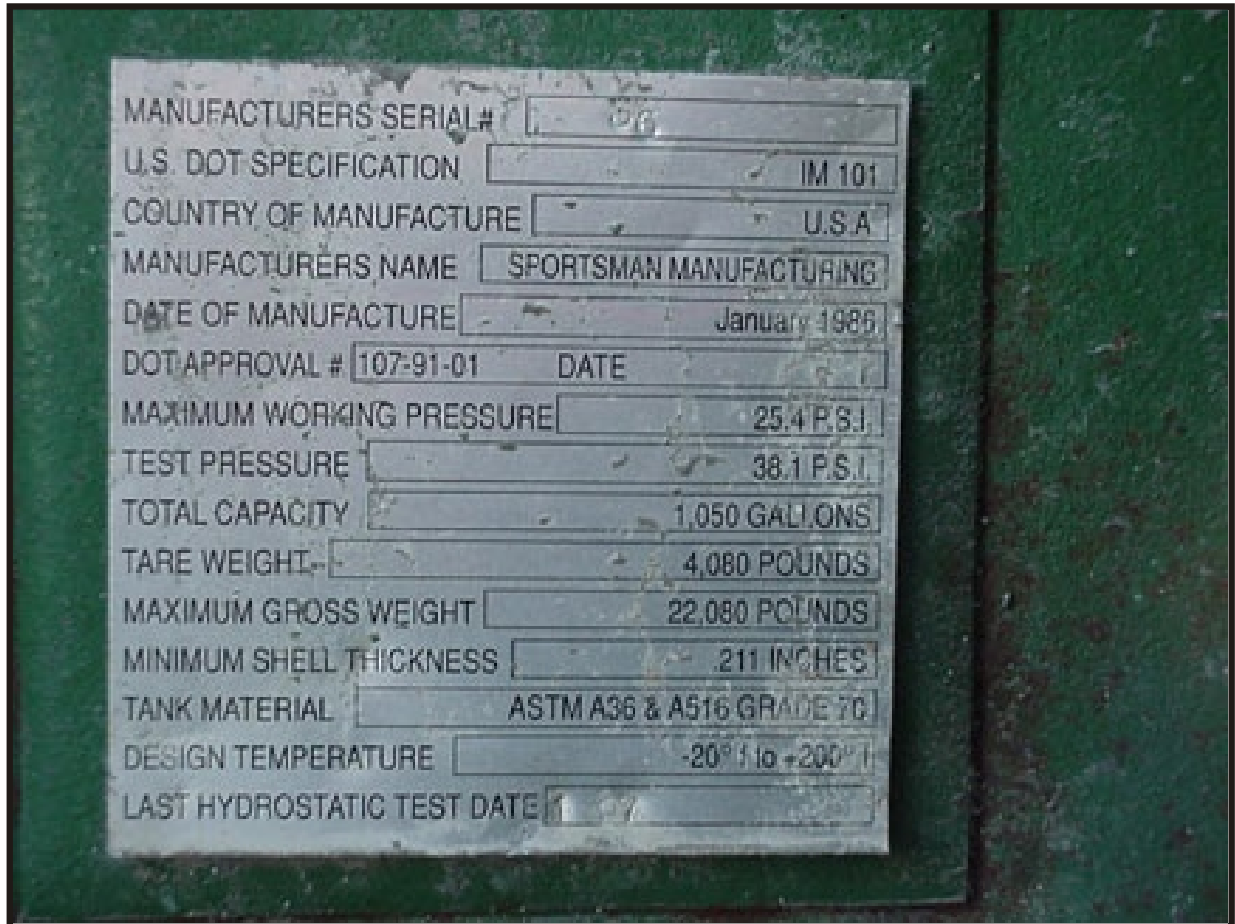
Photograph of Tote Tank Manufacturer's Identification Plate

For picture of the manufacturer's plate, see Attachment 5. At the time of the incident, the tank was filled with Calcium Bromide (CaBr₂). The density of the CaBr₂ was 14.2 pounds per gallon. This calculates to 14,910 pounds of CaBr₂ with a total weight of 18,990 pounds. The tank involved in this incident and other numerous pieces of equipment were not marked with the associated lift weight.
