**Investigation of Fatal Fall  
Through “V” Door  
South Pass Block 62  
OCS-G 01294  
June 15, 2002**

**Gulf of Mexico  
Off the Louisiana Coast**

**U.S. Department of the Interior  
Minerals Management Service  
Gulf of Mexico OCS Regional Office**

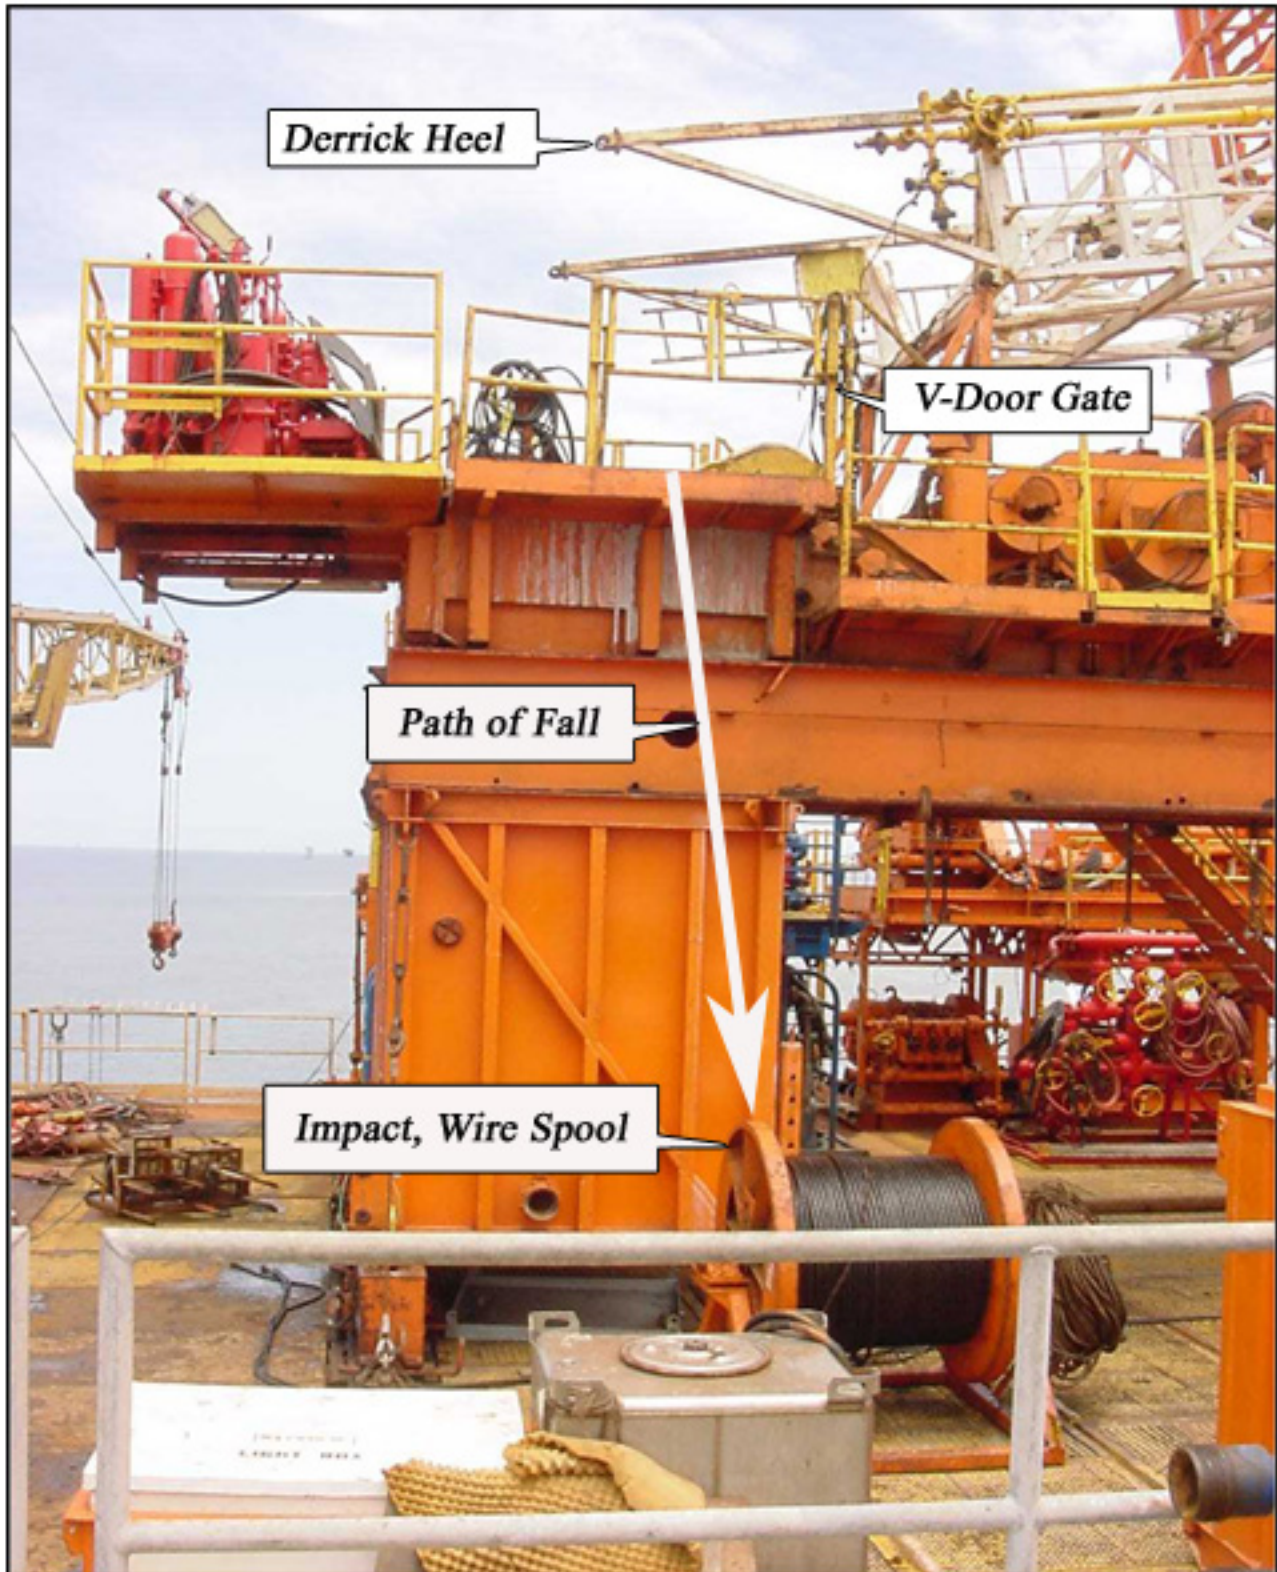
*View of Rig Floor, Derrick Heels, V-Door, Path of Fall*

The tool pusher was slowly raising the derrick as the crew guided the heel sections into place, when the right-side V-door gate suddenly and inadvertently opened. The driller, who apparently was braced against the gate, fell backwards off the rig floor through the V-door, losing his hard hat. He impacted upon a wire rope spool on the deck 19 feet below the rig floor, resulting in his death (*see Attachment 2, path of fall, and Attachment 4*).

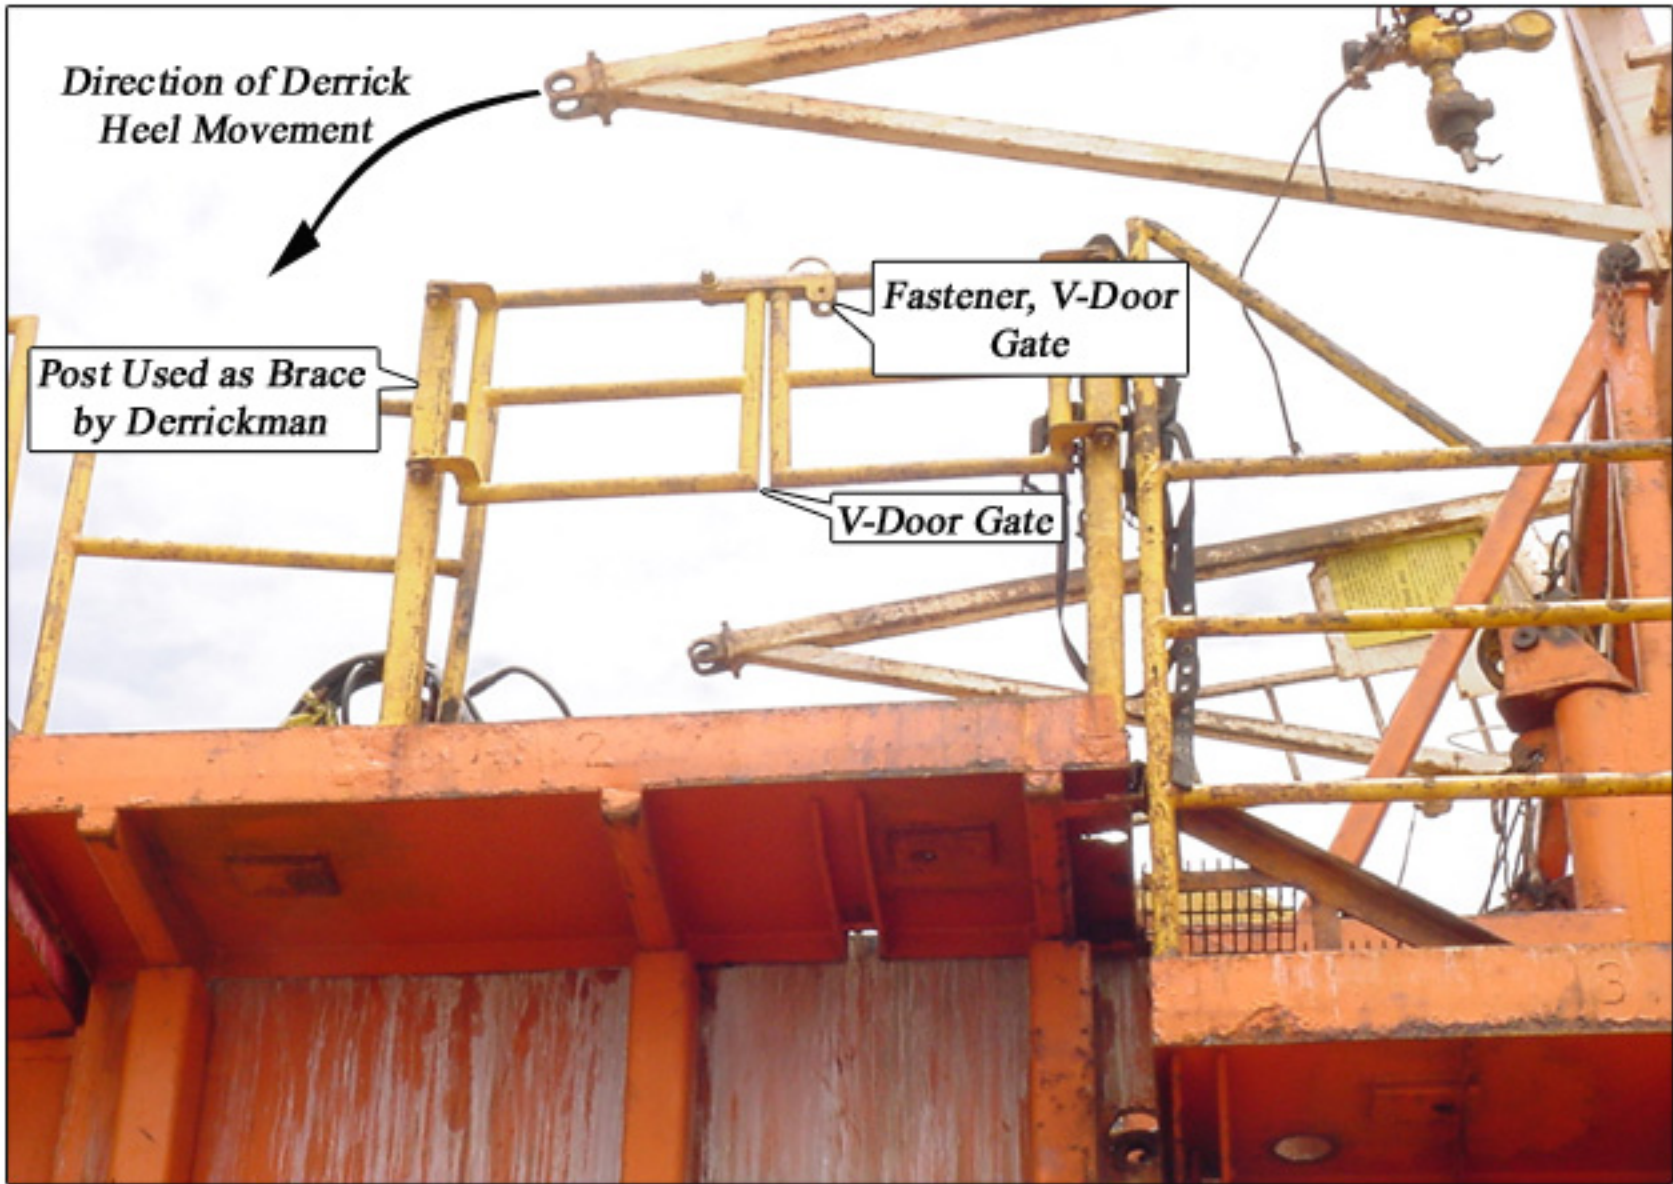
*View of V-Door Gate, Derrick Heel Post Used as Brace for Derrickman*

When inspectors from MMS examined the rig floor and investigated the circumstances of the accident, it was found that the rig floor was surrounded by standard railings and kick boards except at two locations. These locations were the V-doors, one on either side of the rig derrick, which are routinely used to hoist equipment, pipe, etc. onto the floor for use in rig operations. Both of the V-doors were equipped with double gates made of pipe constructed to handrail standards, except that the lower rail was slightly higher from the rig floor than standard rail construction. These gates are hinged from posts attached to the guard rail posts and are constructed so as to swing outward when opened, much like a double door. The top bar of the V-door gate was approximately 4 feet, 1 inch from the rig floor, and the gate and handrails were approximately 28 inches from the heel of the derrick. The gates allow the two V-door openings to be closed off when not being used for equipment movement, thus protecting workers from falling through the openings (*see Attachment 3*).

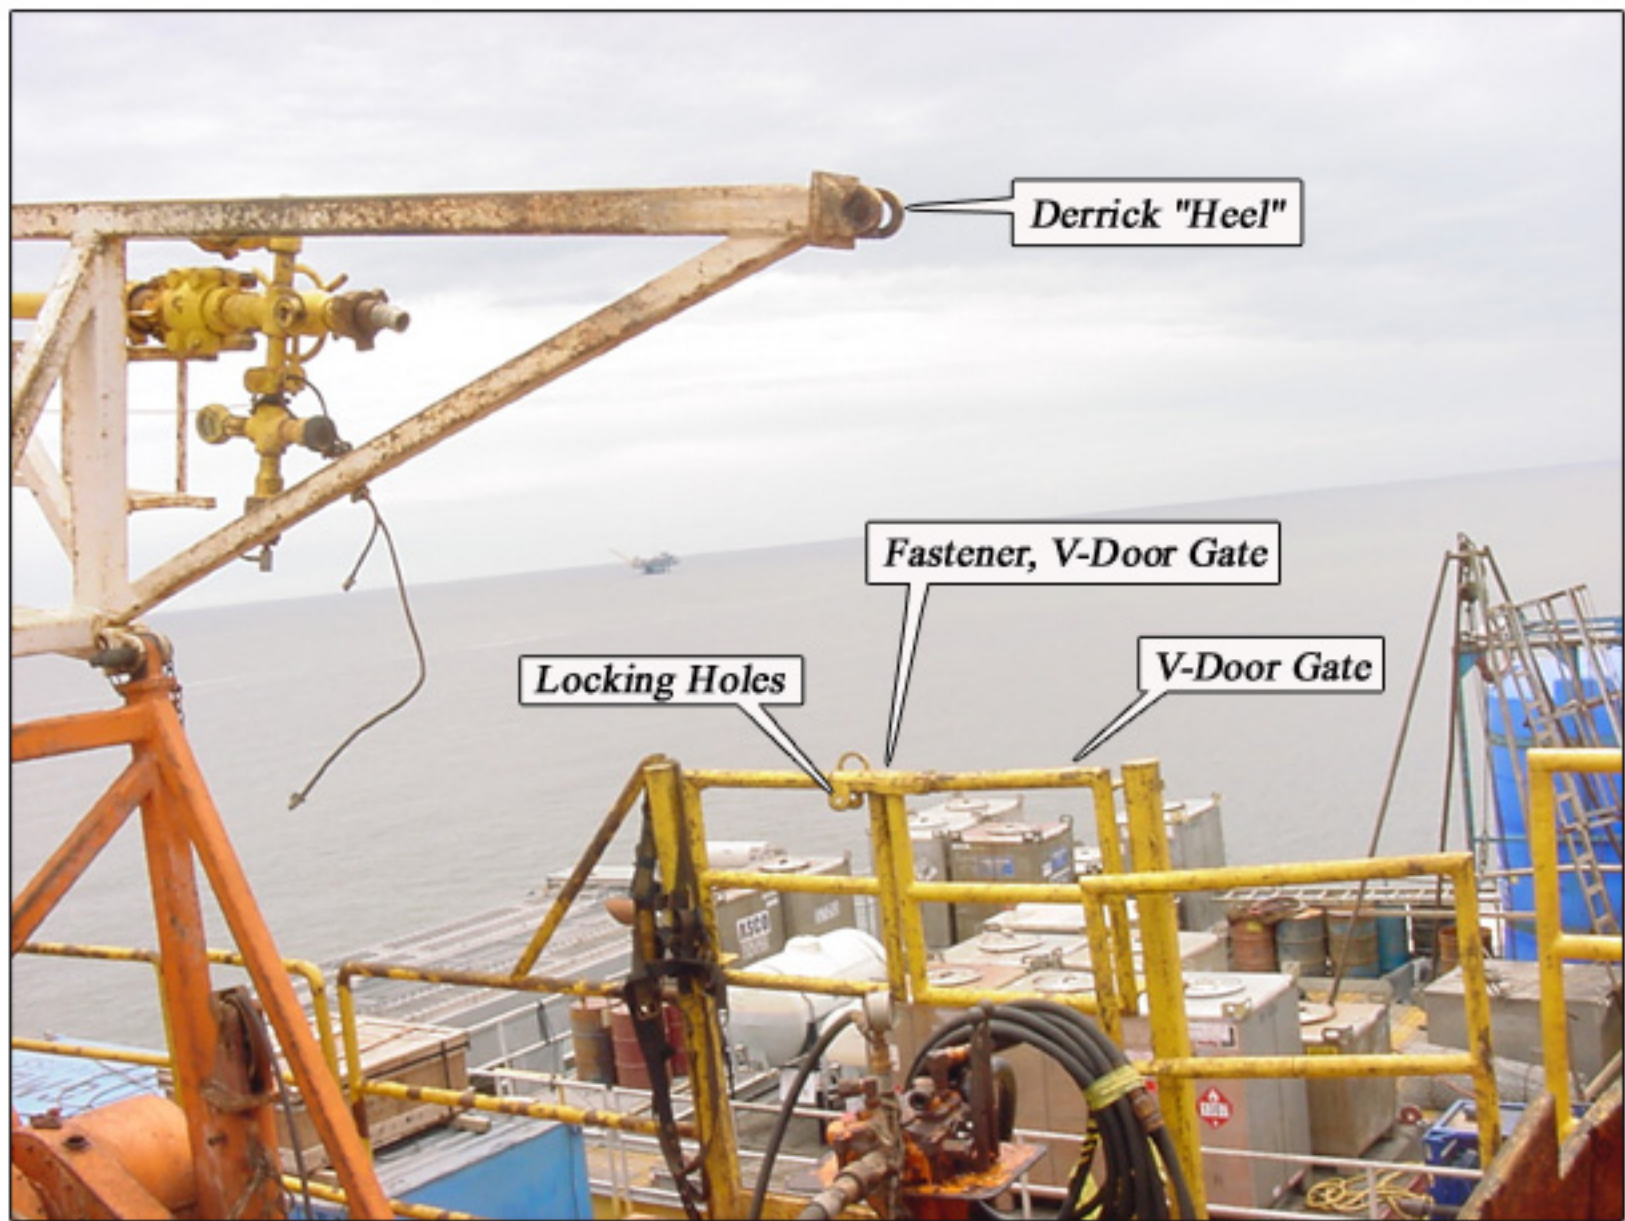
*View from Rig Floor*

long half-piece of pipe (split lengthwise down the middle) bolted to the top rail of one of the gates so that, when lowered, it overlaps about 4 inches of the top rail of both gates (*see Attachment 5, 6, and 7*). When in place, it thus prevents either gate from opening. The Fastener is not positively latched by any automatic mechanism and relies on its weight to stay in place. However, when the mechanism was constructed, provision was made to lock the fastener in the closed position by inserting a pin or pad type lock through a hole through two tabs attached to opposing sides of the Fastener pipe (*see Attachments 6 and 7*). While the derrick was being raised, the left-side V-door gate was closed and secured from opening with the fastener locked in position by a pin through the tab holes. The right-side V-door gate was closed and the gate held shut by the lowering of the Fastener, but the Fastener was not latched or locked by a pin. Thus, the fastener could be raised and the gate opened by lifting the fastener and pressing outward on the gates.

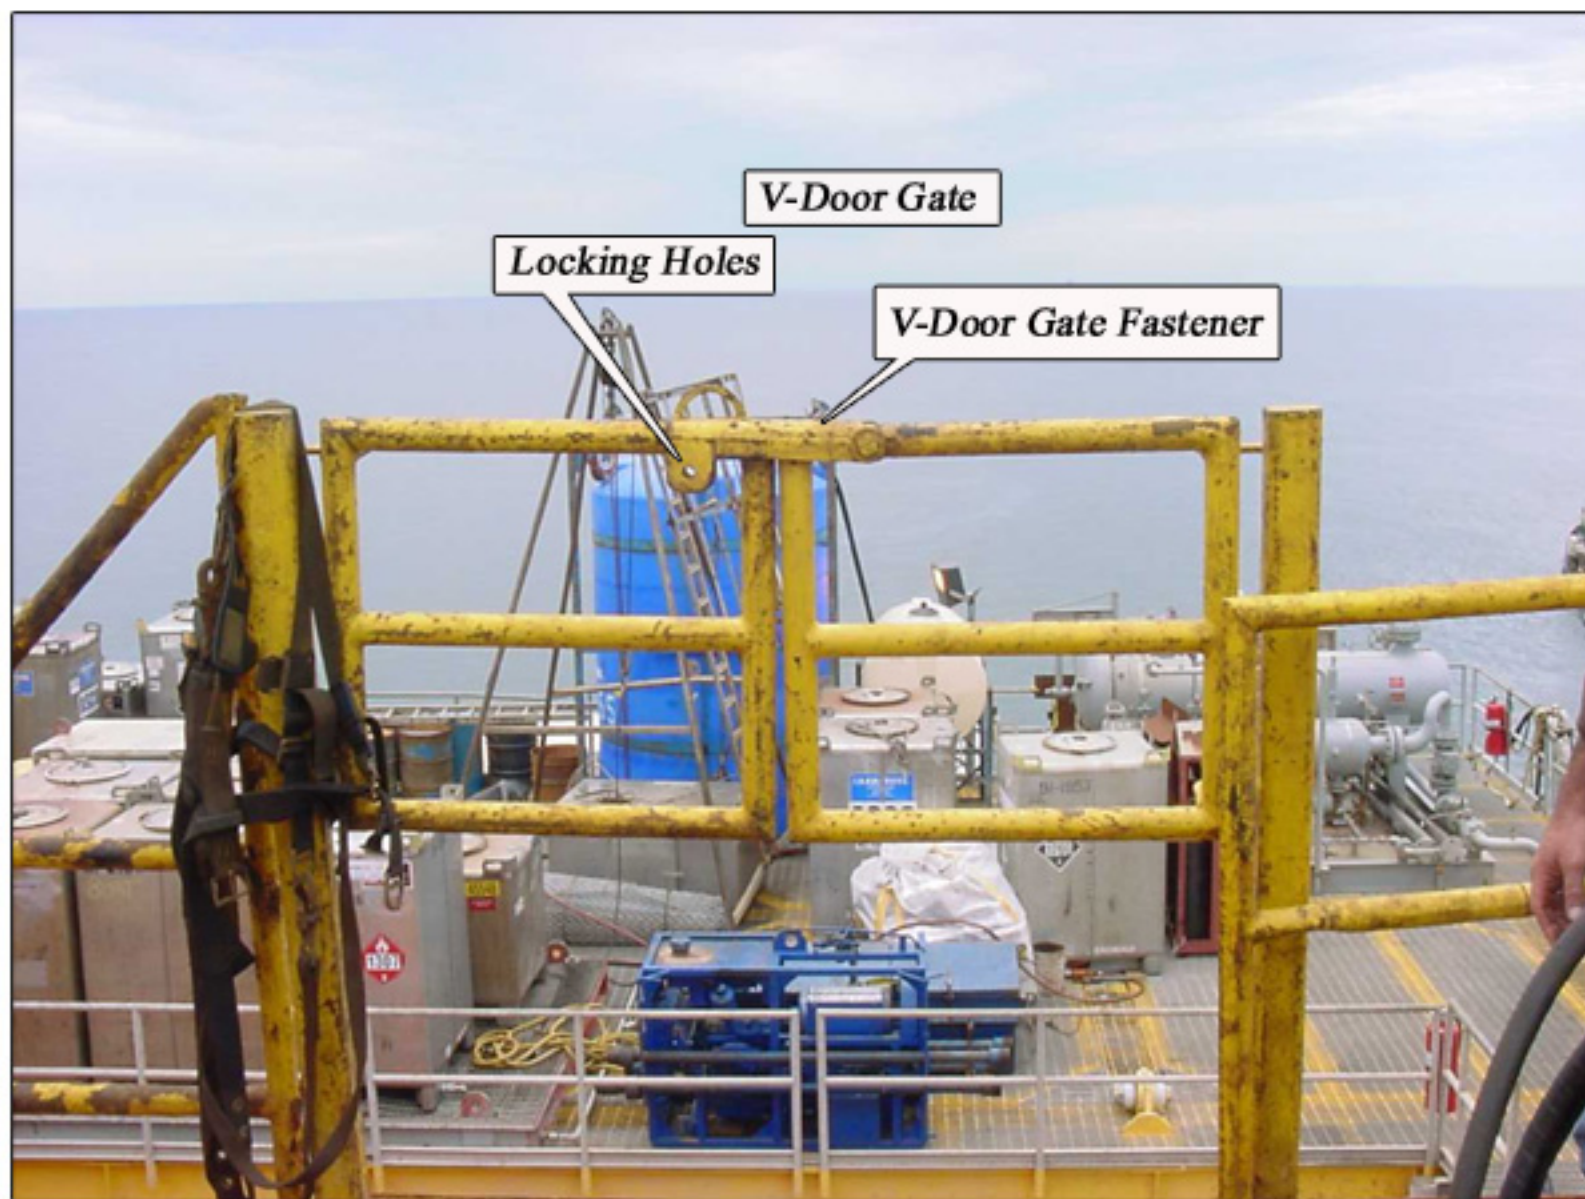
*Close View, V-Door Gate*

It was found that, prior to the accident, the subject V-door gate that inadvertently opened was held shut by the Fastener. During the initial investigation, an inspector for the MMS demonstrated that this Fastener could be opened inadvertently by simply catching a tab of the Fastener on the clothing of someone crouching next to it. After the tab is caught in such a manner, the act of subsequently standing could throw the Fastener back, allowing the gates to be opened by outward pressure. As noted above, two metal tabs extending below the body of the Fastener at the nonhinged end are pierced by a hole to allow a clip or lock to be placed that would positively lock the gate. The unused V-door on the left side of the derrick was positively locked in such a manner (*see Attachment 6*). However, the right-side V-door gate that subsequently opened was not so positively latched.

The MMS recommends to the operators that they review the fastening mechanisms on all barriers covering handrail openings on platform or rigs. These barriers include all types of gates and chains. The MMS recommends that the operators consider installing positive latch or catch mechanisms that prevent the inadvertent opening of such barriers in the course of normal work activities.

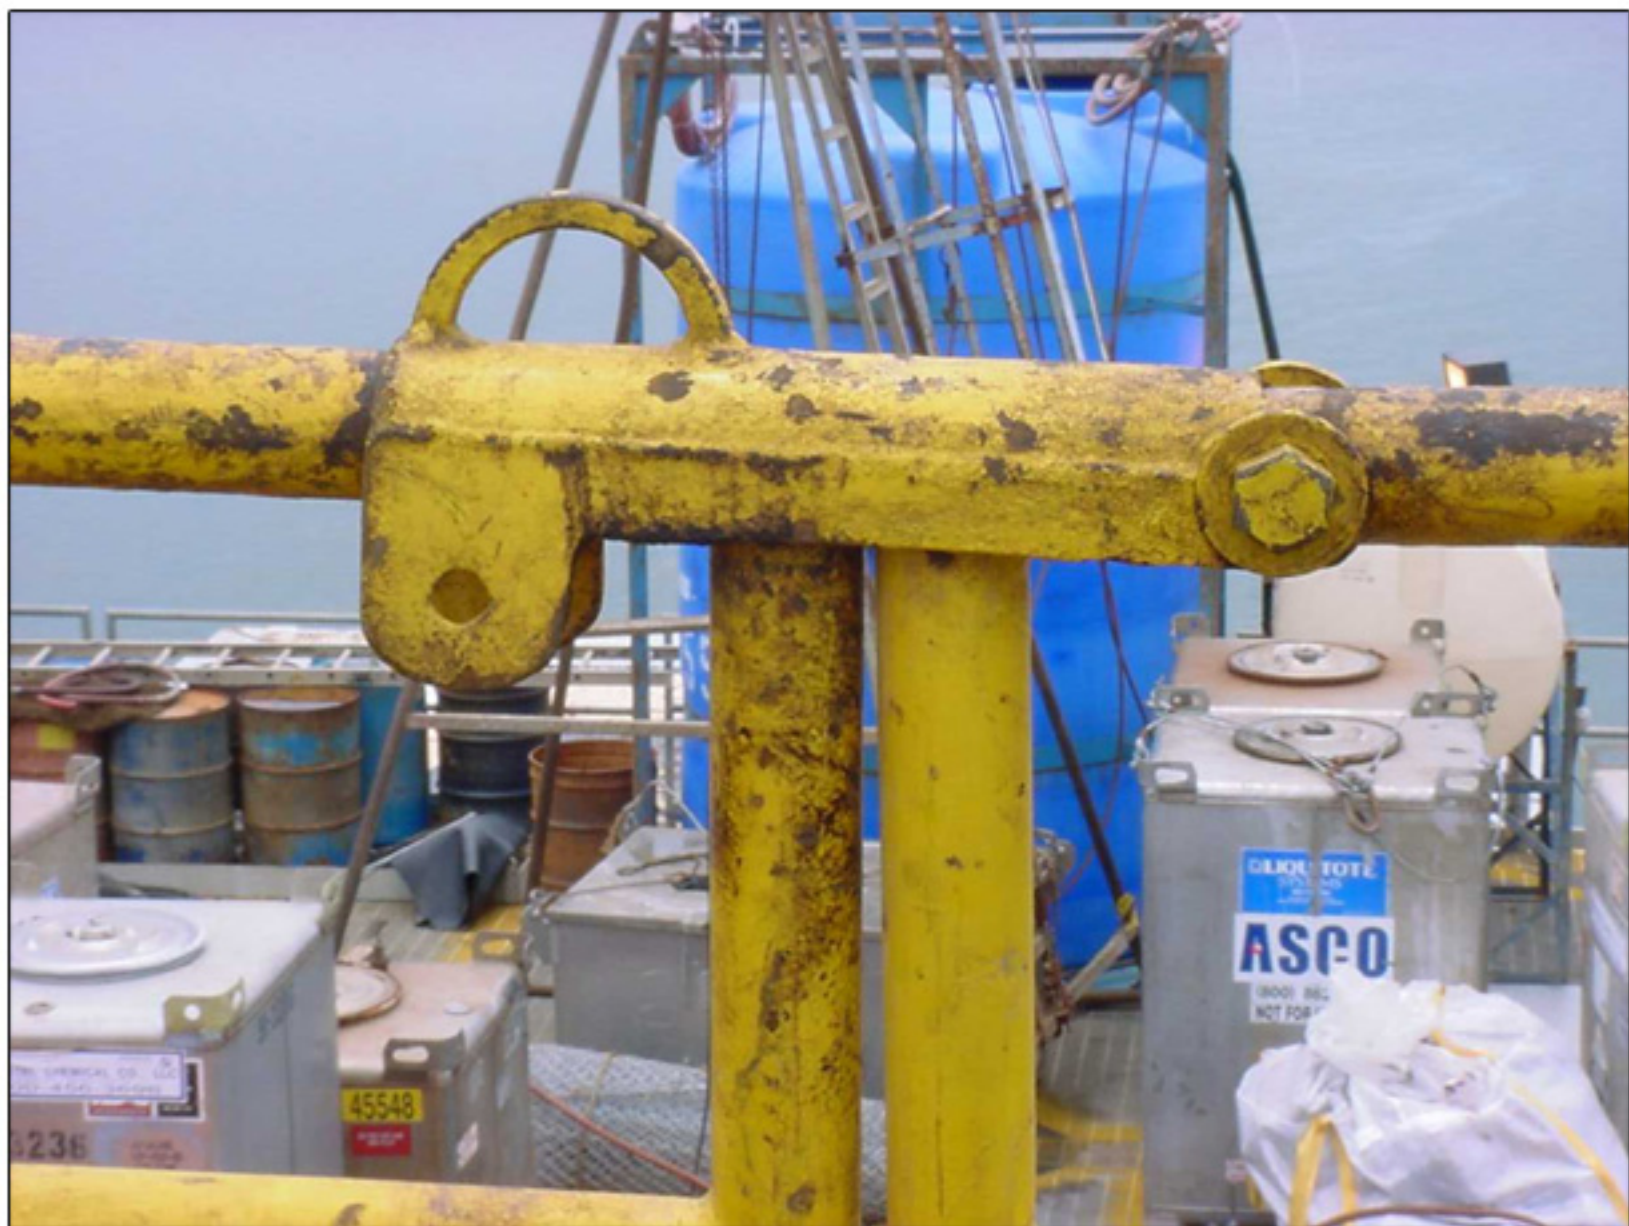
*Close View, Gate Fastener and Lock Hole*

**Cause** The fatal fall was caused by the inadvertent opening of the V-door gate. This inadvertent opening was allowed because of the unintentional raising of the Fastener, which kept the gates closed, and outward pressure on the gate by the driller, who apparently leaned back against the now unsecured V-door gate. The Fastener was apparently inadvertently raised by the movements of work personnel in the normal performance of their duties. Furthermore, the raising of the Fastener was allowed because of a failure to latch the Fastener positively with a pin or lock.
