**Investigation of Blowout
High Island Block A-368
OCS-G 2433
May 9, 2001**

**Gulf of Mexico
Off the Texas Coast**

**U.S. Department of the Interior
Minerals Management Service
Gulf of Mexico OCS Regional Office**

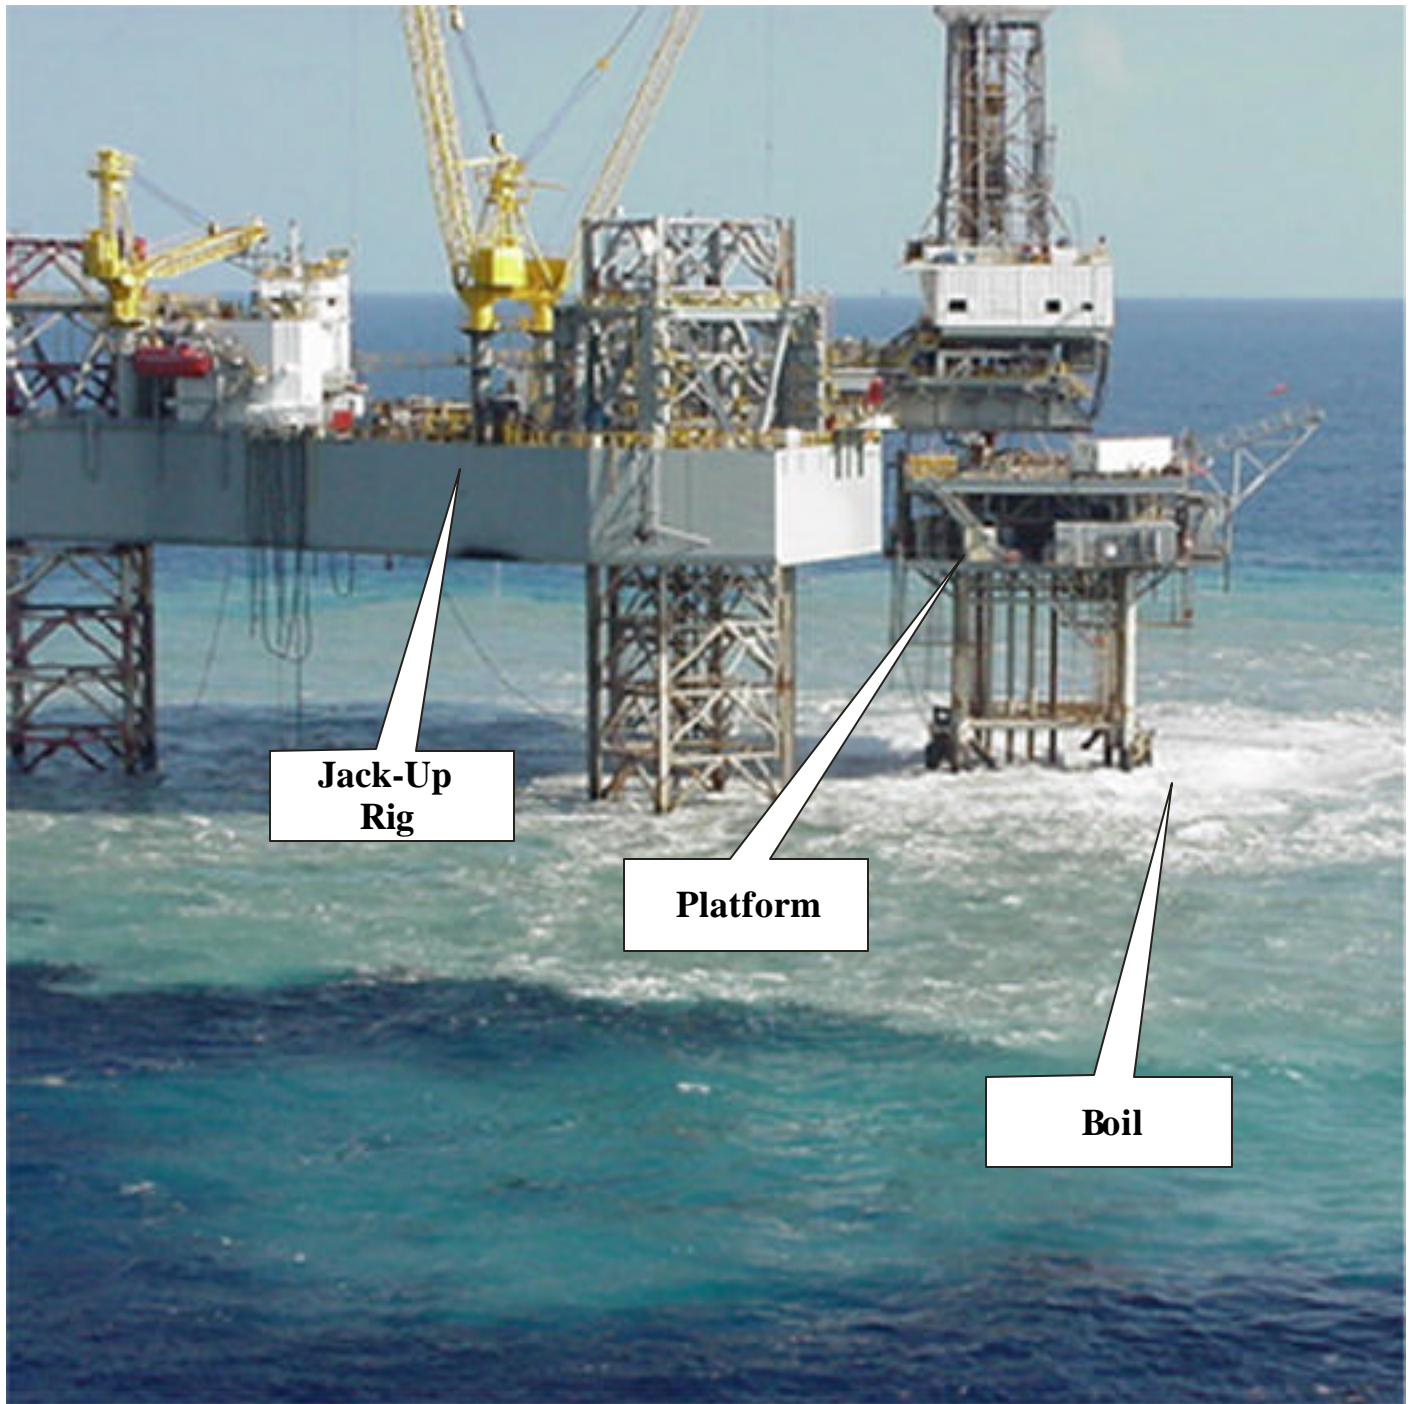
Photograph of platform and rig during gas flow to seafloor

Over a 45-minute period, beginning at 0645 hrs on Wednesday, May 10, 2001, 13 bbls were bled from the annulus. The pressure decreased to 20 psi. At 0730 hrs, gas belched from the annulus between the drive pipe and conductor casing of Well A-10. No activity was noted on the A-5 ST drive pipe. All production operations were shut in. The bubbling increased to a boil between the rig and the platform, and the rig was fully evacuated by 0900 hrs on Thursday May 10, 2001, some 45 hours after the cement job. The Lake Jackson District Office was notified at this time. The uncontrolled gas flow also caused a boil around the entire platform. *For photographs of the platform and rig during the flow of gas to the sea floor, see Attachment 2.*
