**Investigation of Loss of Control
Grand Isle Block 90, Well C-7ST
OCS-G 4003
November 14, 2002**

**Gulf of Mexico
Off the Louisiana Coast**

**U.S. Department of the Interior
Minerals Management Service
Gulf of Mexico OCS Regional Office**

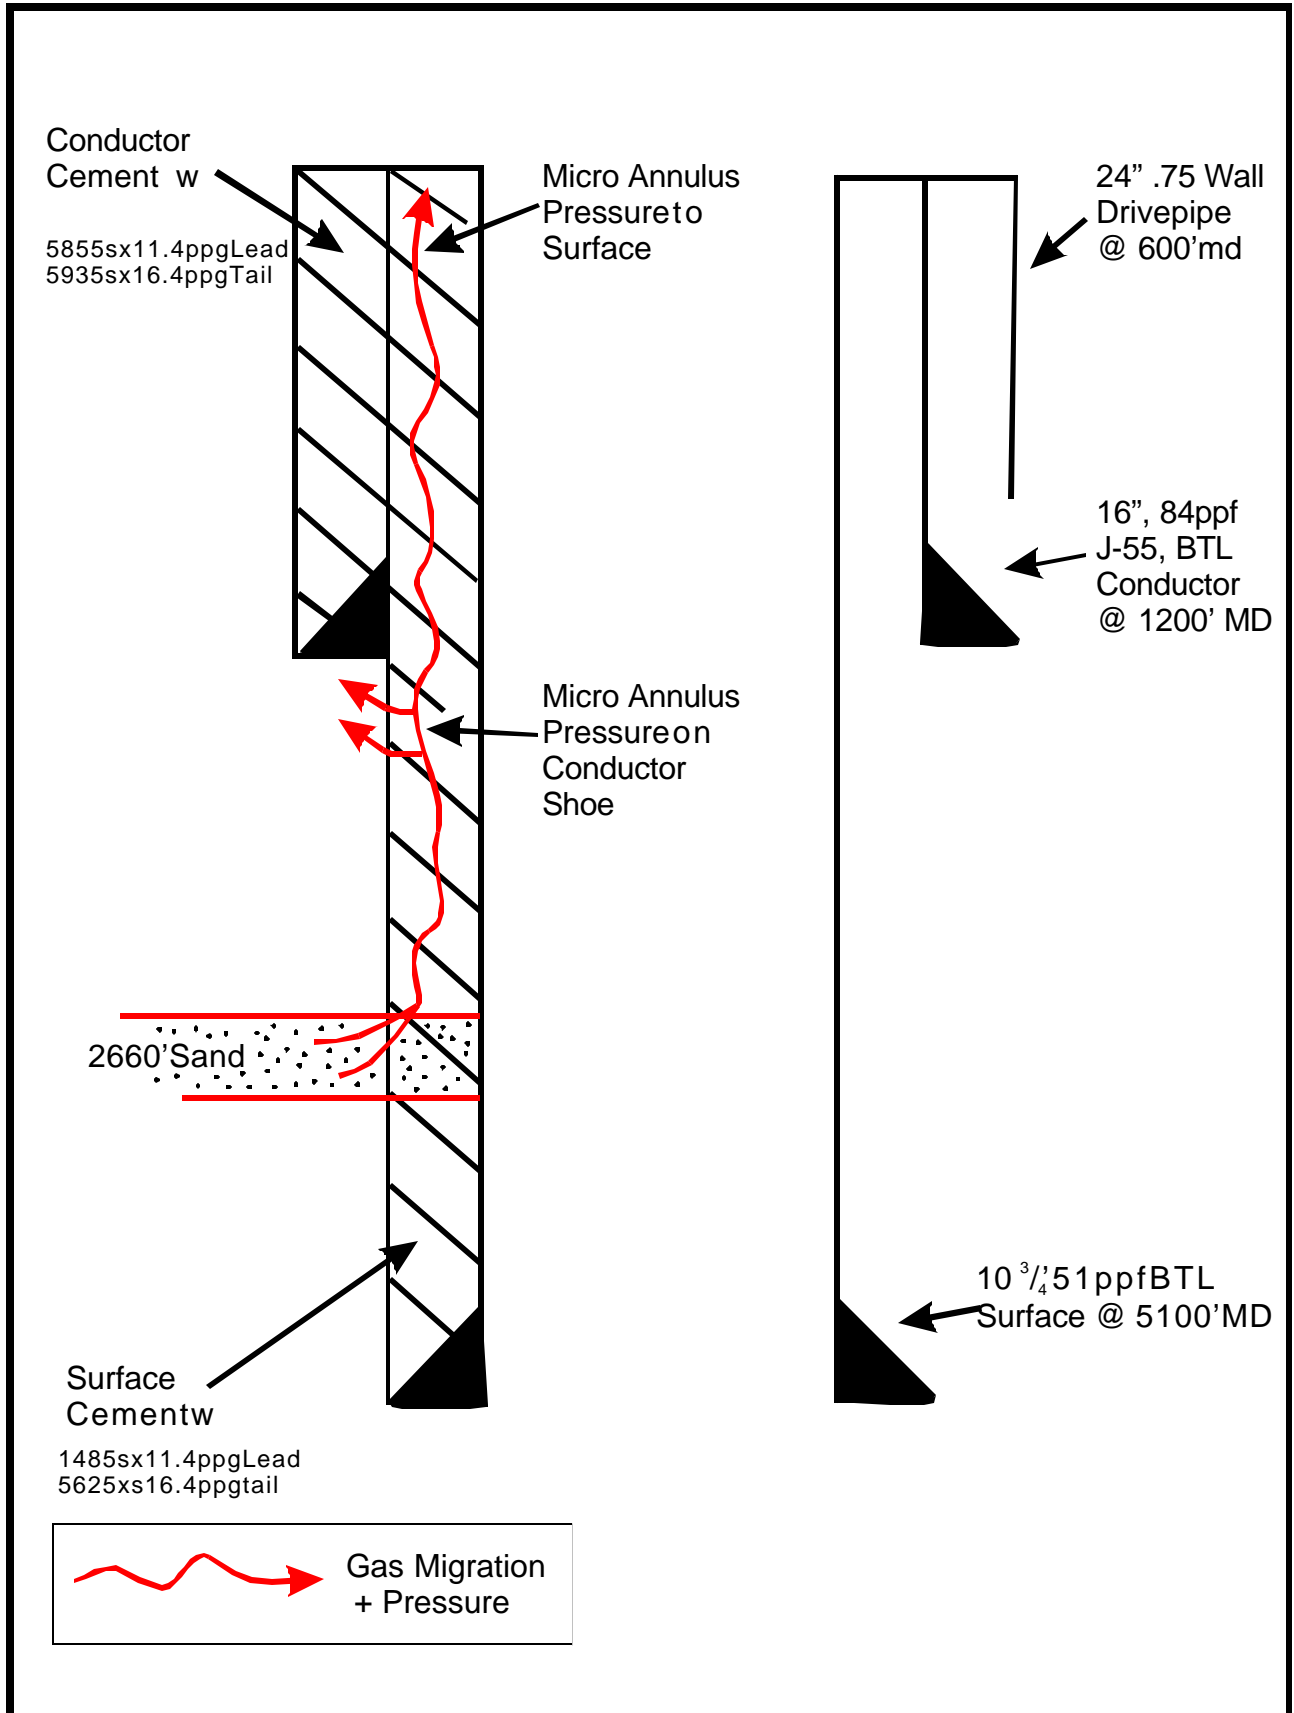
Grand Isle Block 90 C-7ST Well Schematic at time of LOC

In November 2002, the Rig was conducting directional drilling operations on GI-90 Well C-7 ST from the well's surface location on the "C" Platform of GI 93. Sixteen-inch conductor casing had been set at approximately 1,200 ft and cemented to surface. The well had been kicked off at approximately 1,200 ft and the angle had been built to approximately 60 degrees. The well had reached approximately 5,150 ft measured depth (MD). At 2300 hrs, 13 November 2002, surface casing was run to approximately 5,140 ft and cemented to surface with returns (*for well schematic at time of incident, see Attachment 2*).

The loss of control of the subject well was caused by an apparent micro-annulus created during the cementing of the surface casing. This micro-annulus allowed gas from the “2,660-ft sand” to migrate behind the surface casing, past the conductor casing shoe, and into the annulus (*see attachment 2*). Specific actions on the Rig allowed the pressure on the subsurface formations and the conductor casing shoe to rise to levels untested by drilling or leak-off. The subsurface pressure created the possibility of breaching to the surface.

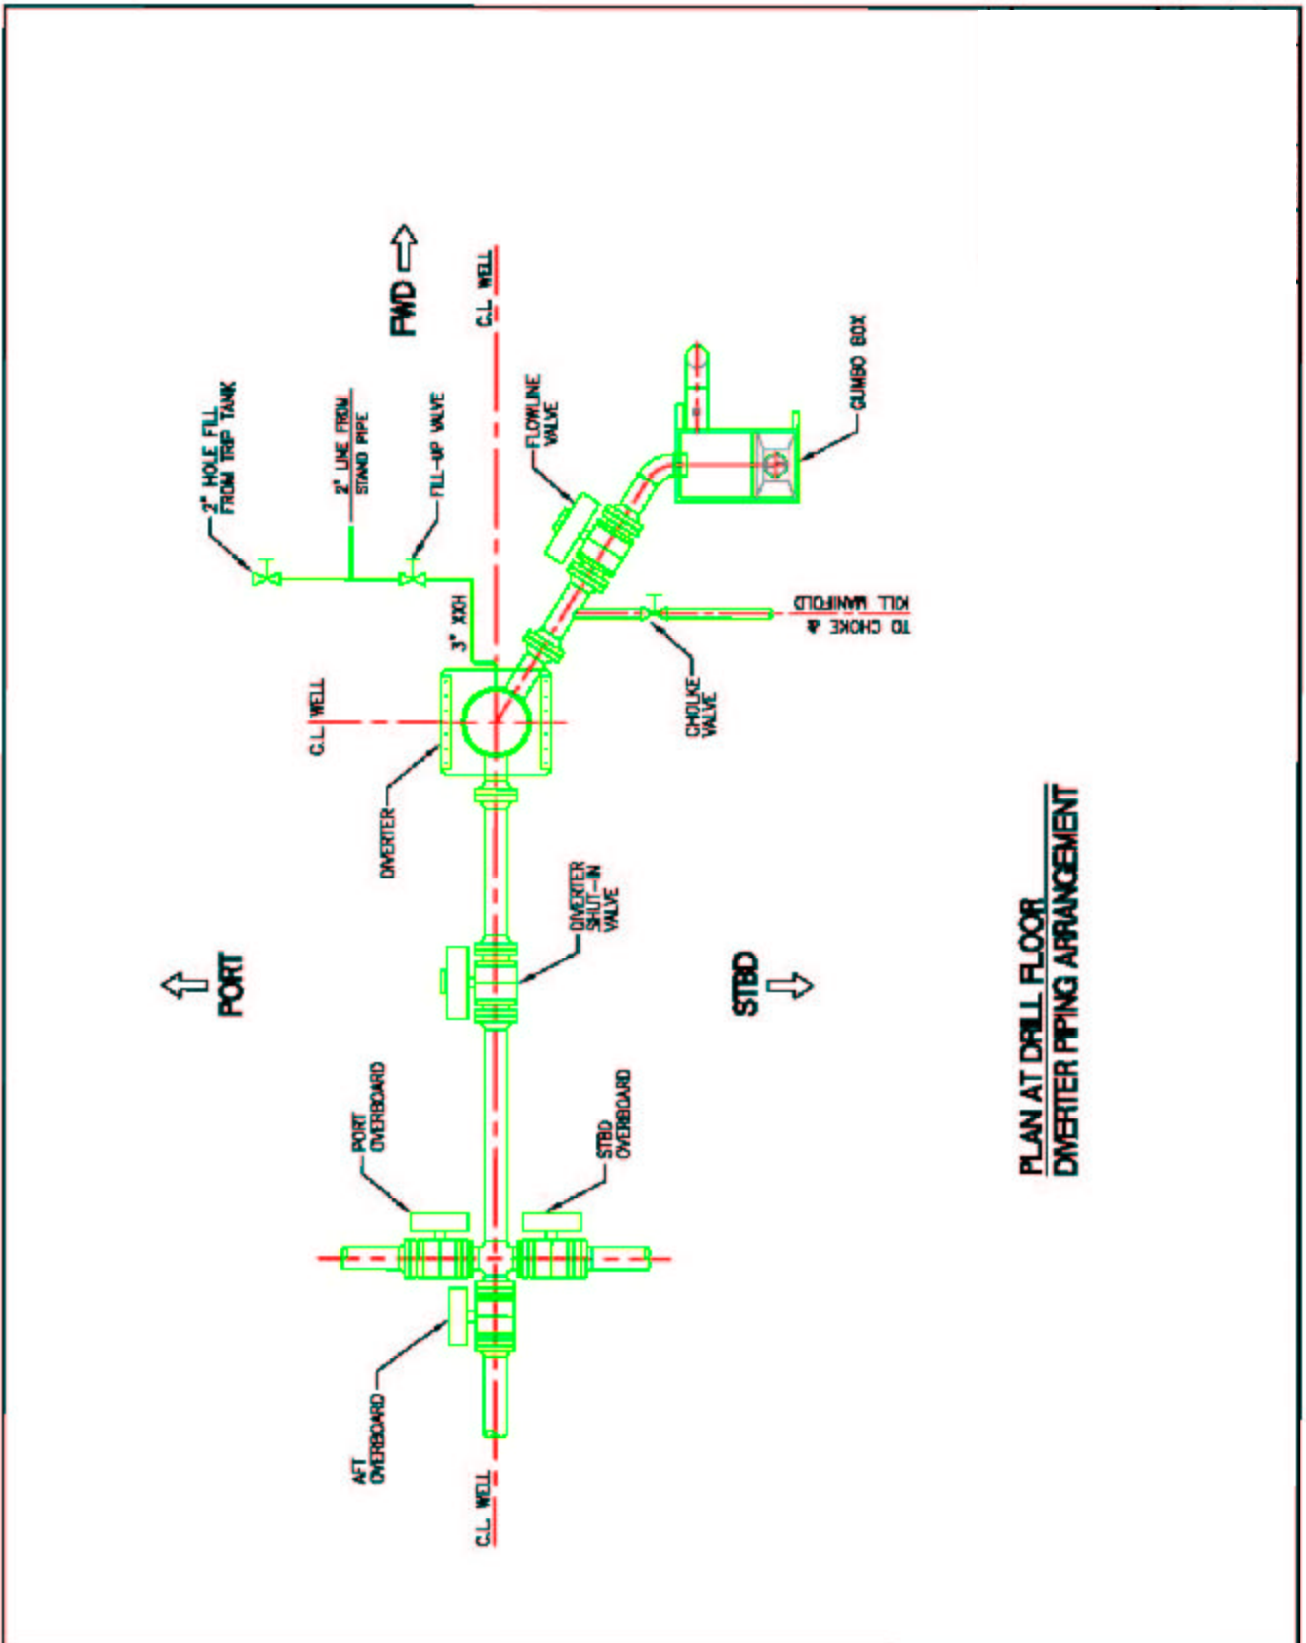
Diverter Piping Arrangement

0245 hrs – Shut well in by placing diverter in “test” mode. Pressure increased to 400 psi. Diverter flowline seals started to leak. By using the lines connecting the diverter housing to the choke manifold (*see Attachment 3*), pressure was twice bled back to 350 psi. Pressure built back to 400 psi both times with increasing flow and fluid returns. Pressure increased to 580 psi, flowline seals leak increased. When gas was detected on the Rig floor, the crew abandoned the floor, leaving the system in the “test” mode. Attempts were made to open diverter ventline valves from tool pusher’s remote station to relieve pressure. Remote would not override “test” mode and open the diverter. It was also found that the diverter flowline seal pressure could not be

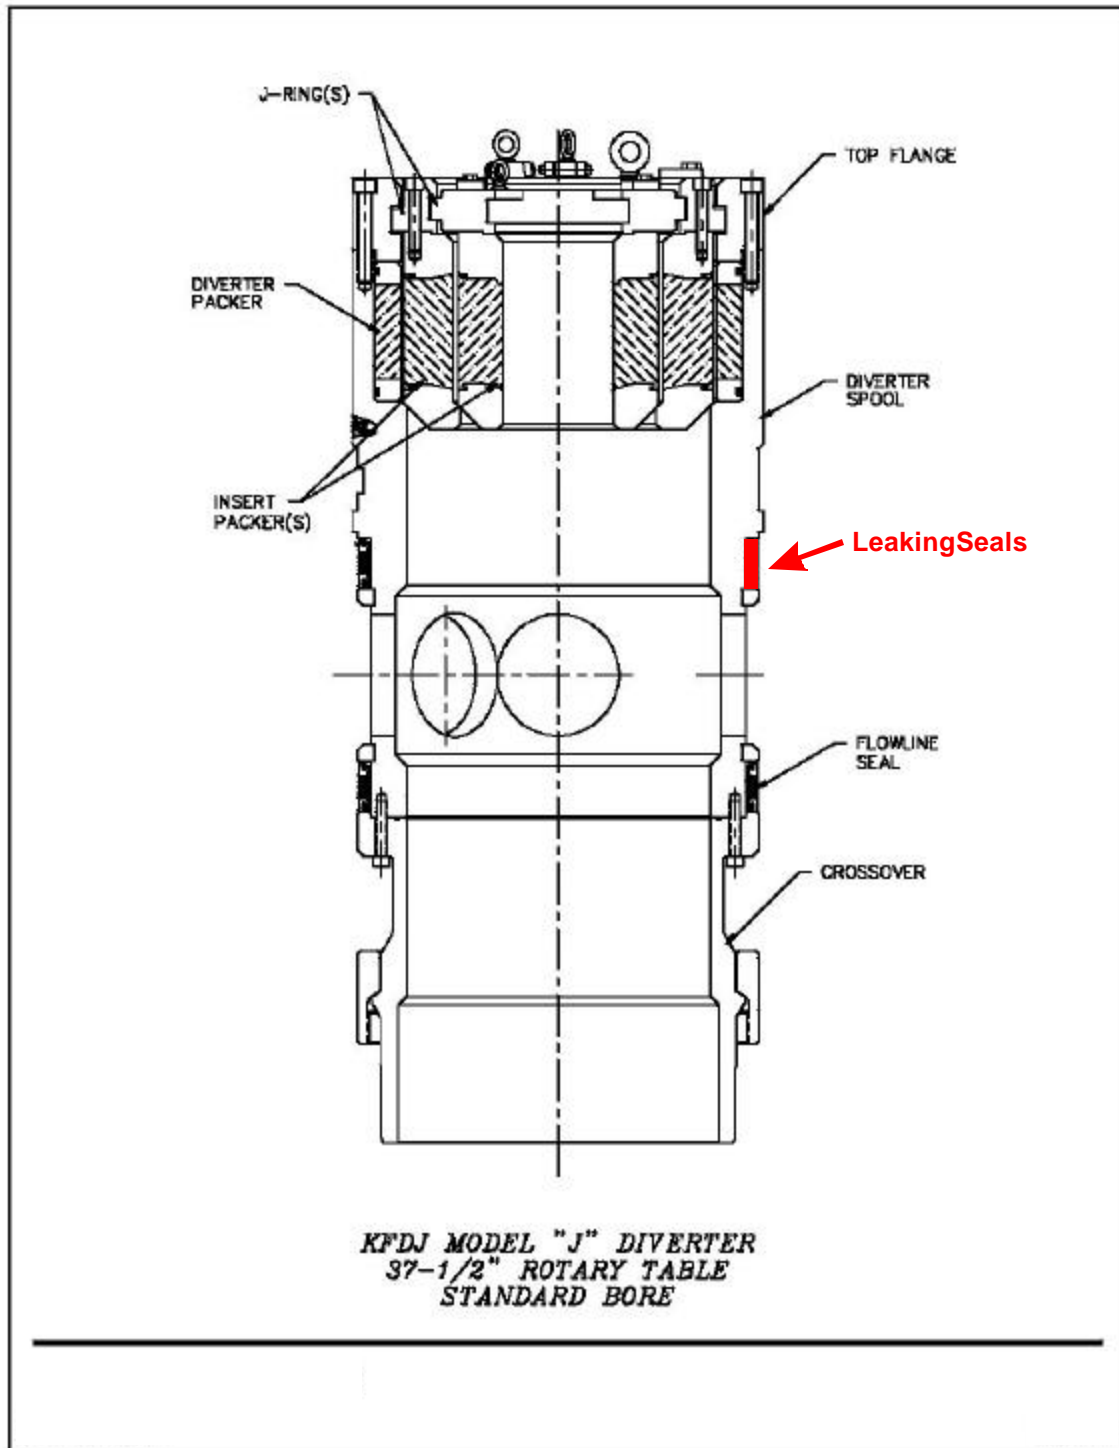
Schematic of diverter and source of leak.

The leakage of gas through the diverter flowline seals of the KFDJ diverter system onto the Rig floor created the actual surface loss of control. It is not known for certain why the diverter flowline seals failed to contain the pressure. However, after the leak in the seals was confirmed, the crew failed to contain the leak by raising the hydraulic seal pressure because of uncertainties about pressure limitations of the seals.

It is not known exactly what caused the flowline seal leak. However, it is possible that the flowline seal pressure was set at 260 psi, as that is the pressure found when the Rig floor was accessed during kill operations. Because the annular pressure is reported to have reached as high as 580 psi, the inability of seals set at 260 psi to contain that pressure is a possible cause of the leakage. It is also possible that the intermittent leak of the diverter flowline seals was related to compression and tension forces transferred to the seal elements by the rocking motion of the Rig. These forces, when added to the casing pressure, possibly created an intermittent leak by momentarily causing the shut-in pressure of the seals to be exceeded as the Rig swayed.

the driller's console control to raise the hydraulic pressure of the flowline seals from 260 psi to 350 psi, successfully containing the surface leakage.
