**Investigation of Fall with Fatality  
High Island Block A-368  
OCS-G 02433  
June 5, 2003**

**Gulf of Mexico  
Off the Texas Coast**

**U.S. Department of the Interior  
Minerals Management Service  
Gulf of Mexico OCS Regional Office**

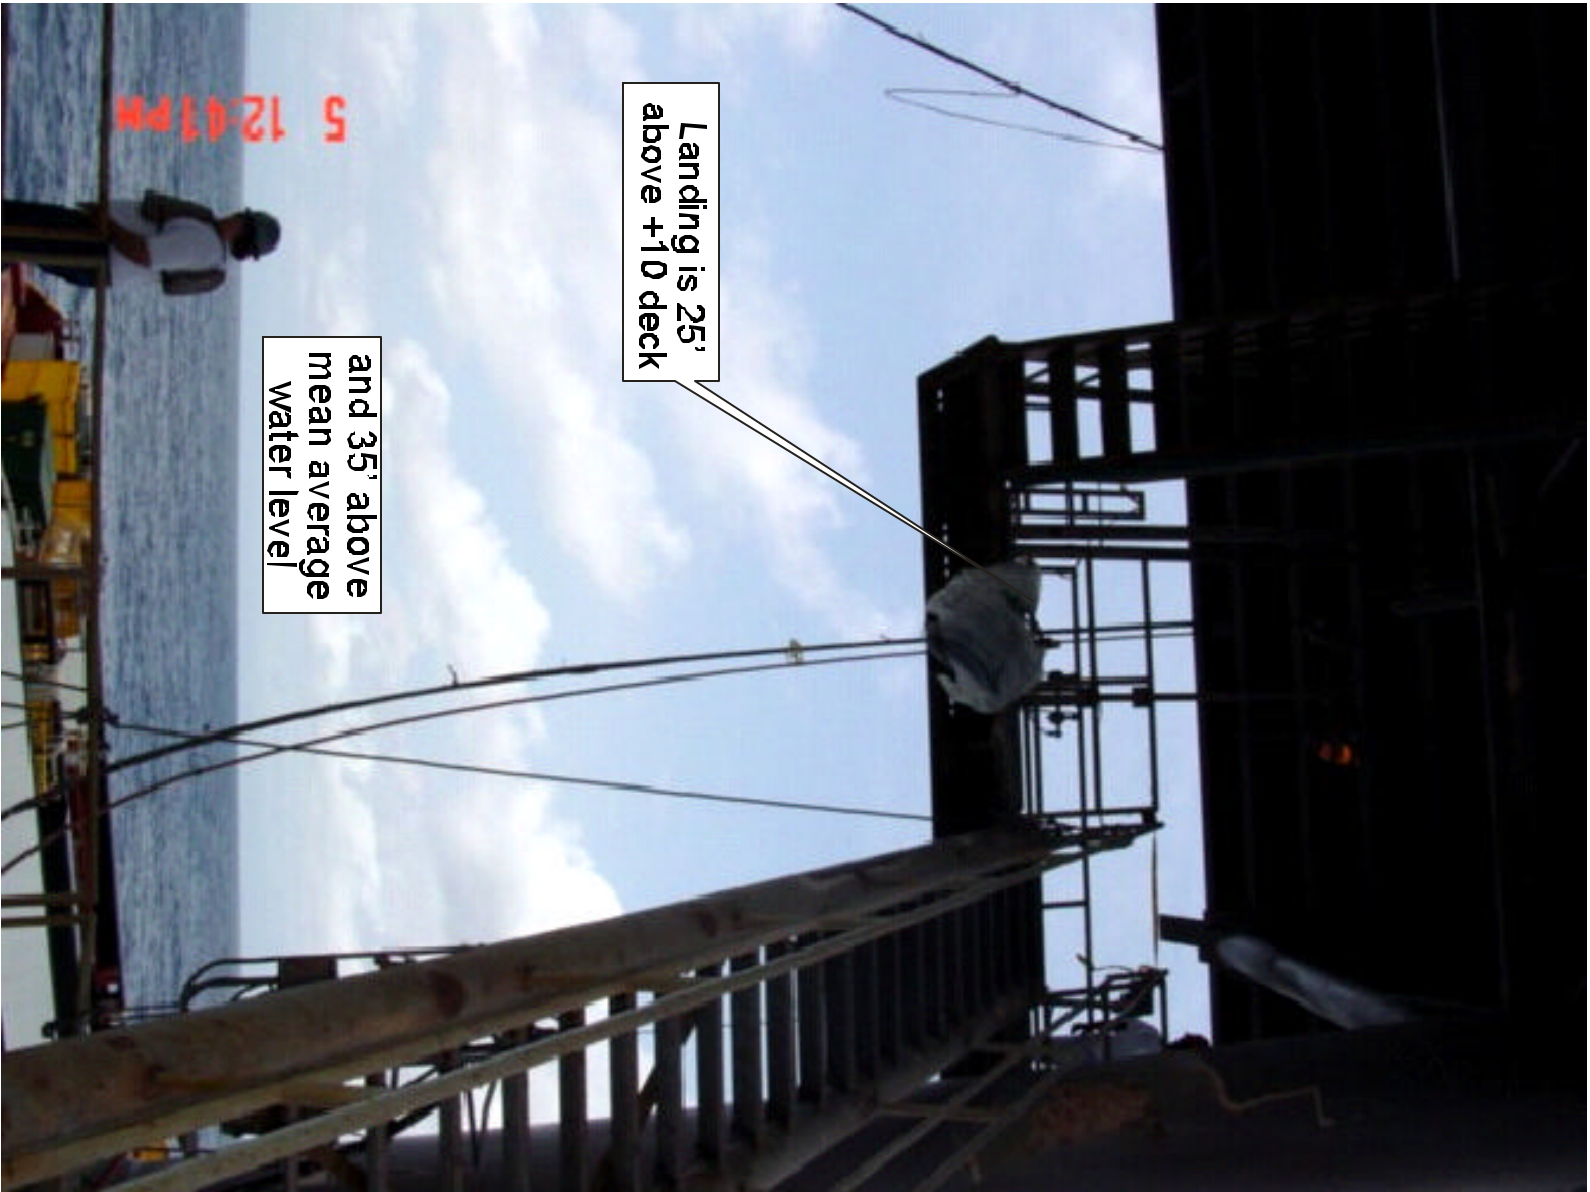
Photograph of stairway landing

The fixture in question extended approximately 2-1/2 feet from the landing of a stairway that leads to the skimmer deck. The stairway landing is approximately 35 feet above the water level, and therefore approximately 25 feet above a 24-inch beam at the plus 12 level. *For a photograph of the landing, see Attachment 3.*

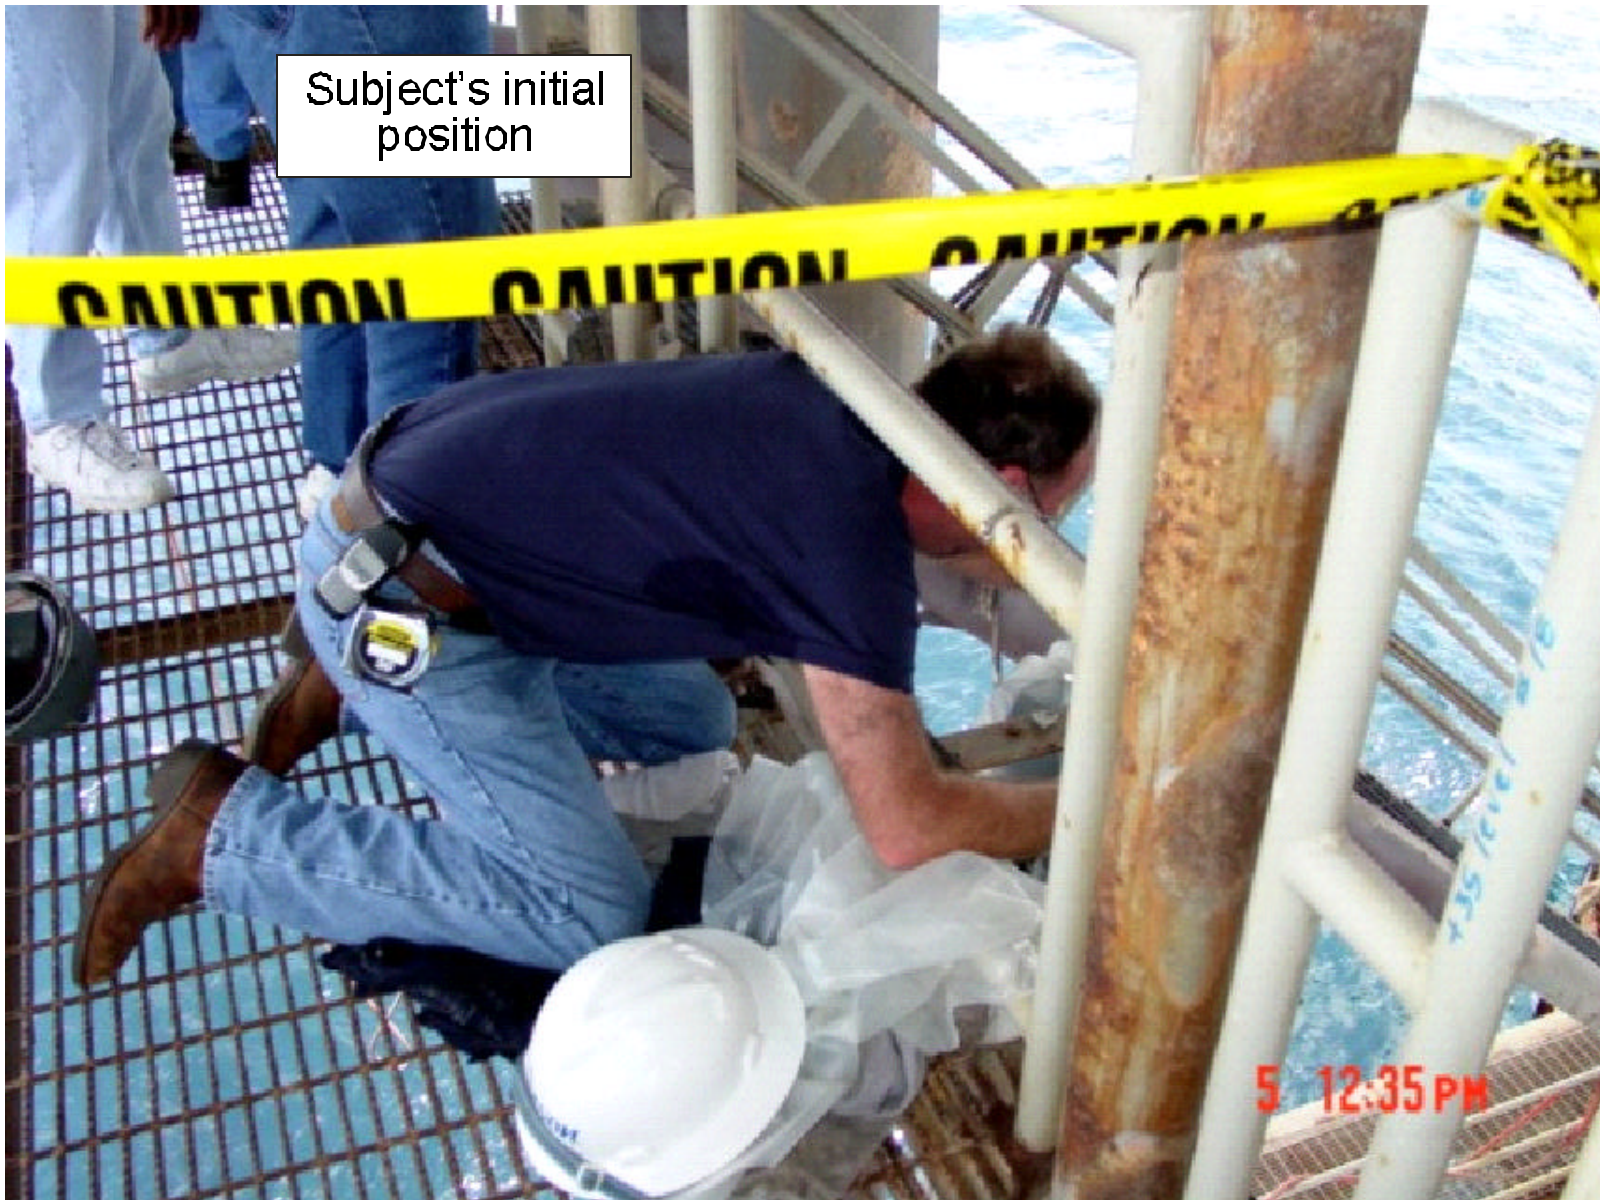
Photograph of employee position simulation

According to the statement given by the MSP supervisor, as he was making his rounds after the safety meeting checking on sand blasters, he saw the MSP employee stretching out through the guardrail and attempting to wrap the light fixture. He called to the employee for the purpose of informing him to put on his PPE, “full body harness and work vest.” He states that the employee looked up at him and pushed out farther to wrap the light. He states that at that moment the light fixture broke and that the employee fell through the guardrail. He states that the employee held on for “a few seconds” before falling, hitting the plus ten deck, and falling into the water. Records indicate that these events occurred at approximately 0630. *For a photograph depicting a simulation of the employee’s position at the time of the accident, see Attachment 4. For a photograph showing the various pertinent levels of the platform, see Attachment 5.*

It is concluded that, when the contractor employee leaned out through the walkway handrails in an attempt to wrap the light fixture with plastic, his center of gravity extended beyond the walkway, with most of his weight being supported by the light fixture. Consequently, when the light fixture gave way, the employee fell through the guardrails for a distance of approximately 23 feet before striking his head on a plus 12 level beam and subsequently falling into the water. It is further concluded that the employee was instructed by his supervisor to use the spider and PPE in performing his task.

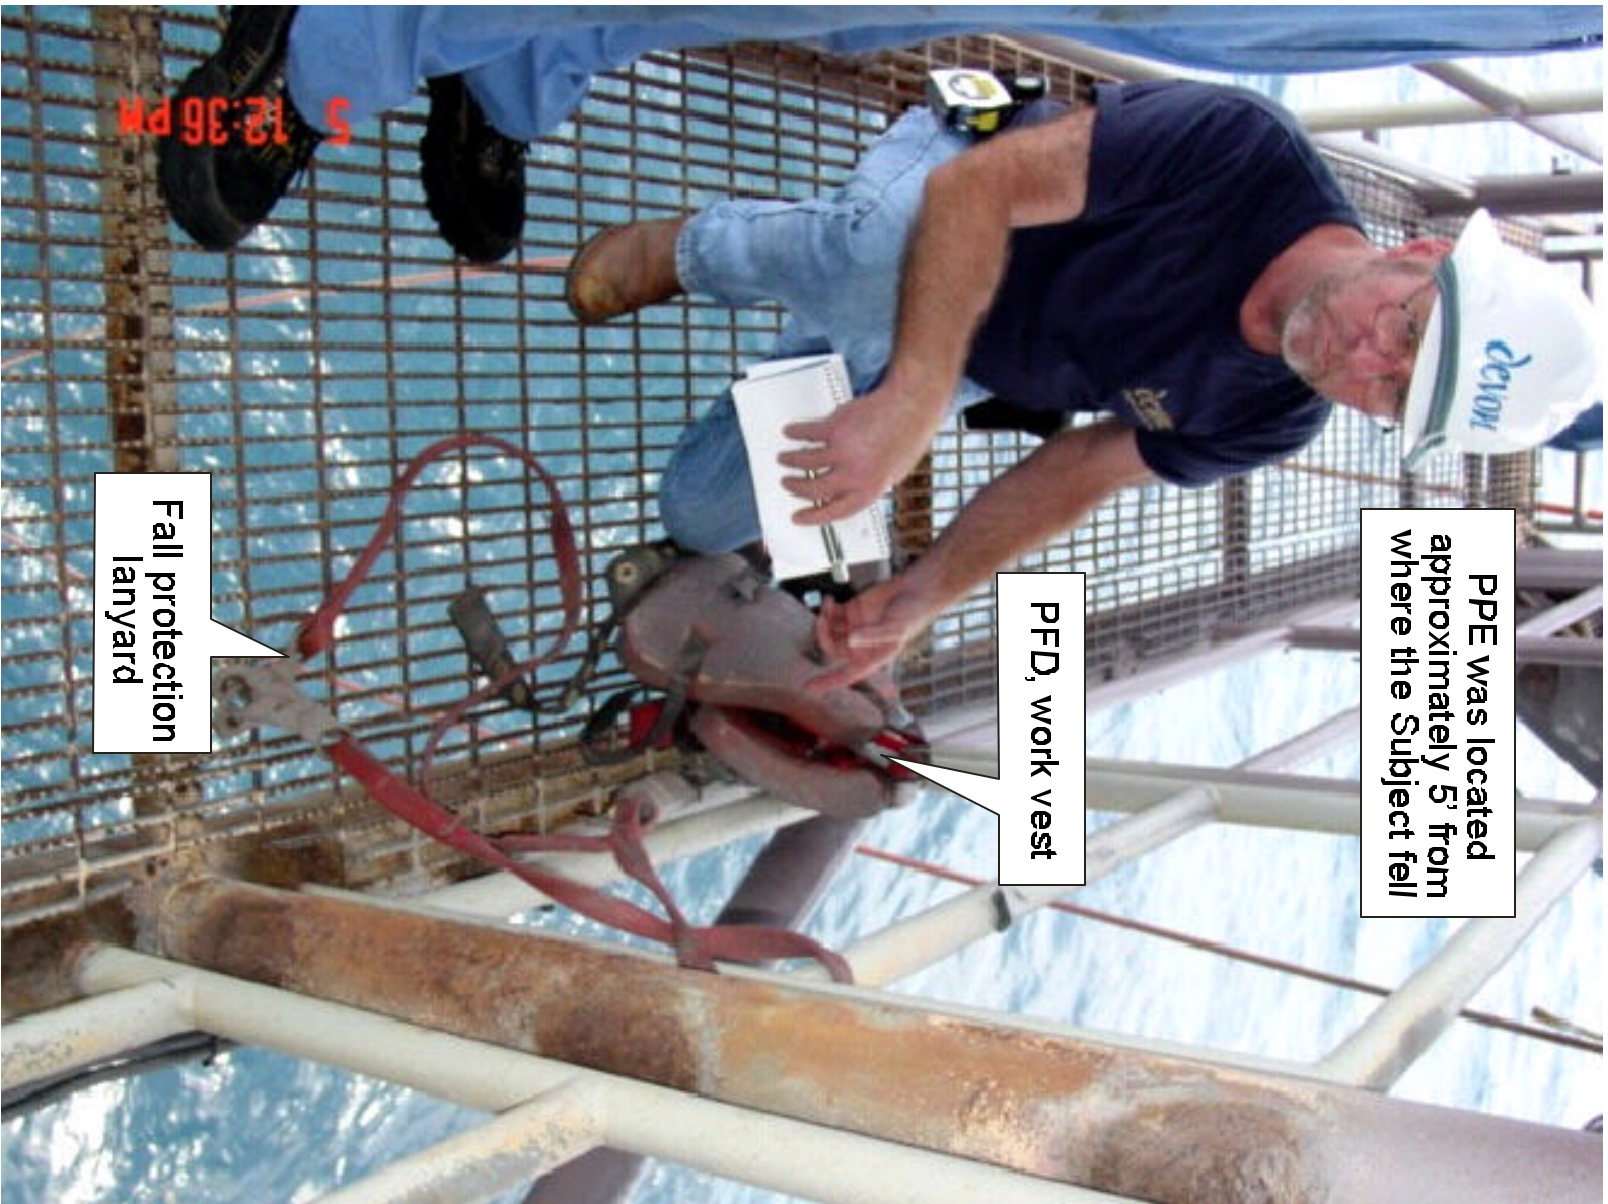
Photograph of post accident scene

An examination of the accident scene revealed that the deceased employee's PPE was located approximately 5 feet from the location on the landing from which the deceased fell. *For a photograph of the post-accident scene, see Attachment 6.*
