**Investigation of Loss of Well Control
Eugene Island Block 107, Well B-1 Workover
OCS-G 15241
8 March 2003**

**Gulf of Mexico
Off the Louisiana Coast**

**U.S. Department of the Interior
Minerals Management Service
Gulf of Mexico OCS Regional Office**

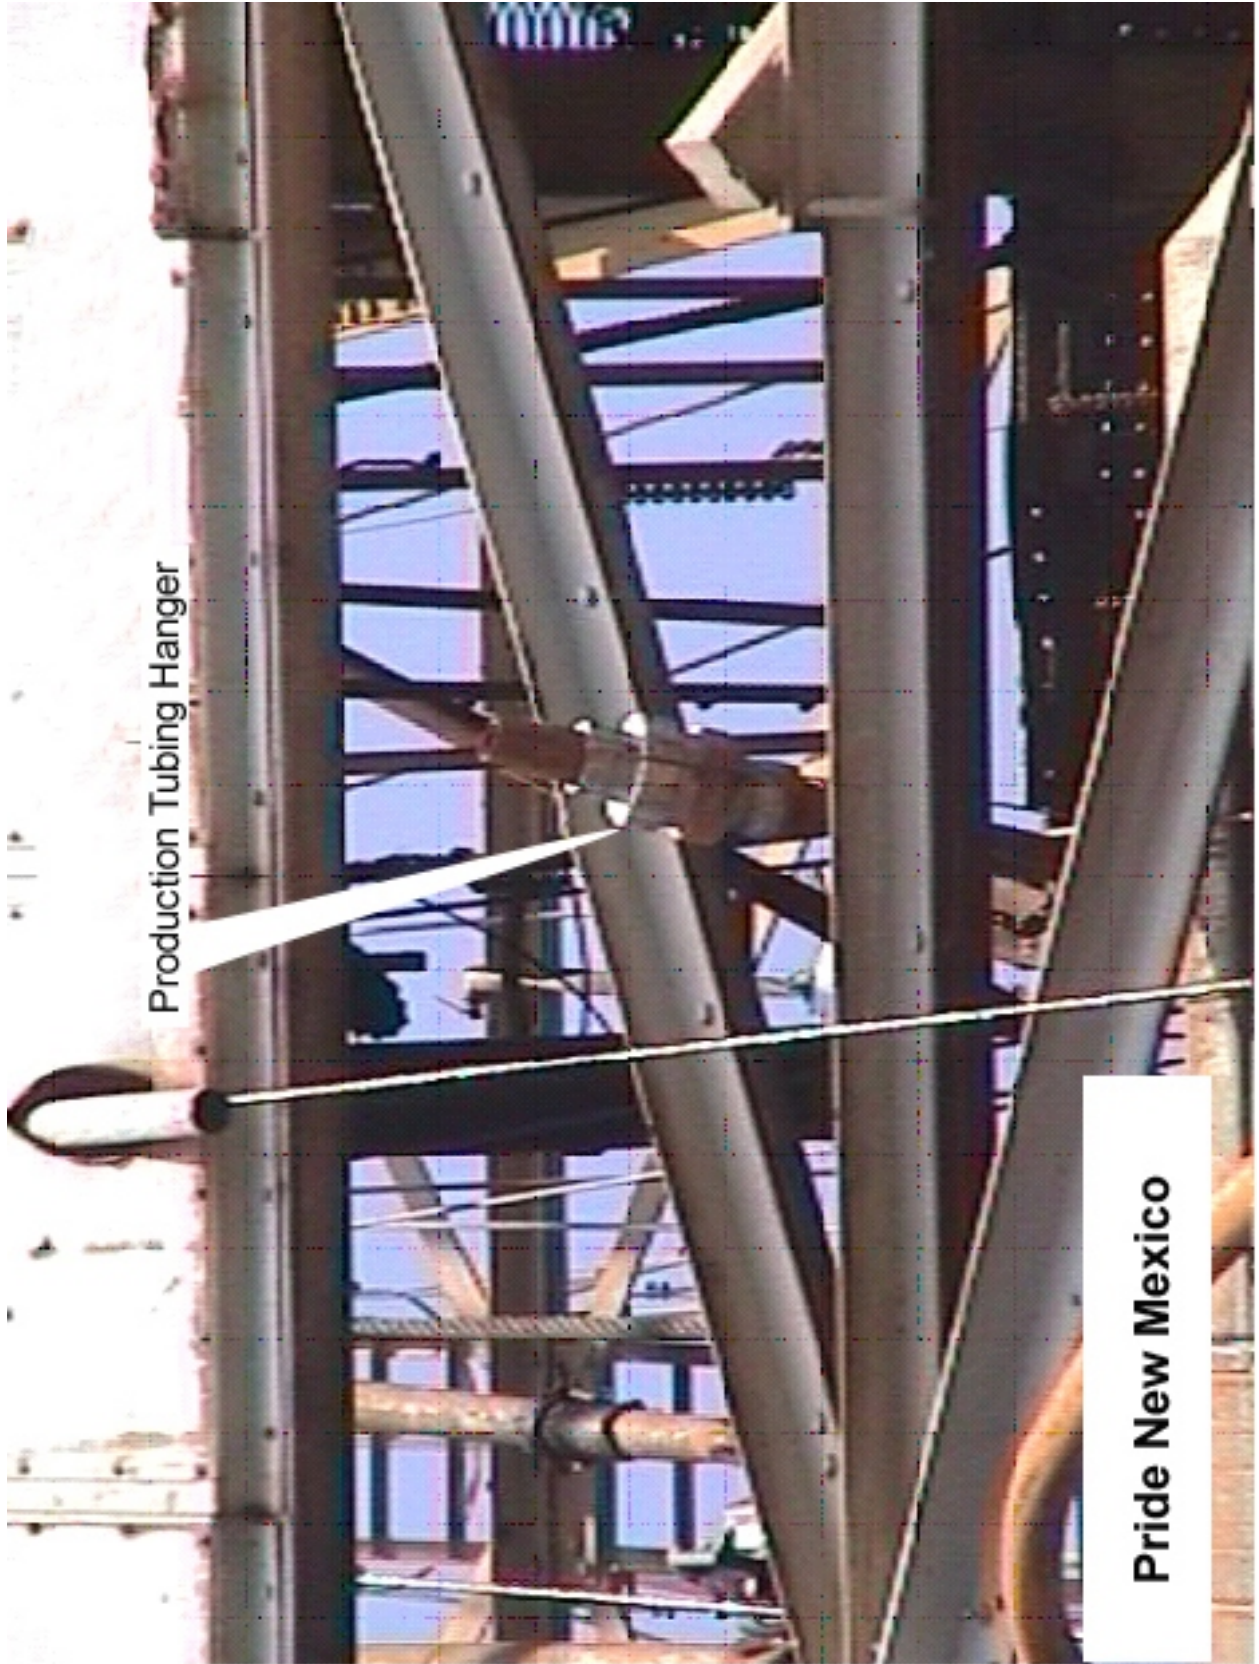
2245 hrs - Pressure on the hanger rose above 6,000 psi. During attempts to control pressure by bleeding, and during preparations to swap valves to lubricate annulus, the hanger and tubing attached to it were suddenly ejected from the wellhead. The ejection was followed by an uncontrolled flow of gas, water, condensate, blowing as high as the crown block, according to testimony. The hanger was later found lodged near the crown block within the derrick (*see Attachment 3*). Approximately 600 ft of 2 7/8-inch production tubing and the surface controlled subsurface safety valve (SCSSV) were found to be wrapped around and through the derrick (*see Attachments 4-6*).

Eugene Island Block 107, Well B-1, Hanger Ejected from Well into Derrick

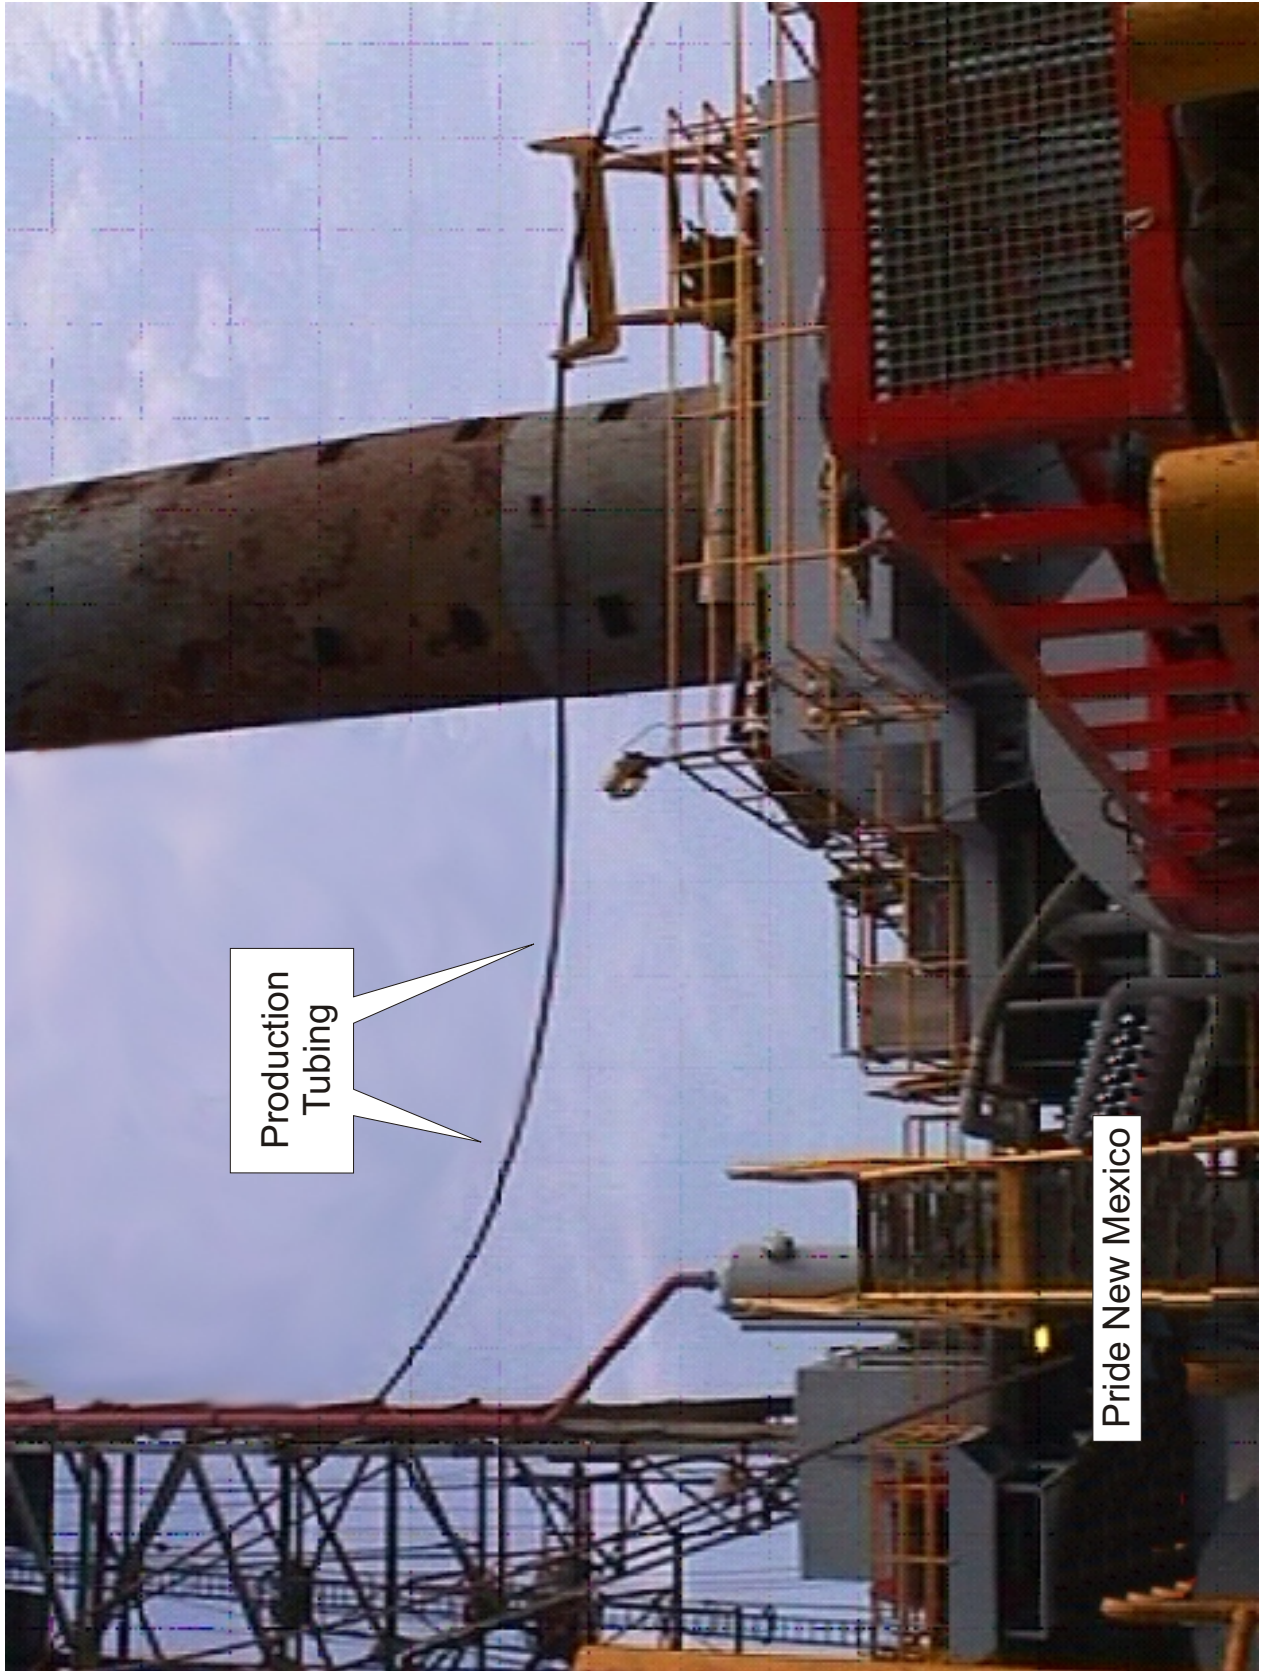
Eugene Island Block 107, Well B-1, Ejected 2 7/8" Tubing

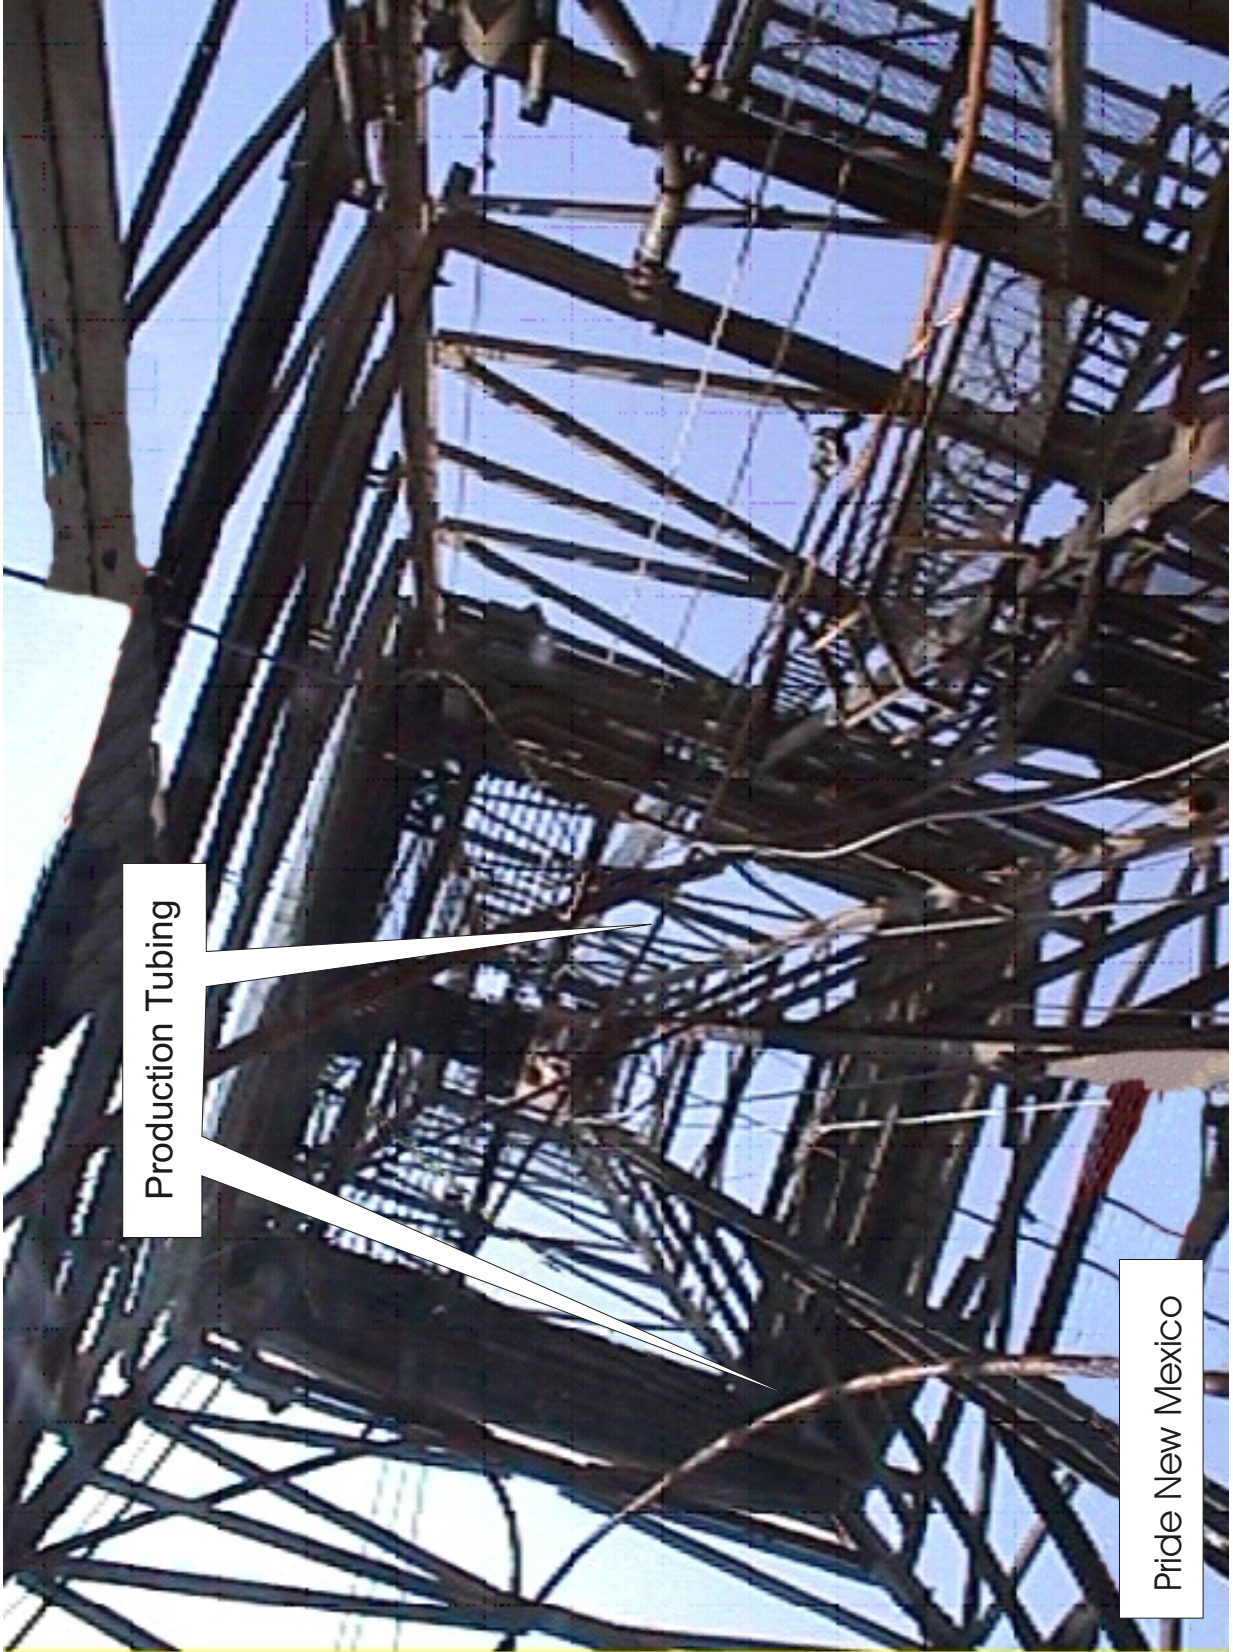
Eugene Island Block 107, Well B-1, Tubing Ejected into Derrick

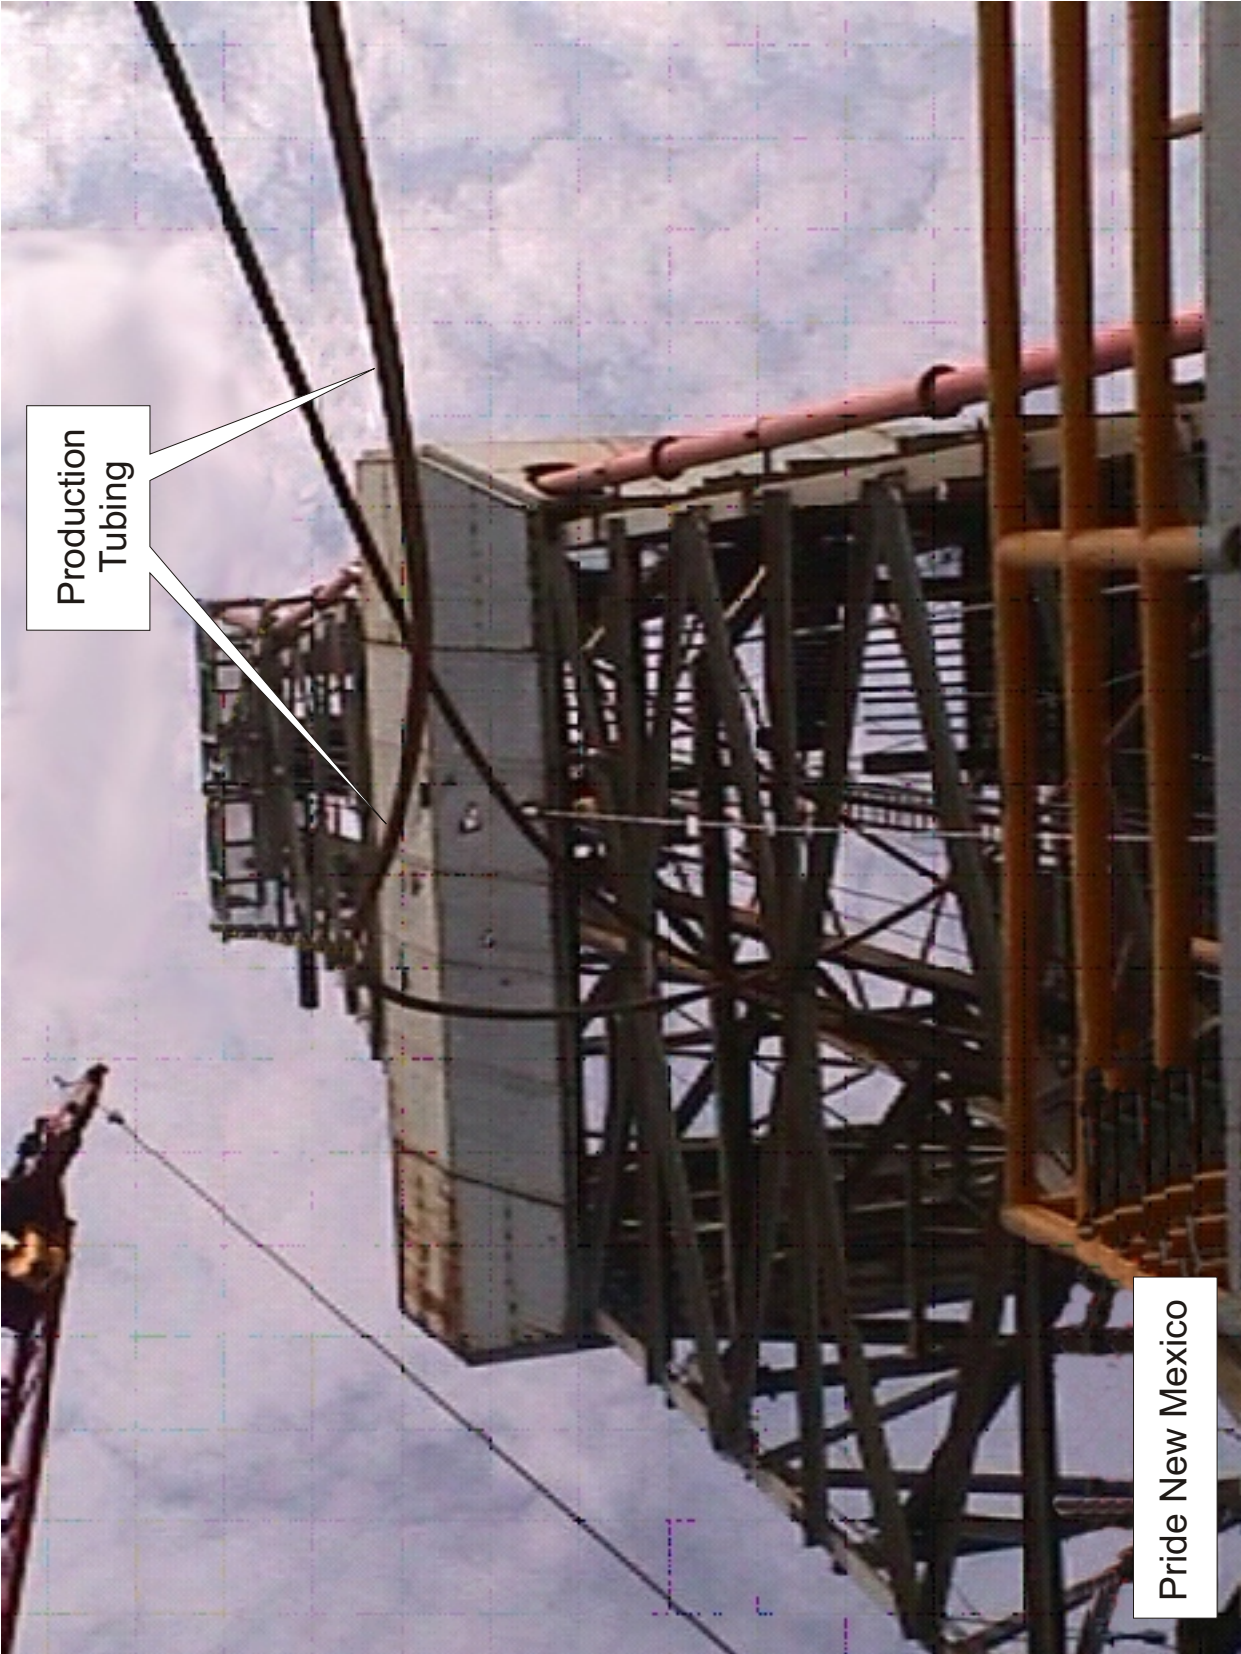
15 – 16 March – Found top of tubing fish at 2,050 ft, grappled tubing, ran wireline to 5,078 ft. Approximately 284 ft of 2 7/8-inch production tubing remained unaccounted for and, according to testimony, was assumed to be blown overboard after being ejected by the force of the uncontrolled flow.

Eugene Island Block 107, Well B-1, Tubing Ejected from Well
Outside of Derrick

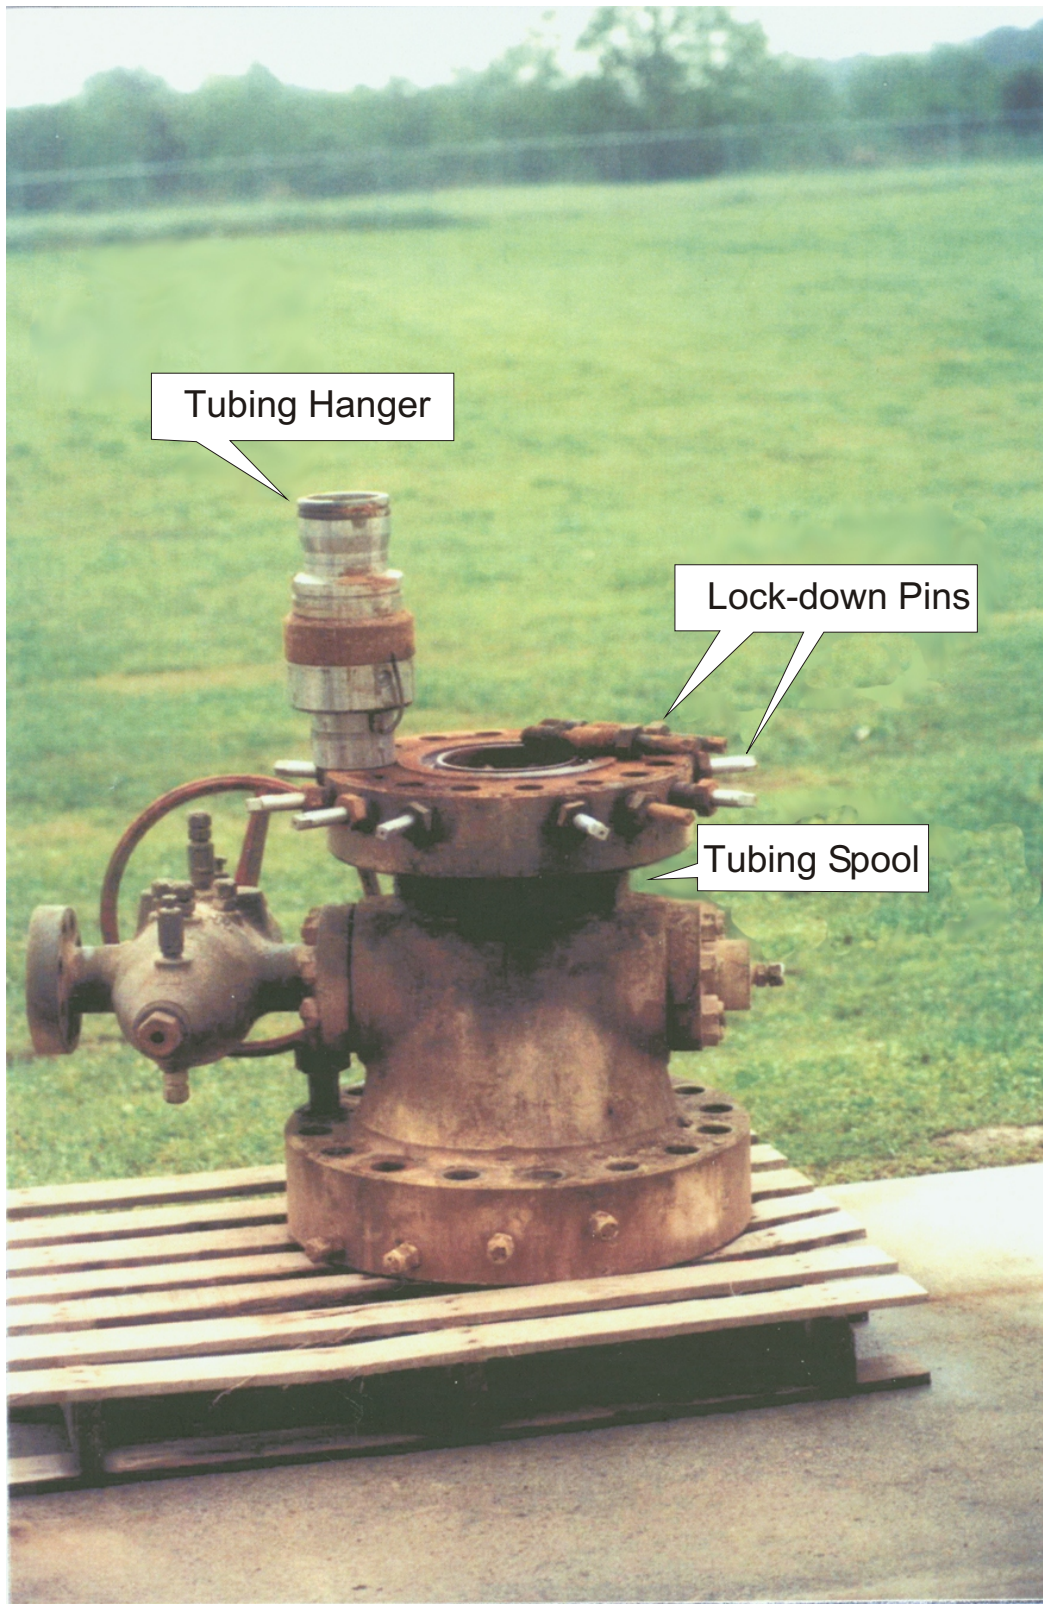
The cause of the ejection of the hanger and tubing was the subject of an internal Operator investigation in conjunction with an investigation by the Manufacturer of the hanger. These reviews determined through inspection of the tubing hanger spool and tubing hanger lockdown lock screws (or hold-down pins) that the hold-down pins holding the tubing hanger in place failed when the pressure reached approximately 6,100 psi (*see pictures, Attachments 7, 8 and 9, diagrams, Attachment 10 and 11*).

The manufacturer's representative had replaced the 12 pins, 3 at a time, six hours prior to the advent of pressure, to manufacturer's specifications according to testimony. However, the pins obviously failed to hold the hanger in place under the well conditions encountered and were found to have their noses sheared off. The pins removed prior to the failure were not sheared. Furthermore, the tubing hanger showed evidence of scraping against the sheared lock screws as it was ejected (*see Attachments 6, 7, and 8*).

Tubing Hanger, Spool, and Lock-down pins from EI Block 107, Well B-1

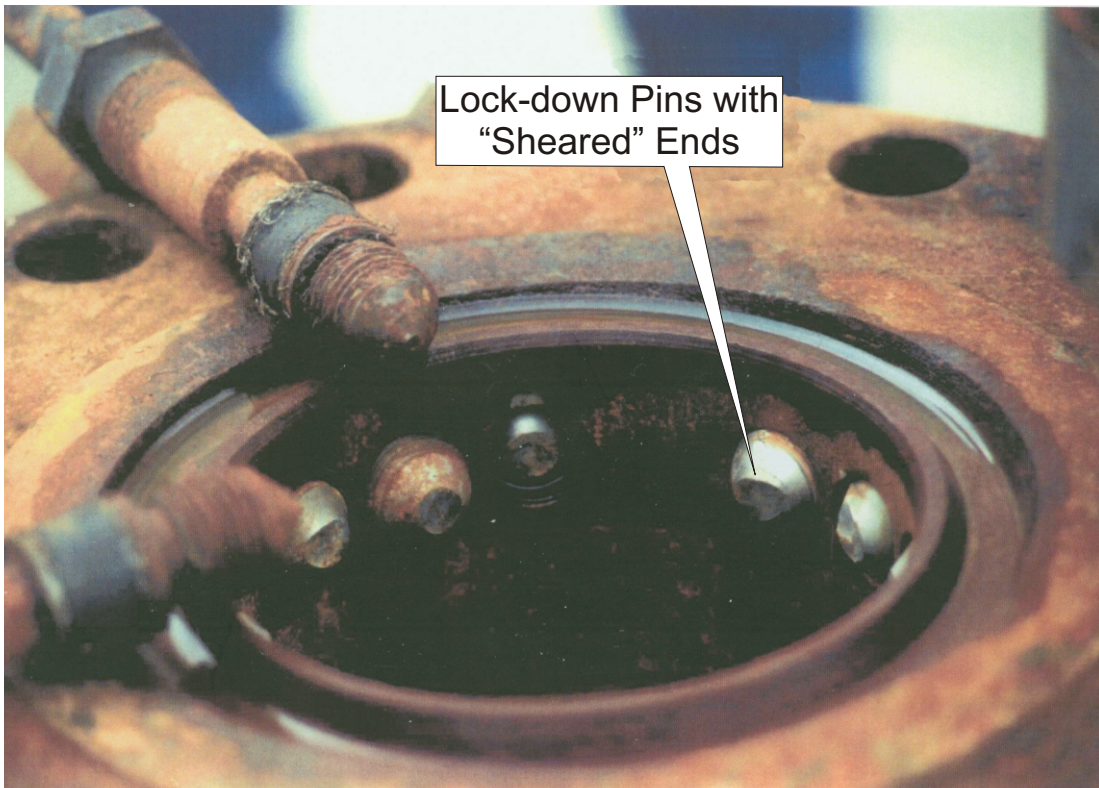
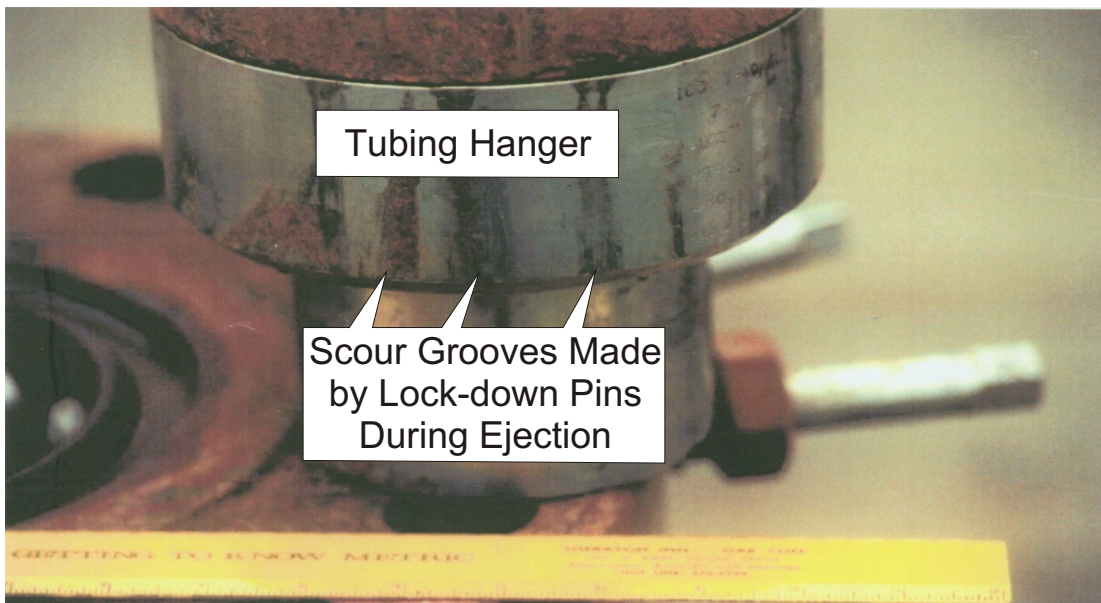
However, in the B-1 well, shortly after the annulus pressure in the wellbore rose above 6,000 psi, the nose of the hold-down pins retaining the hanger in place sheared off (*see pictures, attachment 8 and 9*). The failure allowed the ejection of the hanger followed by loss of well control. According to well service reports, shortly prior to the failure, the hold-down pins of the hanger had been replaced by a representative of the hanger manufacturer, torqued and the settings were re-checked. The hold-down pins hold the tubing hanger in place and energize the sealing elements of the hanger as shown in *Attachment 11 and 12*.

The engineering firms reported back to Operator that the lock-down (hold-down) pins holding the hanger in place failed by shear forces placed on the hanger by the annulus pressure greater than 6,000 psi. Further, the engineering analysis found that the pins as installed would have been expected to fail at about a pressure of 6,100 psi, even though the hanger was rated to contain up to 15,000 psi. A conclusion of the metallurgic and failure studies also found that the reason the pins failed "*was the result of only partial engagement between the [hold-down pins] and energizing ring of the tubing hanger. At the time of failure, the [hold-down pins] were at 39 percent of full engagement. [The engineering report] conclude[d] the partial engagement of the [hold-down pins] was the major contributory factor to the failure.*"

The report also indicates the reason for the failure of the hold-down pins to engage the energizing ring fully. It says, "*the calculated engaged length of the [hold-down pins] (0.173 inches) at failure conditions agrees well with the difference between the nominal drawing dimension for overall length and the measured length of [hold-down pins] (.015-.017 inches) which were sheared in the failure. ... Full engagement of the [hold-down pins] (0.438 inches) is necessary to satisfy the [manufacturer] design criterion for shear (0.53 of yield strength) at the rated working pressure of 15,000 psi with a blind hanger.*"

The conclusion of the technical reports, after full analysis of hardness, tensile properties, diameters, and lengths of the hold-down pins that failed, and additional data, was that the hold-down pins were of proper length and design but were installed so that only a portion of the nose of the pins engaged the tubing hanger. The Manufacturer's representative on the Rig recorded that he had torqued the pins to the proper

Sheared Lock-down Pins, Ejected Tubing Hanger, EI Block 107, Well B-1

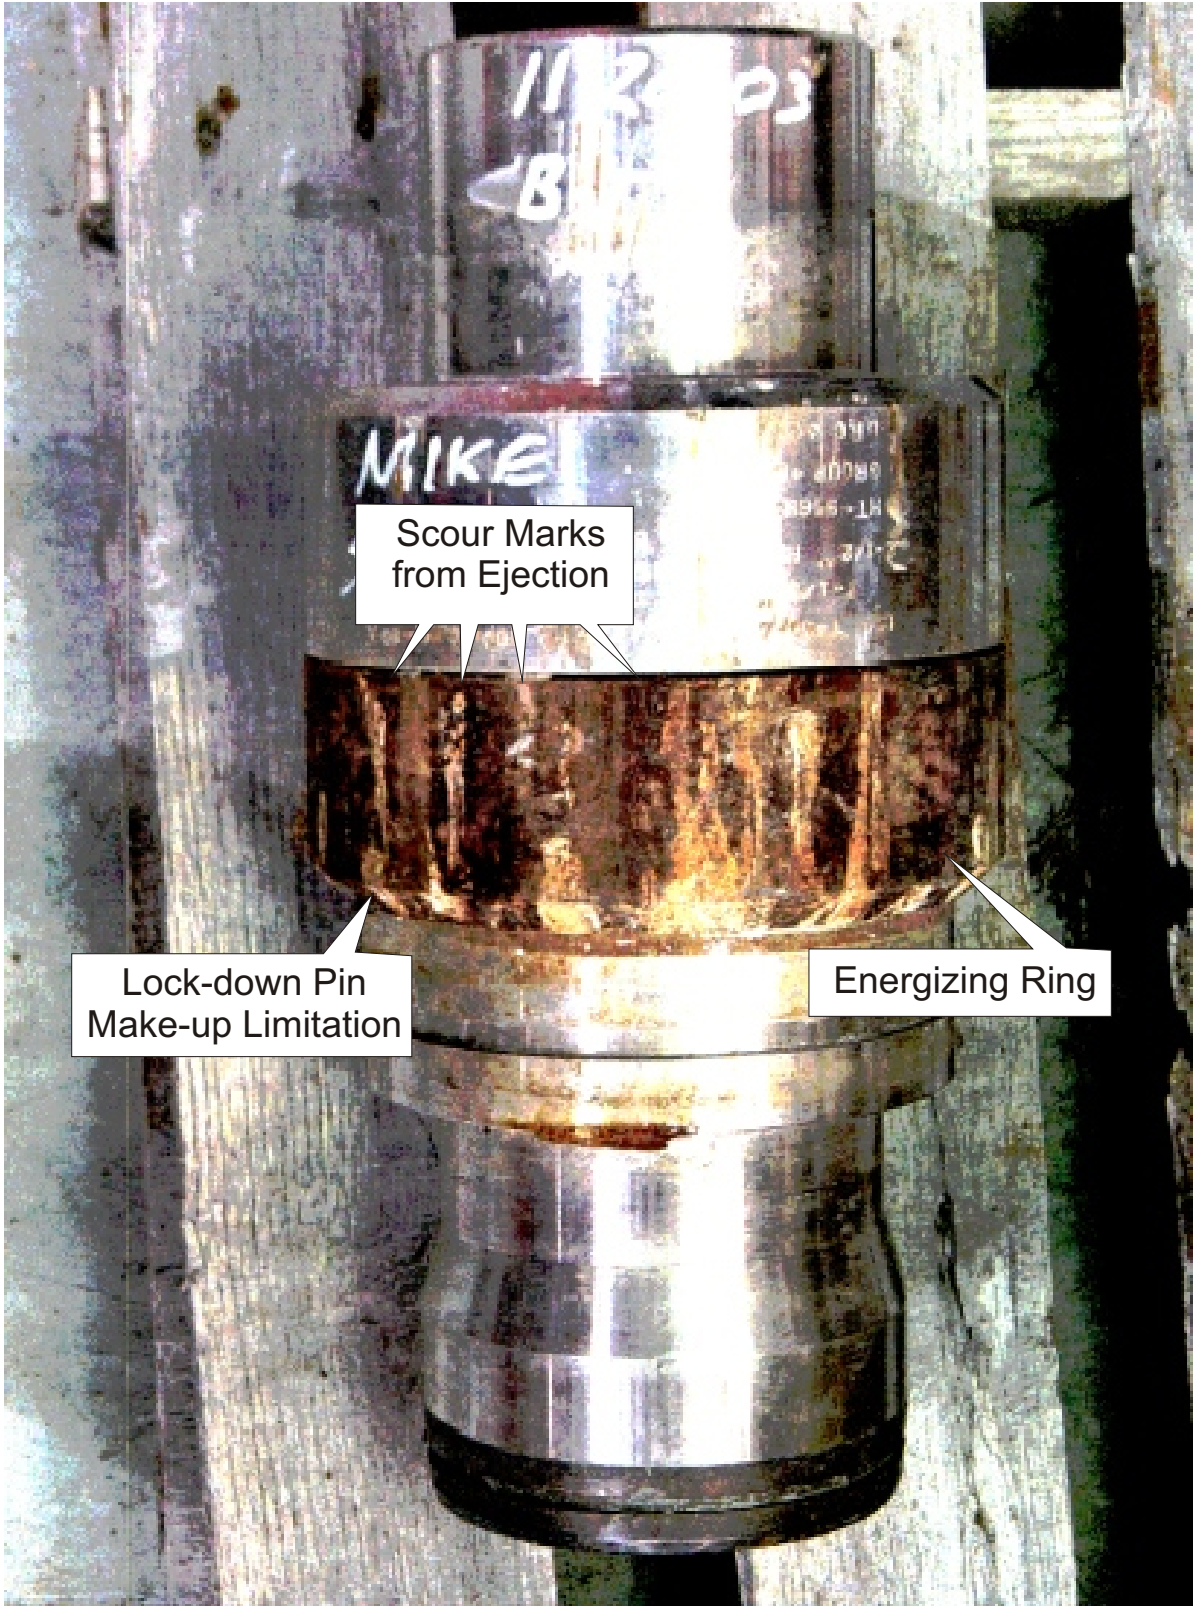
Eugene Island Block 107, Well B-1, Tubing Hanger Showing Energizing Ring Ejection Markings

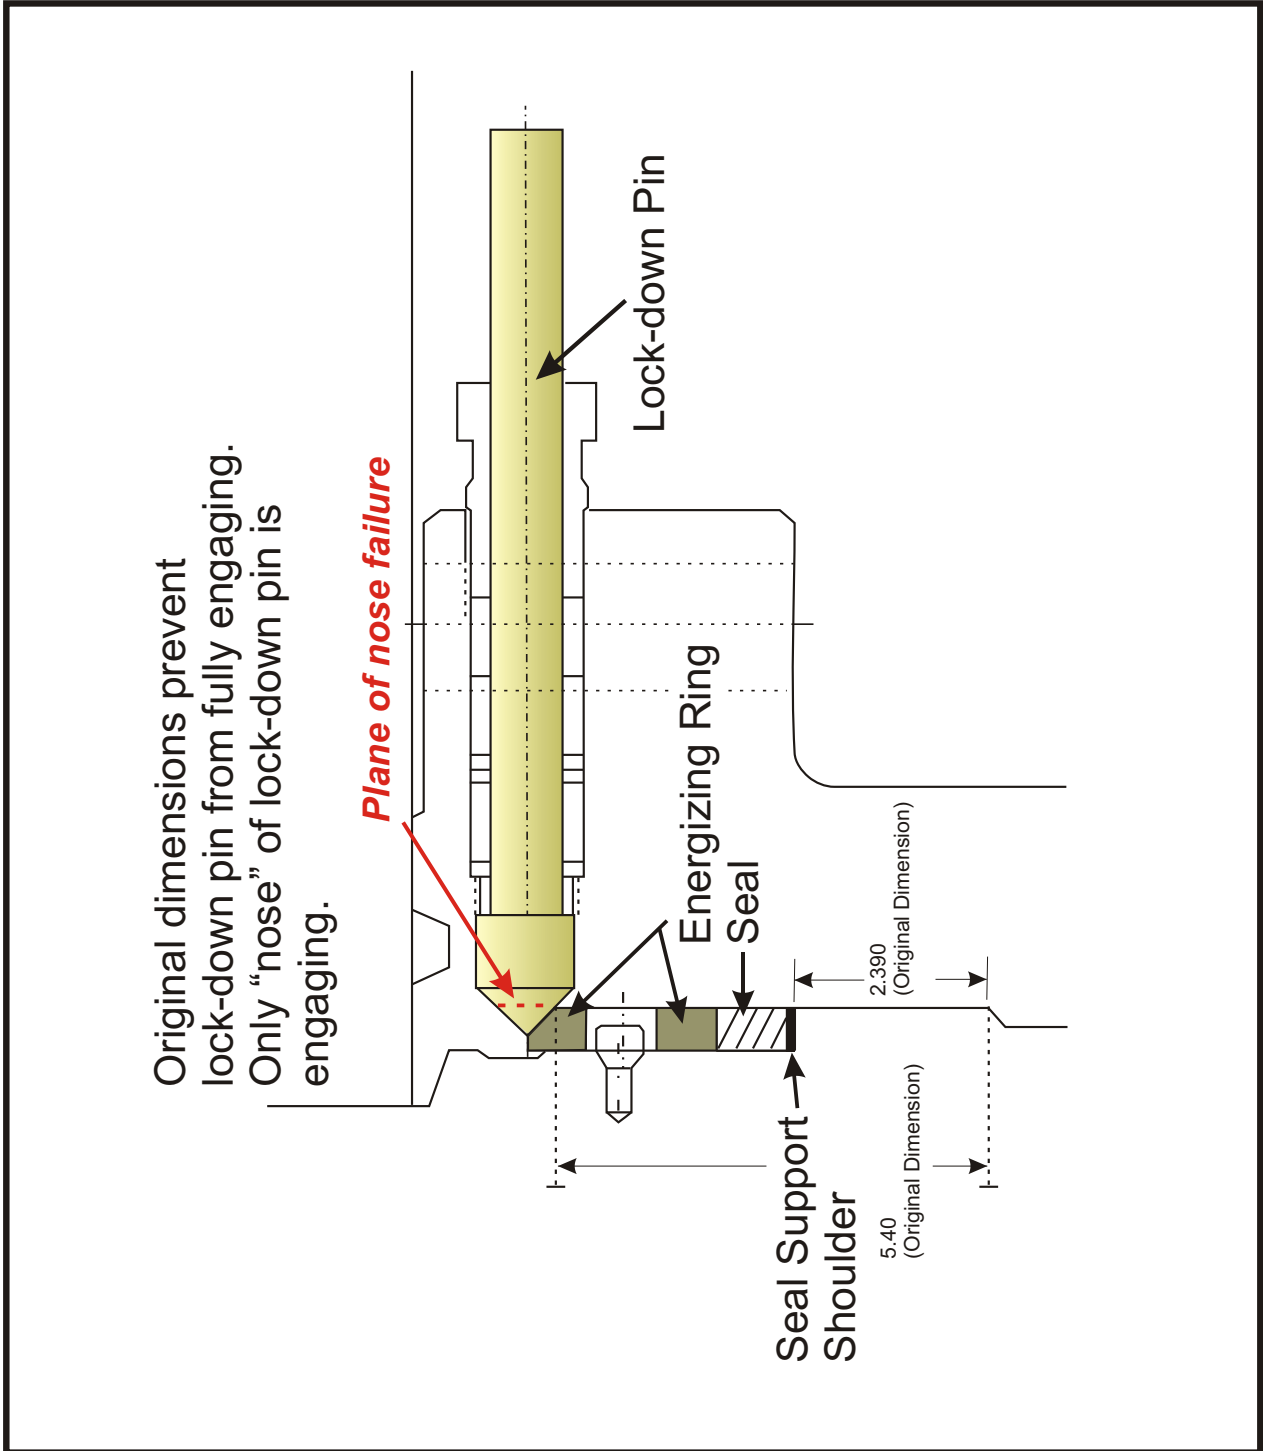
According to testimony, the reason the pins failed to engage the ring to the designed depth, enabling the hanger to contain the designed pressure, lay in a flaw in the design of the hanger as it mated with the hanger spool and energizing ring. The metal-to-metal mate between the hanger and the spool, and between the energizing ring and the hanger, were designed at a 45-degree angle. However, the actual mating of the hanger and spool caused the hanger energizing ring to sit too high in the spool to allow the hold-down pins to be fully run-in.

In a November 24, 2003 letter to the Operator, Manufacturer noted the following: "Design Review: *Review of the 1996 vintage Ingram Cactus manufacturing drawings indicates that the tiedown screws were not capable of retaining the full rated working pressures below the hanger in the absence of additional tubing loads. This situation applies to the Ingram cactus 7 1/16 in Nom. T-40, T-40-CL, CXS, and CT hangers as well as the 7 1/16-inch Type C Tubing Spools in pressure ratings of 2000 to 15,000 psi. The majority of these types of Ingram Cactus designed hangers were corrected in 1998 to increase the amount of tiedown screw [hold-down pin] engagement and therefore, to increase their pressure retention capacity.*

Schematic and Original Dimensions of Engagement of Hanger and Lock-down Pin.

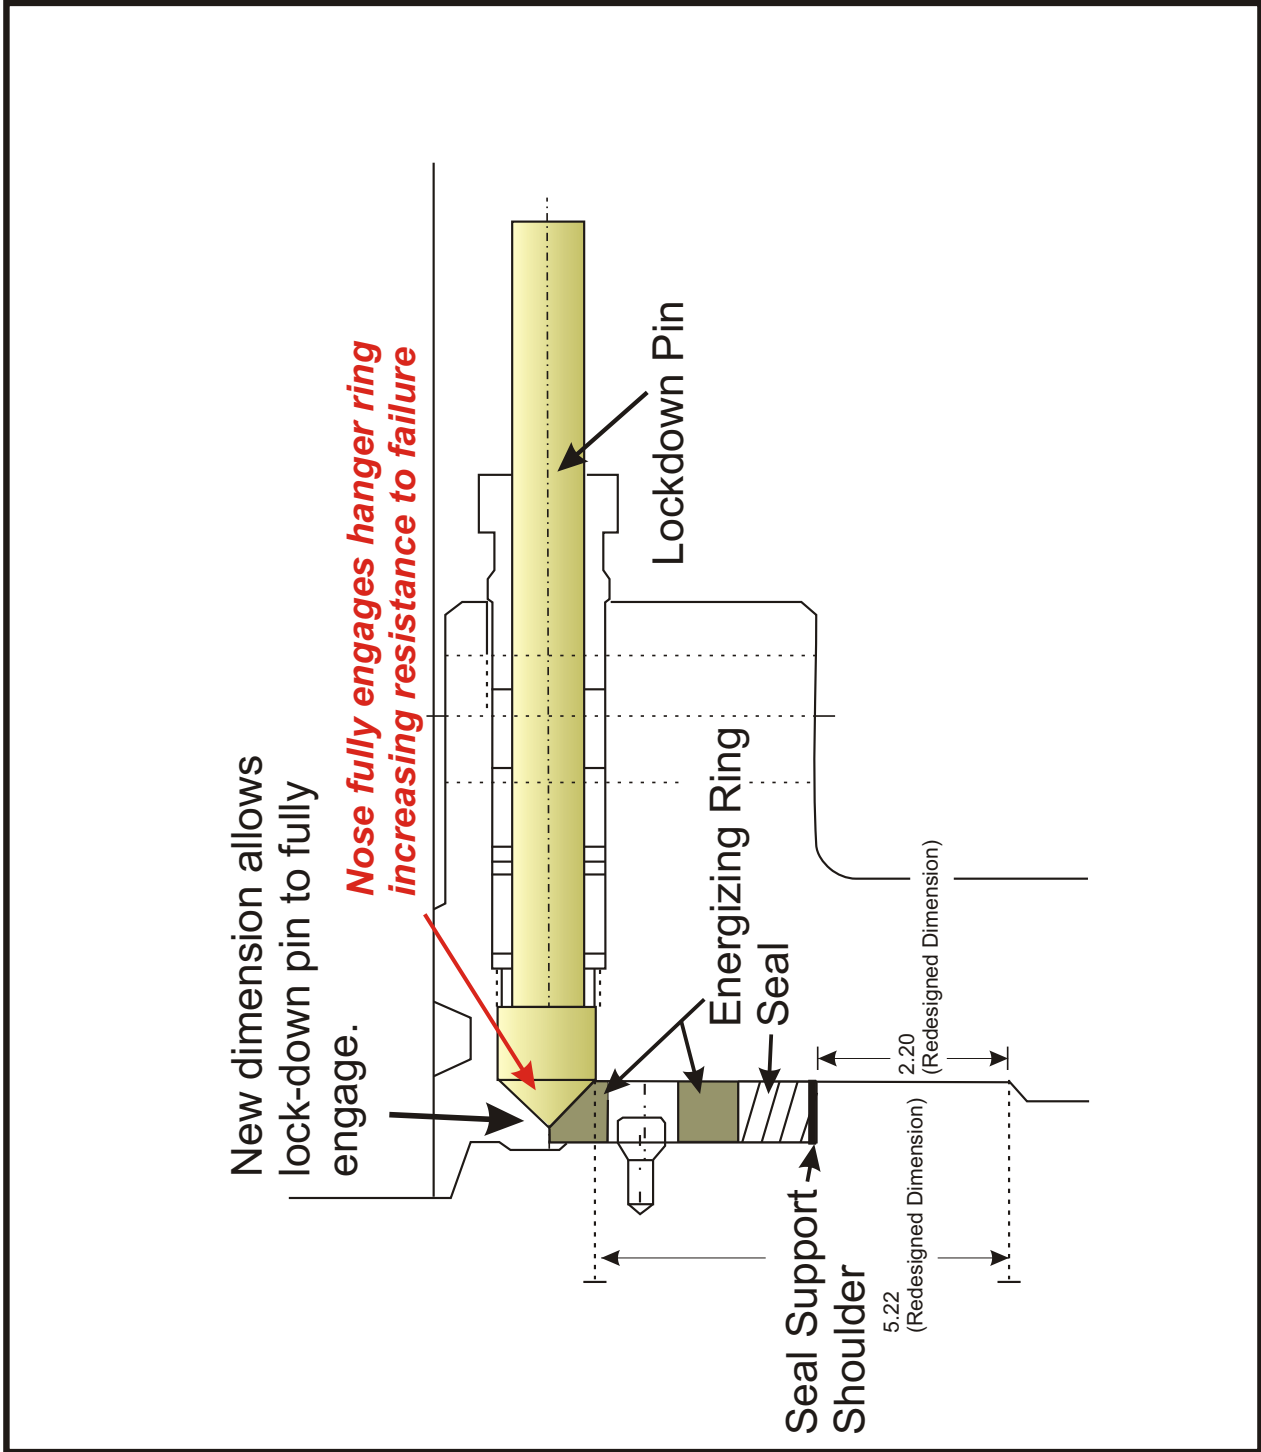
Redesigned Dimensions and Engagement of Hanger and Lock-down Pin.

The Manufacturer safety alert also warned industry that hangers with certain dimensions, such as the one that was ejected from the Well, would not sustain advertised pressures and recommended a re-designed hanger that allowed full engagement of the hold-down pins. The safety alert notes that the design flaw has been corrected in new hangers of this type and warns that hangers manufactured to the previous specification should not be used. The Manufacturer also advises that hangers manufactured and installed to the previous specifications will not hold design pressure under certain circumstances and re-iterates the need to bleed down the pressure fully prior to tree removal.
