**Investigation of Loss of Well Control
South Timbalier Block 230, Well A-7
OCS-G 27169
30 November 2005**

Gulf of Mexico
Off the Louisiana Coast

U.S. Department of the Interior
Minerals Management Service
Gulf of Mexico OCS Regional Office

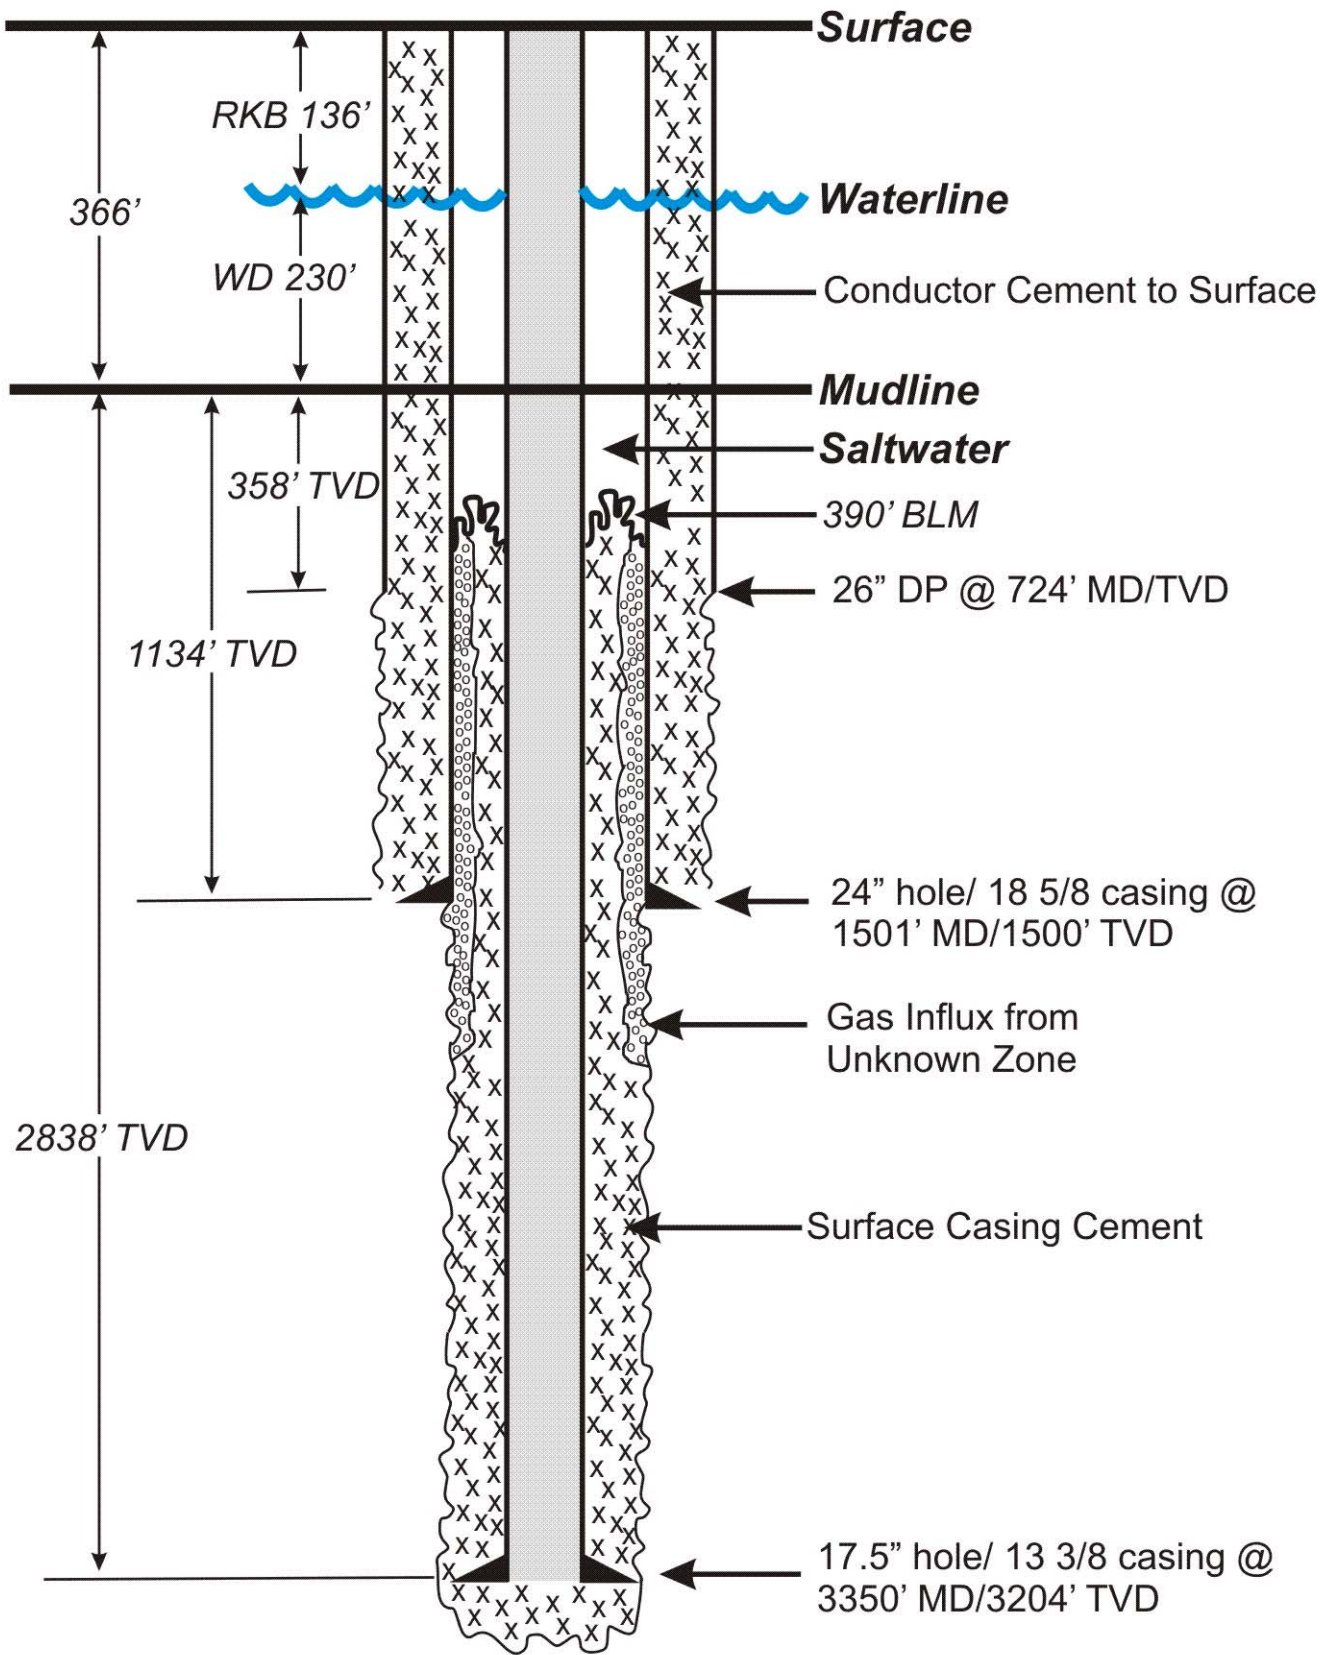
Wellbore Sketch: Lease OCS-G 27169, ST 230, Well A-7.

The well flowed gas, mud, cement, and sand intermittently for approximately fourteen hours. The operator observed a light condensate gas sheen on the water and the estimated spill volume was less than one gallon. The well stopped flowing, the Rig was re-boarded, and repairs were made to the starboard diverter line. This damage was limited to holes in the line resulting from the line being cutout from high velocity flow of cement and sand. Boots & Coots designed and implemented a kill procedure for the well. The 13.375-inch by 18.625-inch annulus was cemented, pressure tested, and drilling operations resumed. (*See Attachment 3 for wellbore sketch of Well A-7.*)
