**Metallurgy of the *RMS Titanic***

Tim Foecke  
Metallurgy Division  
National Institute of Standards and Technology

U.S. DEPARTMENT OF COMMERCE  
Technology Administration  
National Institute of Standards and Technology  
Materials Science and Engineering Laboratory  
Gaithersburg, MD 20899-0001

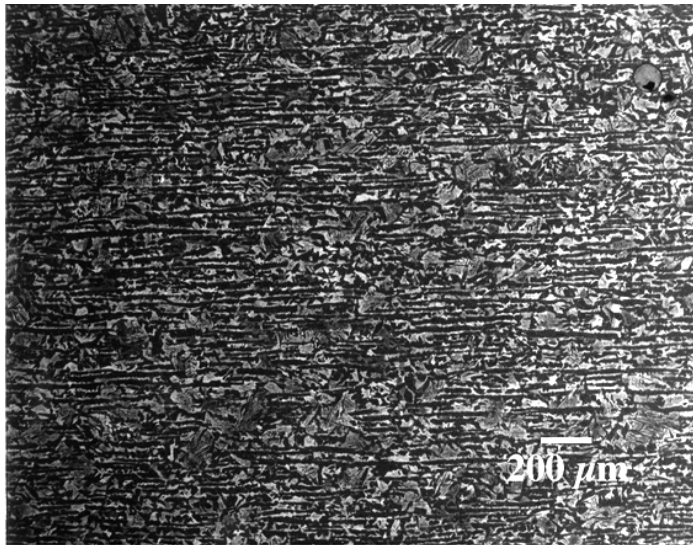
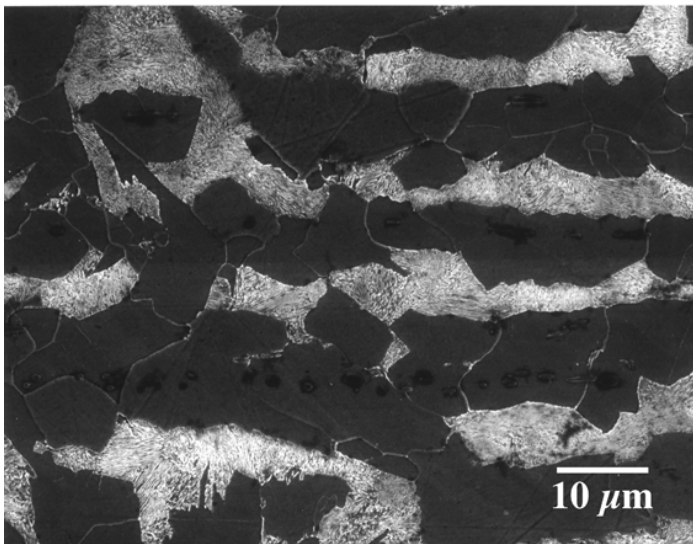
**AISI 1018 25mm (1") Plate**

A comparable modern steel grade is AISI 1018, which has a similar chemistry and does not possess a specialized microstructure. Micrographs of a modern 1018 steel show a finer grain size, much finer pearlite, and smaller and less numerous rare-earth doped MnS particles. This microstructure is typical of that produced in a modern high-speed mill, followed by a quench and normalization treatment.

Figure 1: Scanning electron microscope image of the polished and etched longitudinal sections of steel from the hull of the *Titanic*, and for comparison a modern hot-rolled 25 mm (1") AISI 1018 plate. Note the differences in grain size, pearlite lamella spacing, and MnS particle sizes.

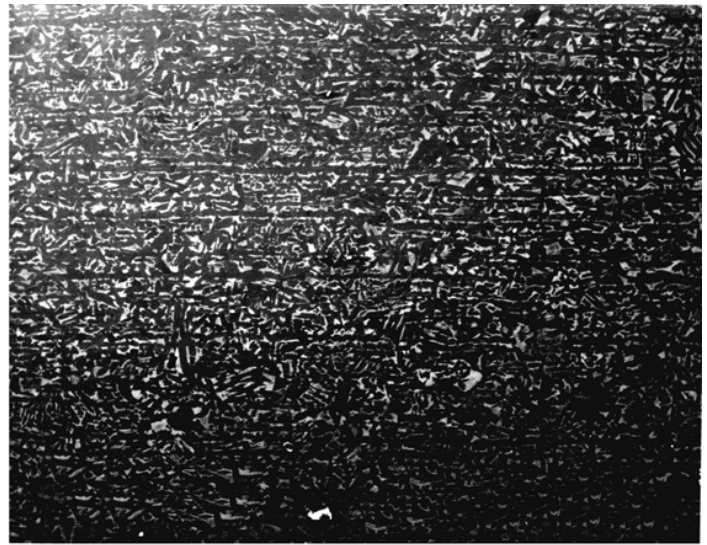
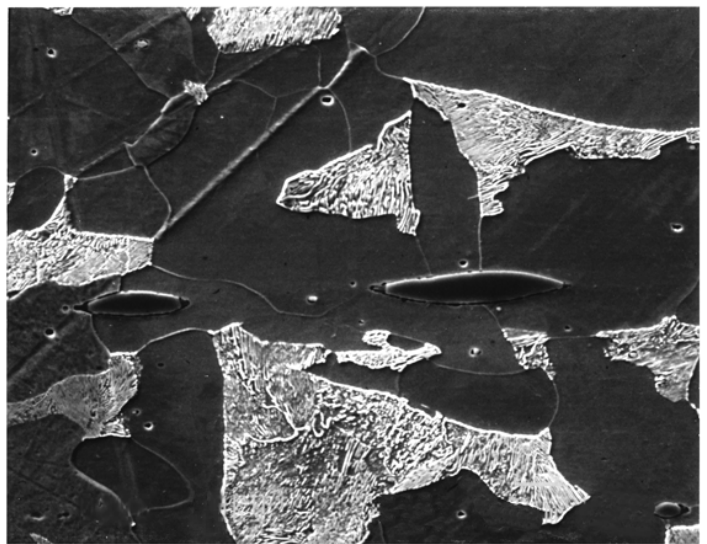
**Titanic Hull Plate**

Steel samples of all three orientations orthogonal with respect to the rolling plane were polished and etched to reveal the microstructure. A ferrite-pearlite microstructure was seen, with large ferrite grains (ASTM number = 4-5, 100  $\mu\text{m}$  to 130  $\mu\text{m}$  equivalent diameter) and large, coarse pearlite colonies (roughly 0.2  $\mu\text{m}$  lamella thickness, but quite variable). The microstructure shows a large amount of banding in the rolling direction. MnS and oxide particles are evident throughout the material, and were quite large, occasionally exceeding 100  $\mu\text{m}$  in length. The MnS particles were deformed into lenticular shapes instead of being melted into stringers. Given the lack of rare-earth additions to increase the sulfide melting point (see table 2), this indicates a low rolling temperature. The large grain size and coarse pearlite are consistent with air-cooling of the rolled

plate, with no evidence of quenching or normalization treatments evident. All of this evidence is consistent with the production of this plate in a low speed rolling mill, as was the norm in turn-of-the-century Ireland.

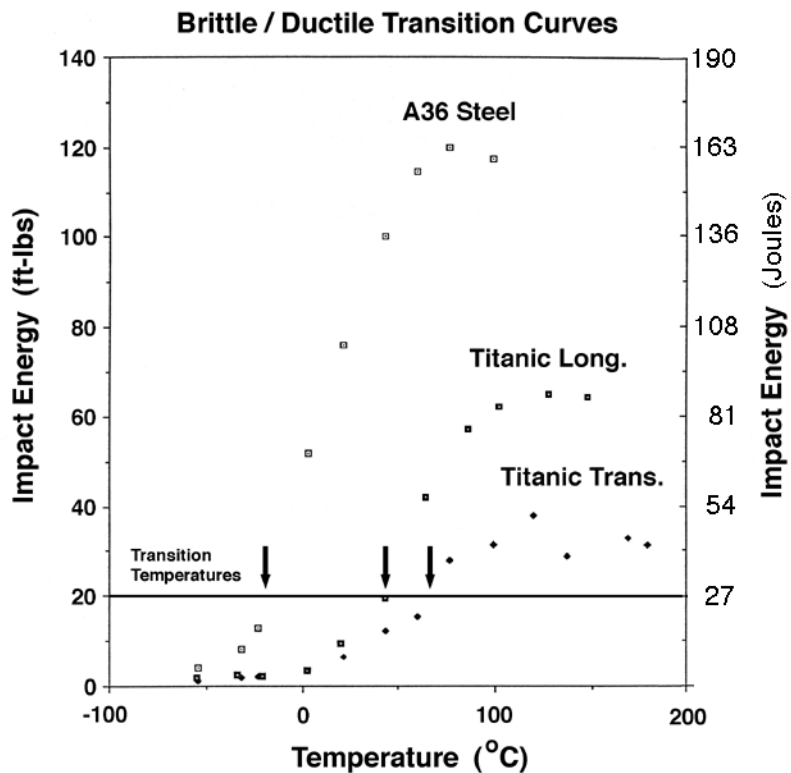
The data produced from tensile tests performed on steel recovered in 1996 [5] and 1991 [2] is shown in Table 1. The uncertainty in this data is unknown. These values are consistent with the design requirements of “15-20 tonnes per inch squared” as specified by Harland and Wolff (the shipbuilder who constructed *Titanic* in Belfast in 1911 [4]). Two groups of Charpy specimens were prepared such that in one group the long direction of the specimens were parallel to the longitudinal direction of the hull plate (LS) and in the second group the long axis of the specimen was parallel to the transverse direction (TL). The adjoining figure compares the experimental results from the Charpy impact test of the *Titanic* hull steel for the longitudinal and transverse rolling directions with a modern ASTM A36 mild steel [7]. Unfortunately for the purposes of a direct correlation of properties and microstructure, the comparison of mechanical behavior was made versus A36 steel, which is chemically nearly identical to AISI 1018 used in the microstructural comparison, but has a more specialized microstructure. Using 20 ft-pounds (27 J.) for the determination of the ductile-brittle transition temperature, the author [5] obtains a transition temperature of  $-15^{\circ}\text{C}$  for the modern A36 steel, while the *Titanic* specimens yielded transition temperatures of  $+40^{\circ}\text{C}$  for specimens in the longitudinal direction and  $+70^{\circ}\text{C}$  for the transverse direction. The transition temperatures for the *Titanic* steel are much above the water temperature of  $-2^{\circ}\text{C}$  at the time of the ship-iceberg collision [1].

Figure 2: A plot of the impact energy measured by the Charpy test versus temperature for two different orientations for the *Titanic* hull steel, as well as modern A36 (which is chemically and microstructurally very similar to AISI 1018). The transition temperature is marked for each series of samples, and is defined as that temperature where the sample exhibited 20 ft-lbs (27 J.) of energy. Data from reference [5]. The uncertainty in the data is unknown.

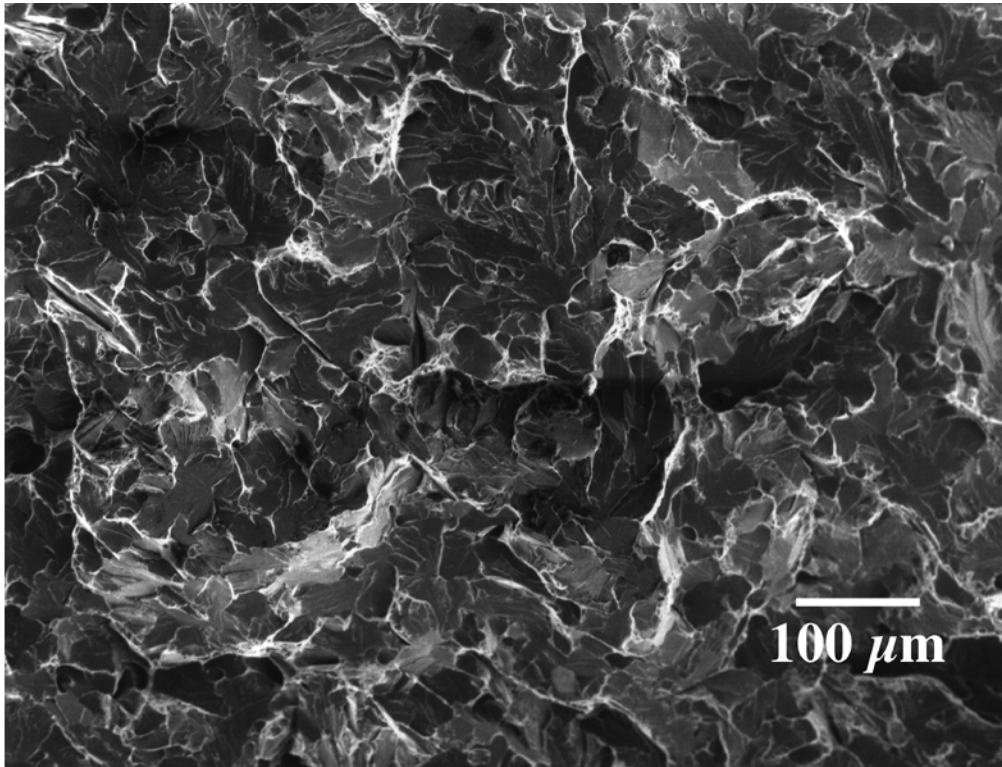
Fracture surfaces cut from the Charpy test specimens tested from the 1996 plate were examined in the scanning electron microscope. Fracture was entirely transgranular (figure 3), with no evidence of fractured grain boundaries. This is significant, in that if the cause of limited fracture ductility of the steel (as evidenced by the absence of microvoids) had been sulfur embrittlement, we would expect sulfur segregation to the grain boundaries and intergranular fracture facets. At ice-brine temperatures, the fracture was nearly entirely brittle, with the ductile portion of the fracture surface estimated to be less than 5 percent (figure 4). Cleavage patches on the surface, made up of 4 to 15 cleaved grains, were seen to originate at fractured MnS particles, as evidenced by tracing river lines on the facets. This indicates that in some cases the MnS particles acted as initiators, but the incidence of these nucleated patches amounted to less than 10% of the surface area of the Charpy bar fracture surface.

Figure 3: SEM fractograph of Charpy bar fracture surface (LT) from a sample fractured at 0° C. Note the presence of cleavage facets and absence of fracture grain boundaries. One or two cleavage patches nucleated by MnS particles can be identified in this image.

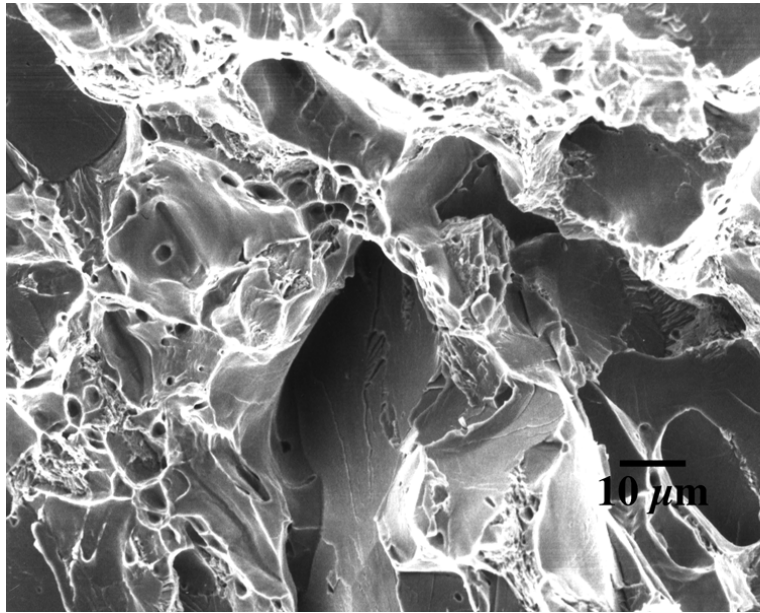
Figure 4: SEM fractograph of Charpy bar fracture surface from a sample fractured at 0° C. Note presence of ductility along ridges. This micrograph contains the largest amount of plasticity observable on the surface in one area of the fracture surface of this sample.

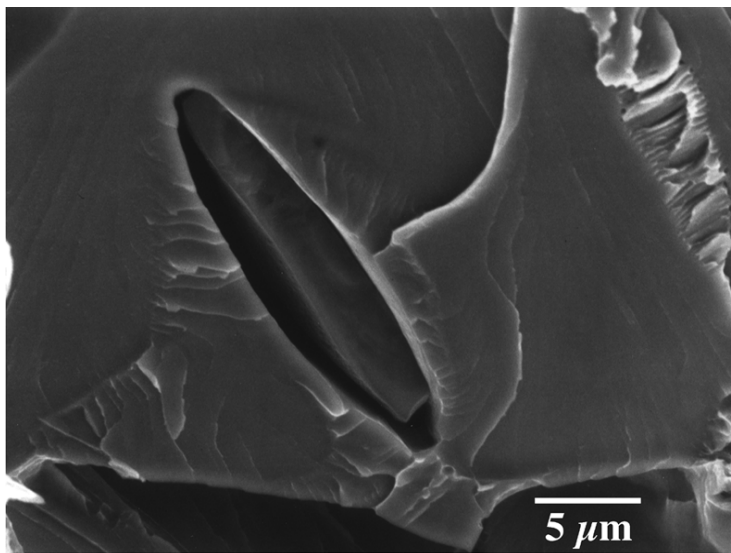
Figure 5: SEM fractograph showing the MnS particle that fractured and nucleated a patch of 15 cleaved grains. This was determined by tracing river lines within the patch. Note the lenticular shape of the particle, the cleavage river lines emanating from the particle, and the fractured course pearlite colony in the upper right corner.

The presence and large size of the MnS particles are considered deleterious to fracture resistance, as they act as crack initiators within the steel at temperatures near the lower shelf [19]. It was seen that the plate recovered in 1996 exhibited 5% ductile fracture during Charpy tests at ice-brine temperatures, and that MnS particles, upon examination of the fracture surface, nucleated a few patches of cleavage. However, the plate recovered in 1991 was 100% brittle even at room temperature [20], placing it firmly in, not near the lower shelf regime. Thus MnS particles would have little to no effect on toughness in this plate. The presence of MnS particles and their effect on crack growth have been found to be much more important at high temperatures than lower temperatures. Their effect on the fracture behavior of both the material in this study as well as the 1991 study [2] are considered negligible. Although cleavage patches have been identified on the fracture surface as having come from the fracture of a MnS particle, and thus the formation of a process-zone would have begun, the occurrence of this was relatively rare. It is believed that the fracture mechanism that controlled at  $-2^{\circ}\text{C}$  would have been weakest-link [18], where the first fractured microstructural feature would have precipitated failure. And as the population of large carbides, in the form of thick pearlite lamella, is many times that of large sulfides, it is more likely that a fractured carbide would precipitate failure.

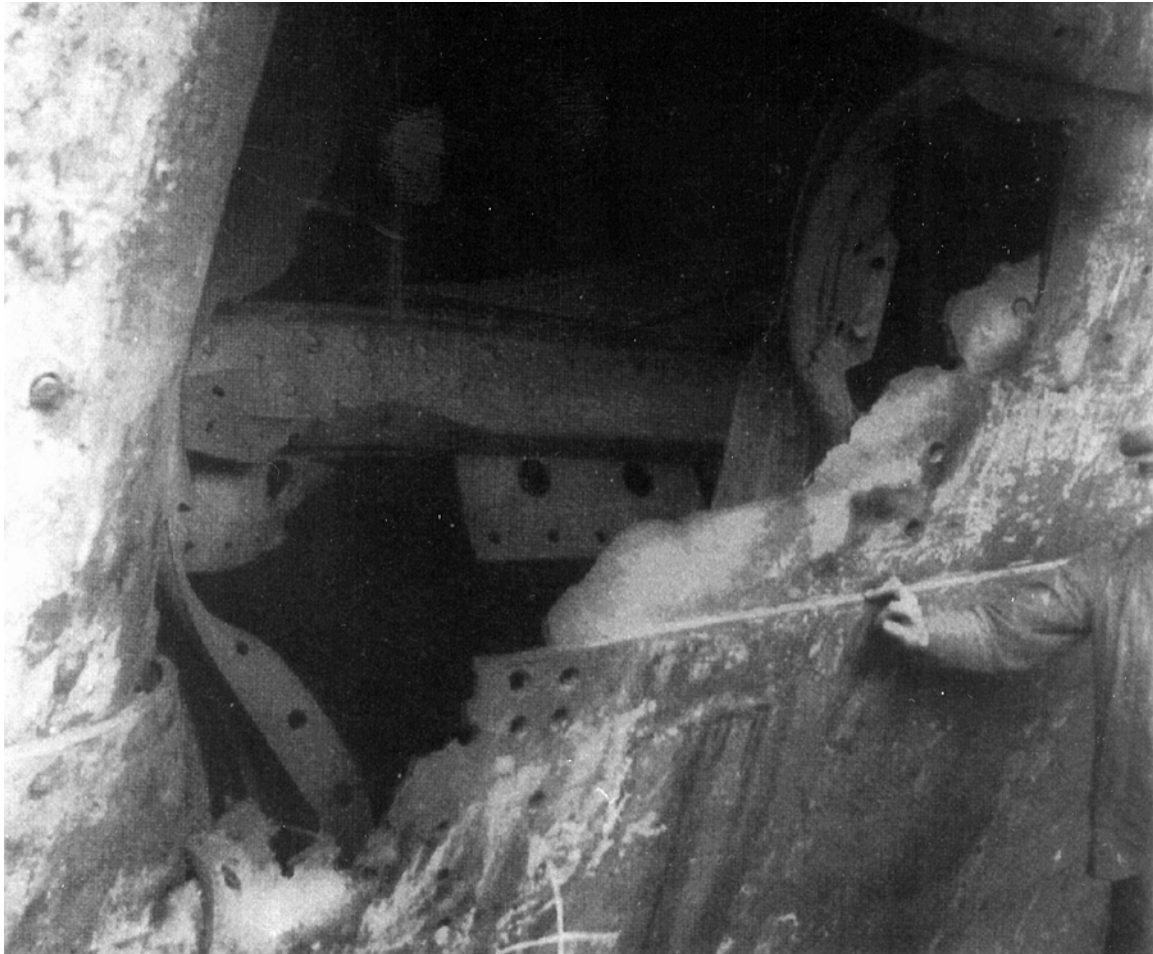
ship with the iceberg at 20+ knots would have occurred at strain rates more in line with a Charpy impact test. At this rate, the steel would exhibit more brittle behavior. Additional evidence comes from photographs of damage to the *Titanic*'s sister ship, *RMS Olympic*, after collision in Belfast harbor with a Royal Navy cruiser, *HMS Hawke* [25] (figure 5). A close examination of the photos show considerable bending of the plates around the hole, while reports of the physical damage include a mention of a triangular piece of hull that fractured into the ship. This would be consistent with a high strain rate impact causing fracture, and then progressively slower deformation as the two ships pressed together, causing bending instead of cracking.

Figure 6: A close-up of the damage to the *RMS Olympic* due to collision with the *HMS Hawke* in the Solent in 1911. Note the man for scale. A considerable amount of plasticity in the hull plates is indicated by the bending and twisting seen in the picture. Note missing rivets. Photo from [25].

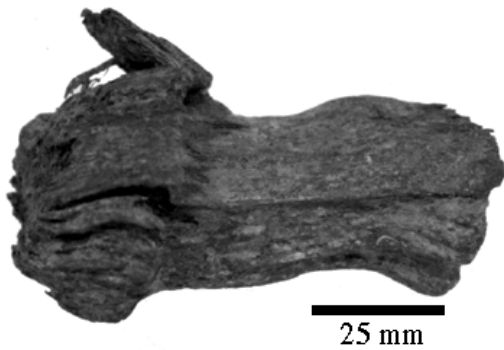
material. This represents a smaller amount of deflection of the hull plate applying the stress through leverage against the supporting rib inside the ship. High residual stresses would increase the tendency of rivets to “pop” during collisions. The presence of high residual stresses in *Titanic* rivets can be seen in a badly-corroded bulkhead rivet, seen in figure 9. The head of the rivet has exfoliated and the slag stringers have spread, driven by residual stress during stress corrosion cracking and dissolution of the ferrite.

Figure 9: Bulkhead rivet from RMS Titanic. Note the portion of the head that exfoliated during corrosion of the ferrite matrix of the wrought iron, under the influence of the residual stress in the rivet.
