**U.S. Department of Energy**  
**Office of River Protection**

CONTRACT NO. DE-AC27-01RV14136 – INSPECTION REPORT A-05-AMWTP-RPPWTP-004 – ON-LOCATION INSPECTION REPORT FOR THE PERIOD OCTOBER 1, 2005, THROUGH DECEMBER 30, 2005

This letter forwards the results of the U.S. Department of Energy (DOE), Office of River Protection (ORP) review of Bechtel National, Inc. (BNI) construction performance of the Waste Treatment and Immobilization Plant (WTP) for the period October 1, 2005, through December 30, 2005. There were three Findings requiring responses by BNI identified during this inspection period. These Findings include: (1) failure to properly maintain the Centrifugal Air Compressors in accordance with requirements; (2) failure to document Industrial Safety and Health issues in the Corrective Action Program; and (3) failure to implement an adequate Supplier Oversight Program. The enclosed Notice of Finding (Enclosure 1) describes these issues and contains the instructions for responding.

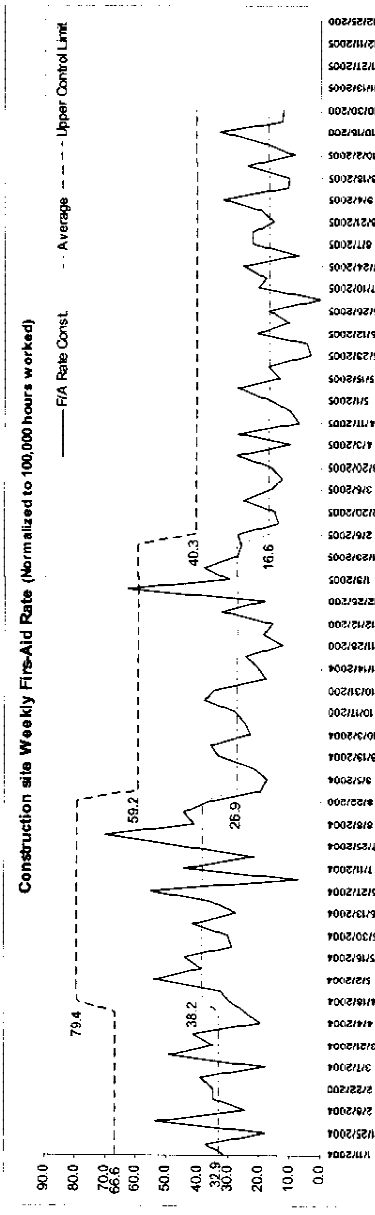
**Construction Site Weekly First-Aid Rate:** This chart is a compilation of all the injuries and does not distinguish between first-aid cases and OSHA recordable cases. It is also based on only craft work hours but includes injuries occurring to non-manuals employees since the number contributed by non-manuals is negligible compared to manual employees.

Based on the construction site first-aid cases, the trend over the past two years has improved. The average weekly first-aid rate is currently 16.6 cases per 100,000 hours worked. This is an improvement from a high of 79.4 cases per 100,000 hours worked between April and August, 2004. The current trend started in January 2005. The process variation as measured by the standard deviation has also improved from the high of 13.7 occurring between April and August, 2004 down to 7.9. The average weekly first-aid rate and variation have been relatively constant since February 2005 with no unusual outliers or groupings. The outlier during the week of 1/2/05 was due to a higher number of injuries resulting from slips caused by a relatively large snowfall accumulation at the site during the week.

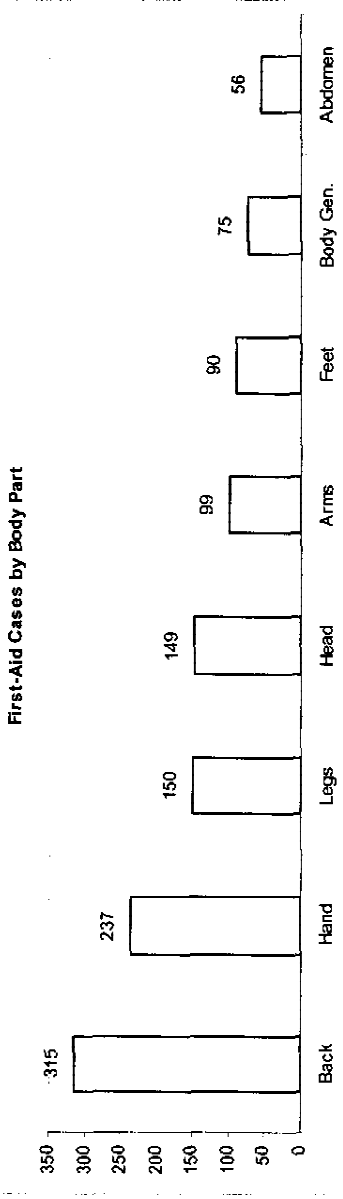
1. First-Aid Cases by Body Part: This graph breaks out the various first-aid cases over the past two years based on the location on the body. Back included neck, shoulders, and spine. Hand included the wrists. Legs included the knees. Head included face, mouth, teeth, eyes, ears, and nose. Feet included the ankles and toes. Body general included areas affecting the overall body. Abdomen included the groin area, pelvis, buttocks, chest, ribs, and internal organs.

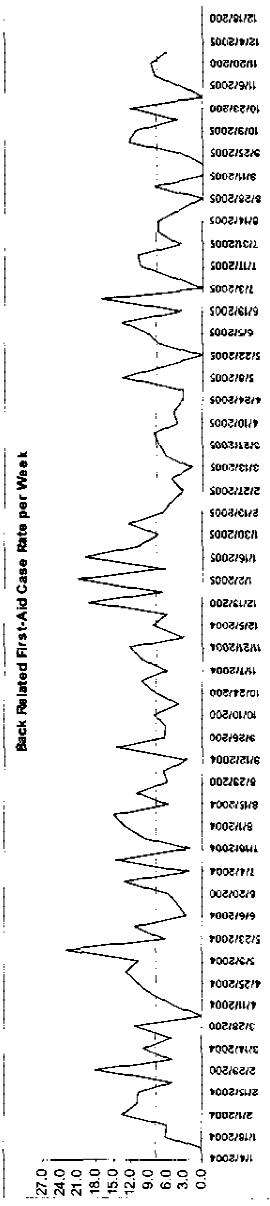
2. Back Related First-Aid Case Rate per Week: No significant trend was identified with this chart. However, it appears that the case rate since 2/13/2005 has decreased since most of the data points lay below the average.

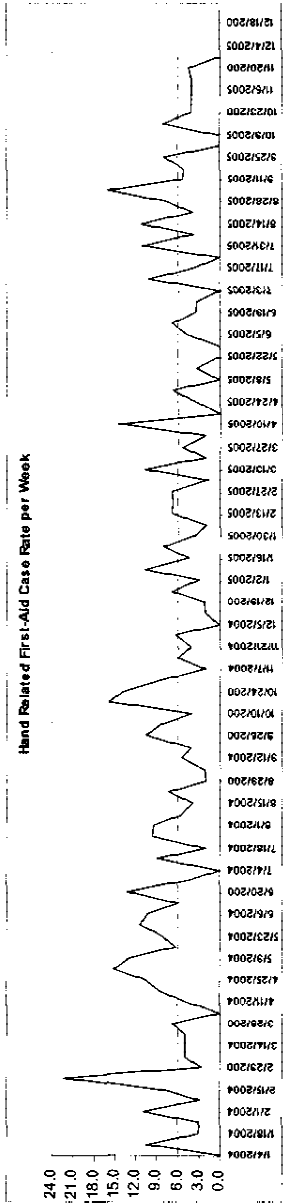
3. Hand Related First-Aid Case Rate per Week: No significant trend is demonstrated by this control chart. There appears to be relatively little change in the variation or the rate of occurrence. This indicates that the hand injury rate is constant and the process is stable.

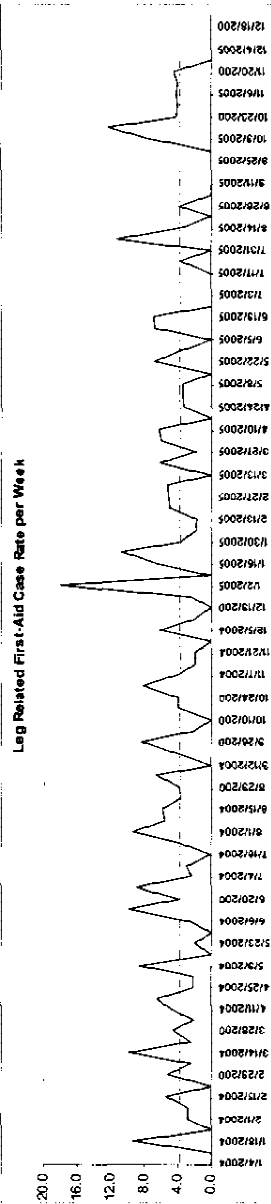
4. Leg Related First-Aid Case Rate per Week: No significant trend is demonstrated by this control chart. There appears to be relatively little change in the variation or the rate of occurrence. This indicates that the rate of leg injuries constant and the process is stable.

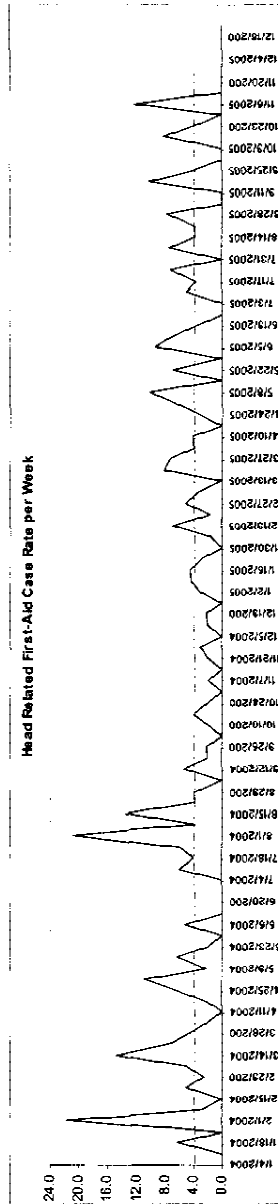
5. Head Related First-Aid Case Rate per Week: No significant trends were demonstrated by this control chart, although there appears to be improvement in the variation of occurrence during 2005. It also appears during the last quarter of 2004 the case rate dropped for a period of time but came back up. No specific reason was identified for this decrease. This rate of head injuries appears constant and the process is stable.

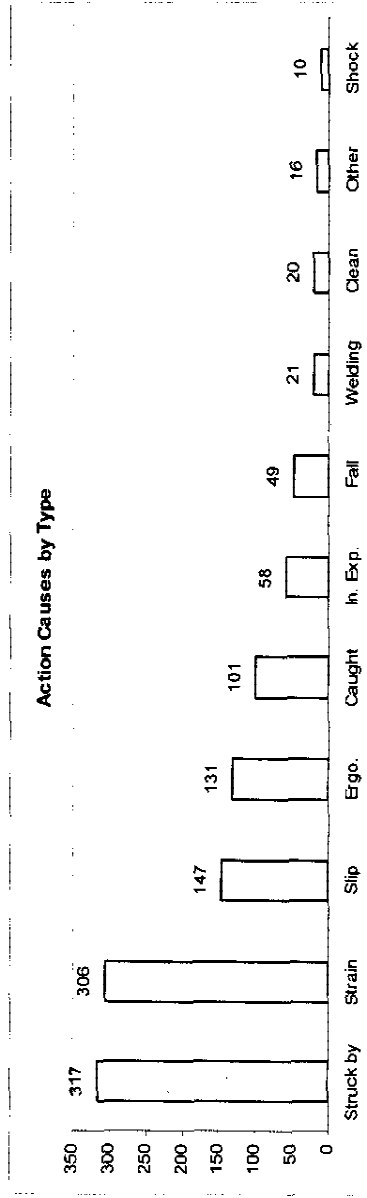
Action Causes by Type: This graph breaks out the various action causes over the past two years based on the following categories as listed and defined below. Struck-by (struck-against) included injuries caused by foreign bodies in the eye, cutting, or by falling objects. Strain included injuries caused by overexertion, lifting, climbing, pulling, or pushing. Slip or trips resulting in injury. Ergonomics included injuries caused by repetitive motion, body position, or ergonomic hazards. Caught included injuries caused by being caught in or between something. Internal exposure included injuries caused by exposure to noise, dust, radiation, heat/cold environment, or inhaling, absorbing, or ingesting some hazardous material. Fall included injuries caused by falling from elevation or on the same surface (not slip or trip). Welding included any injury caused by welding. Clean included injuries caused by grinding, sanding, scraping, cleaning, or blowing actions. Other included injuries caused by vehicles or injuries not classified under any other listed cause. Shock included events due to electrical shock.

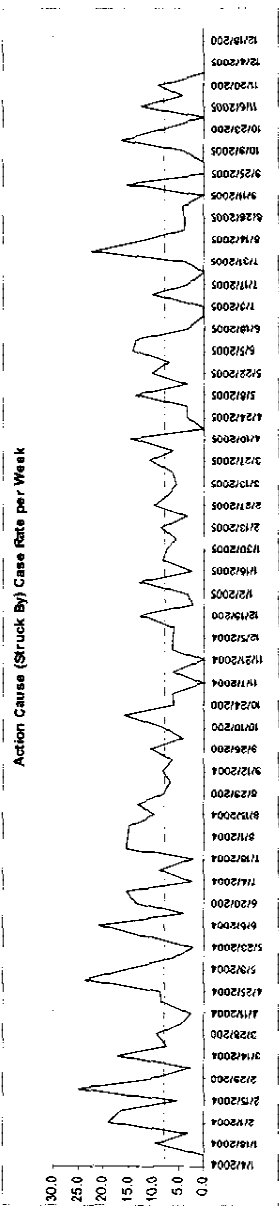
1. Action Cause (Struck By) Case Rate per Week: No significant trends were demonstrated by this control chart. Injury rates due to this cause remain steady and the process is stable.

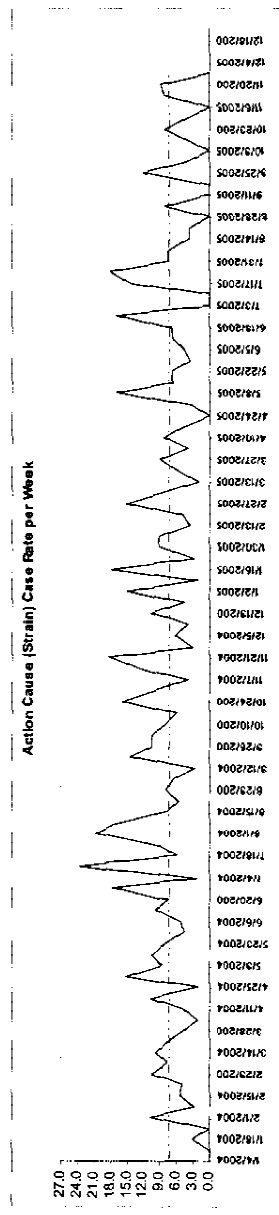
2. Action Cause (Strain) Case Rate per Week: No significant adverse trends were demonstrated by this control chart. It appears that the rate has improved during the last quarter of 2005 since the variation appears to lie below the average. Injuries due to this cause appear to have improved and demonstrate process stability.

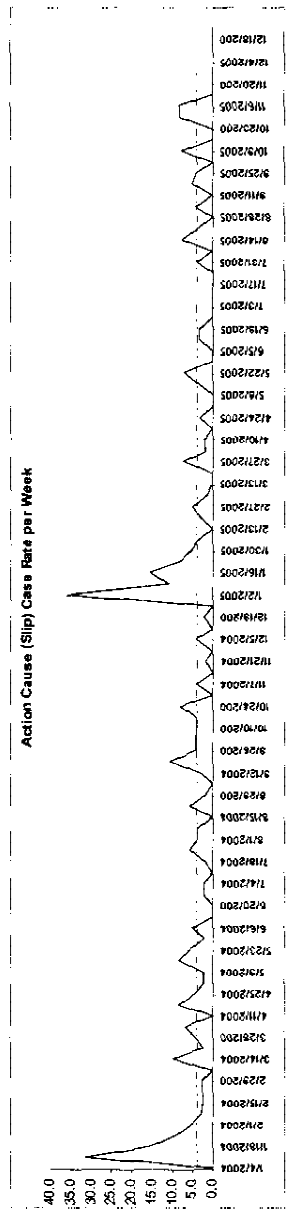
3. Action Cause (Slip) Case Rate per Week: This chart demonstrates an adverse trend during the early winter months of January and February. While this is not unexpected it demonstrates that the safety process for preventing slips is least effective during these two months. The variation is relatively low during the rest of the year indicating these two outliers are unique and repetitive and may therefore require action. BNI should evaluate what actions are needed to eliminate this jump in the causal rate. The outlier discussed in the Construction Site Weekly First-Aid Rate chart indicated snow accumulation attributed to the 2005 spike. However, after reviewing the individual events no unique attribute could explain the increase.

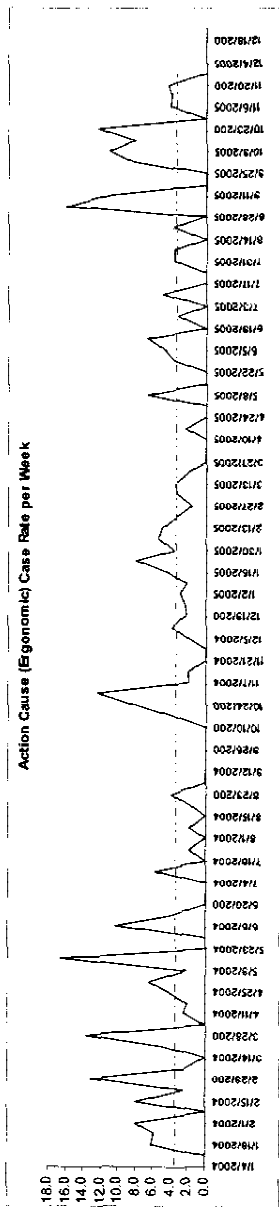
4. Action Cause (Ergonomic) Case Rate per Week: No significant adverse trends were demonstrated by this control chart. However, it appears that the variation itself is inconsistent which indicates instability in the safety processes designed to minimize ergonomic injuries. Increased variability may be a leading indicator that the injury rate will worsen. Further monitoring and evaluation is needed to understand this situation.

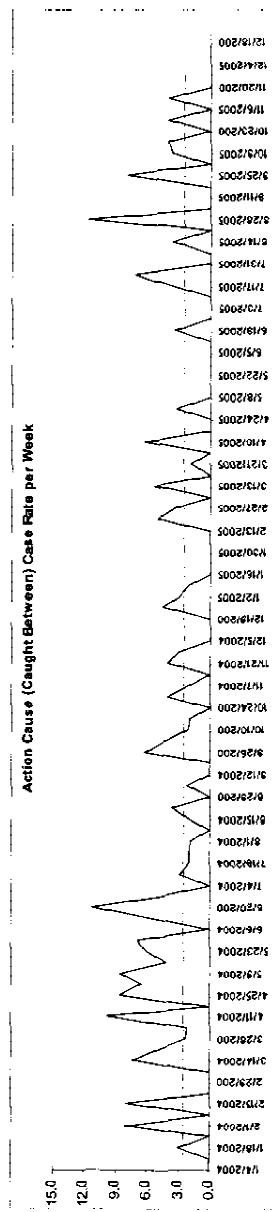
5. Action Cause (Caught Between) Case Rate per Week: No significant adverse trends were demonstrated by this control chart. Injuries due to this cause appear steady and demonstrate process stability.
