U.S. Department of Energy

CONTRACT NO. DE-AC27-99RL14047 – SURVEILLANCE REPORT S-07-AMTF-TANKFARM-001, C FARM ELECTRICAL SYSTEMS SUREVEILLANCE

DOE-ORP Surveillance Report

Title: C Farm Electrical Surveillance

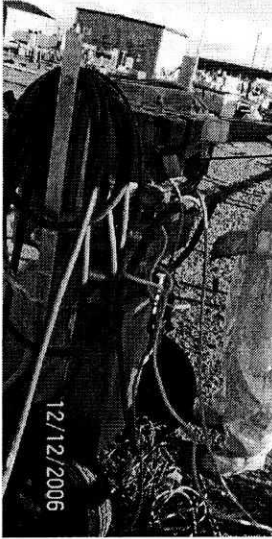
Three unused extension cords were connected to a portable power panel still in service. Electricians removed the extension cords from the portable power panel and bundled them along with others cords on the ground.

NEC, 2005 Edition, Article 590.3(D) states that temporary wiring shall be removed immediately upon completion of construction or purpose for which the wiring was installed.

Three unused extension cords left plugged into the portable power panel.

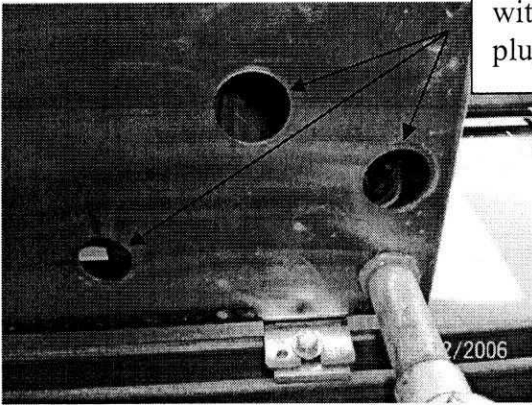
Panel CO6B-WT-PNL-101 did not meet NEC and OSHA requirements where three unused cable openings were not plugged on the bottom side.

NEC, 2005 Edition, Article 110.12(A) states unused cable openings in housings shall be effectively closed to afford protection equivalent to the wall of the equipment. OSHA Standards for General Industry, 29 CFR 1910, Subpart S, 2004, paragraph 1910.305(b)(1) states that unused openings in cabinets shall be effectively closed.

Panel CO6B-WT-PNL-101 with unused openings not plugged.

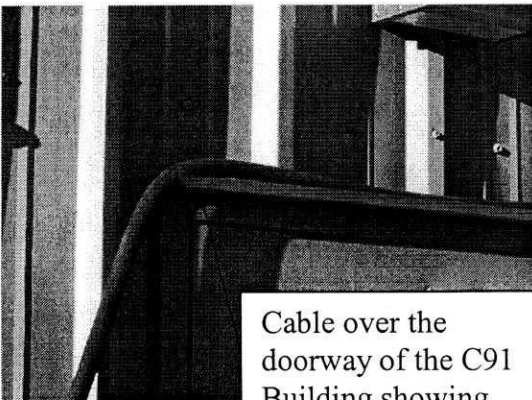
A cable was strung above the doorway and over a ventilation pipe at the C91 building. The rain lip edge had slightly worn into the insulation.

NEC, 2005 Edition, Article 590.4(H) states flexible cords and cables shall be protected from accidental damage. Sharp corners and projections shall be avoided. OSHA Standards for General Industry, 29 CFR 1910, Subpart S, 2004, paragraph 1910.305(a)(2)(iii)(G) states flexible cords and cables shall be protected from accidental damage. Sharp corners and projections shall be avoided.

Cable over the doorway of the C91 Building showing wear from the rain lip edge.

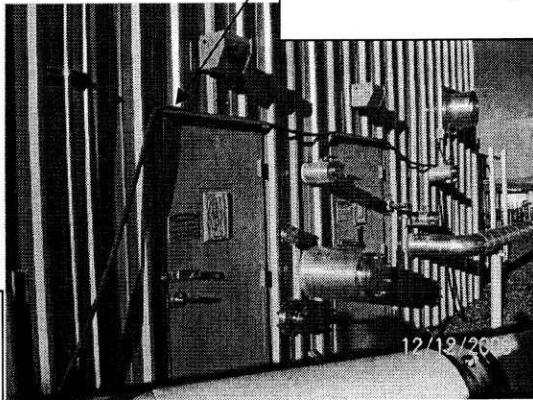
C91 Building with the stretched cable over the doorway.
