07-TOD-014

CONTRACT NO. DE-AC27-99RL14047 – U.S. DEPARTMENT OF ENERGY,
OFFICE OF RIVER PROTECTION (ORP) TANK FARM OPERATIONS DIVISION
(TOD) QUARTERLY REPORT FOR THE FIRST QUARTER OF FISCAL YEAR
2007

Tank Farms Operations Division Quarterly Report

**First Quarter Fiscal Year 2007
October through December 2006**

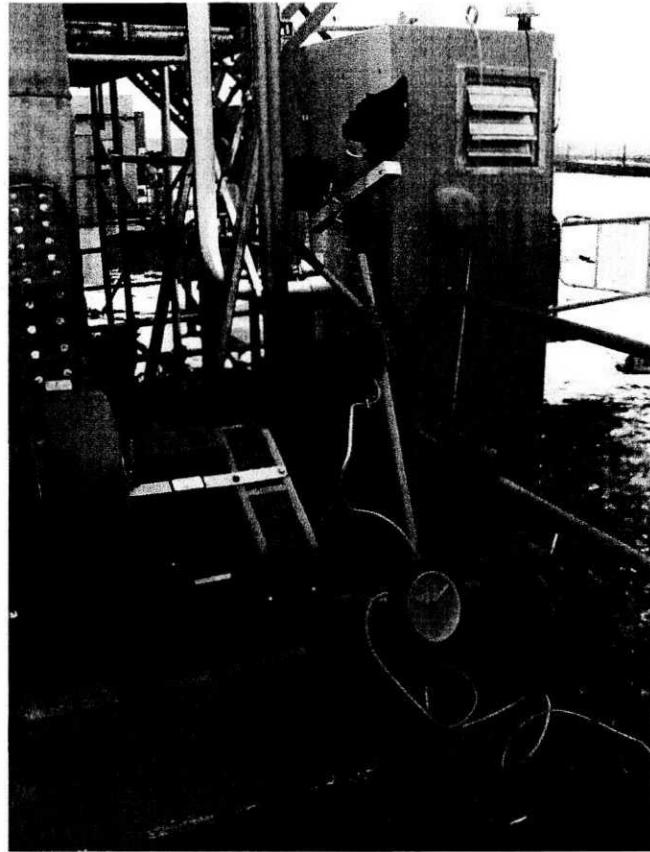
Photo 1: AN Farm Primary Exhaust showing a light used to heat an uninsulated record sampler return after lines were blocked due to condensate freezing.

- Record sampler line freezing occurred in AW and AN Farms. In AN Farm, operations opened the drain valve on the record sampler return line and got the sampler to run. In AW Farm the return line does not have a drain and the return line was removed.
