NOAA/NWS METEOROLOGICAL ASSESSMENT FOR TYPHOON PONGSONA IN: POHNPEI STATE, FSM; CHUUK STATE, FSM; GUAM; AND, ROTA, CNMI

The National Oceanic and Atmospheric Administration (NOAA) National Weather Service (NWS) Meteorological Assessment Team for Typhoon Pongsona

April 2003

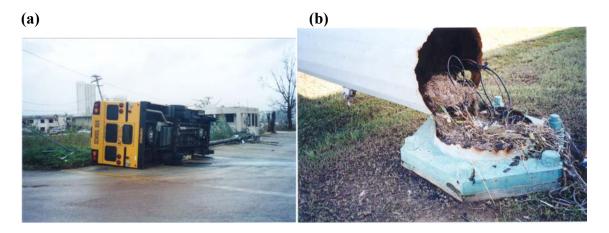
Figure 15. (a) Toppled bus in Tamuning. (b) Toppled light pole at the Paseo baseball field. Note thinness of the rusted metal at the base.

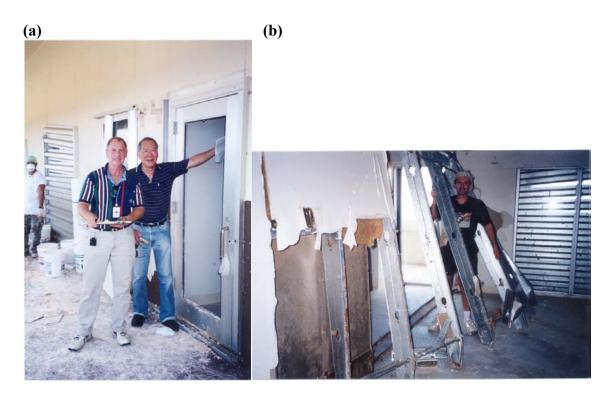
- a) Guam Memorial Hospital. The damage to the interior portions of the hospital (emergency room, pediatrics, and intensive care) was due to a sudden build-up of tremendous wind pressures, resulting from the loss of glass doors (Figure 16a) during the peak of the typhoon passage; this breakage permitted the intrusion of strong winds into the rooms. It is postulated that the glass doors were impacted by flying debris. Internal dry-wall partitions were damaged by the high wind pressures (Figure 16b). Not many glass windows were damaged, and there was no visible damage to the building's main structural system.

Figure 16. **(a)** Broken glass door at the Guam Memorial Hospital. **(b)** Dislodged internal wall in the pediatrics ward of the Guam Memorial Hospital. Assessment authors Chip Guard, Art Chiu, and Mark Lander appear from left to right.

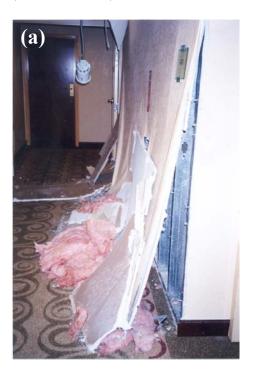
- c) Hotel. A major hotel at Tumon Bay sustained severe broken glass windows facing the bay. The breakage permitted the winds to breach the building envelope and the sudden build-up of internal pressures damaged some of the hallway dry-board walls (Figure 18a) and blew out some of the lightweight external wall material (Figure 18b). Several windows and sliding glass doors at the lobby level were broken. There was no damage to the building's main structural system.

Figure 18. (a) Blown in interior wall of a major Upper Tumon hotel. (b) Blown out exterior wall of a major Upper Tumon hotel. (NOAA Photos)

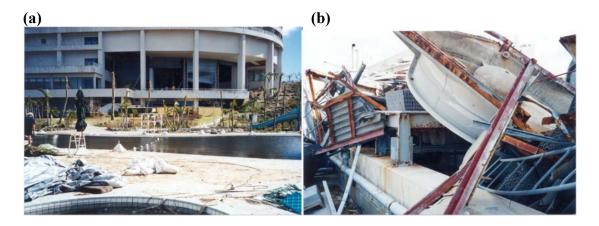
- d) Hotel. Another hotel, at the northerly-end of Tumon Bay, sustained heavy losses to its vertical rolling doors facing the bay (Figure 19a). The increased wind pressure caused damage to the mezzanine floor area and ceiling, but there was no damage to the building's main structural system. Overall, the glass windows and doors of the rooms of this hotel were able to resist the wind forces adequately. However, the air-conditioning system for this hotel collapsed during the storm. It was noted that many of the supporting members and parts for this air-conditioning system were badly corroded and therefore they were not able to withstand the impact of the high wind loads (Figure 19b). Proper preventive maintenance against corrosion might have mitigated this failure.

Figure 19. (a) Severely damaged typhoon doors of a major Upper Tumon hotel. **(b)** Severely rusted and corroded frame and connectors of one of the air conditioning units at a major Upper Tumon hotel.

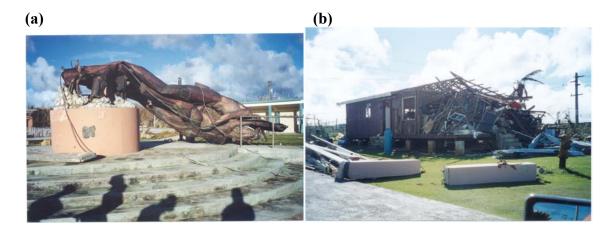
- f) Single-Family Residences. Many of the older, wooden-frame buildings with corrugated metal roofing were destroyed by the strong winds. (Typhoon Chata'an in July had already damaged much of this building stock.) Wood rot, termite infestation, corrosion of the nail connections and hurricane clips, together with the intensity and duration of the storm, all contributed to the demise of these older structures (Figure 20b).

Figure 20. (a) Toppled statue at Two Lover's Point. Note failure of guy wires. **(b)** Severely damaged wood-rotted and termite-infested wooden house in Maite. (NOAA Photos)

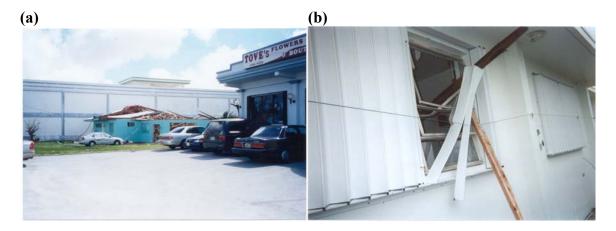
The reinforced concrete frame or reinforced concrete masonry homes resisted the onslaught of the winds very well. Except for occasional visible damage to roof tiles, and damaged windows and doors, these structures showed no signs of distress (Figure 21a and Figure 21b).

Figure 21. (a) Concrete buildings held up well except for the loss of doors and windows. Wooden buildings sandwiched between concrete buildings did not fare so well. (NOAA Photo) **(b)** While storm shutters played a very important role in reducing water damage in buildings, they occasionally were victims of flying debris. (Photo by Carman Lujan)

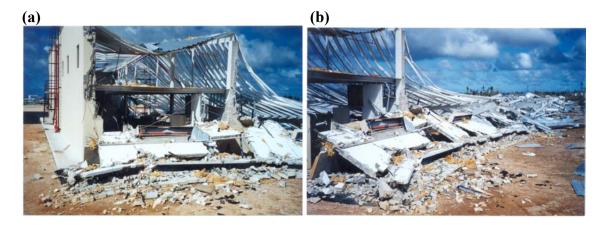
Figure 22. (a) Nearly completed warehouse in Macheche, Dededo with reinforced concrete wall still standing. **(b)** Same building from another angle showing total destruction of the side walls and roof structure. (NOAA Photos)

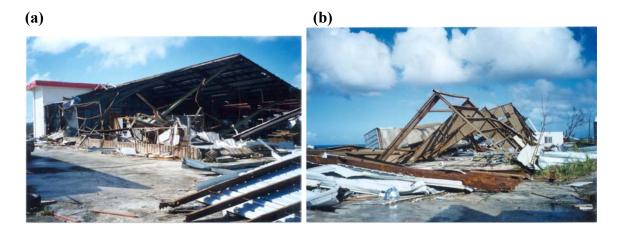
- h) Industrial Building in Maite. Another industrial building along the cliff line in Maite was in an utter collapse stage. Upon close inspection, it was noted that the main structural rigid-frame members, beams, purlins and column base anchors were in advanced stages of rust. Many of the webs were rusted through (Figure 23a and Figure 23b). Also, it was

surmised that the failure mechanism was most probably initiated by the impact from a container that had been slammed against the side of the building. Metal roofing sheets were found in the vicinity of a reinforced concrete apartment building adjacent to the damaged structure; these sheets had been torn off another building about 200 meters away and carried by wind action to this location.

Figure 23. (a) Industrial building near the cliff line at Maite. **(b)** Same building from another angle. Note overturned container that may have helped to destroy the building. (NOAA Photos)

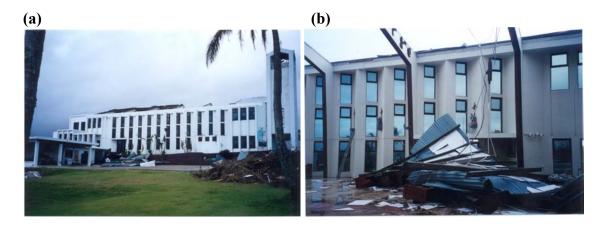
- j) Church in Sinajana. A steel reinforced masonry church in Sinajana received catastrophic damage to its wood and corrugated metal roof, when improperly installed storm shutters were breached and the front doors blew in. The sudden build-up of internal pressures caused the roof to separate from its supporting beams (Figure 24). Recently installed, well-engineered "storm-proof" windows were unscathed by the debris and increased pressures. The roof proved to be the weakest part of the structure. Similar damage occurred to a church in Mangilao.

Figure 24. (a) St. Judes Church in Sinajana exterior view. (b) St. Judes Church interior view. (NOAA Photos)

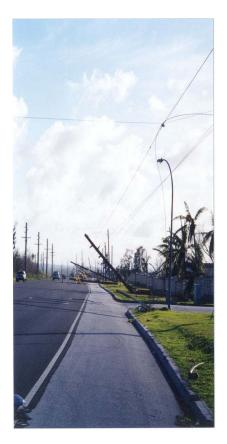
Figure 25. (a) Damage to hollow-spun concrete power poles at Carnation Road in Latte Heights, Dededo. (b) Some hollow-spun concrete power poles were improperly constructed with the pre-stressing steel cables bundled down the hollow center instead of being imbedded in the concrete. (NOAA Photos)

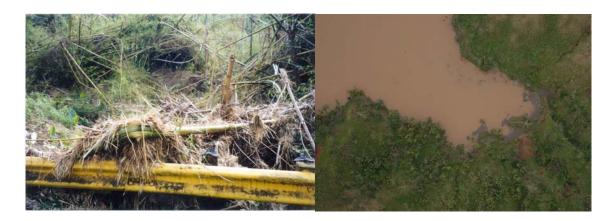
- c). Water and waste-water systems: During Typhoon Chata'an's passage in July, many rivers flooded to levels not seen by long-time residents before. These swollen rivers scoured gorges, dislodging many old trees, and causing heavy erosion and numerous landslides. The heavy runoff from Pongsona into the Fena Watershed again caused considerable erosion (Figure 26a) and severe silting in the Fena Reservoir, making lake waters unsuitable for drinking water production for several days (Figure 26b). Water and waste-water services were knocked out to most of the island, primarily due to the loss of power and the failure of emergency generators. An assessment by the US Army Corps of Engineers indicated that direct storm damage to both systems was minimal, but that most of the experienced failures were due to poor preventive maintenance.

Figure 26. (a) Erosion and debris accumulation at a bridge, due to record rainfalls in central parts of Guam. (NOAA Photo) (b) Silt and debris in the Fena Reservoir on the US Naval Magazine following Typhoon Pongsona. (Official Navy Photos by JO1 Melody Kight Courtesy of COMNAVMAR)

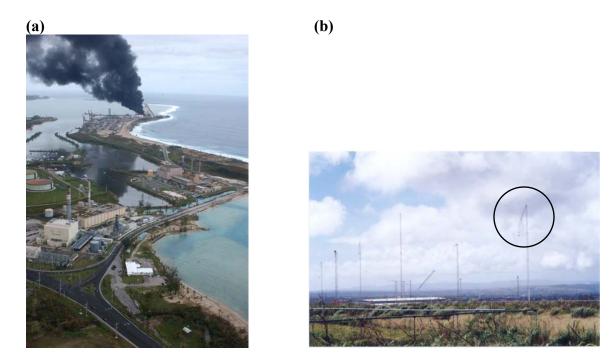
- d). Other infrastructure components: One of the greatest impacts of the typhoon was a fire at the fuel farm at the commercial port (Figure 27a). The fire burned for five days, preventing distribution of gasoline across the island (and across much of Micronesia). This caused a severe gas shortage, greatly hampering recovery and delaying the acquisition of data for this assessment. The cause of the fire is unknown, but may have been started by lightning. Eyewitnesses reported that Typhoon Pongsona contained an extraordinary amount of lightning during its movement over Guam.

Coastal erosion washed out a few stretches of road and blocked several stretches of road with rubble and sand. Downed trees and power poles blocked numerous roadways, although most had been cleared by the time the assessment team had arrived. High winds caused sever damage to many communications towers, including several at a communications station in Barrigada (Figure 27b).

Figure 27. (a) Fuel farm with burning tanks at the commercial port on Guam. Photo was taken 5 days after Ponsona's passage. (Official Navy Photos by JO1 Melody Kight Courtesy of COMNAVMAR) (b) High winds from Pongsona caused damage to several towers at a Communications facility in Barrigada (note the bent-over top of the tower located inside the black circle). (NOAA Photo)

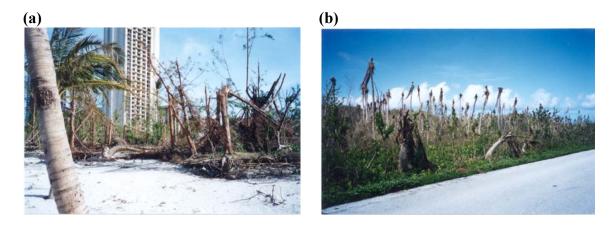
Figure 29. (a) Splintered Australian pine trees at Ypao Beach, Lower Tumon, Guam near area of maximum wind. (b) Twisted crowns of coconut palms at Ritidian Point (NW Guam) indicating the rapid change in wind direction during eye passage. (NOAA Photos)

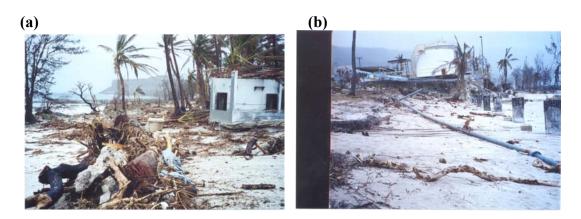
Figure 32. (a) Near coastal effects of the 22-foot storm surge observed at Songsong Village, Rota. (b) Effects of the surge on the fuel-loading pipeline at Songsong, Rota.

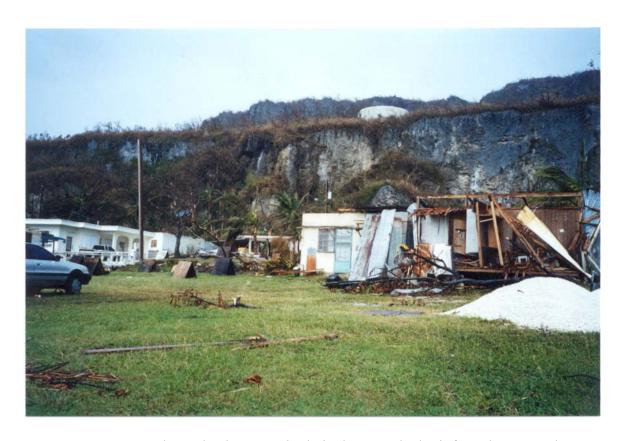
Figure 33. Destroyed wooden house and relatively unscathed reinforced concrete house in eastern Songsong Village, Rota, CNMI.
