National Transportation Safety Board

Safety Recommendation

Date: January 2, 2004

In reply refer to: A-03-57

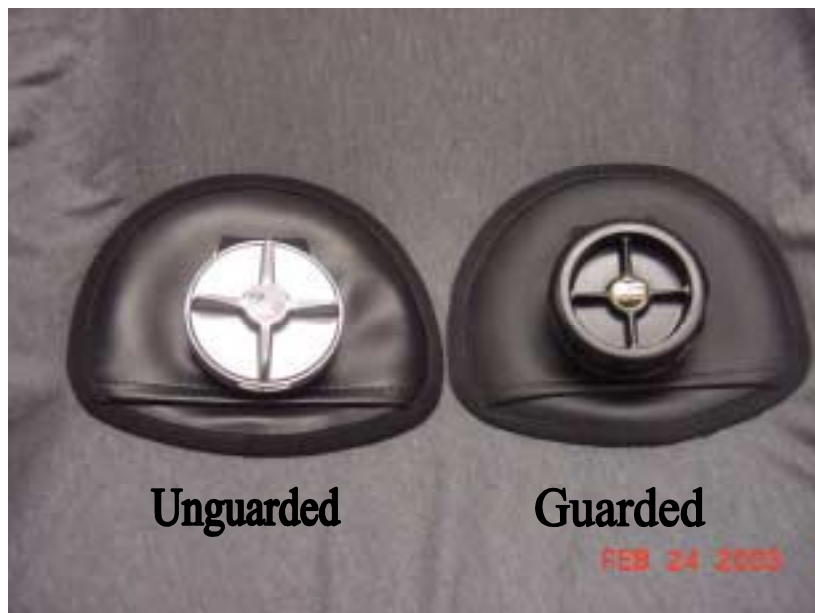
Safety Board staff conducted postaccident ground tests on a Beech 1900D airplane during which a subject of about the same height as the captain, seated in a crewmember seat, pulled aft and rotated the yoke. The tests demonstrated that it was possible for the yoke to contact the rotary seatbelt buckle vane and release the seatbelt buckle. This scenario is consistent with

The problem of inadvertent unlatching of the Pacific Scientific seatbelt buckle was discovered during a flight test of a Boeing 737-400 airplane. When a British test pilot performed a maneuver requiring full aft movement of the control column, a clipboard attached to the yoke contacted the pilot's rotary seatbelt buckle and inadvertently unlatched the seatbelt and shoulder harness. Boeing and a United Kingdom Civil Aviation Authority (CAA) representative present during the flight test requested that Pacific Scientific change its design and develop a protective guard for the buckle-release mechanism. Consequently, Pacific Scientific and Boeing engineers designed a new guarded seatbelt buckle that includes a protective circular guard around the rotary vanes of the seatbelt to prevent the inadvertent release of the restraints.² See figure 1.

Figure 1. Pacific Scientific seatbelt buckles.

Identify all airplanes equipped with unguarded flight crewmember rotary seatbelt buckles and require replacement with guarded buckles that cannot be inadvertently unlatched. (A-03-57)
