# National Transportation Safety Board

## Safety Recommendation

**In reply refer to:** A-04-42 and -43

On September 25, 2003, about 0658 central daylight time, a McDonnell Douglas<sup>1</sup> MD-80, N462AA, operated by American Airlines as flight 1128, experienced fumes and smoke in the cabin after powering back from the gate at Dallas/Fort Worth International Airport (DFW), Dallas, Texas.<sup>2</sup> The airplane was about 200 feet from the jetway when the captain initiated an emergency evacuation. The flight was to be operated as a scheduled domestic passenger flight from DFW to Tampa International Airport, Tampa, Florida, under the provisions of 14 *Code of Federal Regulations* Part 121. The airplane was not damaged, and 8 of the 89 passengers sustained minor injuries during the evacuation. None of the five crewmembers was injured.

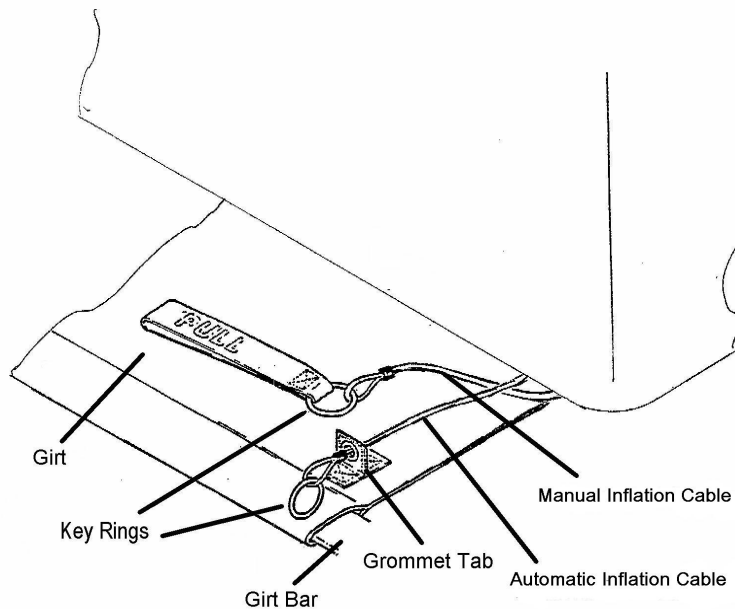
Figure 1. Air Cruisers P/N 29984-series tailcone slide

mounted in a hard pack cover at the end of the tailcone catwalk and is attached to the catwalk by a girt bar (see figure 1), which is inserted into two girt bar floor fittings. The girt bar is connected to the slide by a fabric girt. By design, deployment and inflation of the slide are automatically initiated when the aft bulkhead door leading to the tailcone is opened in the armed mode. The tailcone is rigged with cables that release the tailcone from the airplane when the door is opened, subsequently allowing the tailcone to fall to the ground. Cables simultaneously pull the hard pack cover and evacuation slide off the catwalk. An inflation cable that is attached to a grommet tab on the girt becomes taut and is pulled from the inflation reservoir's regulator valve (shown in figure 2) as the slide falls from the catwalk, releasing a compressed gas mixture into an inflation hose. An aspirator attached to the hose draws ambient air into the slide where it mixes with the compressed gas mixture and inflates the slide.

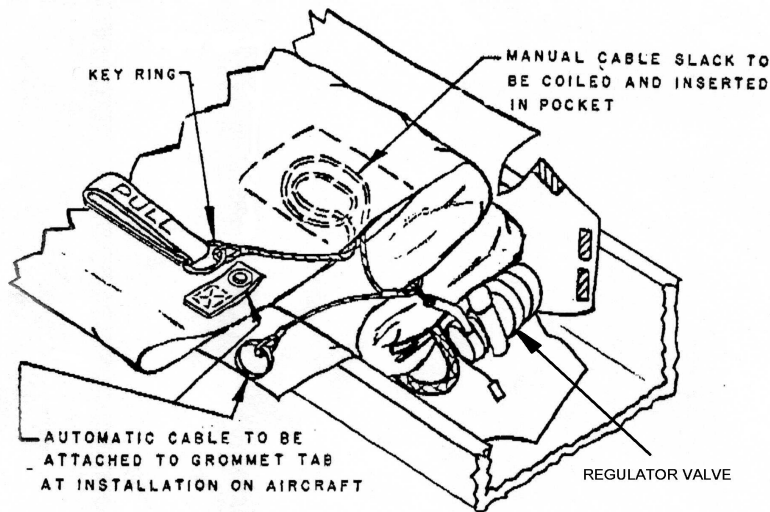
Figure 2. Air Cruisers P/N 29984-series tailcone slide (partially unpacked)

The slide inflation cable originates in the regulator as a single cable, then divides into two portions: a 5-inch-long cable that ends in a key ring (the automatic cable discussed above) and a 42-inch-long cable that ends in a key ring attached to a red manual inflation handle (the manual cable). The manual cable provides a means of inflating the slide if automatic inflation does not occur. The automatic cable is attached to the fixed grommet tab when the slide is installed on an airplane, whereas the manual cable is coiled into a stitched pocket in the girt, with the red "PULL" handle attached to the girt by Velcro (see figure 2).

Second, photographs of the inflation cable from the incident slide showed that the red "PULL" handle on the incident slide was incorrectly attached to the automatic (shorter) cable and that only a key ring was attached to the manual (longer) cable. If an incorrectly rigged slide is installed on an airplane in this manner (as the incident slide was), it would most likely deploy but not inflate because of the difference in the lengths of the automatic and manual inflation cables. When the slide is properly rigged, the shorter, automatic inflation cable becomes taut almost immediately, and the slide begins to inflate. However, if the slide is rigged as it was on the incident airplane, it is unlikely that the longer, manual inflation cable would become sufficiently taut and, thus, it is unlikely that the regulator valve would activate. Additionally, in this incorrectly rigged configuration, the manual inflation handle on the shorter, automatic cable would most likely be torn away from the Velcro as the slide pack fell from the tailcone and, therefore, would not be available for subsequent manual slide inflation.

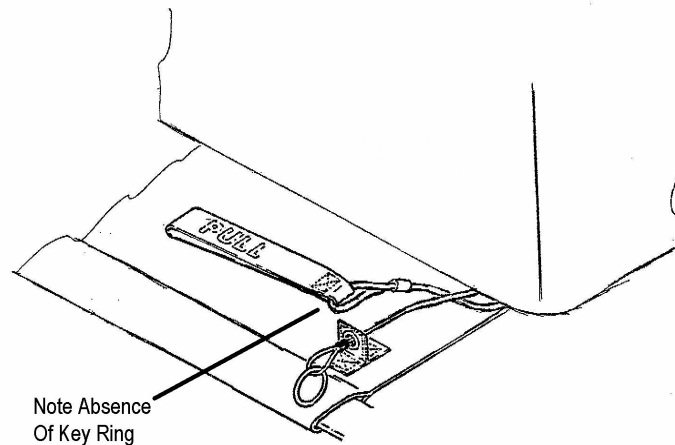
Figure 3. Air Cruisers P/N 29984-series tailcone slide, revised per SB 304-25-24

On April 27, 1992, Air Cruisers issued Service Bulletin (SB) 304-25-24 for P/N D29984-series evacuation slides manufactured before serial number 0940. The SB instructed operators to remove and discard cable assembly P/N 37028-105, which contained key rings attached to both the automatic and manual portions of the inflation cable (as shown in figure 1), and install new cable assembly P/N 61866-101, which contained a key ring attached to the automatic cable but not to the manual cable (as shown in figure 3). On the new cable assembly, the red “PULL” handle is attached directly to the manual portion of the cable. The SB also stated that Air Cruisers “folding procedure P-11843 will require a revision as a result of this service bulletin.”

American Airlines reported that the actions called for in SB 304-25-24 had not been implemented in its MD-80 fleet. Additionally, discussions with two American Airlines slide shop employees revealed that when they occasionally received P/N 61866-101 cable assemblies from the airline’s inflation reservoir overhaul facility, employees removed the newer style manual inflation handles (with no key ring) and replaced them with an older style red manual inflation handle (with a key ring). According to the American Airlines slide shop employees, they accomplished this task in accordance with guidance contained in Air Cruisers slide folding procedure P-11843, which instructed, “attach loop of manual cable to key ring on pull handle.” The Safety Board’s review of Air Cruisers folding procedure revealed that it had not been updated as deemed necessary in SB 304-25-24.

Air Cruisers issued a revised folding procedure P-11843 on December 19, 2003. The revised procedure clarifies the stowage location of the manual inflation cable and includes the updated drawing shown in figure 3. Also on December 19, 2003, Boeing released an "All-Base" message notifying MD-80 and MD-90<sup>3</sup> operators of the findings of the investigation and suggesting that operators consider a one-time inspection for proper cable routing as well as implementation of the actions called for in SB 304-25-24 at the earliest maintenance opportunity.

Expediently issue an airworthiness directive to require operators to implement Air Cruisers Service Bulletin 304-25-24 on an accelerated schedule and not wait for the slides' next regularly scheduled maintenance interval. (A-04-42)
