# National Transportation Safety Board

## Safety Recommendation

**Date:** June 25, 2004

**In reply refer to:** A-04-48 through -50

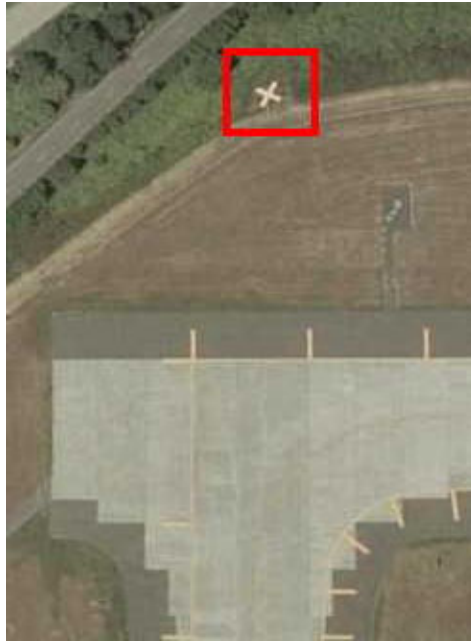
Management at SEA has made several attempts to address this issue, including the installation of a small nonstandard<sup>5</sup> "X" about 200 feet off the north end of the taxiway (see figure 2) in May 2000 and the installation of a larger 24-foot-wide bright yellow "X" about 80 feet off the north end of the taxiway (see figure 3) in May 2003. The airport also added a note to the Airport Facility Directory advising pilots, "do not mistake Txy Tango for runway." Other corrective actions include a note stating, "caution...do not mistake Taxiway Tango for Runway 16R" being added to the automatic terminal information service (ATIS) and the centerline lights on runway 16R being set to operate 24 hours a day. Most recently, on January 26, 2004, the airport installed an additional lighted "X" (see figure 4) in front of the 24-foot-wide "X." However, despite the airport's efforts, flight crews continue to mistake taxiway T for an active runway (as evidenced by the most recent February 2004 near-landing incident<sup>6</sup>).

**Figure 2.** Aerial photograph of first “X” placed near taxiway T at SEA in May 2000

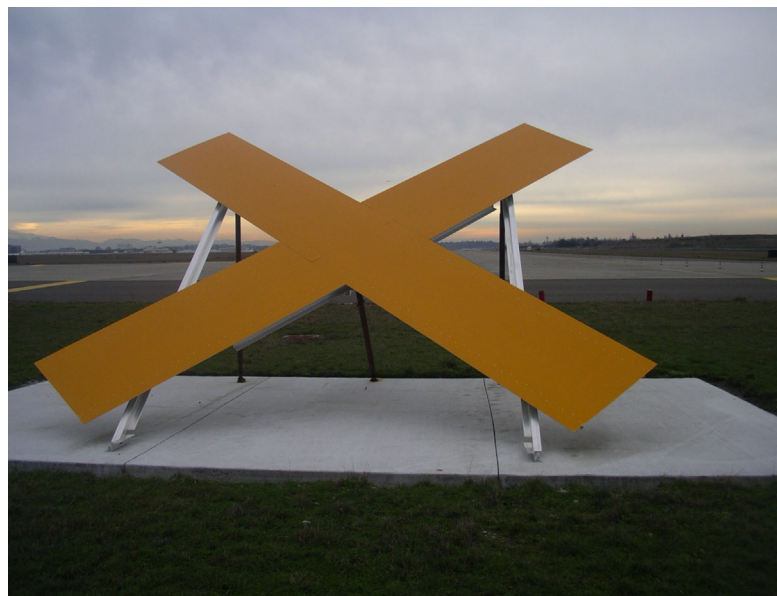
**Figure 3.** Second “X” placed near taxiway T at SEA in May 2003

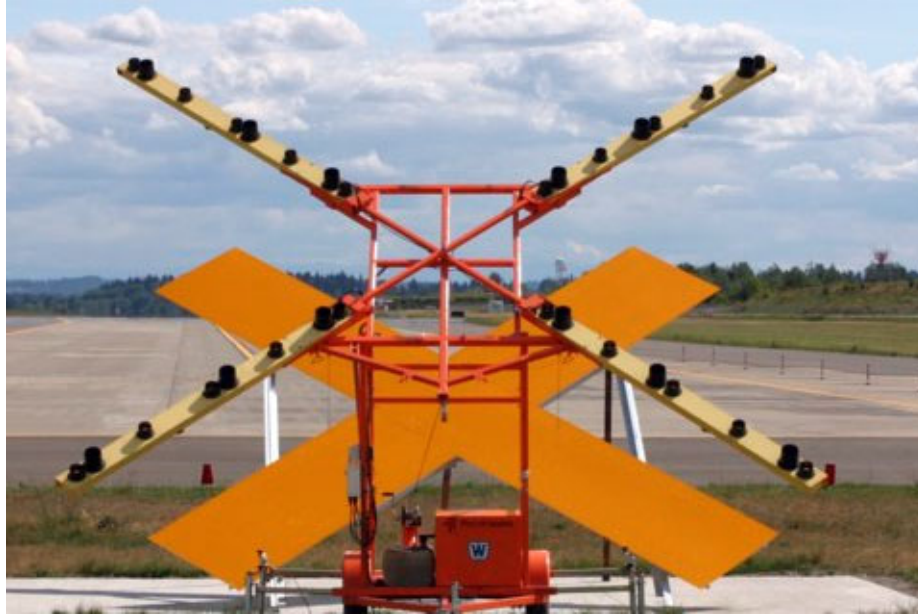
<sup>6</sup> According to the flight crew from the February 2004 incident, the lighted "X" was not visible until about 1/2 mile from the end of the taxiway, the centerline lights on runway 16R were on dim and "could not be seen" during their approach and landing, and the ATIS note was not being broadcast at the time of the event (which the Federal Aviation Administration flight standards district office confirmed).

**Figure 4.** Third “X” placed near taxiway T at SEA in January 2004

Allow Seattle-Tacoma International Airport, as an interim solution, to apply a) large nonstandard taxiway identification markings (such as the word “TAXIWAY”) at regular intervals to the full width of the taxiway T surface, starting near the approach end and continuing for one-half the length of the taxiway; and b) a continuous serpentine line over the taxiway centerline, between each of the aforementioned nonstandard taxiway identification markings. (A-04-48)

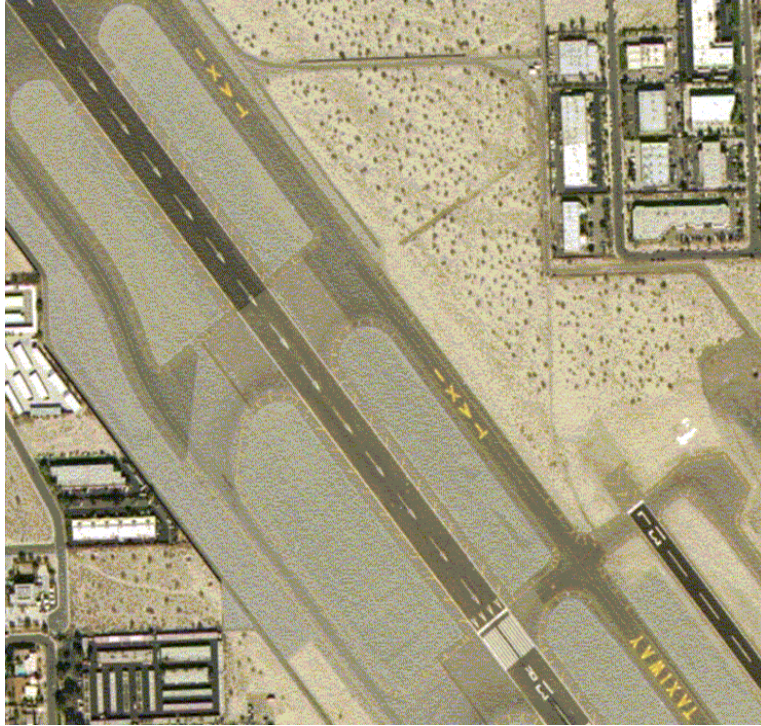
For example, after adding a second parallel runway in 1991, Palm Springs International Airport (PSP), Palm Springs, California, began experiencing inadvertent landings on taxiway C. Over several years, PSP made many efforts to correct the problem, including painting the word “TAXIWAY” about 4,000 feet down the 10,000-foot taxiway, widening the runway centerlines, adding fixed-distance markings to the new runway, printing larger runway identification numbers, outlining runway markings in black borders, and repainting runway and taxiway markings whenever they lost their brightness or color. Although airport personnel noted some improvement, the landings continued to occur, reaching almost 20 taxiway landings by 1995. In that year, PSP personnel added the word “TAXI” in large block letters in the taxiway area that pilots had mistaken for the touchdown zone and repeated the word about 1,000 feet further down the taxiway (see figure 5). In addition, the airport applied serpentine lines, each of which runs for about 1,200 feet, over the top of the standard taxiway centerline markings in two sections in the area where aircraft had been touching down on the taxiway (see figure 6). Since these additions, according to the airport’s Deputy Director of Operations, the rate of aircraft inadvertently landing on the taxiway has been reduced, and no such events have occurred in the last 4 years.

**Figure 5.** Aerial photograph of taxiway markings at PSP

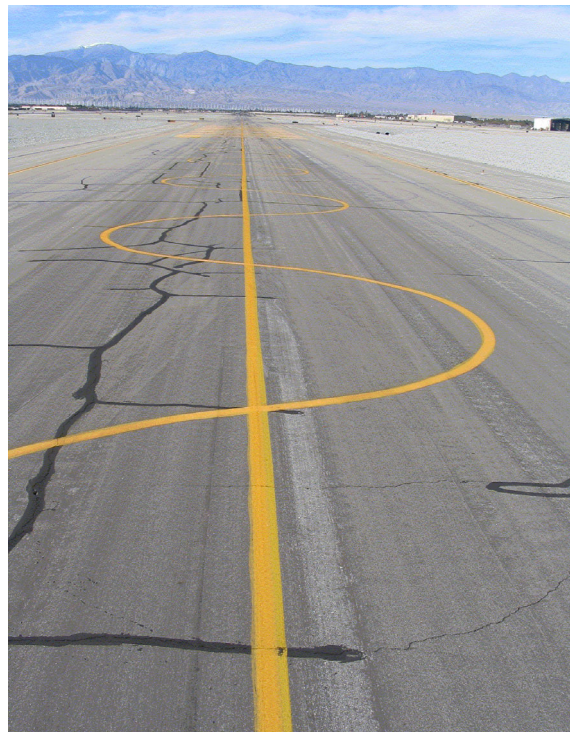
**Figure 6.** Serpentine line on a taxiway at PSP

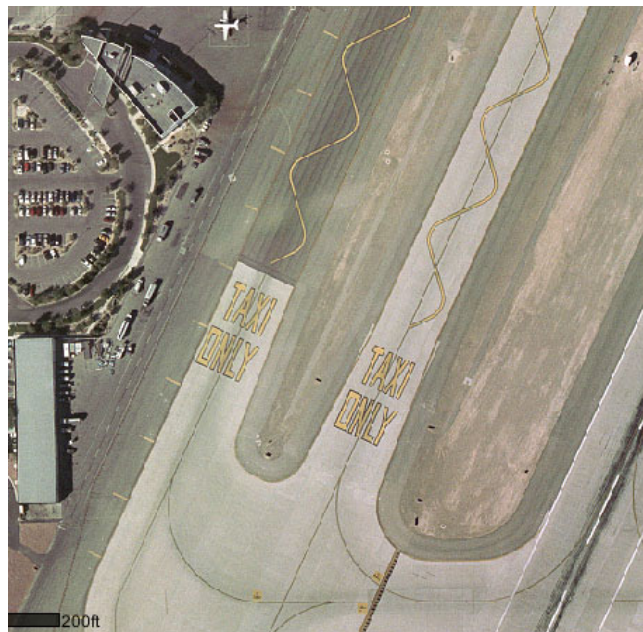
According to a representative of airport operations at McCarran International Airport (LAS), Las Vegas, Nevada, the airport first experienced a problem with airplanes landing on a taxiway (which was parallel to a general aviation [GA] runway) in the 1970s. LAS addressed the problem by painting “TAXI ONLY” and a serpentine taxiway centerline on the taxiway. The airport experienced a similar problem again in 1997 when it replaced the GA runway and parallel taxiway with a full-length runway parallel to existing runway 19L. The LAS representative stated that five airplanes landed on a parallel taxiway within the first 2 weeks after installing the second full-length runway. Again, the airport decided to paint “TAXI ONLY” and a serpentine centerline on the taxiway (see figure 7). According to the LAS representative, an average of one airplane a day lined up on the taxiway on approach during the 2-week period that the airport was coordinating the process to add the taxiway markings. Landings on the taxiway were eliminated once the nonstandard taxiway markings were completed.

**Figure 7.** Taxiway Markings at LAS
