National Transportation Safety Board

Safety Recommendation

In reply refer to: A-04-51 and -52

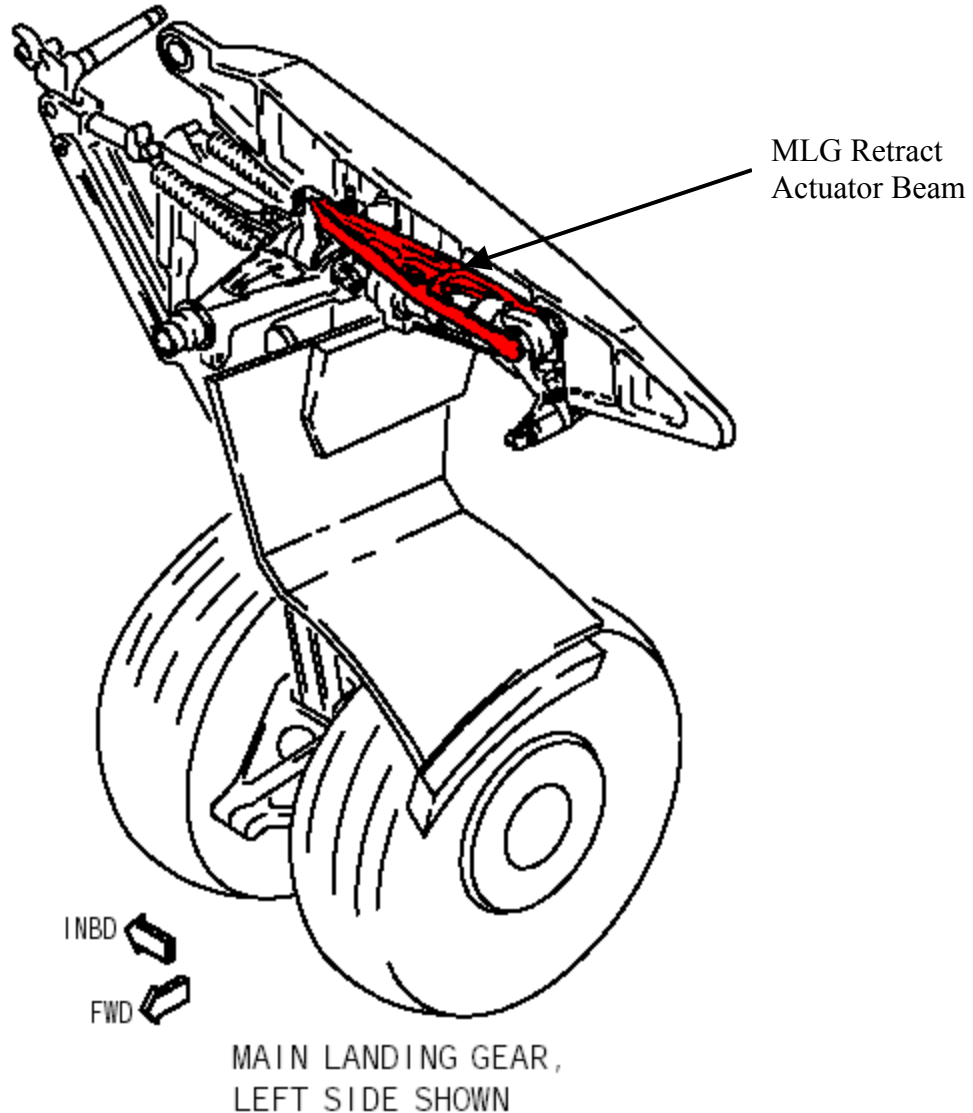
Figure 1. 737 MLG Retract Actuator Beam

On August 12, 2003, a Boeing 737-500, registration EI-CDD, operating as an Aer Lingus flight en route from Amsterdam to Dublin, suffered a fracture of the left main landing gear (MLG) retract actuator beam, commonly known as the “walking beam” (see figure 1). The pilot reported hearing a loud noise when the landing gear was retracted on takeoff but, because there were no abnormal indications in the cockpit, proceeded with the flight to its destination. In preparation for landing, the landing gear was extended and again a loud noise was heard. The flight landed safely with no injuries to the crew or passengers.¹

During postflight examination, it was discovered that the left MLG retract actuator beam was fractured into two pieces and several nearby cables and components were damaged. Specifically, the spoiler cables were severed, the rear spar and landing gear beam were damaged, the aileron pulley bracket was dislocated, and the aileron cables were pinched. During the course of the investigation, Boeing informed the Safety Board of three similar incidents in which an MLG retract actuator beam had failed. In all four cases, the MLG had been previously overhauled.²

Boeing's examination of the failed retract actuator beams from all four incidents revealed that proper overhaul procedures were not followed. The Aer Lingus retract actuator beam failure was caused by stress corrosion cracking initiating at embedded aluminum oxide particles that were not removed after an abrasive grit blasting procedure during the previous overhaul, which took place in January 1998, more than 5 years (10,304 cycles/14,011 flight hours) prior to the MLG failure. The cause of two of the other failures³ was stress corrosion cracking initiating from small corrosion pits that were not entirely removed during the previous overhaul. In the fourth case,⁴ the cracking initiated in an area of heat damage/burning determined to have been

caused by incorrect stylus cadmium plating.⁵ After the first three incidents, on January 30, 2003, Boeing issued Service Bulletin (SB) 737-32A1355⁶ recommending inspection of the retract actuator beam for damage and rework of the retract actuator beam with an organic finish (paint) that provides increased durability. The new finish gives better protection from in-service damage and corrosion. This SB was not accomplished on any of the four incident MLG retract actuator beams and was not applicable based on their in-service times.⁷

Expedite the issuance of an airworthiness directive requiring compliance with Boeing Service Bulletin 737-32A1355 for the inspection and rework of the Boeing 737 main landing gear retract actuator beam. (A-04-51)

Require a detailed inspection, as soon as possible, of those Boeing 737 main landing gear retract actuator beams specified in Boeing Service Bulletin 737-32A1355 for nicks, gouges, corrosion and cracking and, if necessary, require

rework in accordance with the procedures in Boeing Service Bulletin 737-32A1355. (A-04-52)
