National Transportation Safety Board

Safety Recommendation

In reply refer to: H-04-17

This recommendation, which addresses barrier design, is derived from the Safety Board's investigation of an April 4, 2002, accident involving a child care van in Memphis, Tennessee,¹ and is consistent with the evidence we found and the analysis we performed. As a result of this investigation, the Safety Board has reiterated 1 past recommendation and issued 10 new safety recommendations, 1 of which is addressed to the American Association of State Highway and Transportation Officials. Information supporting this recommendation is discussed below. The Safety Board would appreciate a response from you within 90 days addressing the actions you have taken or intend to take to implement our recommendation.

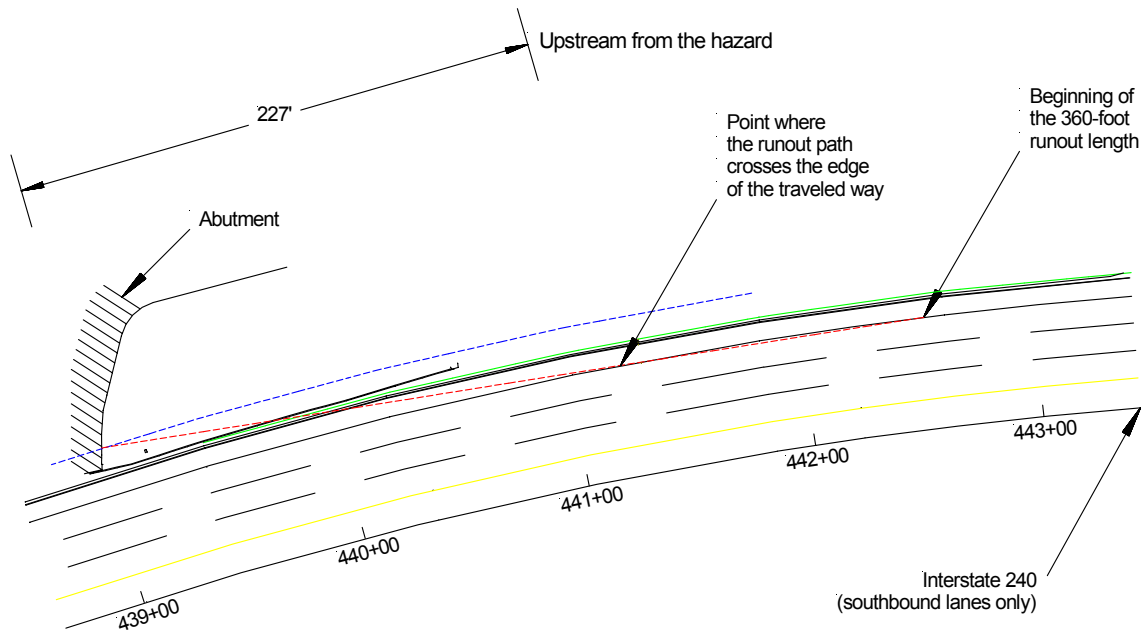
The roadside barrier at the accident site extended 160 feet from the bridge abutment. Based on a plot of the accident site, using the 21-foot clear zone and the 360-foot runout length recommended by AASHTO for design speeds of 55 mph,² the barrier's calculated length of need is 79 feet. As can be seen in figure 1, when the runout length is plotted, it actually intersects the roadway only 227 feet from the bridge abutment because of the roadway's curvature, so that the full 360 feet is not available for errant drivers to recover.

Figure 1. True runout length on curve.

Because of the horizontal curve before the bridge abutment, the length of need of the guardrail should be calculated to account for vehicles that leave the roadway tangent to the curve, as the accident vehicle did. Your organization states in one of its design examples³ that when a vehicle leaves the road on the outside of the curve (as in this accident), it generally follows a tangential path. In such cases, the tangent line from the curve to the clear zone or outside edge of the hazard should be used instead of the theoretical runout length.

Because of the curvature of the roadway, a vehicle can depart the roadway at a distance further from the hazard than that predicted by AASHTO's recommended runout length. When a vehicle "straightens out" the curve, it departs the roadway further from the hazard but still needs to be redirected or provide room to stop. When this occurs, the vehicle can completely miss the barrier system designed to protect against the hazard, as was the case in this accident and others. Memphis Police Department records indicate three fatal (including this accident) and two property damage accidents at the accident location between 1997 and 2002 in which vehicles became trapped behind the guardrail.

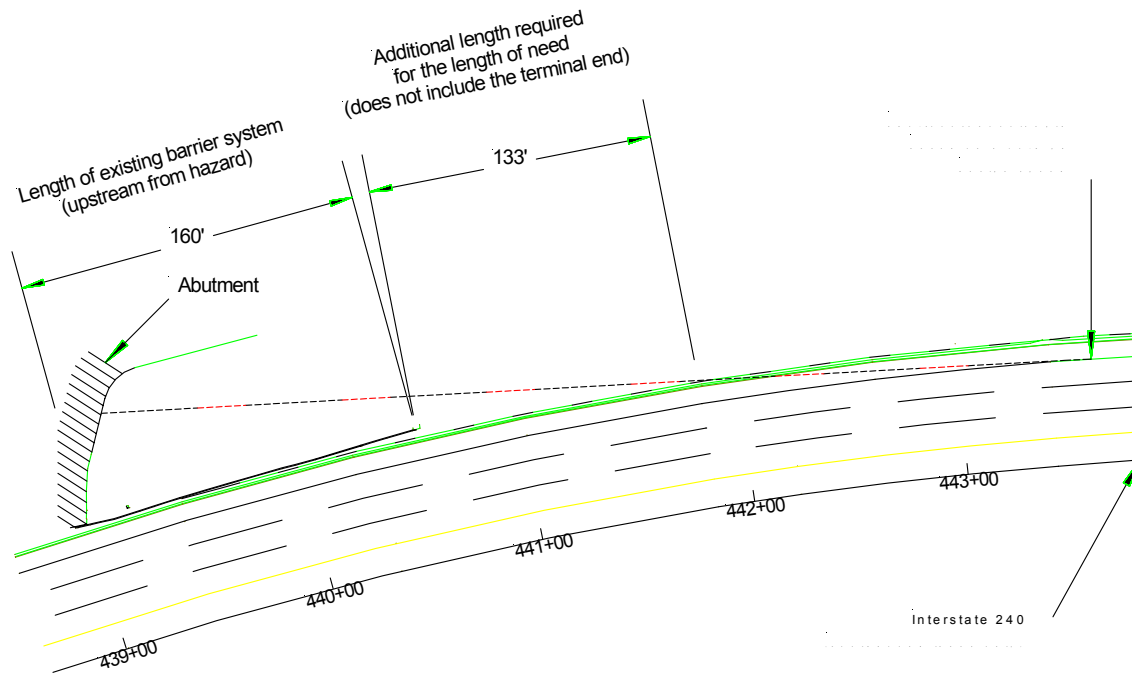
Using AASHTO's formulas and a runout length of 480 feet (based on the 85th percentile speed of 70 mph) and plotting the trajectory of a vehicle that leaves the roadway tangential to the curve, the barrier system's length of need is 293 feet, exceeding the existing barrier's length by 133 feet, not including the end treatment. (See figure 2.) By extending the barrier, the likelihood of an errant vehicle impacting the barrier system and being redirected away from the bridge abutment increases. For a driver trapped behind the barrier, the additional length would provide the opportunity to stop before colliding with the bridge abutment.

Figure 2. Length of need based on speed and roadway curvature.

The Safety Board concludes that given the roadway curvature and the lack of a clear zone, the barrier at the accident site was not long enough to prevent a vehicle that departed the roadway from going behind the barrier or to allow an errant vehicle to recover before striking the bridge abutment. AASHTO's *Roadside Design Guide* does not specifically address these types of situations or direct the highway designer to examine the need for longer runout lengths if the conditions could contribute to a vehicle becoming trapped behind the barrier or if the roadway curves.

Modify the guidance contained in the *Roadside Design Guide* to clearly provide designers with information on the design of roadway barrier systems in situations where the roadway curves or where the terrain, hazards, and barrier system could trap an errant vehicle behind the barrier system. (H-04-17)
