NATIONAL TRANSPORTATION SAFETY BOARD  
WASHINGTON, D.C.

SAFETY RECOMMENDATION(S)

H-75-16

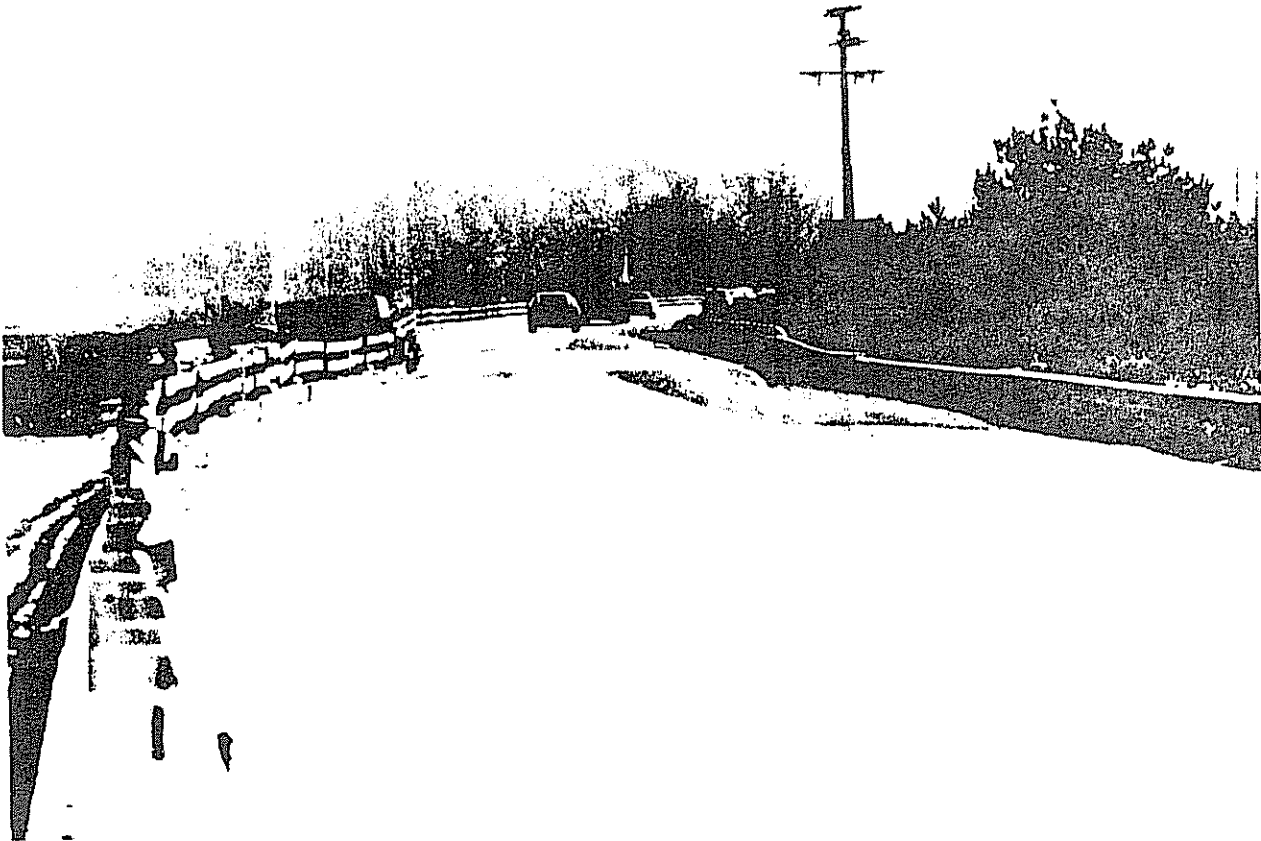
- (1) Lane markings are too faint to see, especially at night or when the road is wet; some lane markings which are no longer current are still visible, which can confuse motorists; and the lane markings which indicate transitional lanes on the shoulders are too abrupt for the posted speed limit.
- (2) The timber barricades, which are used both as traffic barriers and road edge delineators can be knocked into the roadway by a vehicle or blown onto the roadway by the wind; the barricade rail forms a spear when it is hit by a vehicle; and when struck, the barricades are inadequate, at posted speeds, to safely redirect traffic onto the roadway.

Transition site at Interstate 495 and Backlick Road where a fatal accident occurred on January 11, 1975. This photo illustrates typical hazards of timber barricades inadequate to redirect traffic when struck and lane markings still visible though no longer current. This photo does not represent visual conditions at the time of the accident.

Investigate the above-mentioned hazards to determine if they still exist, and, if so, take appropriate action to correct them. (CLASS I.)
