Log No. 1011227 Rev. 1-75-17  
**NATIONAL TRANSPORTATION SAFETY BOARD**  
WASHINGTON, D.C.

SAFETY RECOMMENDATION(S)

R-75- 17

TRACE OF LOCOMOTIVE YAW  
E-60-CP ELECTRIC LOCOMOTIVE  
AMTRAK NO. 9650

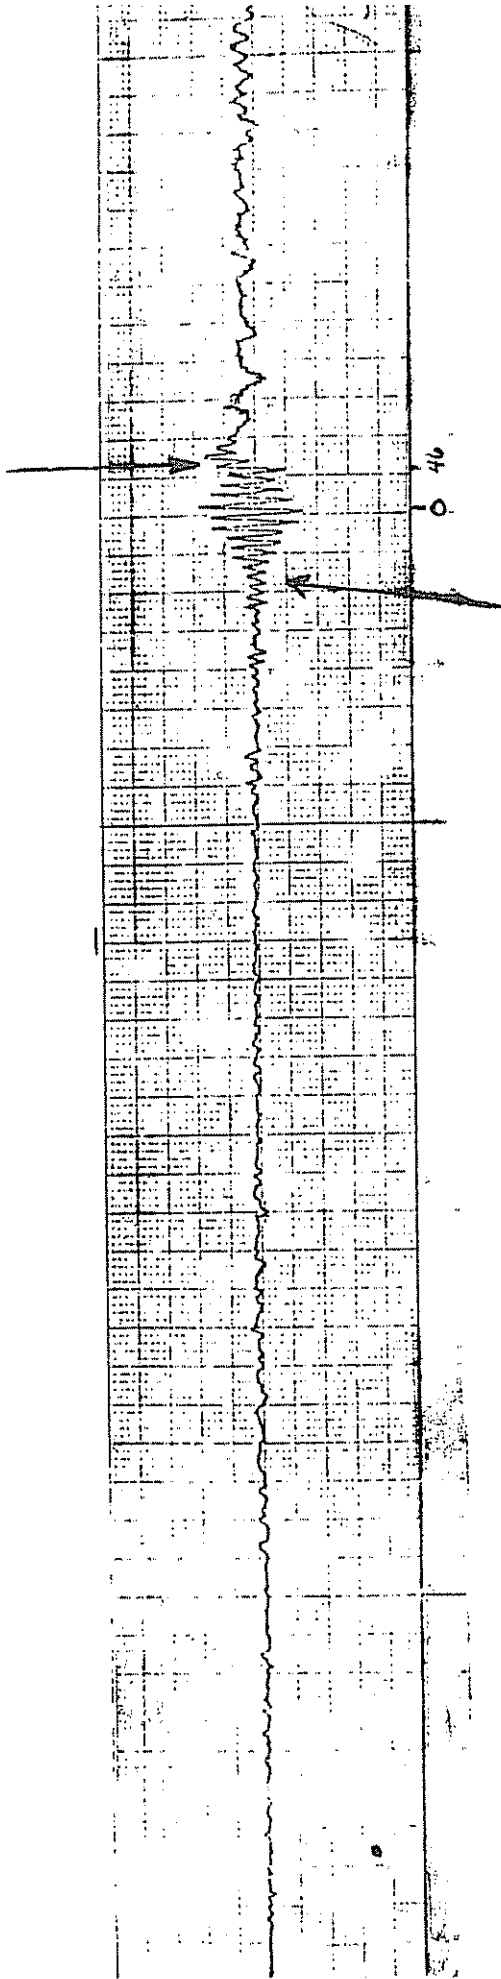
FIGURE 1

Instrumentation of the front truck indicated that excessive vibratory yawing occurred as the locomotive approached the point of derailment and that the derailment occurred after 10 to 15 oscillations. (See Figure 1.) Records of previous runs of about 80 mph on February 6 and 100 mph on February 13 show similar vibratory yawing of the locomotive at the same track location. The records indicate that, with the locomotive traveling at 100 mph over that section of track, some relationship between the track and the locomotive induced vibratory yawing and oscillations sustained for 8 to 16 cycles at a frequency of about 3.5 Hz. The frequency corresponded approximately to the number of joints passed by one wheel in one second.

100 mph = 146.6 feet/ second  
3.8 oscillations per second = 38.5 feet/ oscillation

1. The Federal Railroad Administration monitor the testing of the E60CP locomotive and determine that the conditions which caused the derailment are corrected before the locomotive is placed in service, utilizing its authority under Section 203 of Federal Railroad Safety Act of 1970.
