National Transportation Safety Board

Washington, D.C. 20594
Safety Recommendation

Date: **NOV 14 1996**
In reply refer to: A-96-124 through -127

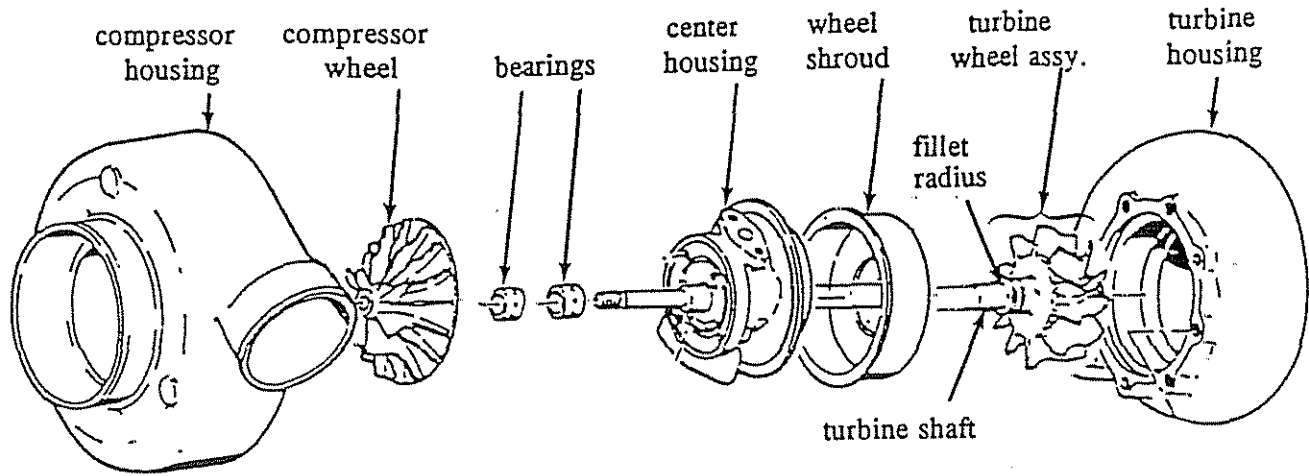
Figure 1. AlliedSignal Model T1879 Turbocharger

The Safety Board's investigation of the accident found that the turbine shaft on the left engine turbocharger, an AlliedSignal Aerospace Company Model T1879, was fractured where the shaft is joined to the turbine wheel.² Examination of the turbine shaft in the Safety Board's materials laboratory revealed ratchet marks indicative of fatigue cracking initiating from a large number of origins within the radius. Scanning electron microscope (SEM) examination disclosed fatigue striations on the relatively undamaged regions of the fracture. The turbine shaft normally has a fillet radius at the point where the shaft is joined to the turbine wheel; however, the failed shaft had a sharp corner. SEM examination showed that the radius had been filled with chrome plating that had increased the dimension of the turbine shaft bearing journal lands to the dimension of the adjacent section of the turbine shaft. A longitudinal section taken through the centerline of the turbine shaft revealed that the shaft met the manufacturer's dimensional requirements before chrome plating. The AlliedSignal overhaul manual for the Model T1879 turbocharger states that chrome plating of shaft journals and wheel hub surfaces is not permitted.

²See Figure 1 for a diagram of the AlliedSignal Model T1879 Turbocharger.

Require operators of all AlliedSignal aircraft turbochargers overhauled or repaired by repair stations other than the manufacturer's to inspect those turbochargers for unauthorized parts or for chrome plating that is not recommended by the manufacturer. Require the removal and replacement of these component parts when found. (A-96-124)

Examine the policy that allowed the FAA to approve machining and chrome plating of AlliedSignal aircraft turbocharger turbine shafts when such repairs were contrary to the procedures recommended by the manufacturer. Rescind that approval and issue an airworthiness directive requiring the removal of all chrome-plated turbine shafts and replacement with approved AlliedSignal aircraft turbocharger turbine shafts. (A-96-125)
