National Transportation Safety Board

Washington, D.C. 20594
Safety Recommendation

In reply refer to : A-96-23 and -24

On March 21, 1996, a Sukhoi SU-29 high performance aerobatic airplane, N729SU, crashed near New Orleans, Louisiana. The pilot was killed, and the airplane was destroyed. Radar data indicate that the airplane was maneuvering in a manner consistent with the performance of aerobatics before the accident.

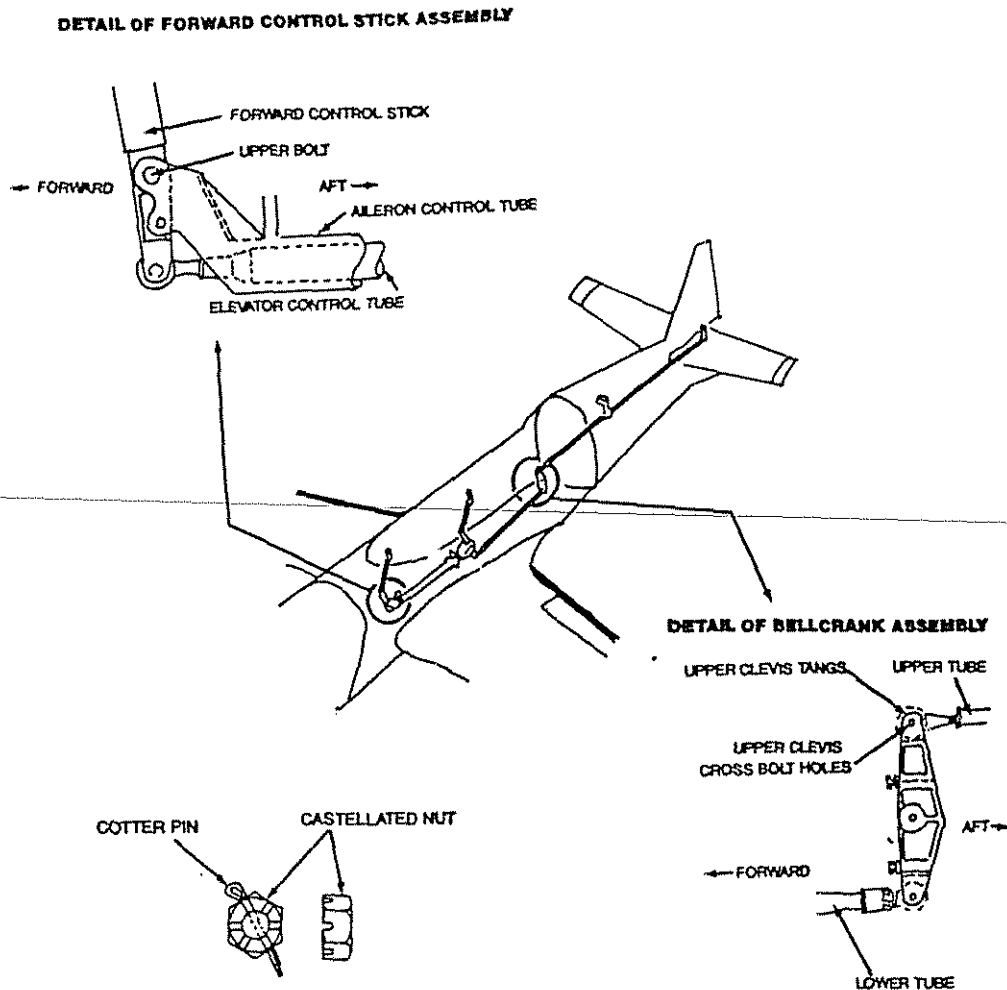
The elevator control system of an SU-29 consists of tubes, a bellcrank, and a few intermediate joints that connect the control sticks to the elevator for pitch control (see Figure 1). The bellcrank is oriented vertically, and tubes are attached to the bellcrank in the fore and aft direction by threaded spherical rod end bearings. The spherical rod end bearings are connected to the bellcrank's clevis tangs by bolts that are secured with castellated nuts and flared cotter pins. The forward end of the lower tube (forward of the bellcrank) is connected to the aft cockpit control stick and serves as the only pitch control input to the bellcrank. The forward end of the upper tube (aft of the bellcrank) connects to the bellcrank's upper clevis tangs at the upper clevis crossbolt holes. The upper tube and other control system components actuate the elevator. The bellcrank reverses the motion of the lower and upper control tubes and slightly alters the leverage ratio. With an aft movement of the pilot's control stick, the lower elevator tube moves forward, causing aft movement of the upper tube.

The wreckage of N729SU was found in a swamp with the wings, fuselage, and empennage fragmented. The elevator and aileron control system tubes were broken in numerous places. The elevator upper tube was detached from the bellcrank, but the bellcrank's upper clevis tangs were undamaged. The upper clevis cross bolt holes contained bushings that were round and undistorted, and the bolt, castellated nut, and cotter pin were missing.

The Safety Board's material laboratory measured the upper clevis cross bolt holes of the bellcrank from the accident airplane using an optical comparator and video measurement system and confirmed that the bolt holes were not distorted. Examination of the upper clevis cross bolt holes under higher magnification revealed that a bolt had been previously installed, but that the bolt was not present when the plane crashed. This suggests that the bolt migrated out of the clevis holes of the bellcrank during the flight, causing the loss of control. Loss of the cotter pin would have allowed the castellated nut, if installed, to back off the bolt and the bolt to migrate from the clevis holes thus allowing the upper tube to disengage from the bellcrank.

Issue a telegraphic airworthiness directive to the owners of all U.S.-registered Sukhoi SU-29 and SU-31 airplanes requiring immediate inspection to ensure that the flight control systems are properly assembled and that all control system cotter pins are properly installed. (Class I, Urgent Action) (A-96-23)
