Status of MIPP RICH

Rajendran Raja
Fermilab

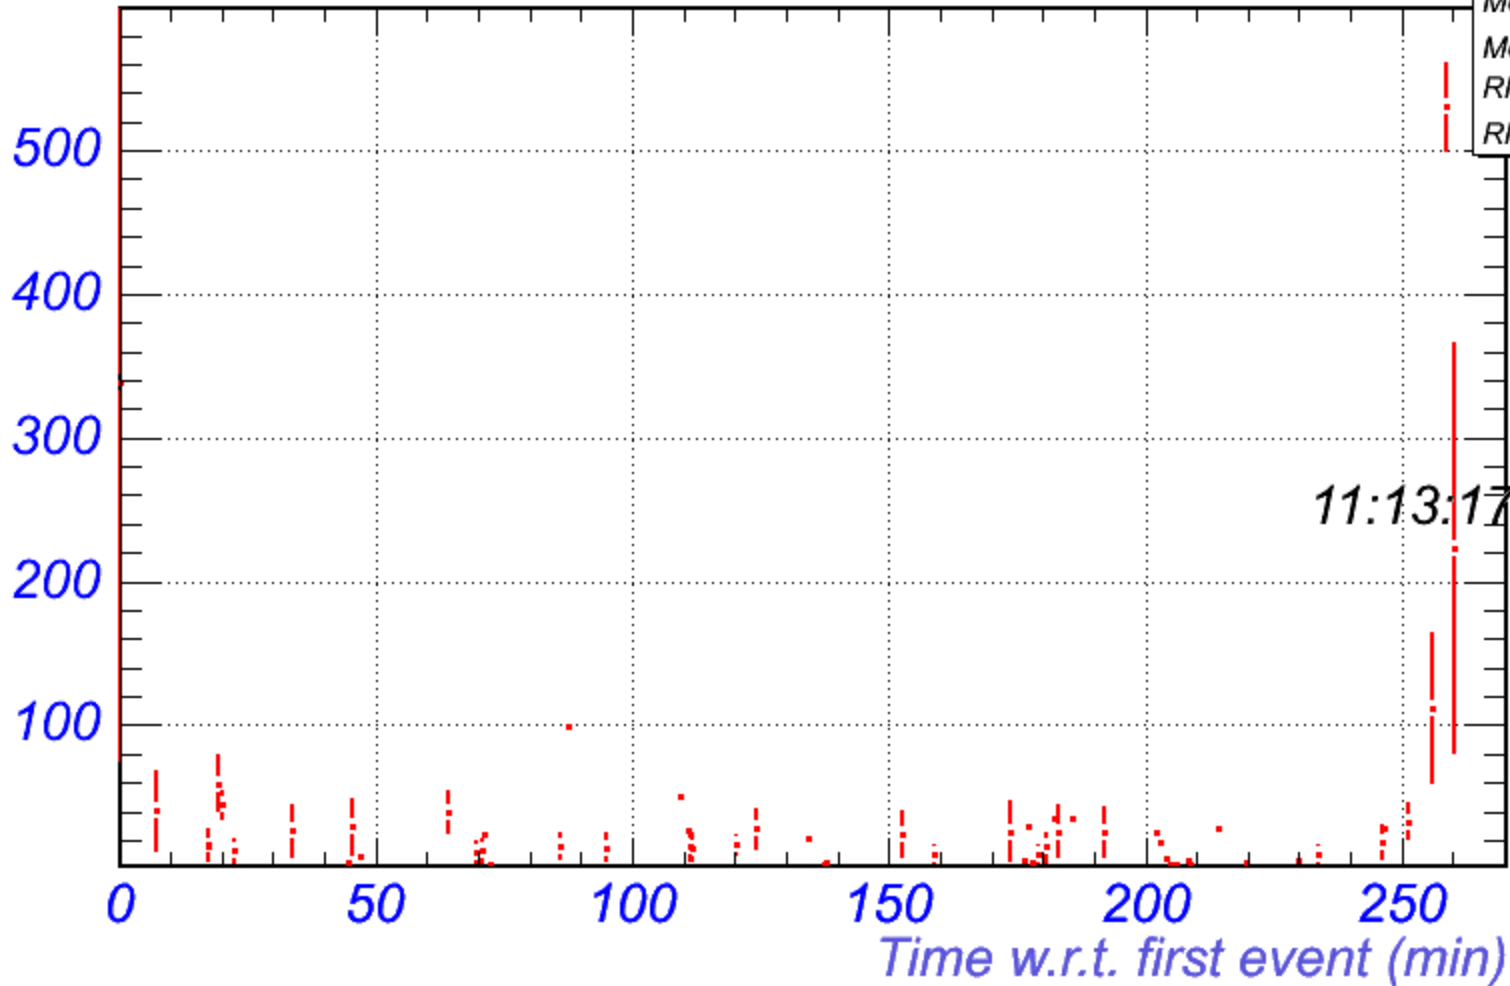
Number of RICH digits vs. time

- The HV was turned on March 2, 2004. All HV was set at 1400 V to begin with. This was 50-500 V below nominal.
- There was some sort of power glitch a week later. May be unconnected.
- Last event taken on March 14, 2003 at 11:13:11 AM.

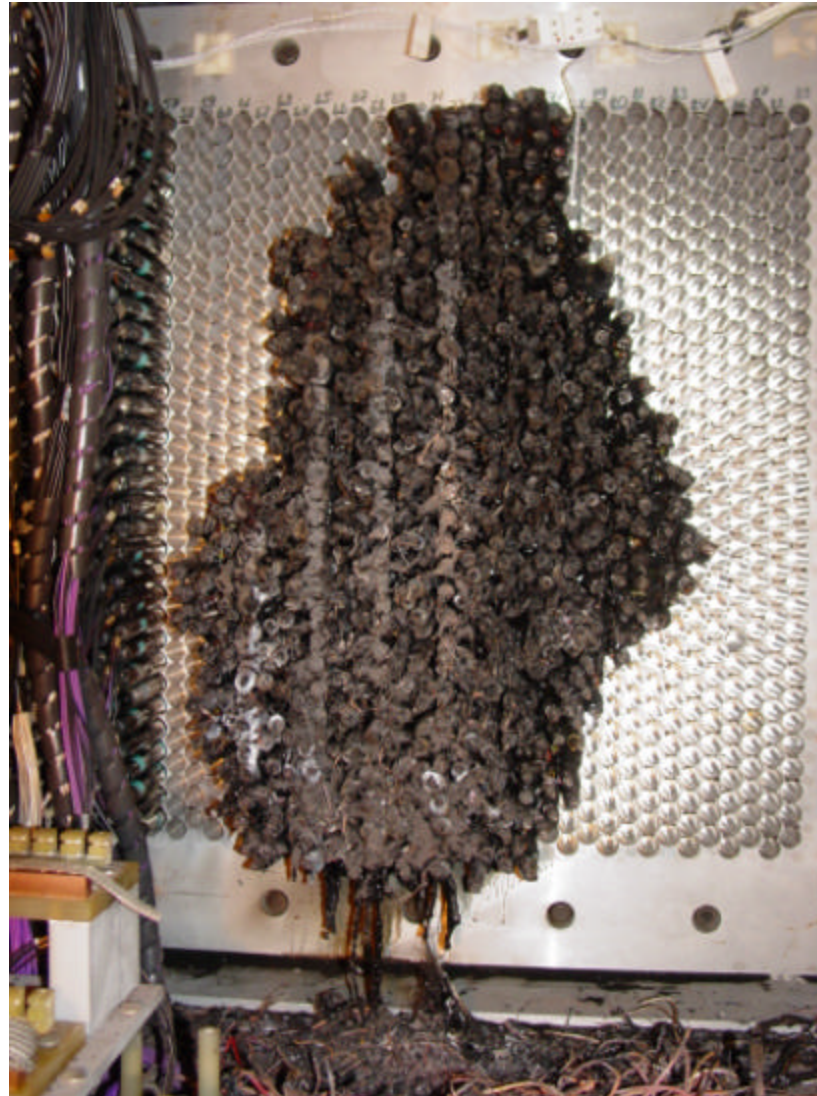
RICH Pictures

- All our readout electronics OK.
- Why did the Klixons not fire and kill the HV? Klixons were irrelevant
- How much damage has been suffered by the bases? (we have lost ~ 30% of detector)
- How much damage has been suffered by the phototubes? (working on this)
- The blowers were working. Did the cooler lose power before the incident? NO

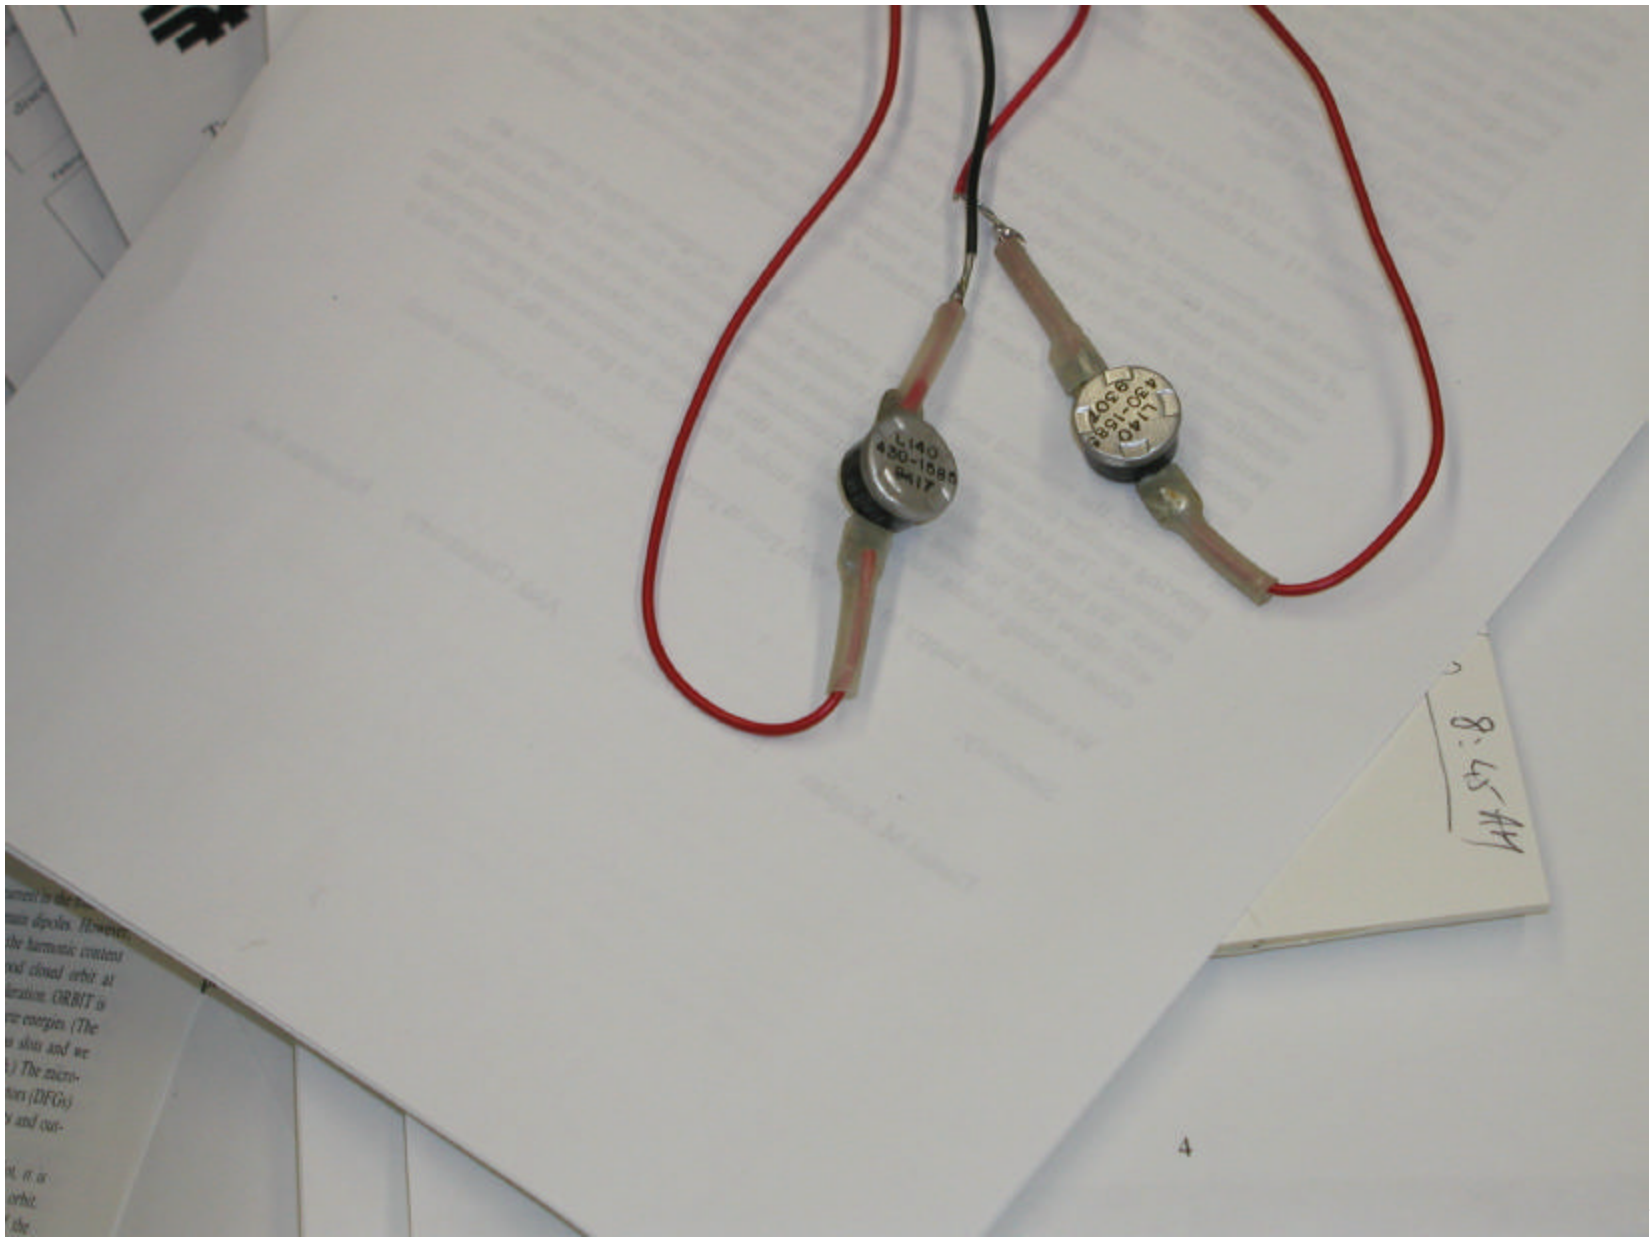
Klixon testing

Bad Klixon in center of hot spot

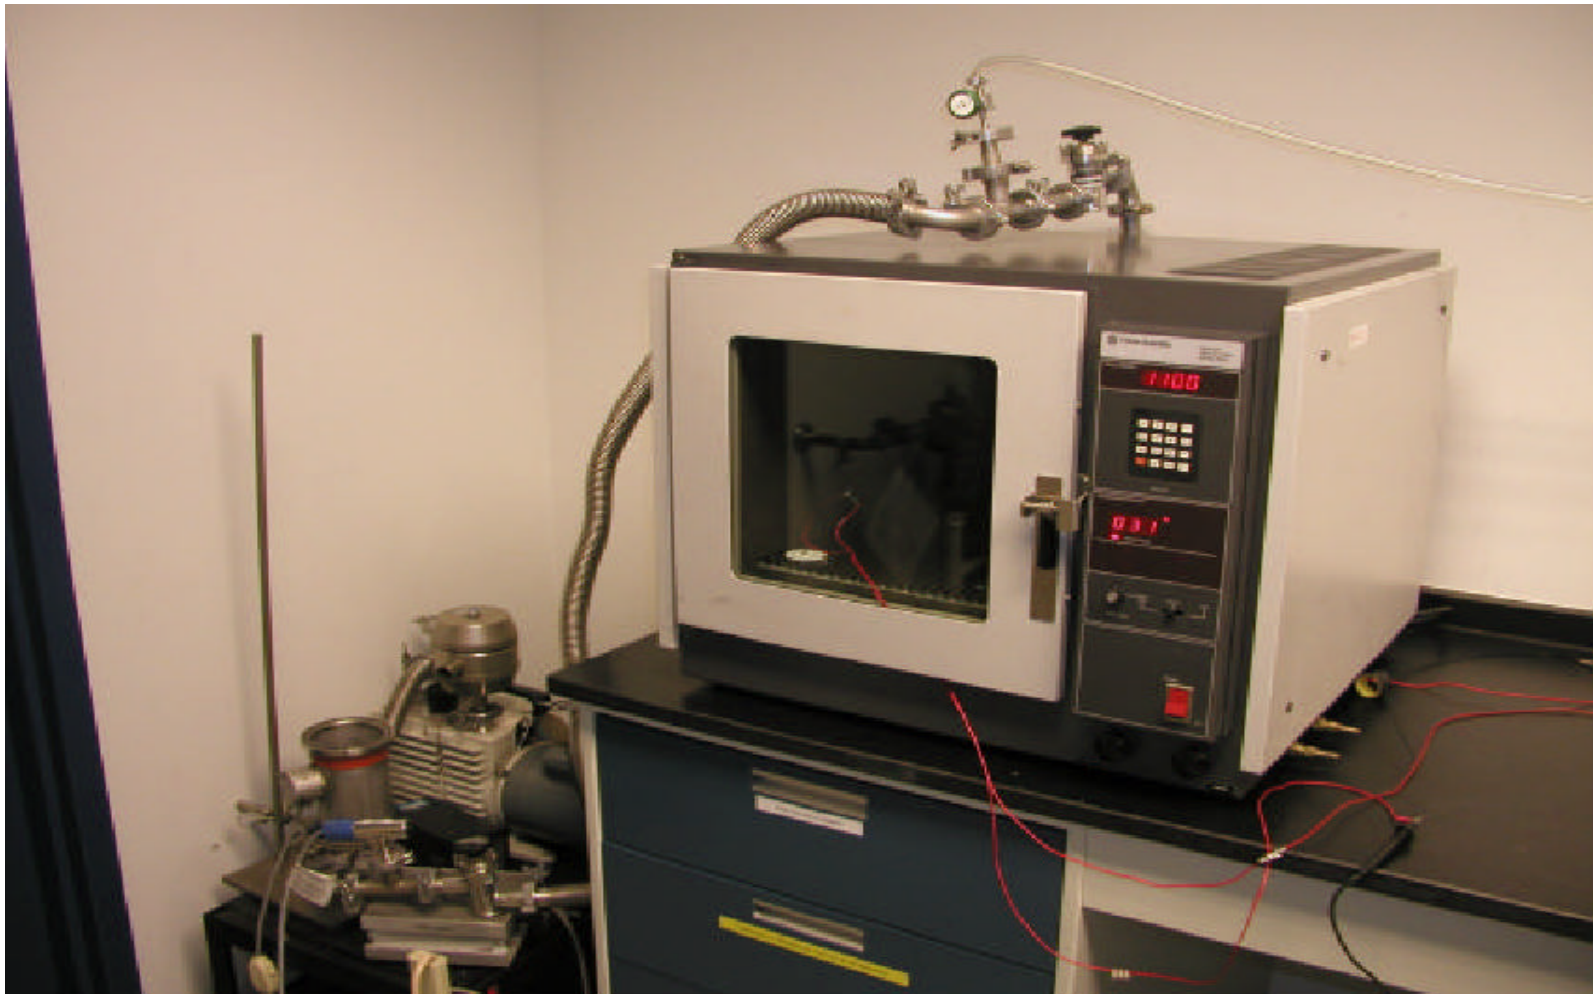
Testing Klixons

Figure 1 Oven with klixon in. The white object in the oven is a simple “coiled-spring” thermometer that measures the local temperature. The dial on the oven in the middle RHS measures the temperature according to a device in the back of the oven.

- Both good klixons opened up, the first one at 51degrees C, the second one (40-60 degrees C).
- Temperature of hot spot
- Measurement made in Lab 5

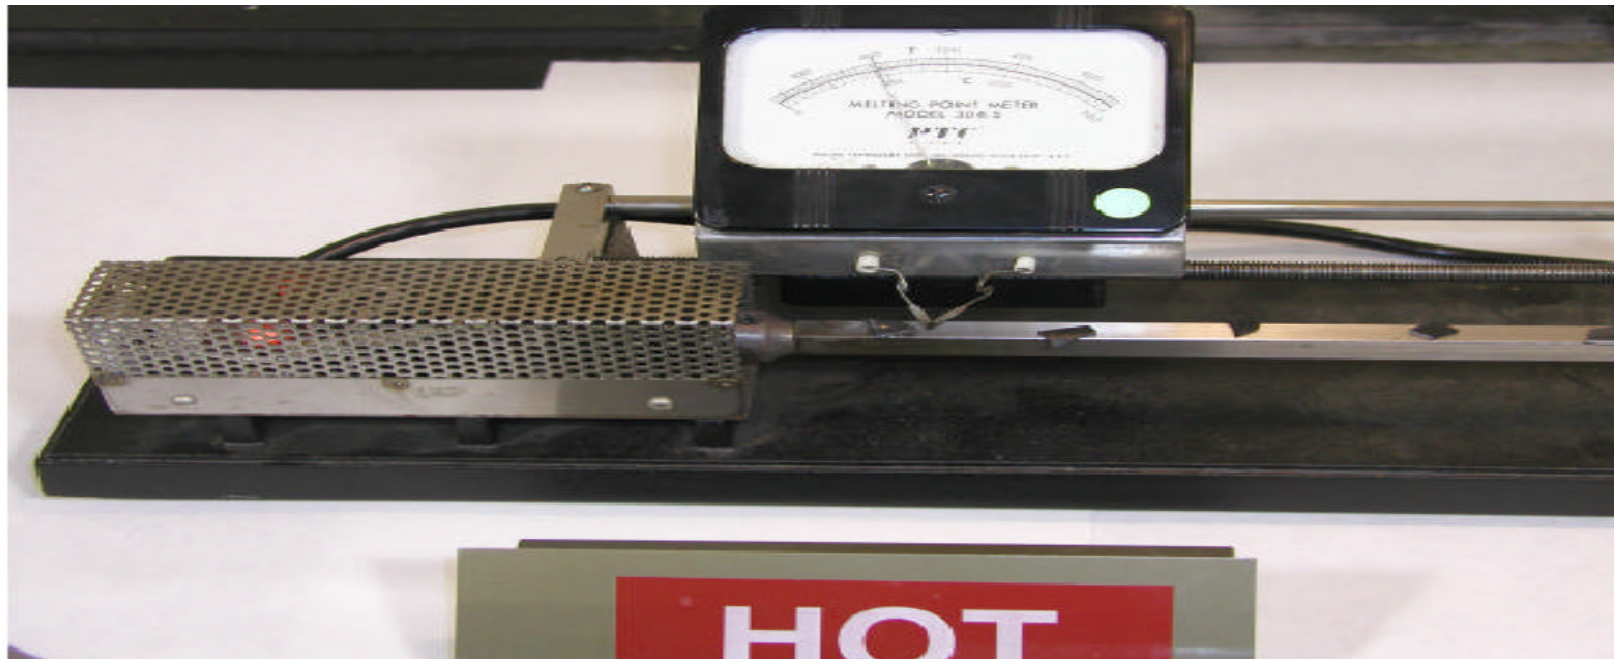
Klixon result

Samples are placed on a rod that is heated gradually from one end. The temperature rises gradually at the left hand end. There is a temperature gradient across the bar. The temperature at any point in the bar can be measured by the sliding meter. There was also a thermocouple which could measure temperature.

Conclusion—The heat in the affected area was so intense as to melt the plastic. So it must have exceeded 266 degrees C. For the heat NOT to trigger the good klixons implies a very sharp heat gradient consistent with a fire and NOT a heating problem due to inadequate cooling.
