MIPP Status

Status of MI PP RICH

Rich Panel Report

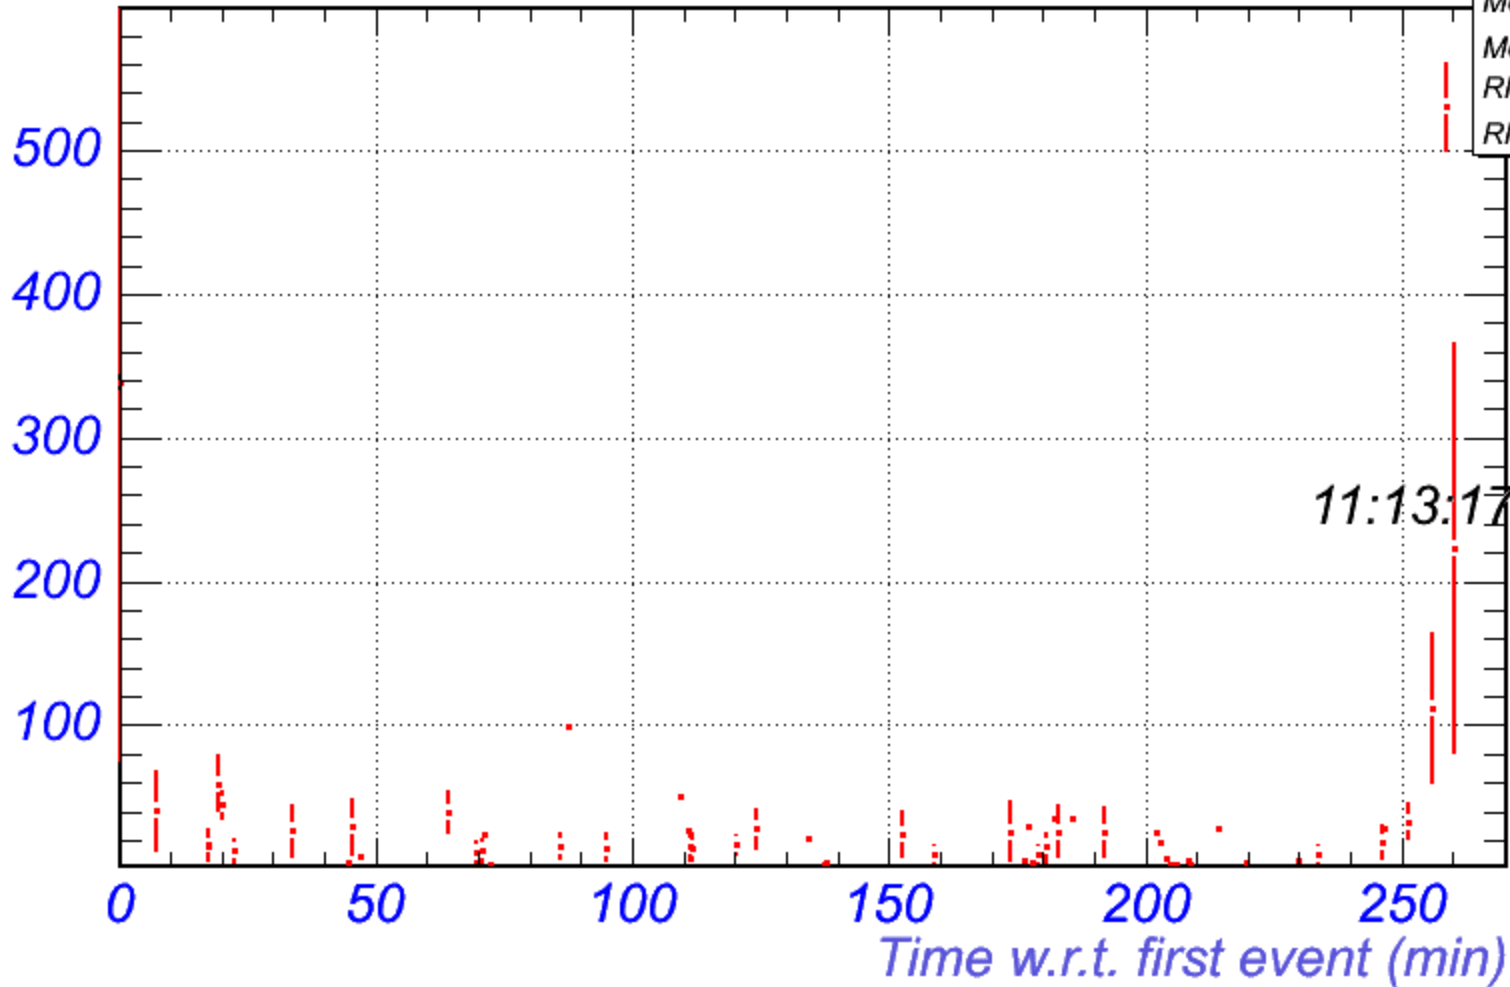
Number of RICH digits vs. time

- The HV was turned on March 2, 2004. All HV was set at 1400 V to begin with. This was 50-500 V below nominal.
- There was some sort of power glitch a week later. May be unconnected.
- Last event taken on March 14, 2003 at 11:13:11 AM.

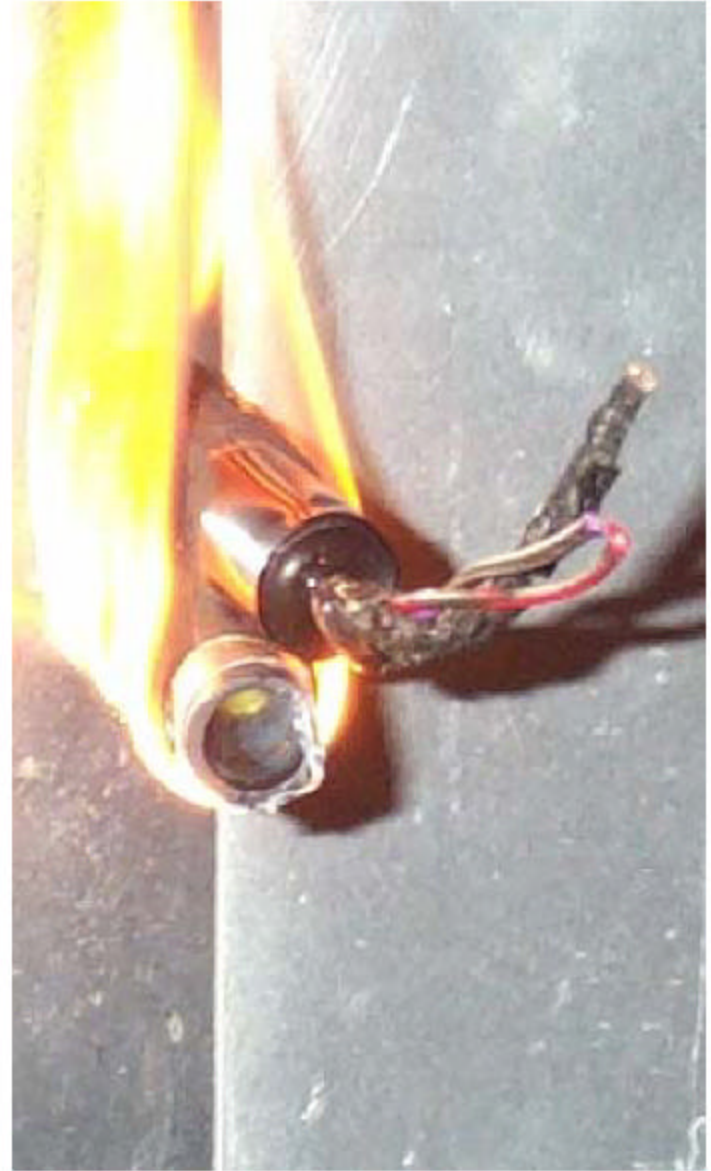
Fire tests

- 3 tests on both bases
- 1 with flame, 1 with piezoelectric spark
- Third with only Hamamatsu
 - » Picture shows 25 seconds into burn

- Enough energy was present in some form to ignite the FEU-60 base
- FEU-60 base burned rapidly to consumption in 2-3 mins.
- FEU-60 base dripped its burning material enough to spread the fire
- Hamamtsu R-760 base does not burn by itself
- Fire duration was most likely 3-10 mins

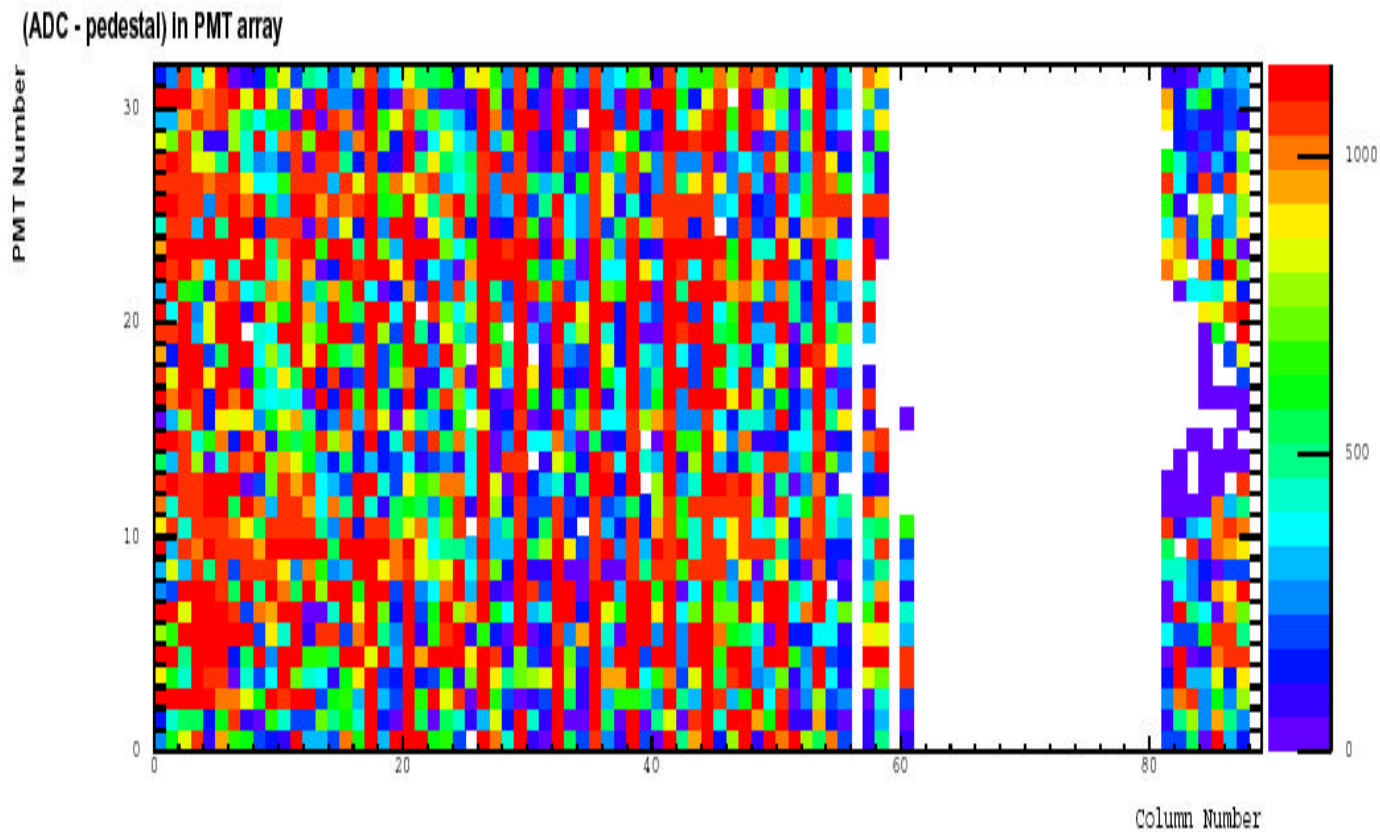
Tube testing results

- PPD has given us green light to implement panel recommendations
- RI CH front end moved to Lab6
- Clean up of burnt tubes proceeding. Should be completed today. ES&H analysis indicates some HCl in the soot. None of it affects any circuitry. Protective gear being worn.
- Tube testing completed-Good news. Tubes not in the immediate fire have survived. Tube bases in the fire were burnt. Tubes in the fire (without bases) need testing. We can run with the chains that have survived.

- Phase 1- With surviving tubes, deploy as soon as the panel recommendations are in place 3-4 weeks.
- Phase 1.5 -Recover good tubes (with good bases whose cables have been damaged and make new columns). Insert these as they become available.
- Phase 2- Build new bases for good tubes (with bad bases) and buy new tubes. (Longer term).

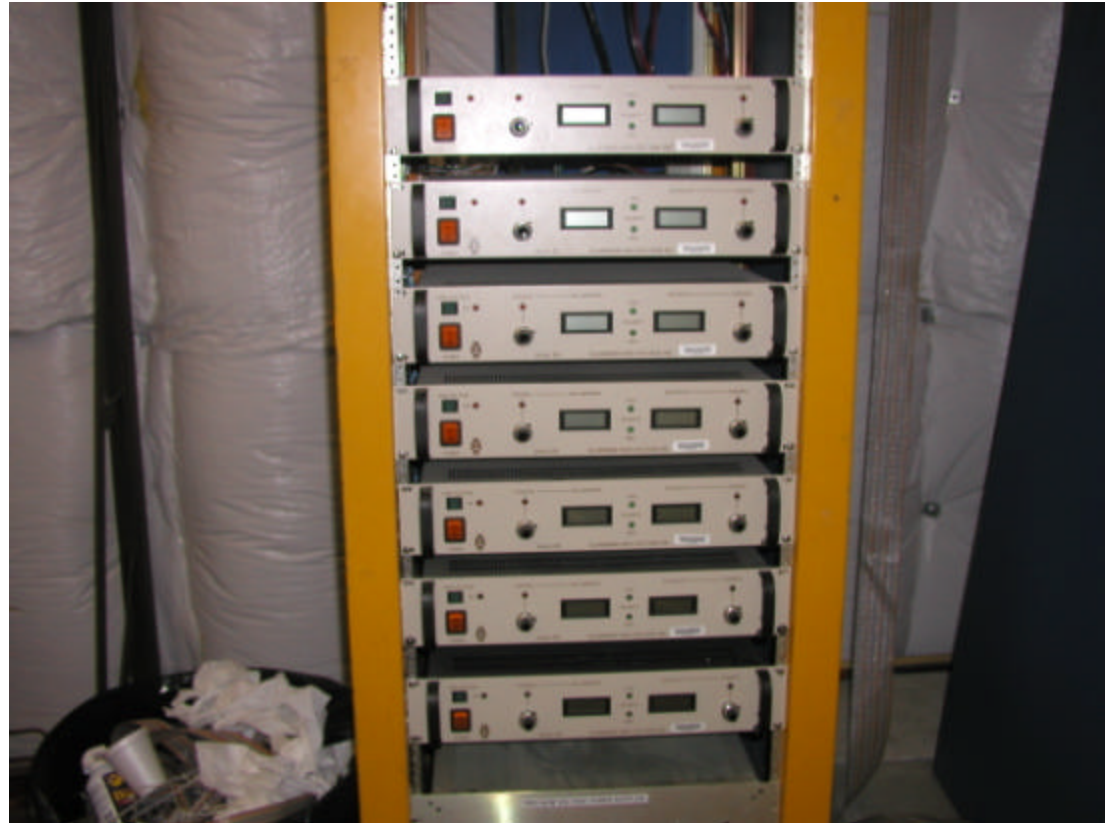
RICH HV supplies

- Current trip limits
3x100mA, 2x140 mA. Trips work.
- Interlocked with RICH
- Interlocks work
- Put out 900Watts for ~3000 phototubes
