# National Transportation Safety Board

## Safety Recommendation

**In reply refer to:** A-03-40

On April 27, 2002, about 0300 local time (0900 universal coordinated time), a DC-10-40F, N141WE, operated by Centurion Air Cargo, Inc., sustained substantial damage to the left wing and all three of its hydraulic systems when pieces of ruptured tire from the left main landing gear penetrated the left wing lower access panel during takeoff from San Salvador International Airport, San Salvador, El Salvador. The flight crew continued with the takeoff but returned to the airport approximately 30 minutes later. There were no injuries to the three flight crewmembers and two mechanics on board. The flight was being operated as a 14 *Code of Federal Regulations* (CFR) Part 121 cargo flight from San Salvador to Guatemala City, Guatemala, on an instrument flight rules flight plan. The accident occurred in visual meteorological conditions.<sup>1</sup>

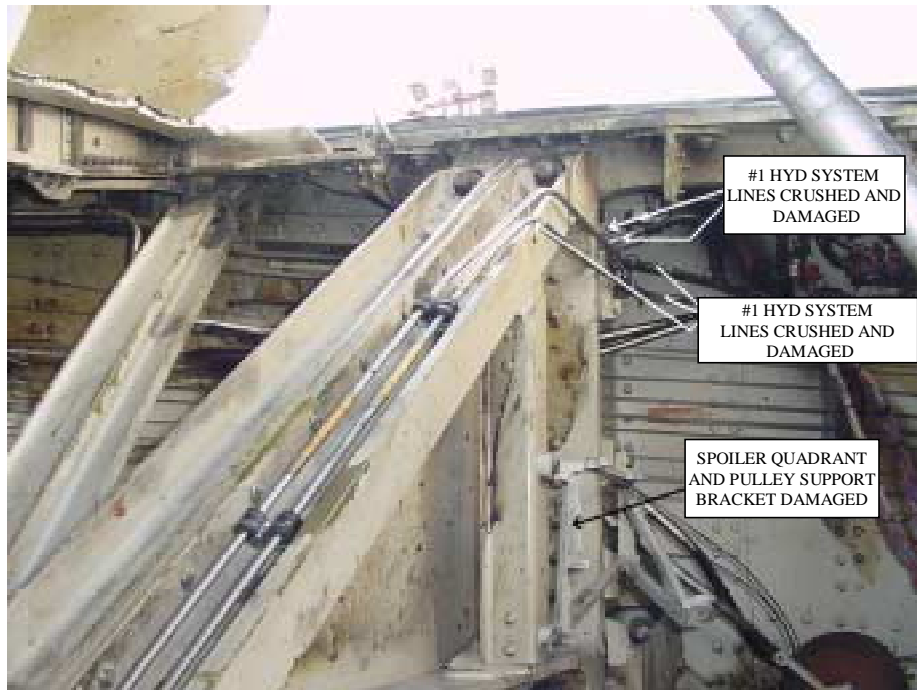
During postaccident examination of the airplane, the tread on the number 1 tire (in the outboard front position on the left main landing gear) was found damaged, but the tire continued to hold air pressure. The number 5 tire (in the outboard rear position on the left main landing gear) was found ruptured. Extensive damage was observed in the left wing, above the left main landing gear, that included fractured lines in the number 1 and 2 hydraulic systems (see figures 1 and 2); a severely dented line in the number 3 hydraulic system; and damaged mechanical

**Figure 1 –Damaged #1 Hydraulic System Lines**

Require adequate protection of DC-10 hydraulic system components in the wing area from tire fragments in the event of a tire rupture. Such protection may include, but is not limited to, installing stronger wing access panels; shielding the hydraulic lines; installing fuses in the hydraulic lines in this area; or rerouting the hydraulic lines to provide greater separation between the systems. (A-03-40)

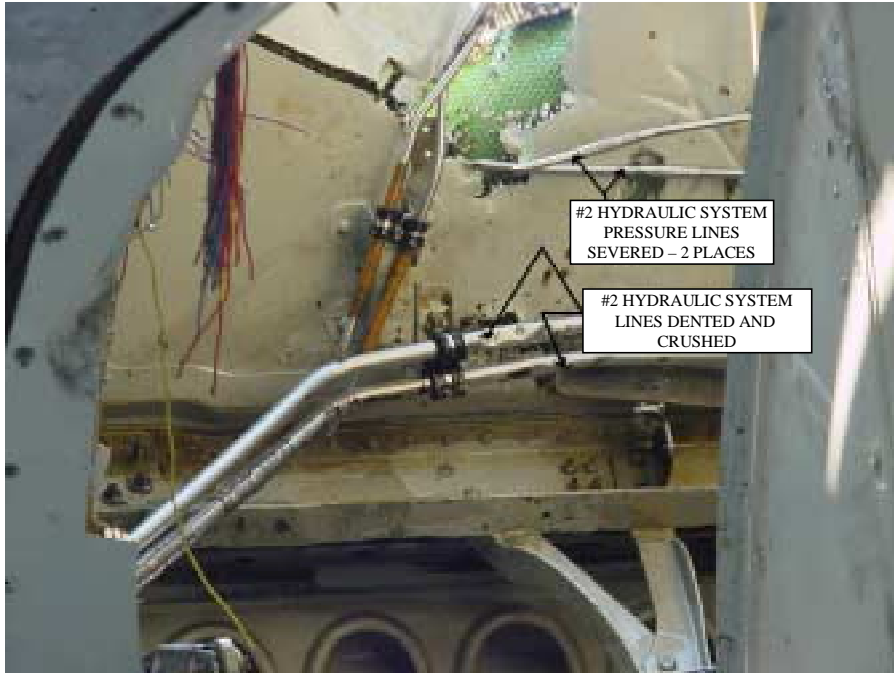
**Figure 2 – Severed and Damaged #2 Hydraulic System Lines**

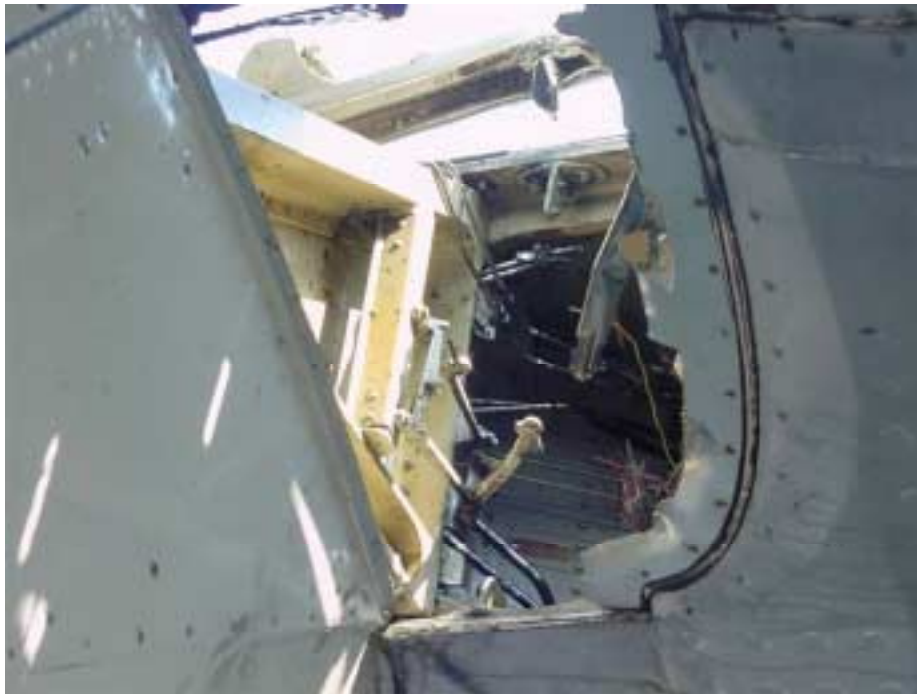
control cables, pulleys, pushrods, and electrical wiring. The lower wing access panel<sup>2</sup> that shields these components was completely destroyed (see figure 3) by the fragments from the number 5 tire. The tire pieces retained enough energy to exit through the upper wing skin, creating a hole measuring approximately 12 inches by 18 inches (see figure 4). A thrust reverser cascade from another airplane<sup>3</sup> was found left of the centerline on the takeoff runway, where the accident airplane's left main landing gear would have contacted it during the takeoff roll.

<sup>2</sup> The lower wing access panel is a lightweight, all-aluminum honeycomb structure that measures about 0.34 inch thick with an outer skin that measures about 0.016 inch thick. Boeing has indicated that it is currently working on a design change to strengthen the access panel that was breached in this accident. However, no schedule was provided for completing the change.

**Figure 3 – Damage to the Lower Wing Access Panel (view from below)**

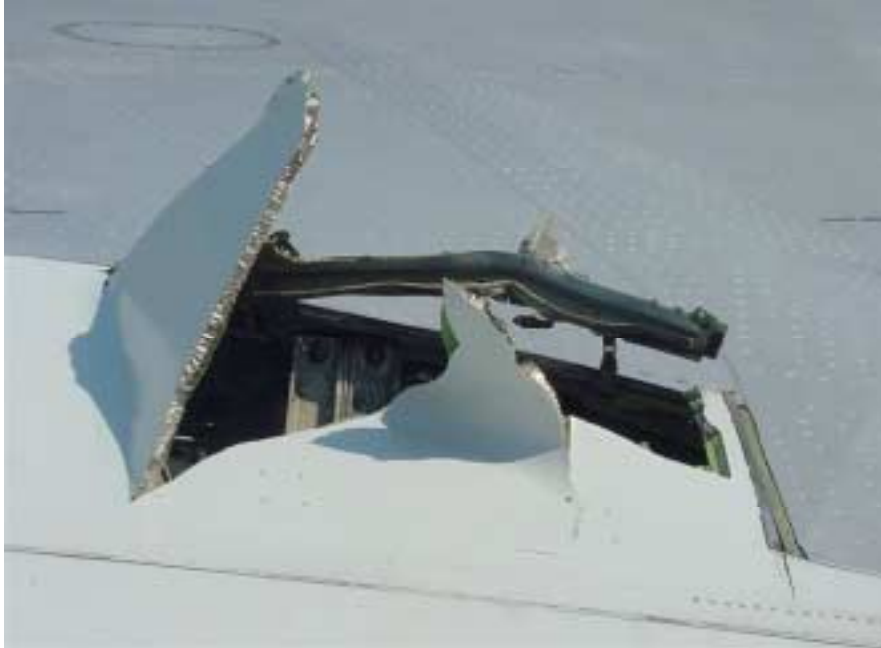
**Figure 4 –Damage on the Upper Wing Caused by Exiting Debris**
