National Transportation Safety Board

Safety Recommendation

Date: March 21, 2007

In reply refer to: A-07-33

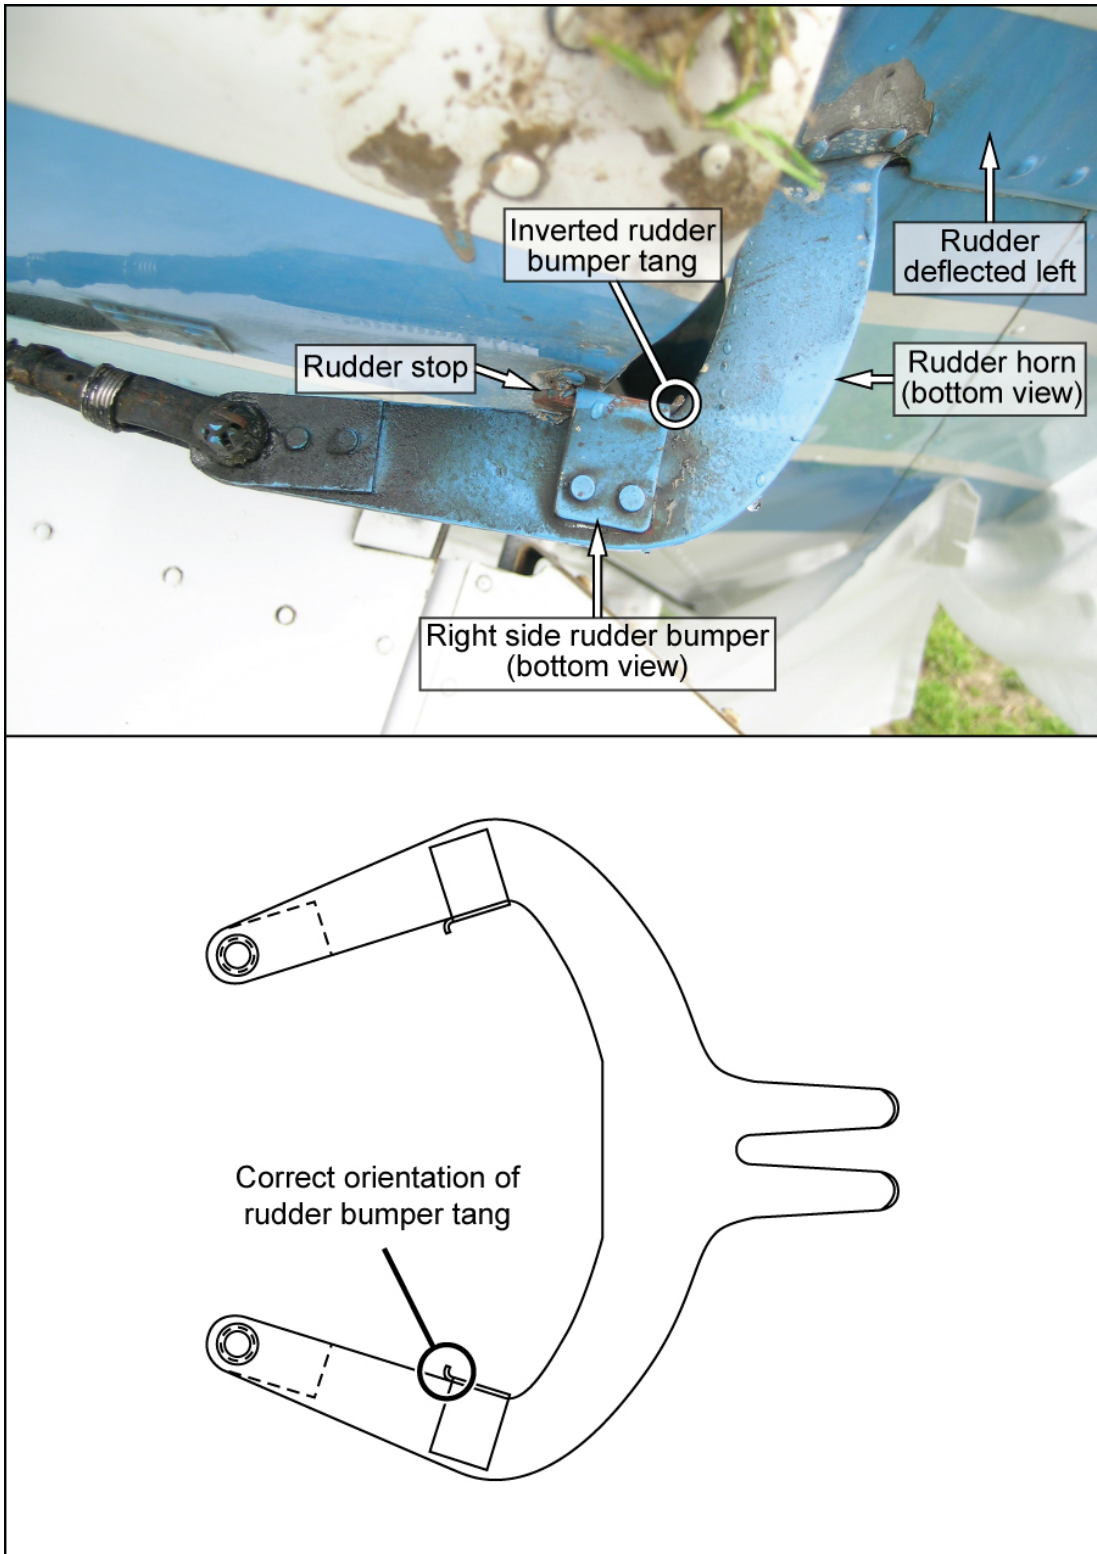
Examination of the wreckage revealed that the rudder was jammed approximately 35°, which is beyond its left travel limit.² Further examination revealed that the two rudder bumpers had been installed inverted and that the right rudder bumper had traveled beyond the rudder stop and had locked behind it. As shown in the photograph in figure 1, the accident airplane's right rudder bumper had traveled to the right of the rudder stop when it was supposed to be to the left of the rudder stop; the drawing in figure 1 shows the rudder bumper's correct orientation. The inverted rudder bumpers may have caused the rudder jam because, when a rudder bumper is inverted, the "tang" (portion of the rudder bumper that contacts the rudder stop to prevent the bumper from further travel) points toward instead of away from the curvature of the rudder horn; thus, the rudder bumper can pass over and beyond the stop and result in a jam.

Figure 1. Photograph of accident airplane's rudder horn and drawing of a rudder horn showing correct rudder bumper tang orientation.

The investigation could not determine whether the incorrect installation of the rudder bumpers occurred at the time of production or during the airplane's maintenance history. Review of the maintenance records indicated no record of work having been performed on the rudder bumpers during the airplane's 28-year history. Maintenance records indicated, however, that work had been performed near the rudder bumpers on several occasions. Also, paint observed on the inverted rudder bumpers during postaccident examination was consistent with the maintenance records, which indicate the airplane was painted about 8 years before the accident. There were no maintenance records of work being performed on the rudder bumpers in at least 8 years.

Issue an airworthiness directive requiring that Cessna 150 and 152 models comply with Cessna's Service Bulletin No. SEB01-1 and undergo a one-time inspection at the next 100-hour or annual inspection to verify that the rudder bumpers are correctly installed on the rudder horn assembly. (A-07-33)
