National Transportation Safety Board

Safety Recommendation

Date: October 19, 2007

In reply refer to: A-07-87 and -88

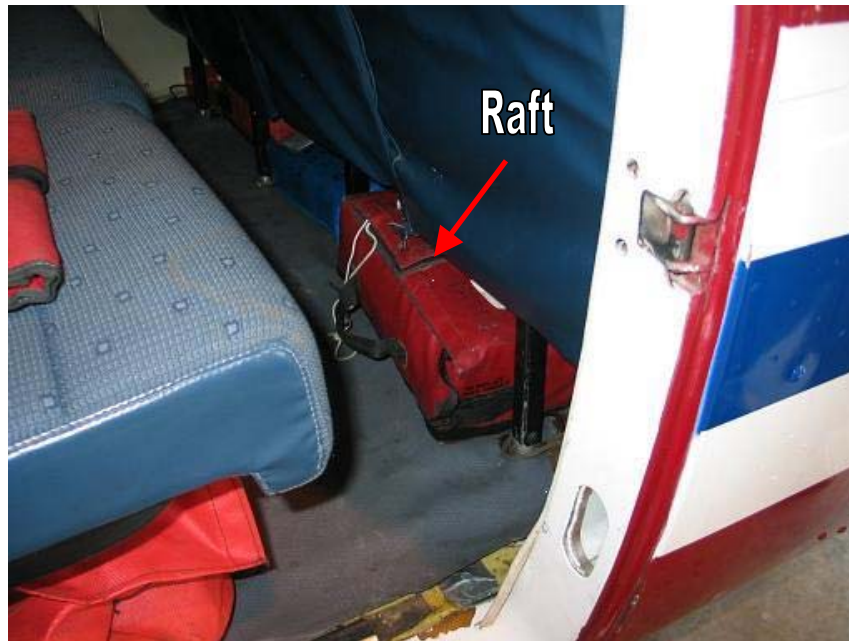
As the helicopter hit the water, the floats on the right side burst, causing the helicopter to roll sharply to the right. The occupants quickly evacuated the rapidly flooding cabin. Neither of the two 18-pound liferafts that were stored under the outboard first row of cabin seats (see figure 1 for an example of the location of these liferafts) was retrieved before the helicopter sank. The captain stated during a postaccident interview that he thought about retrieving one of the liferafts but could not find them; the first officer stated that there was not enough time to remove the liferafts because the helicopter sank so rapidly. Without a liferaft to protect them from the Gulf waters, several of the passengers suffered hypothermia. All occupants wore personal

Figure 1. Photograph showing liferaft location on board a Sikorsky S-76 helicopter

Require that all existing and new turbine-powered helicopters operating in the Gulf of Mexico and certificated with five or more seats be equipped with externally mounted liferafts large enough to accommodate all occupants.
(A-07-87)

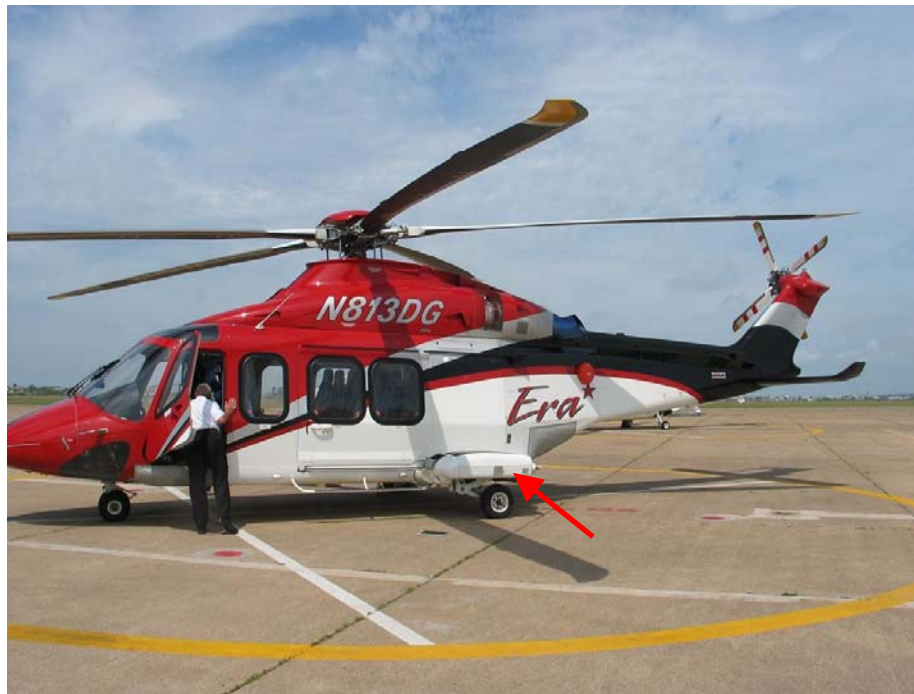
water. The Safety Board is aware that, in the past 5 years, the Federal Aviation Administration (FAA) has certificated externally mounted liferafts for several different models of helicopters. One type integrates the floats and incorporates either two 6-person or two 10-person liferafts with inflation systems. The float/liferafts are mounted on the landing gear skid tubes, and a mechanical handle/lever or an electrically activated switch in the cockpit and in an overhead console between the cockpit and passenger compartment initiates inflation of the liferafts after the floats inflate.¹⁶ Some of the external liferaft systems are equipped with an external (mechanically operated) T-handle that provides a backup means of deployment in case the flight crew is incapacitated. The largest supplier¹⁷ of externally mounted liferafts holds supplemental type certificates (STC) for Agusta, Bell, and Eurocopter model helicopters (figure 2 shows an Agusta Westland AB139 model helicopter equipped with an external liferaft).

Figure 2. An external liferaft pod on an Agusta Westland AB139 helicopter (as indicated by the red arrow).

turbine-powered helicopters operating in the Gulf with externally mounted liferafts could increase the chances for occupant survival following an accident, the Safety Board believes that the FAA should require that all existing and new turbine-powered helicopters operating in the Gulf of Mexico and certificated with five or more seats be equipped with externally mounted liferafts large enough to accommodate all occupants.
